MINERALS PROGRAM INSPECTION REPORT
PHONE: (303) 866-3567

MINE NAME: Bijou Clay Mine	MINE/PROSPECTING ID#: M-1997-007	MINERAL: Clay (general)	COUNTY: Elbert
INSPECTION TYPE: Surety Release Inspection	WEATHER: Clear	INSP. DATE: August 3, 2023	INSP. TIME: 10:05
OPERATOR: The Denver Brick Company	OPERATOR REPRESENTATIVE: Richard Murphy	TYPE OF OPERATION: 112c - Construction Regular Operation	
REASON FOR INSPECTION: Surety Release Requested	BOND CALCULATION TYPE: Complete Bond	BOND AMOUNT: \$196,124.37	
DATE OF COMPLAINT: NA	POST INSP. CONTACTS: None	JOINT INSP. AGENCY: None	
INSPECTOR(S): Joel Renfro Amy Eschberger	INSPECTOR'S SIGNATURE:

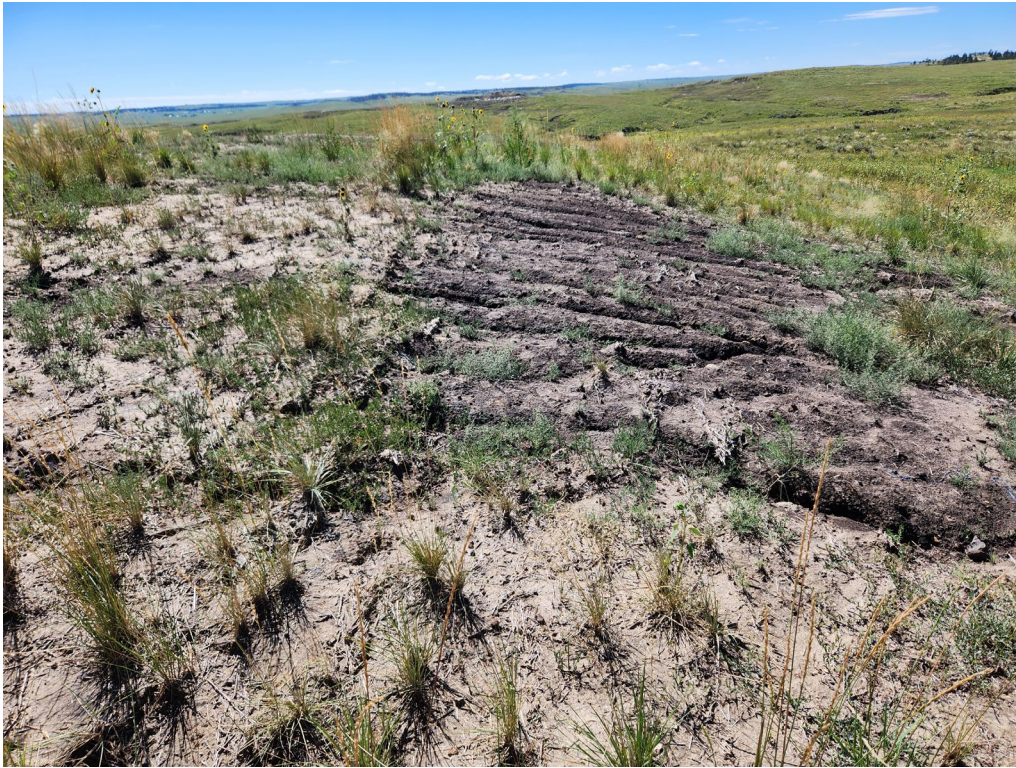
PROBLEM #1: Erosion gullies and rills were observed on-site. Gullies were found north west of the phase 4 pit and also east of the phase 3 pit. Rill erosion was observed throughout the site on bare slopes, which may form into gullies if left untouched. This is a problem at this time for failure to protect the affected land from erosion pursuant to C.R.S. 34-32.5-116(4)(j) and Rule 3.1.6(3).

During the current inspection, erosion in the form of rills and gullies were observed throughout the site. Rills were found mostly along graded slopes. A large gully was observed in the southwest (see **photos 23-24**) at the northwestern corner of the phase 4 mining area. A larger gully was found in the northeast (see **photos 21-22**) at the eastern edge of the phase 3 mining area, where stormwater from the affected land enters a natural ephemeral drainage that runs off site. The operator has constructed a shallow detention basin on the floor of the phase 3 area to help manage stormwater. This detention basin does not appear to be effectively managing stormwater, at least not after the strong storm events that recently occurred in the area. Considering the large gully that has formed at the eastern edge of the detention basin in which stormwater entered into the natural drainage east of the permit, there is a high risk in this area of off-site damage. Pursuant to C.R.S. 34-32.5-116(4)(j) and Rule 3.1.6(3), all surface areas of the affected land, including spoil piles, shall be stabilized and protected so as to effectively control erosion. Additionally, Rule 3.1.5(3) requires all grading be done in a manner to control erosion and siltation of the affected lands, to protect areas outside the affected land from slides and other damage. Accordingly, erosion is cited as a problem in this report (see **Problem #1**). The operator shall provide photo documentation to the Division verifying the described erosion gullies have been repaired, rills are being controlled, and that the site has been reconstructed and stabilized to prevent erosion damage. Refer to **photos 6-10, 21-24** for images of some of the observed erosion features.

Photo 6. Bare patch of eroded topsoil forming rills in phase 1 mining area, looking east.

CORRECTIVE ACTIONS: The operator shall provide photo documentation to the Division verifying erosion gullies have been repaired, rills are being controlled, and that the site has been reconstructed and stabilized to prevent further erosion damage by the corrective action date.

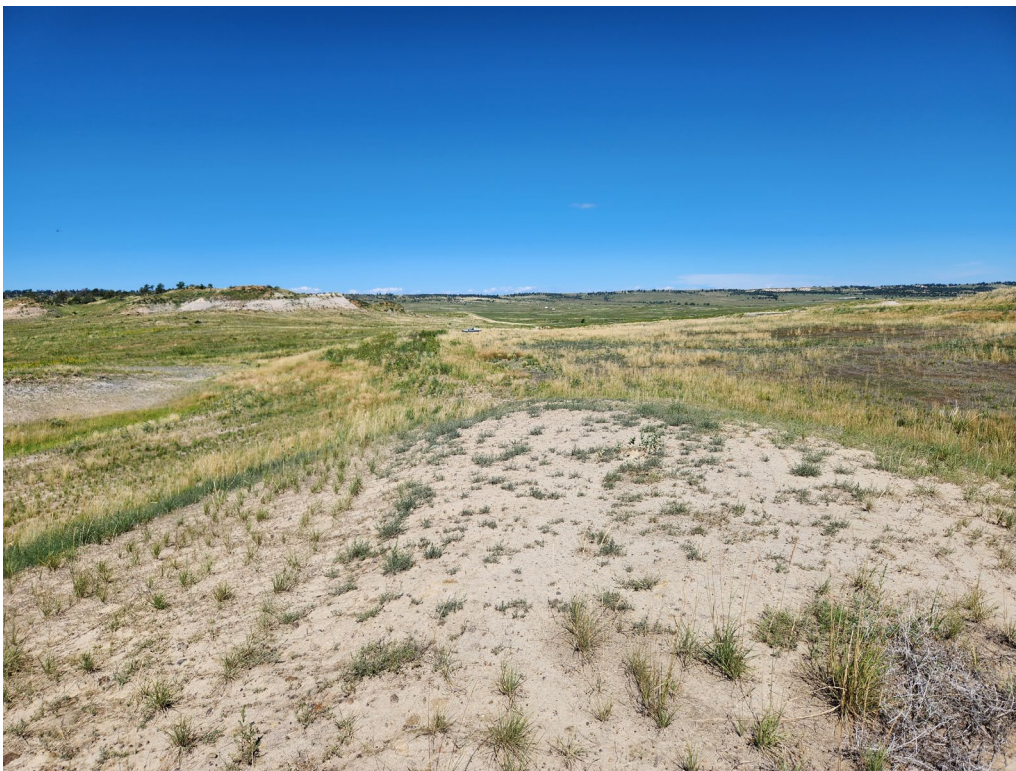
Vegetation within the site consisted of grasses found in the approved seed mix. Dense stands of established grasses were observed in some areas, particularly in the earlier reclaimed phase 2 and phase 3 areas. However, scattered bare patches were observed throughout the site, particularly on top of graded slopes. These bare patches appear to be contributing to the erosion issues observed at the site. Refer to **photos 3-13** for images of revegetation. The Division would like to remind the operator of Rule 3.1.10(1), which states in those areas where revegetation is part of the Reclamation Plan, land shall be revegetated in such a way as to establish a diverse, effective, and long-lasting vegetative cover that is capable of self-regeneration without continued dependence on irrigation, soil amendments or fertilizer, and is at least equal in extent of cover to the natural vegetation of the surrounding area. The Division recommends the operator reseed any bare areas as soon as practicable, and closely monitor the growth of desired vegetation to ensure the affected lands are revegetated in accordance with Rule 3.1.10(1).

Photo 7. Bare patch of land in phase 1 mining area, looking west.

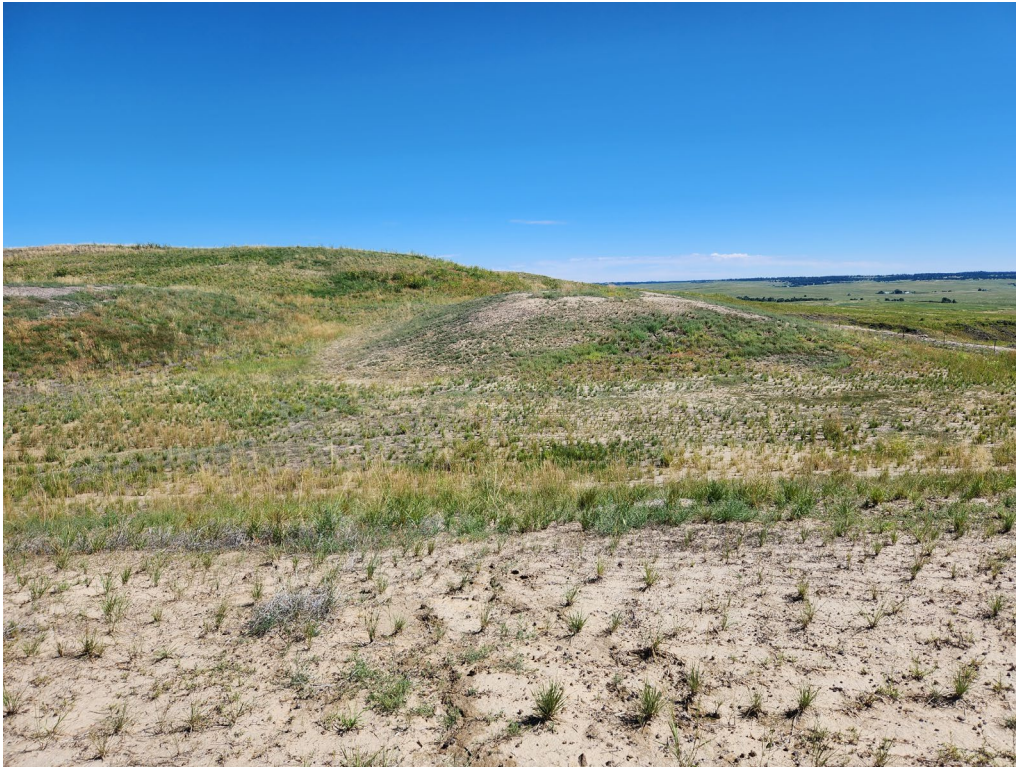
Photo 8. Sparse revegetation in phase 2 mining area, looking north.

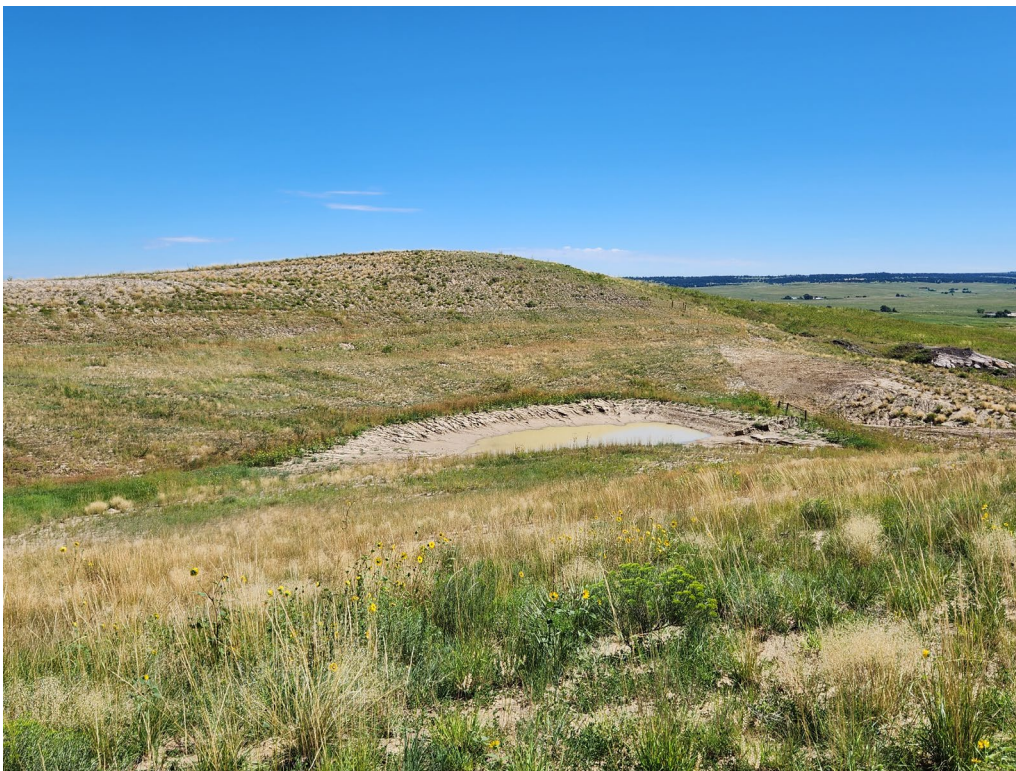
Photo 9. Revegetation in phase 3 mining area, looking north.

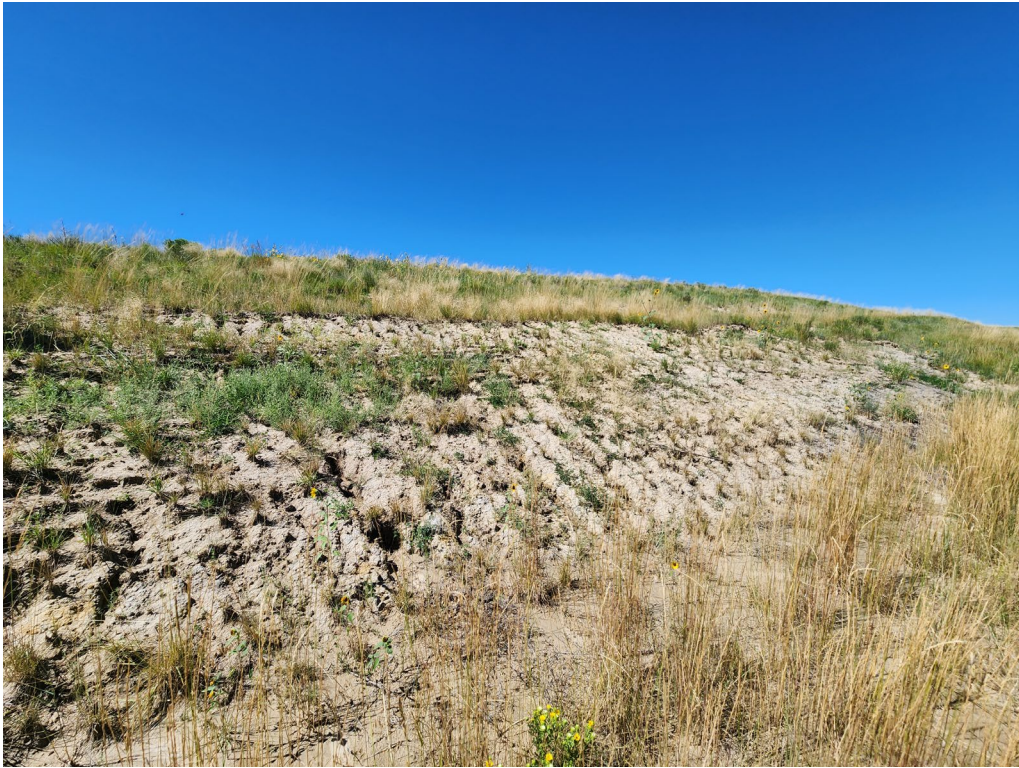
Photo 10. Eroded slope forming rills between phase 3 and phase 2 mining areas, looking southwest.

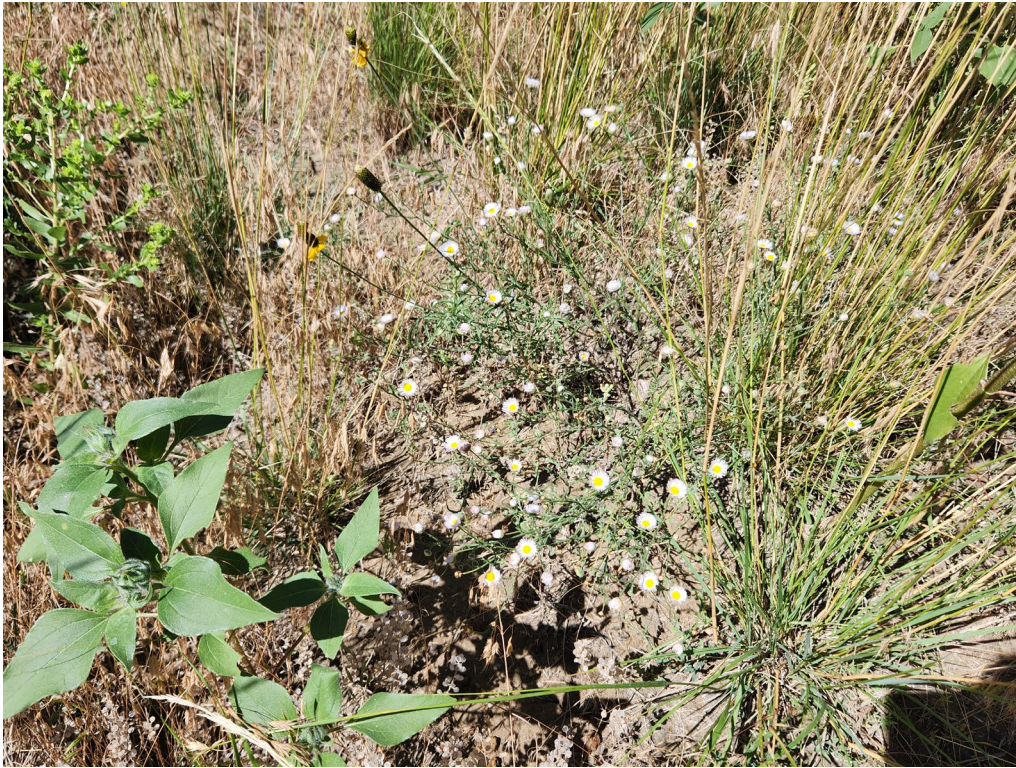
PROBLEM #2: There are state-listed noxious weeds present on site. This is a problem for failure to employ weed control methods for state listed noxious weed species within the permitted area, and to reduce the spread of weeds to nearby areas as required by Rule 3.1.10(6).

Many species of noxious weeds were present at the time of inspection, including Musk Thistle, Chamomile, Downey Brome (Cheatgrass), Diffuse Knapweed, and Field Bindweed. This is cited as a problem in this report (see **Problem #2**). The operator will need to submit evidence that noxious weeds are being treated in accordance with the approved weed management plan. Evidence includes, but is not limited to, an invoice for service, receipt of chemical purchase, and/or images of sprayed plants. Refer to **photos 14-19** for images of some noxious weeds observed at the site.

Photo 14. Chamomile located in southwest portion of site.

CORRECTIVE ACTIONS: The operator shall submit evidence (invoice for service, receipt of chemical purchase, and/or images of sprayed plants) to the Division of implementation of the approved weed control plan by the corrective action due date.

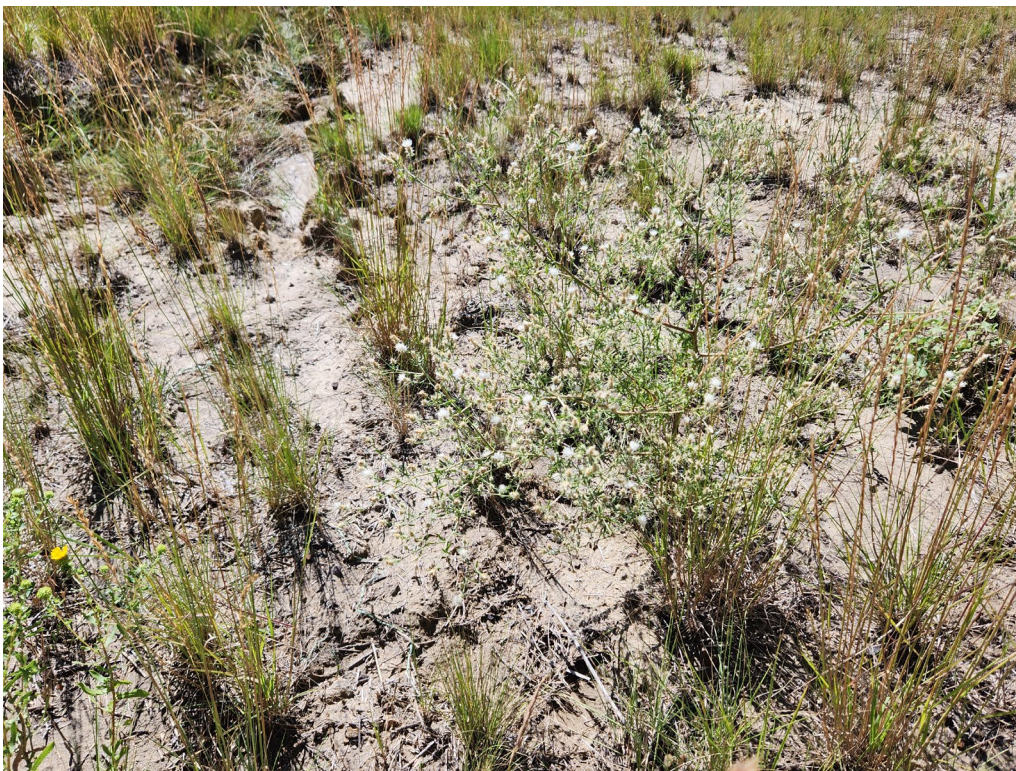
Photo 15. Diffuse Knapweed located in southwest portion of site.

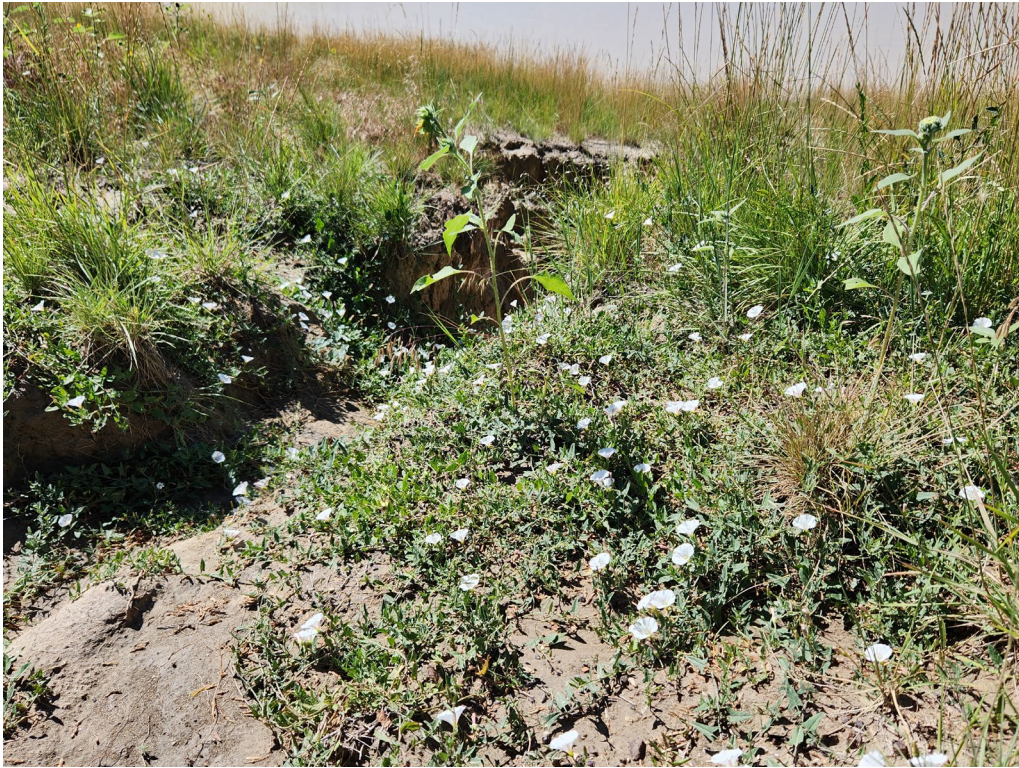
Photo 16. Field Bindweed located in southwest portion of site.

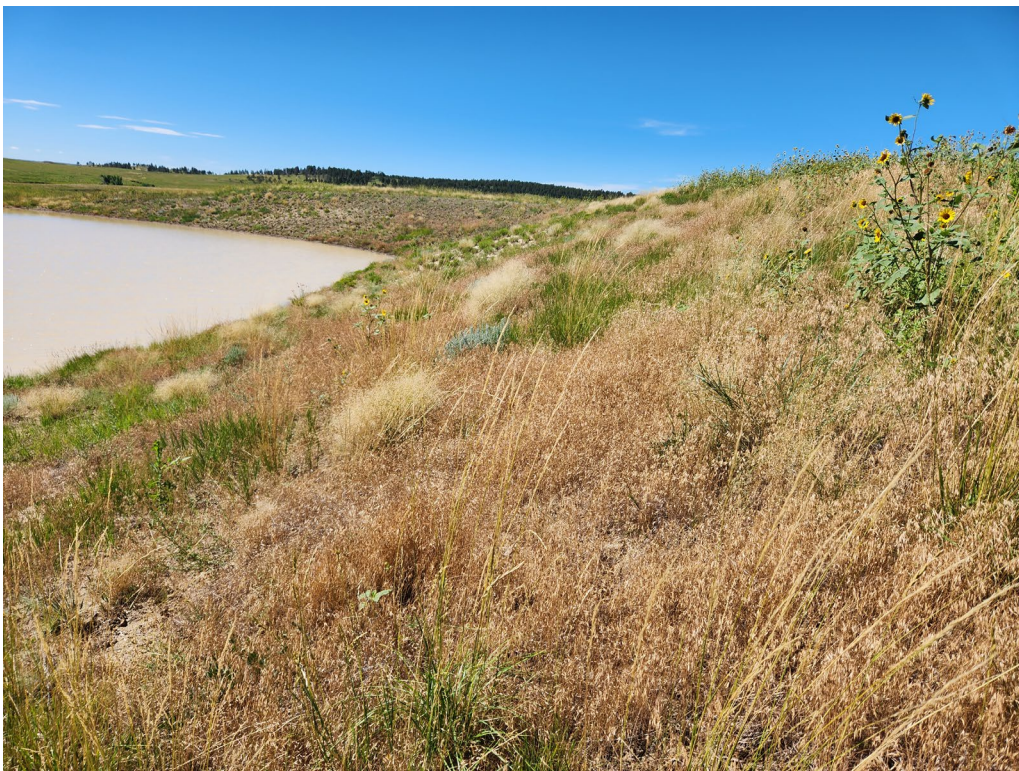
Photo 17. Downey Brome (Cheatgrass) patch located in southwest portion of site.

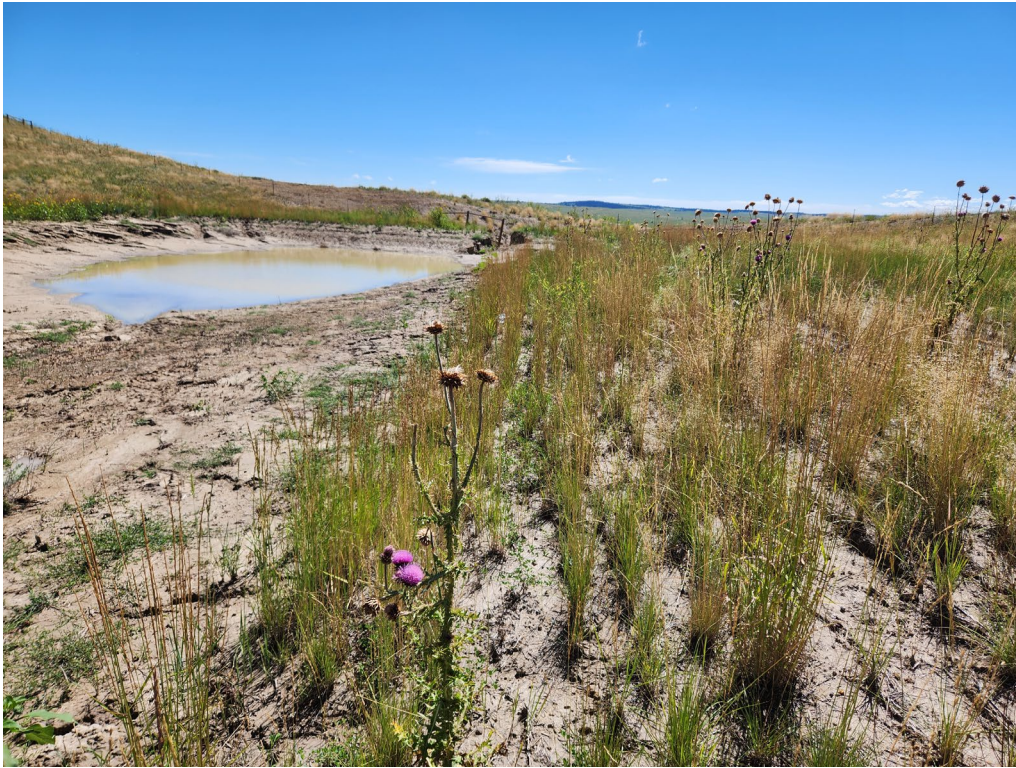
Photo 18. Musk Thistle located south of detention basin in northeast portion of site.

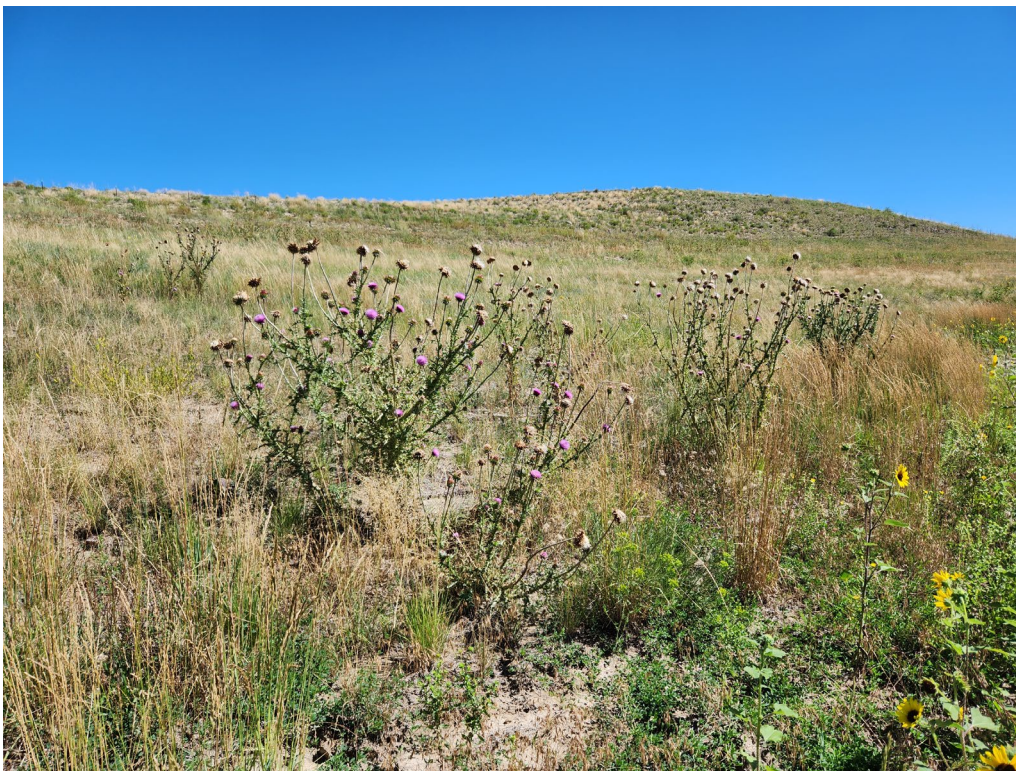
Photo 19. Musk Thistle located north of detention basin in northwest portion of site.

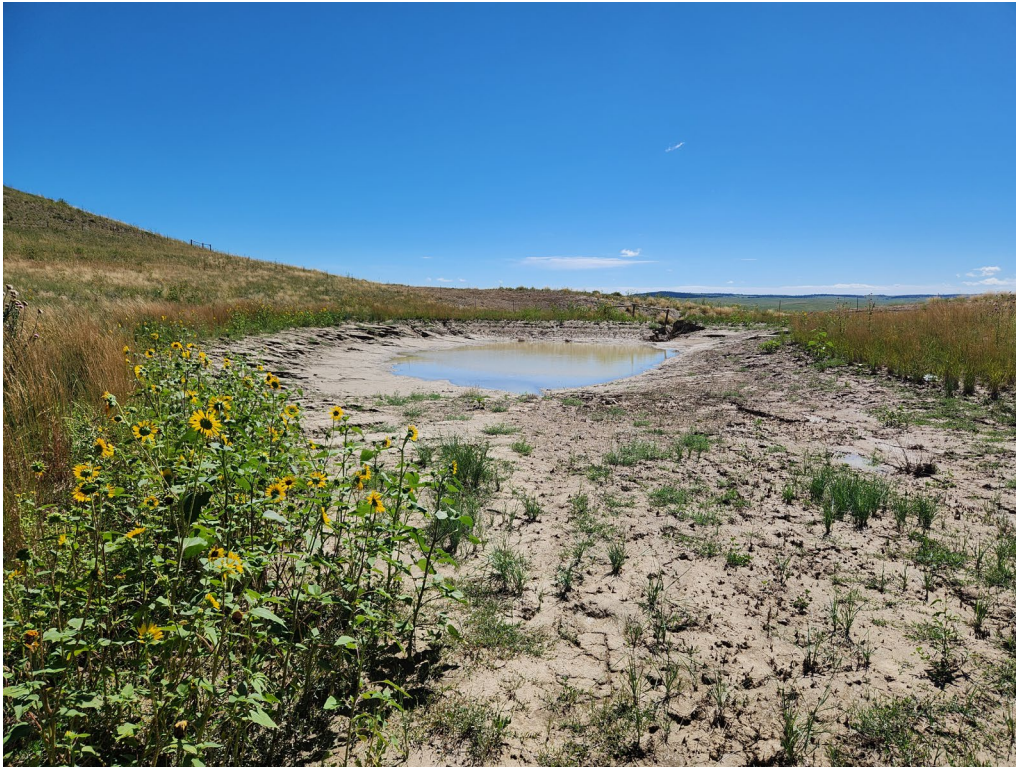
Photo 20. Detention basin located at northeast edge of site, looking east.

If any stormwater management structures are proposed to remain for reclamation (e.g., detention basins, channels, riprap features), the operator will need to submit a Technical Revision to revise the reclamation plan and map to incorporate these structures. During the inspection, the operator mentioned the detention basin might be used by the landowner as a livestock pond. While leaving a livestock pond would be consistent with the approved rangeland post-mining land use for the site, the approved reclamation plan and map do not include leaving ponds. Therefore, if the operator wishes to leave any livestock ponds at the site, the reclamation plan and map must be updated accordingly through a Technical Revision submittal. The current approved reclamation plan map is enclosed for reference.

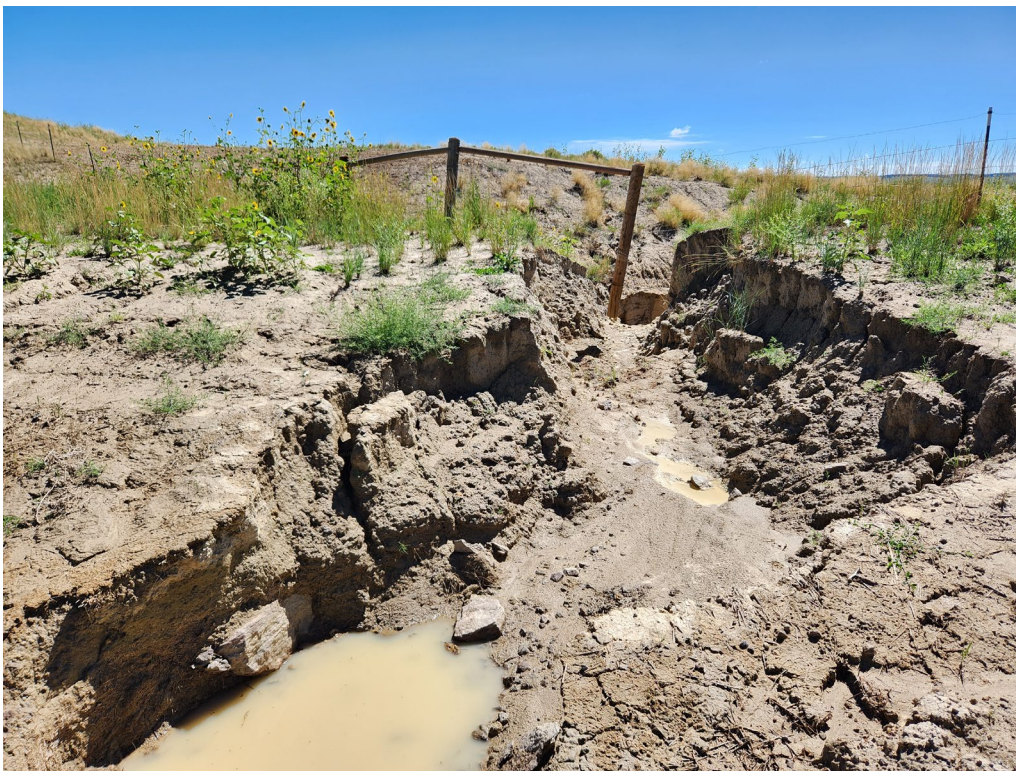
Photo 21. Gully leading from detention basin to natural drainage at eastern permit boundary, looking east.

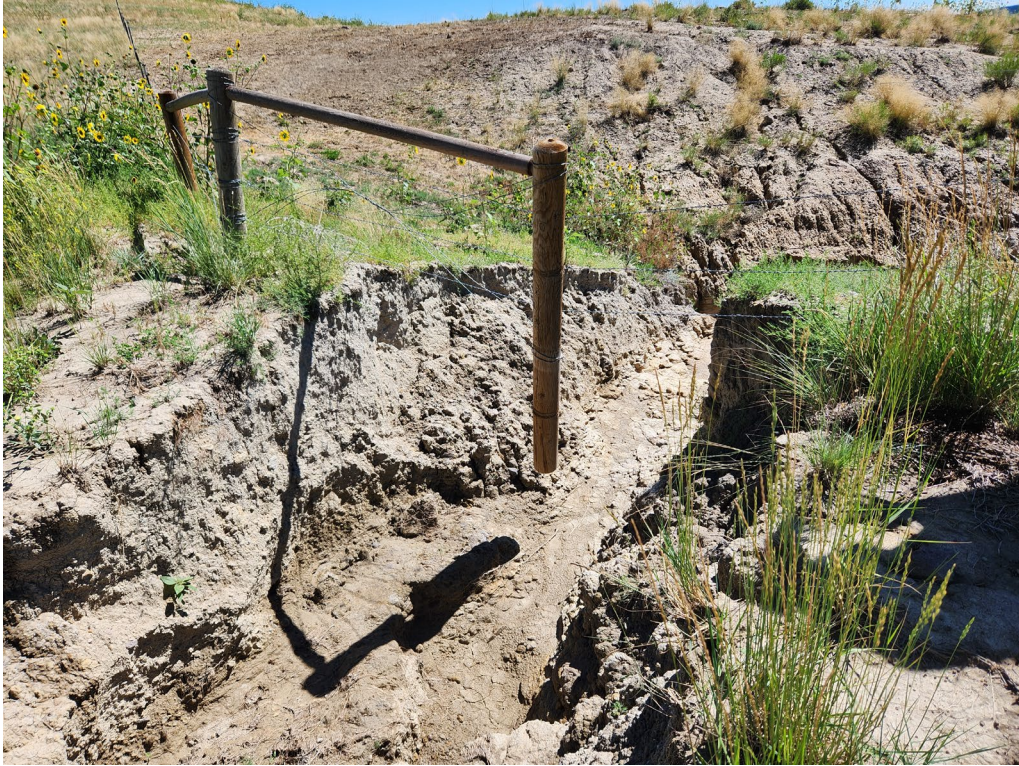
Photo 22. Close up of gully northeast of site, looking east.

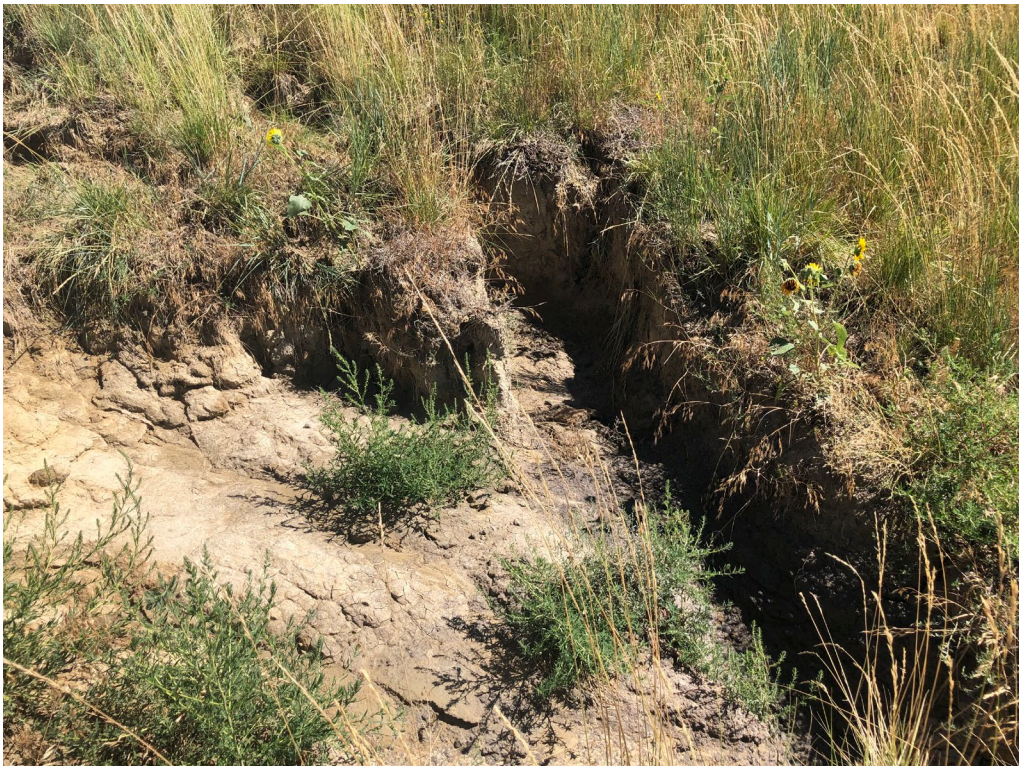
Photo 23. Gully leading into drainage southwest of site into phase 4 pit, looking north.

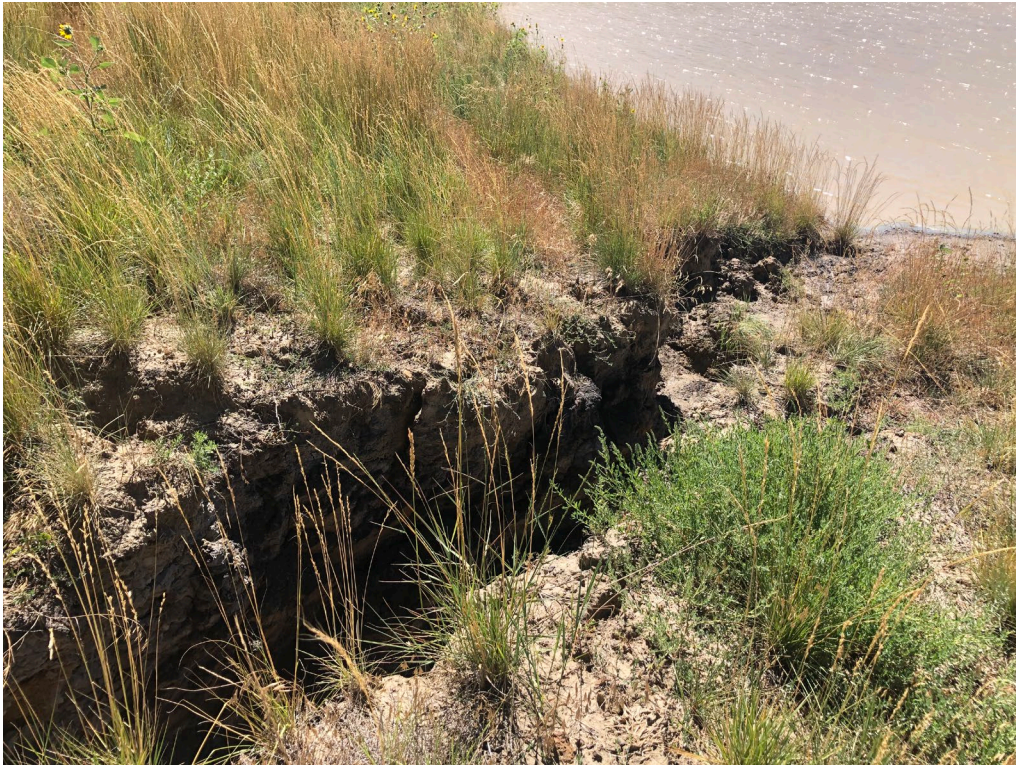
Photo 24. Gully leading into drainage southwest of site into phase 4 pit, looking south.
