Trapper Mine 2023 September Inspection Report

12 September 2023

Permit Number: C1981010 Mine Name: Trapper Mine Operator: Trapper Mining, Inc. Operator Address: Mr. Graham Roberts P.O. Box 187 Craig, CO 81626	County: Moffat Operation Type: Surface Permit Status: Active Ownership: Federal
	Operator Representative Present: Graham Roberts
This report was issued electronically from the Divisions' Denver Office.

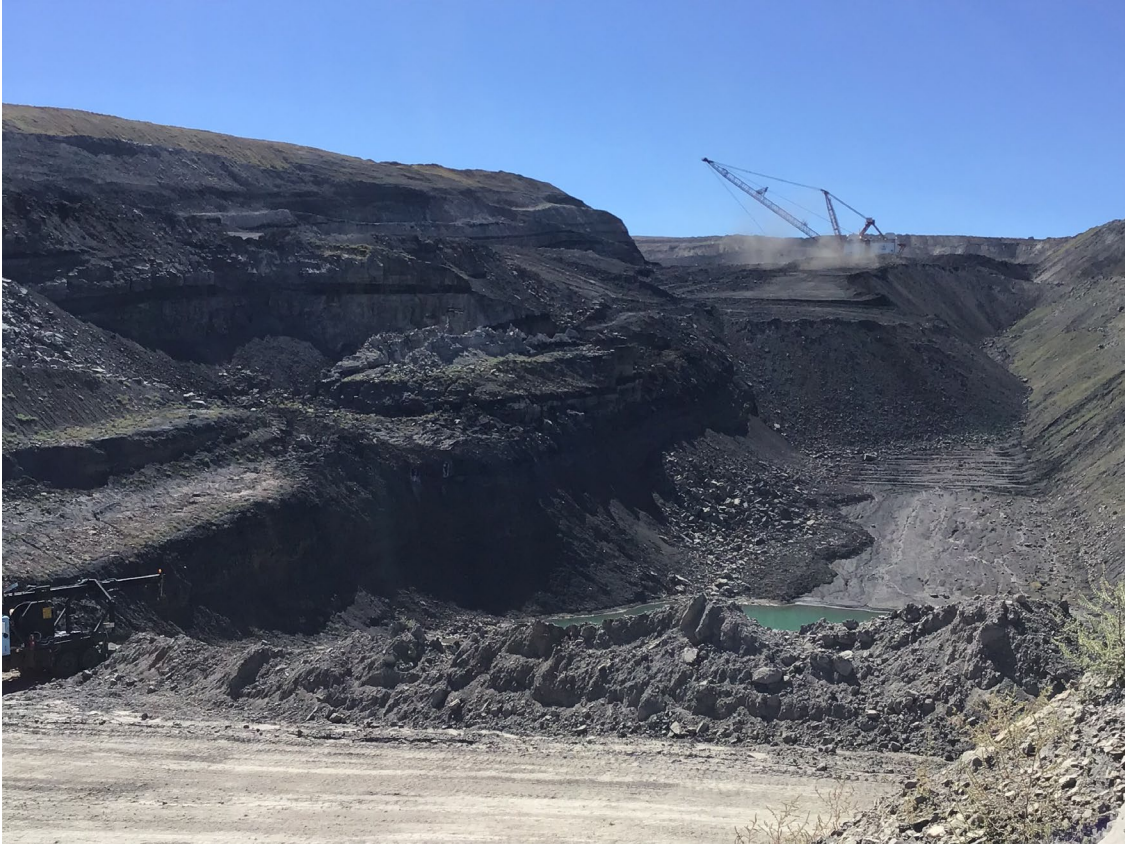
The inspection began in L Pit, where the Molly Braun drag line was working in the south end of the L Pit. The drag line positioned at the north end of the pit was inactive. Spoil was being hauled and loaded, and two blasts were set up. A blast occurred in the afternoon and was not observed as the vantage points provided no visibility to the blast. J Pit has been opened and no activity was occurring at the time of inspection as the Queen Ann dragline was being walked to the pit and is not yet in place for mining.

***Photo 1:** Activities in L Pit, looking south.*

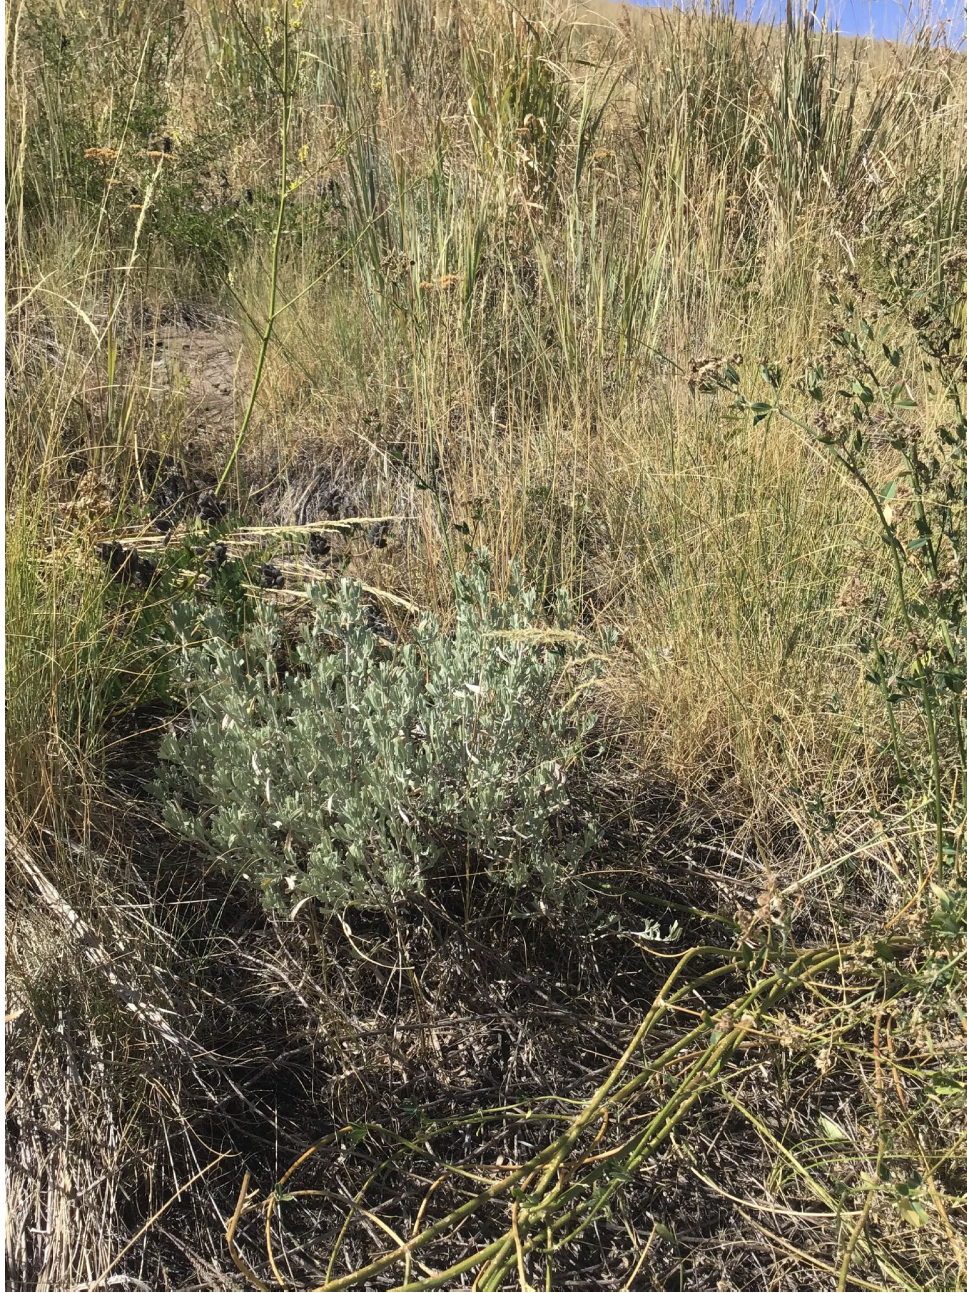
- Revegetated areas of reclamation appear stable with a diversity of species as approved in the seed mixture. Some weeds are present in places. Thistles were noted as was cheat grass. No infestations were noted.
- Vegetation cover was noted in the Phase II bond release request area.

Photo 2: *Vegetation diversity and cover in proposed phase II bond release parcel ZAB-16.*

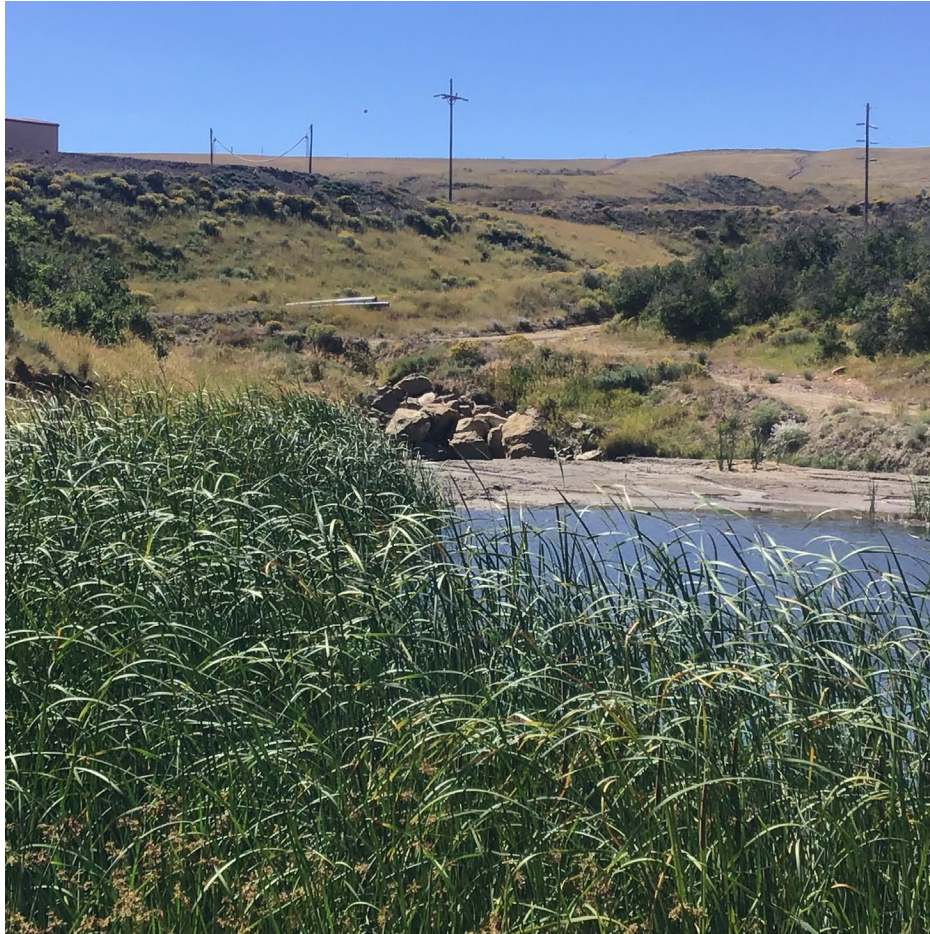
Photo 3: East Middle Flume #3 Pond.

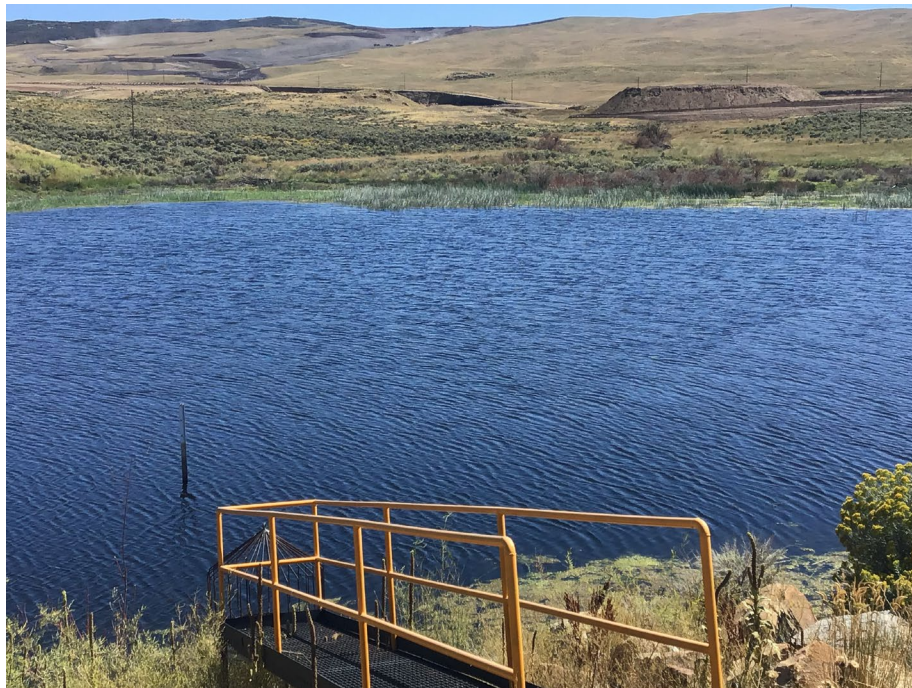
Photo 4: Coyote Pond holding clear water.

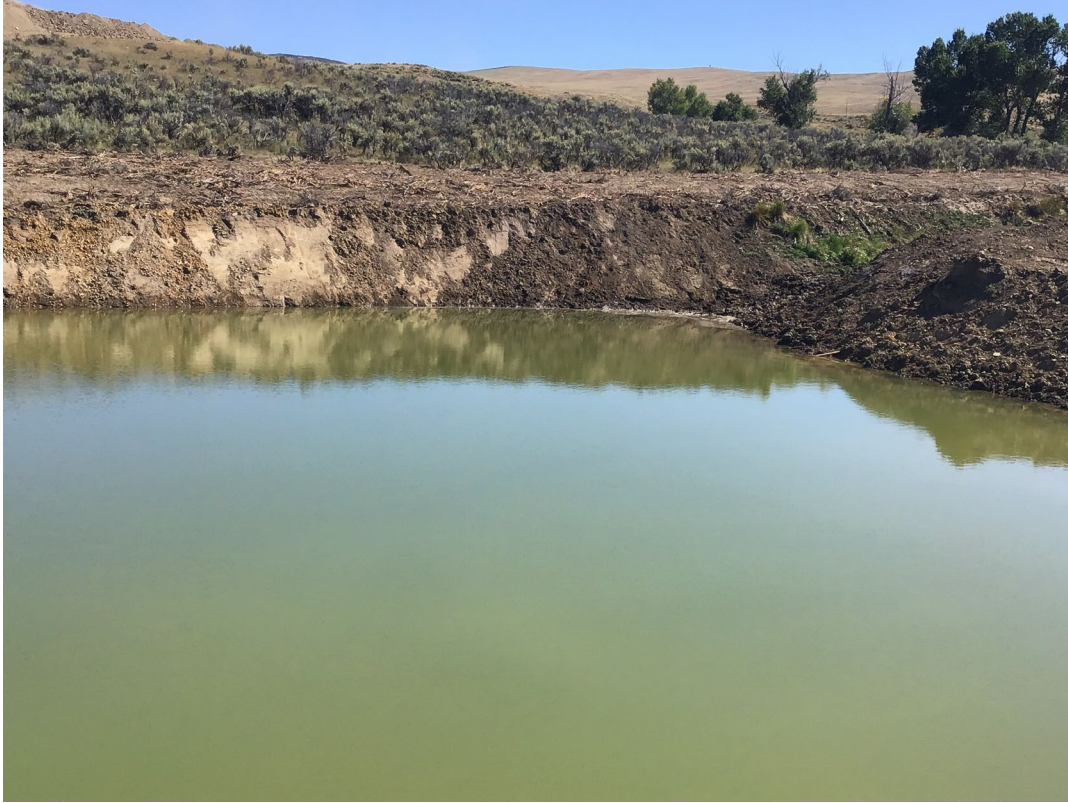
- Far East Buzzard #4 is in process of being finished. A lense of sandstone prevented complete excavation of the pond. This will reduce pond capacity and may require revisiting the sedcad model.

Photo 5: Far East Buzzard Pond #4 holding groundwater.

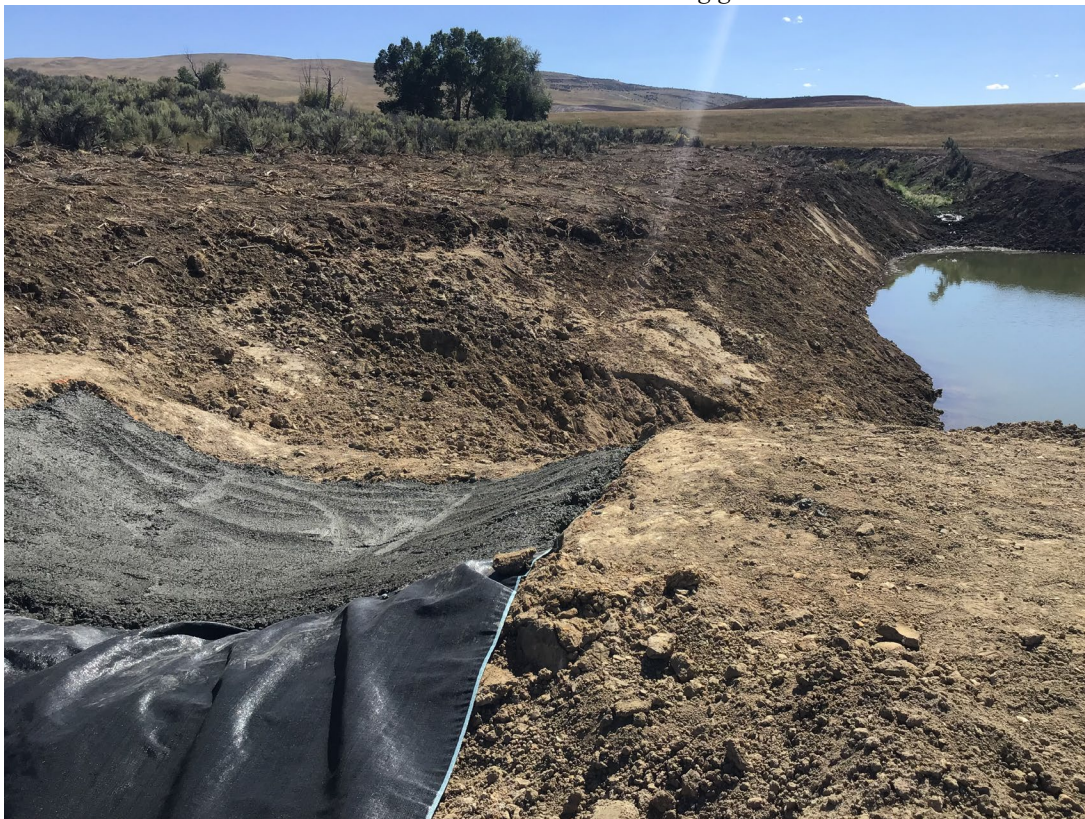
Constructed drainages that experienced erosion as a result of a heavy snow winter and associated runoff have not yet been repaired. The operator has a maintenance plan in place for this field season for drainage repair. Construction of the East Buzzard #3 pond is complete. The spillway had fresh concrete in place and the drainage way is awaiting final armoring. Ground water is prevalent and the pond held approximately five feet of water. Erosion control comprising wattles were in place at the construction site of Far East Buzzard #4 as this pond is under construction. Dredging of Pyeatt pond system was occurring at the time of inspection. . Dozer basins on haul road and various ponds are scheduled for dredging as the season progresses. Pond banks were stable and vegetated. Spillways were in good repair and clear. Flumes were functioning properly and dams were stable, and vegetated with no signs of seepage.

Photo 6: Fresh concrete at spillway of Far East Buzzard #4.

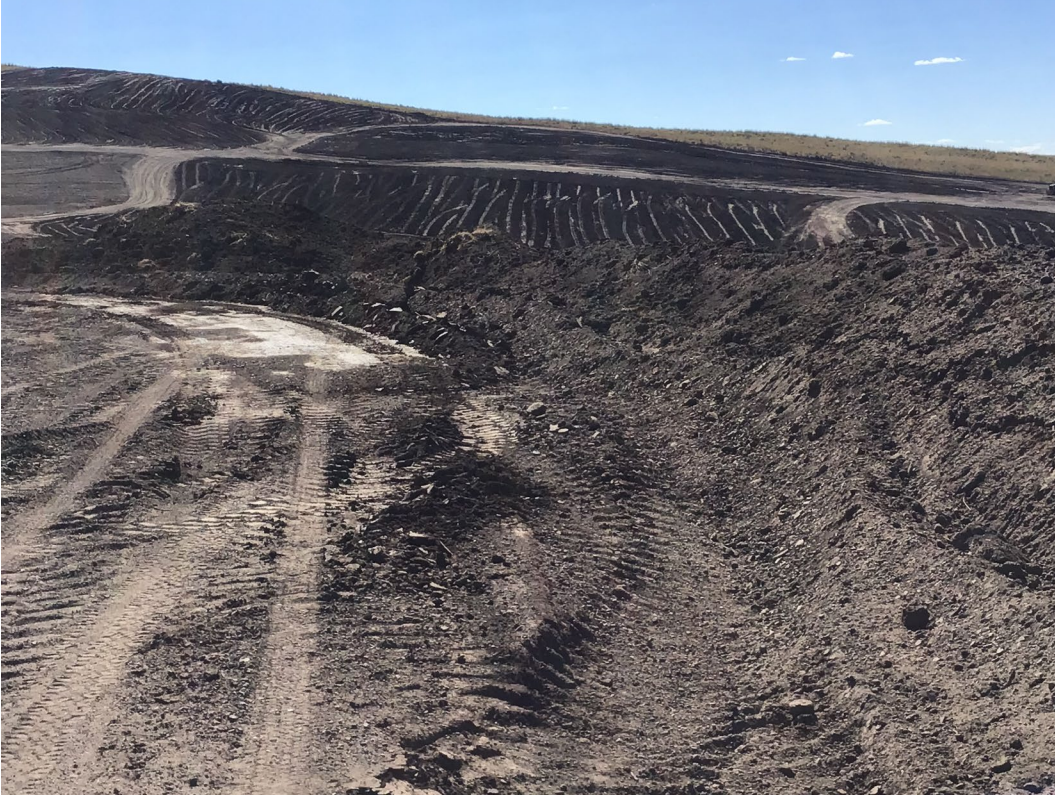
- No instability or riling were noted on the observed topsoil piles. Topsoil piles are vegetated, with vegetation beginning to go dormant.
- Piles appeared to be marked appropriately.
- Topsoil stripping is completed at C Pit.
- Topsoil was being loaded, hauled, dumped and spread in D Pit.

***Photo 7:** D Pit topsoil laydown looking south west.*

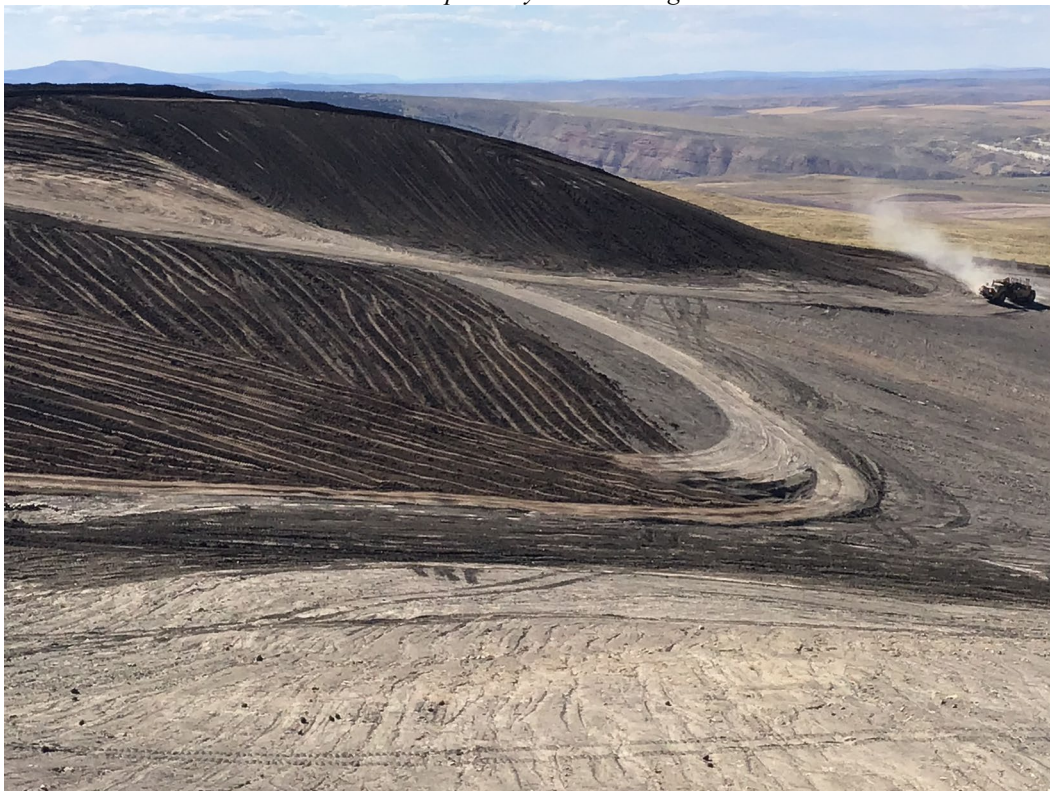
***Photo 8:** D Pit topsoil laydown looking west.*

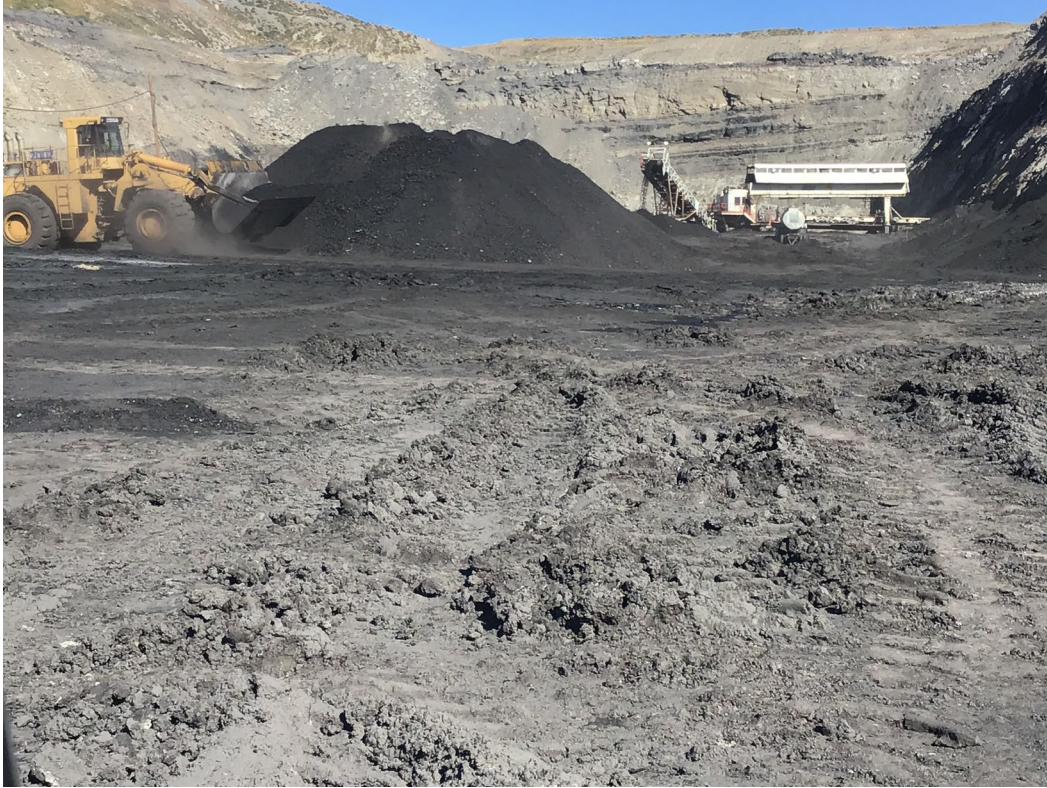
N Pit was active at the time of inspection. Coal was being excavated and placed in stockpiles for hauling later. C Pit stripping has been completed and no activity was occurring at the time of inspection. Construction progress of the Far East Buzzard ponds was observed. The ready line was orderly at the time of inspection. Ash was being hauled to the ash dump.

Photo 9: N Pit mining activities, looking east.

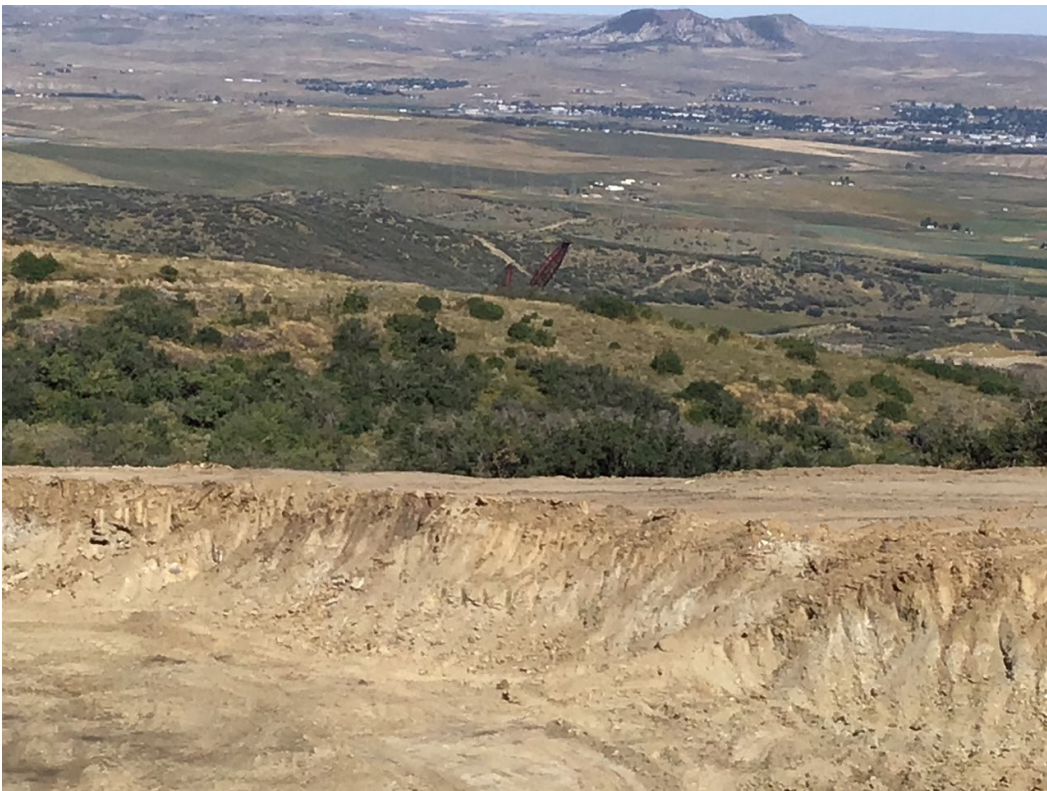
Photo 10: L Pit, looking north to a 200 foot increase in stripping pending a TR.

- Reclamation consists of benched overburden in L Pit awaiting grading, an ongoing activity at Trapper Mine.
- Repair and grading of constructed drainages is scheduled to occur this field season as is grading of benches at west edge of L Pit.
