September 2023 Partial Inspections WF, Seneca IIW

Permit Number: C-1982-057 Mine Name: Seneca II-W Mine Operator: Seneca Property LLC Operator Address: Ms. Miranda Kawcak 29515 Routt County Road 27 Oak Creek, CO 80467	County: Routt Operation Type: Surface Permit Status: Permanent Cessation Ownership: Private
	Operator Representative Present: Kevin Copeland
Operator Representative Signature: (Field Issuance Only)

Inspection Start Date: 13 September, 2023 Inspection Start Time: 09:00 a.m. Inspection End Date: 13 September, 2023 Inspection End Time: 10:30 a.m.		Inspection Type: Coal Partial Inspection Inspection Reason: Normal I&E Program Weather: Clear	
Joint Inspection Agency: None		Joint Inspection Contacts:	
Post Inspection Agency: None		Post Inspection Contacts:	
Inspector(s): Robin Reilley, GISP	Inspector's Signature:

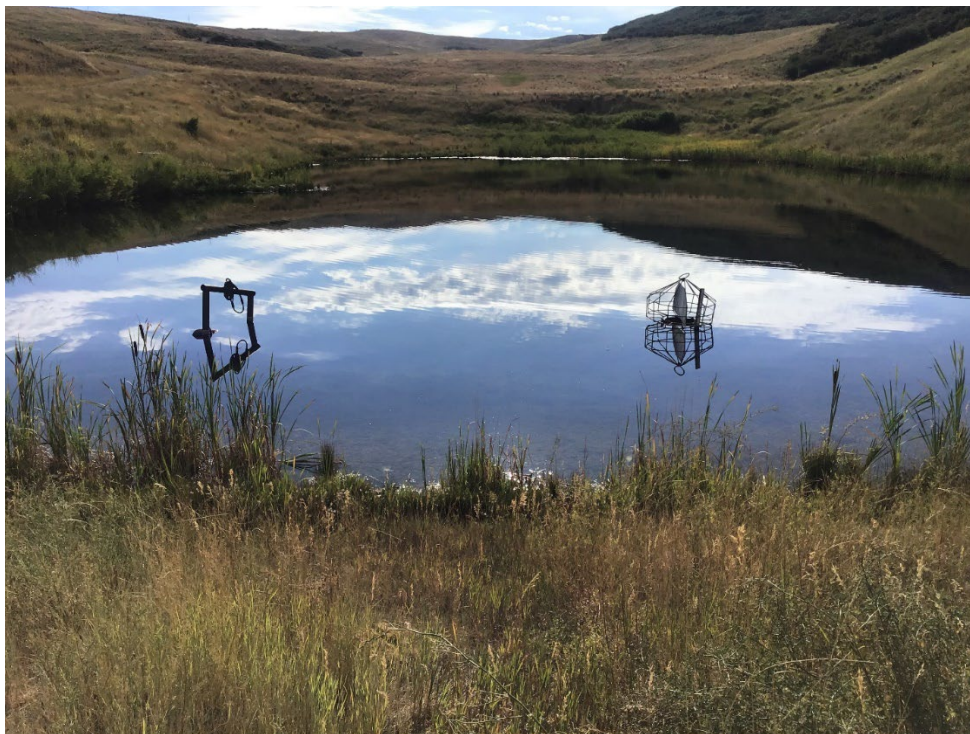
Photo 1: Pond 6.

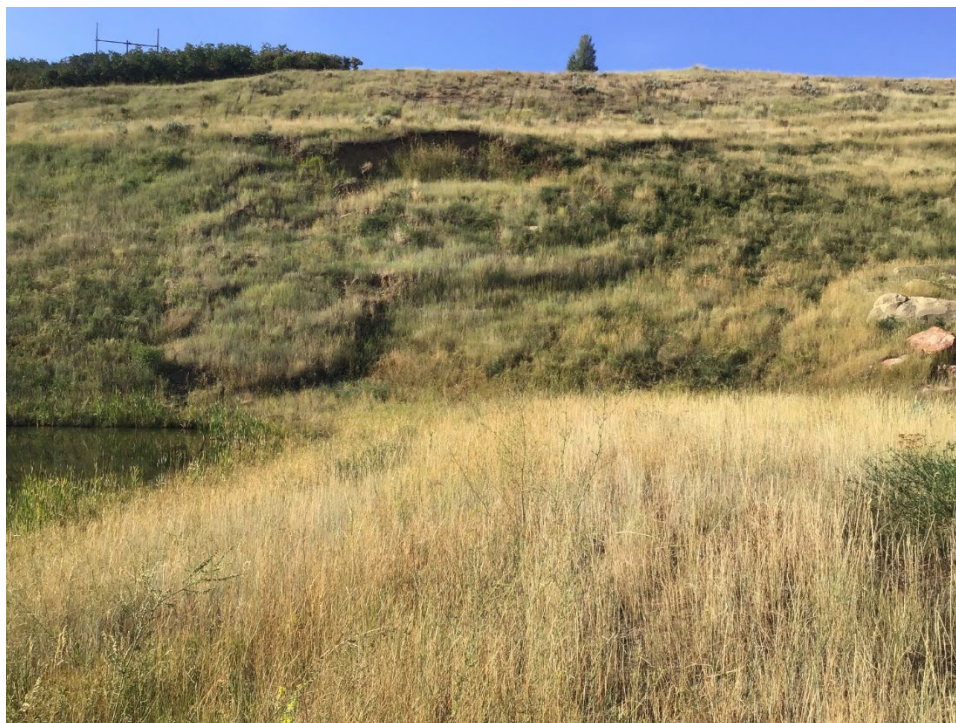
Established slump at Pond 6 was noted. The new slide (spring 2023), downstream from the slump appears to encompass approximately 1/3 of an acre. A crack exists between the two areas.

Photo 2: Slump above Pond 6.

1. Flume at Pond 15 requires resetting.
2. Slide at Pond 6 requires mitigation plan

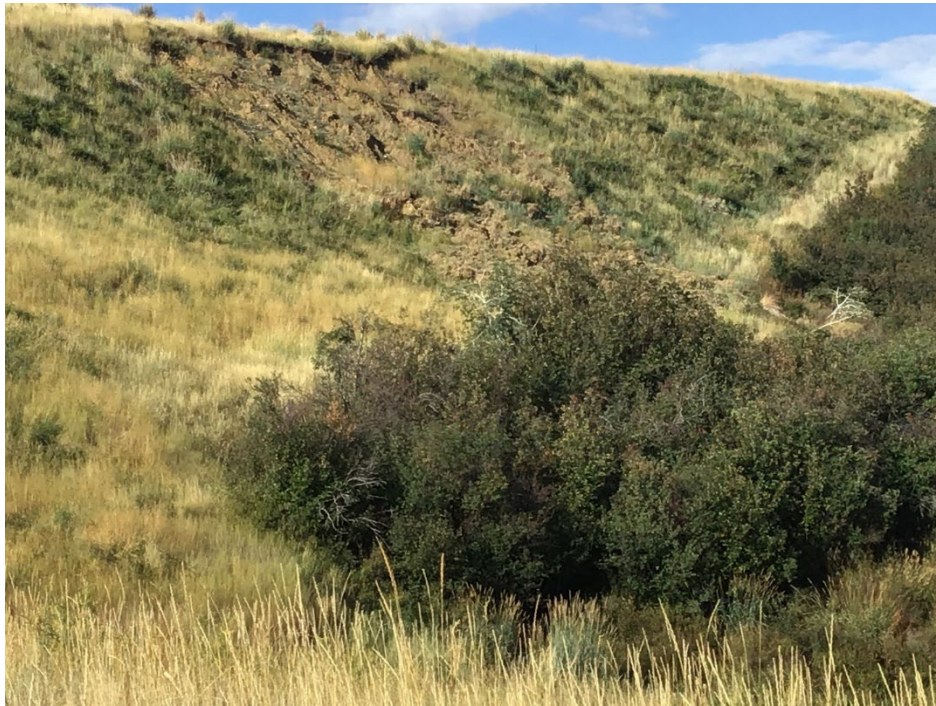
Photo 3: Slide area Pond 6 outlet.

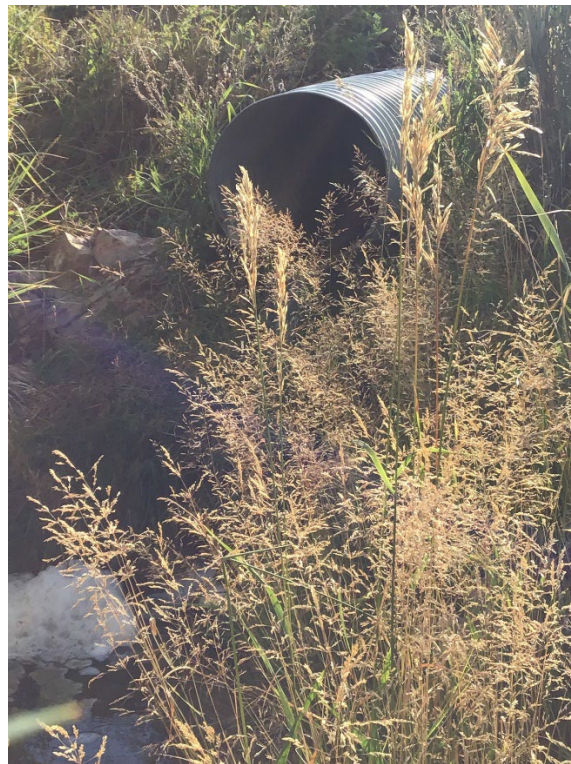
Photo 4: Discharge through Pond 6 discharge culvert.

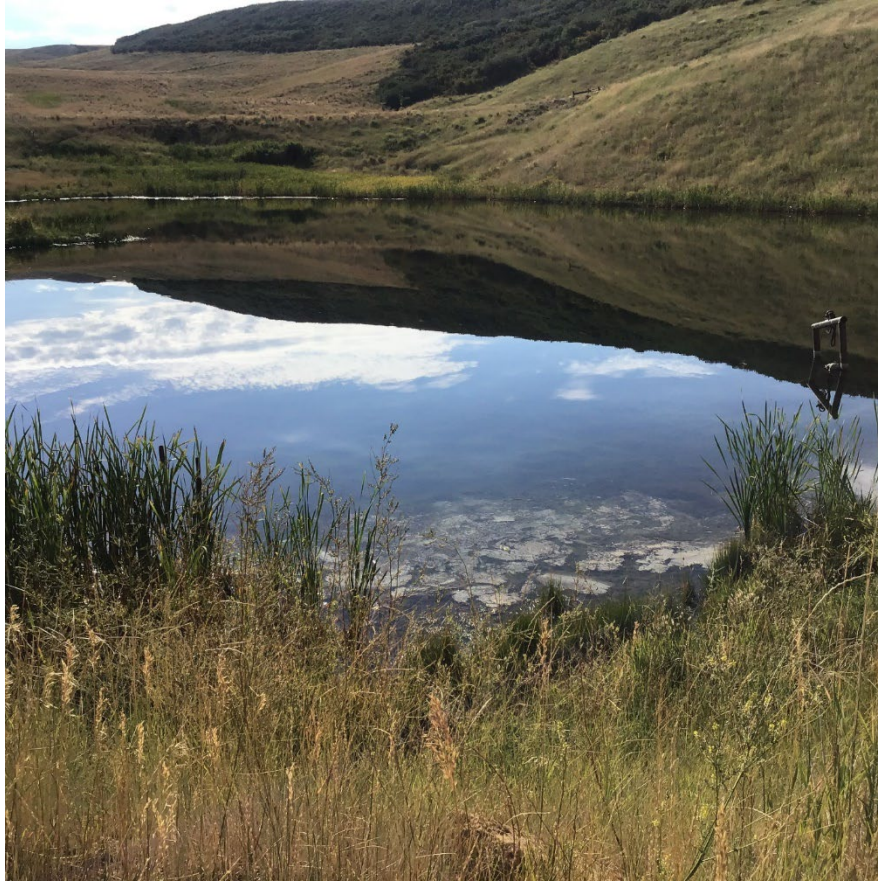
Photo 5: Pond 6 with a small algal growth.

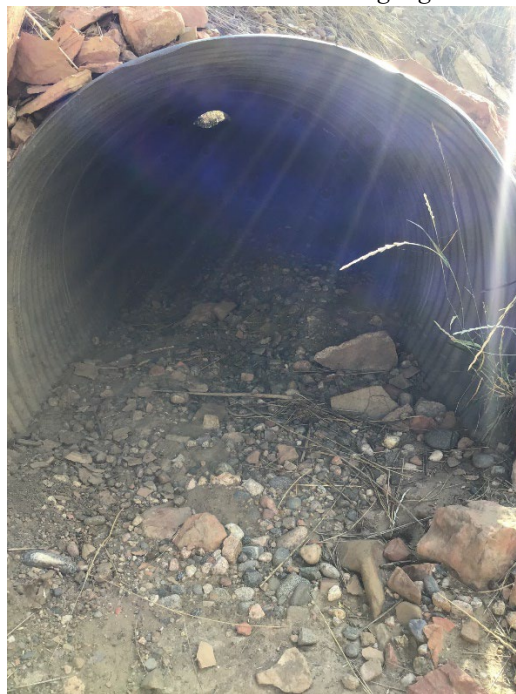
Photo 6: Debris in culvert on road above Pond 6.

Culvert above pond 6 requires cleaning.

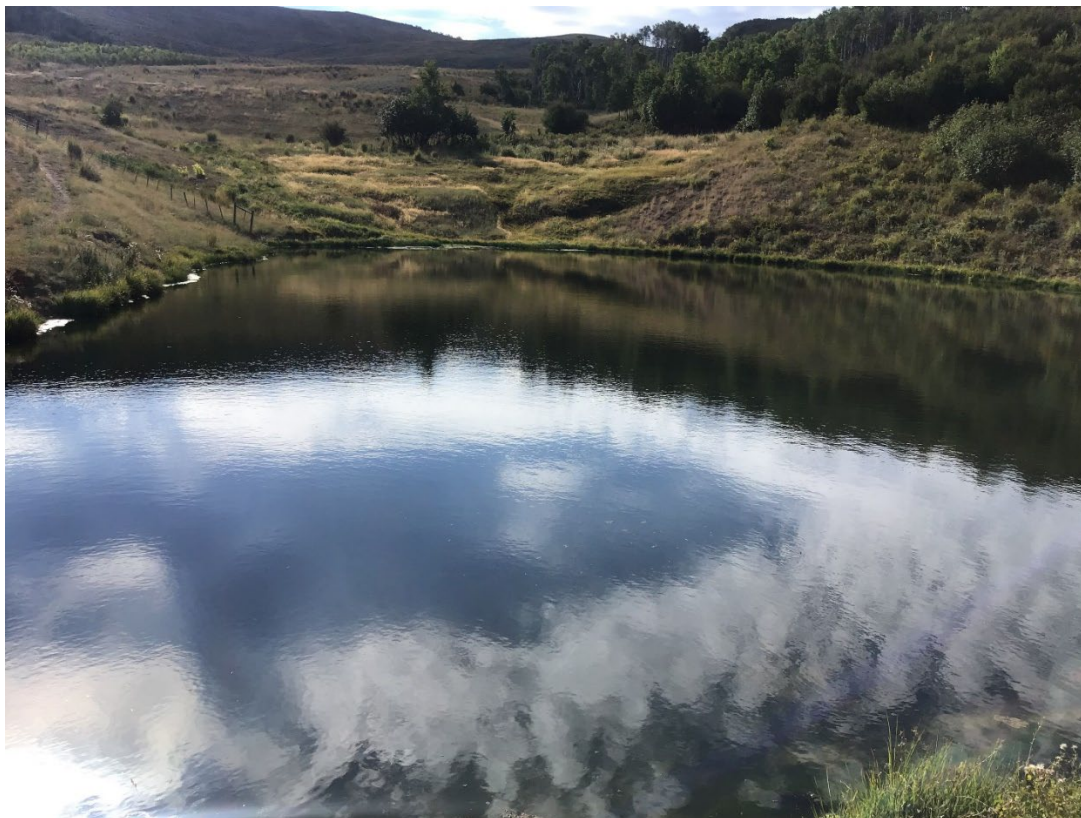
Photo 7: Pond 16 holding water and discharging.

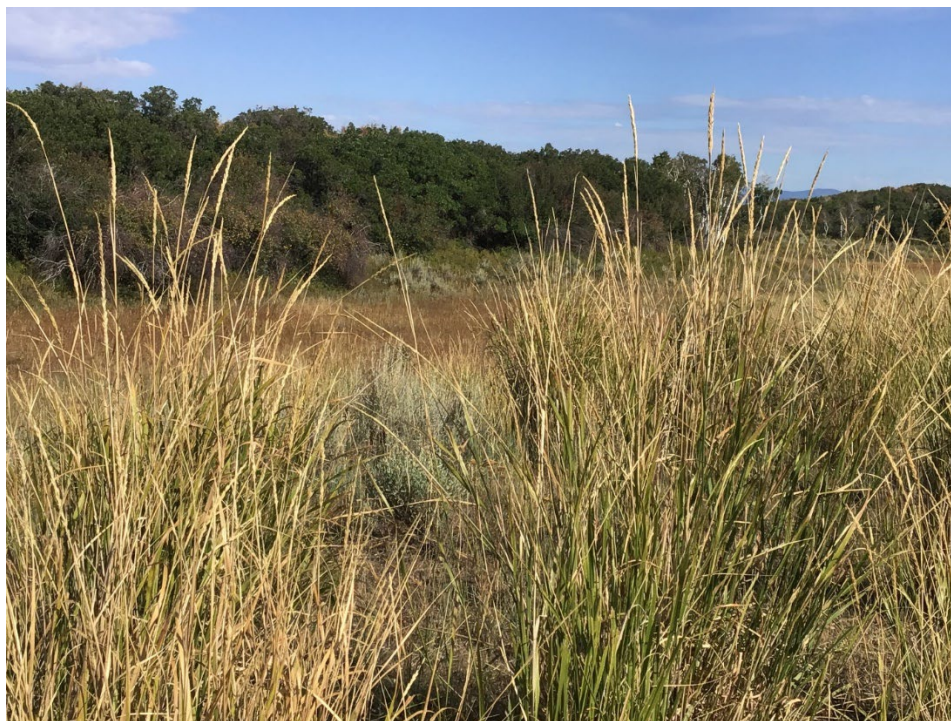
Photo 8: Overview of reclamation and vegetative diversity.

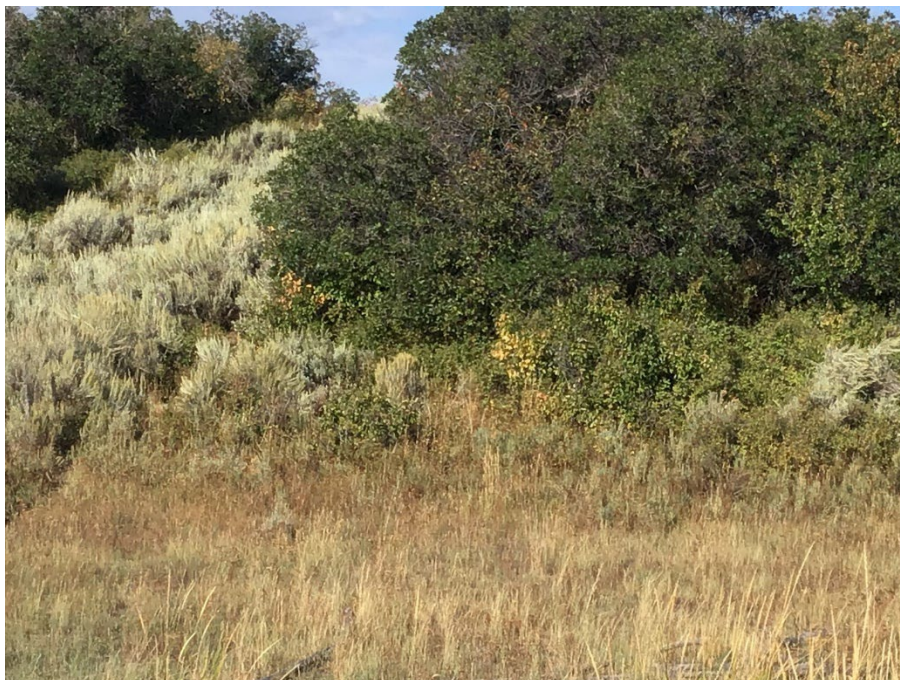
Photo 9: Vegetative diversity.

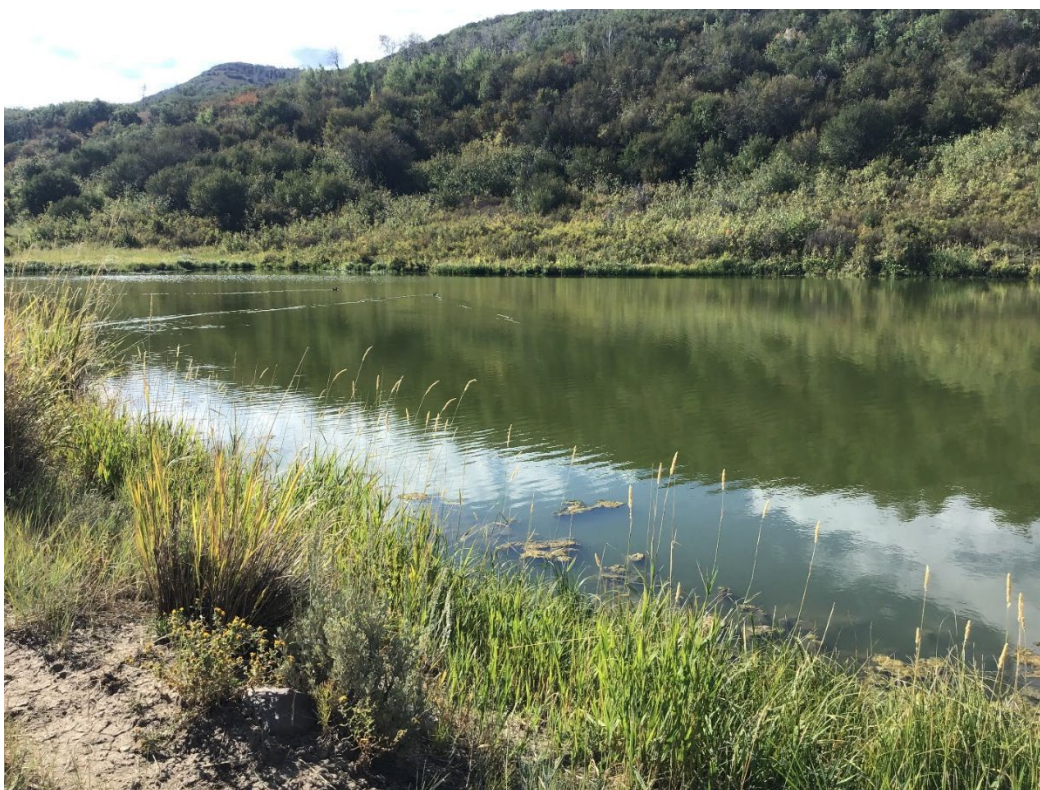
Photo 10: Pond 17, holding turbid water and not discharging.
