## Inspection Sept 2023 Yoast

Please find the September 2023 partial inspections for the Yoast mine. This was a partial inspection.

<b>Permit Number:</b> C-1994-082 <b>Mine Name:</b> Yoast Mine  <b>Operator Address:</b> Seneca Property LLC Ms Miranda Kawcak 29515 Routt County Road No. 27 Oak Creek, CO 80467	<b>County:</b> Routt <b>Operation Type:</b> Surface <b>Permit Status:</b> Permanent Cessation <b>Ownership:</b> Private  <b>Operator Representative Present:</b>  Kevin Copeland
<b>Operator Representative Signature: (Field Issuance Only)</b> This report was issued electronically from the Divisions' Denver Office.

<b>Inspection Start Date:</b> 13 Sept. 2023 <b>Inspection Start Time:</b> 1:00 p.m. <b>Inspection End Date:</b> 13 Sept. 2023 <b>Inspection End Time:</b> 13:30 p.m.	<b>Inspection Type:</b> Coal Partial Inspection <b>Inspection Reason:</b> Normal I&E Program <b>Weather:</b> Clear
<b>Joint Inspection Agency:</b>  None	<b>Joint Inspection Contacts:</b>
<b>Post Inspection Agency:</b>  None	<b>Post Inspection Contacts:</b>
<b>Inspector(s):</b>  Robin Reilley, M.S. GISP	<b>Inspector's Signature:</b>

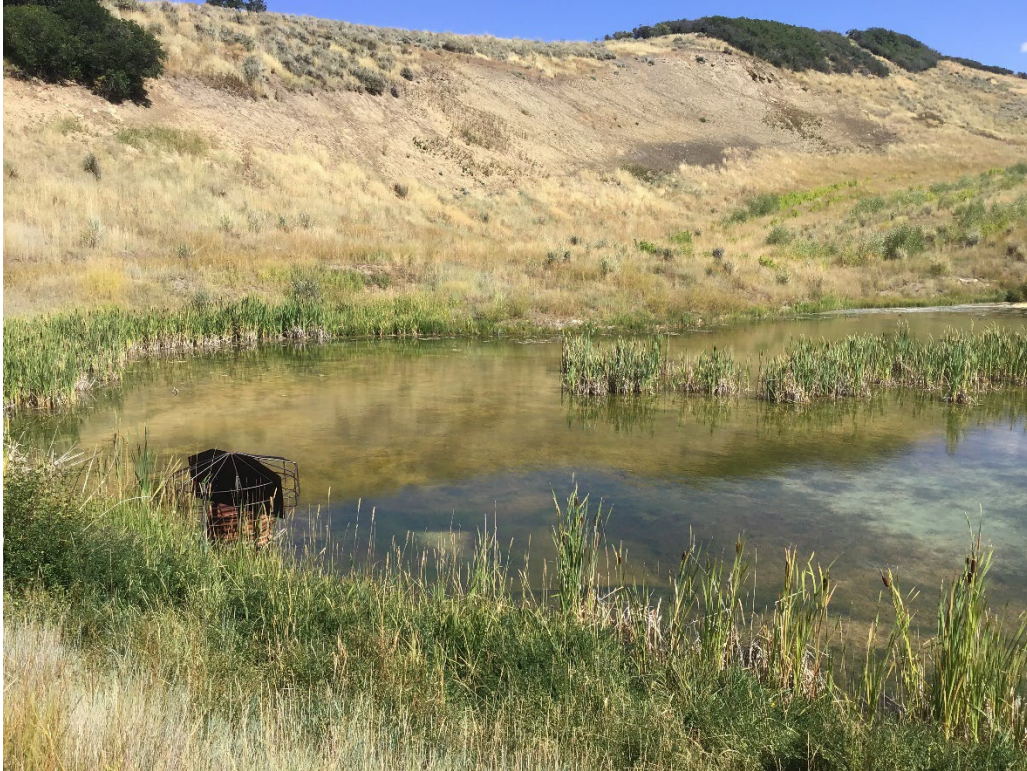
Reclamation has been completed at the site with the exception of the hillside above Pond 12.

- Pond 12 was discharging clear water through flume at the time of inspection. The flume is encompassed by tall grasses.
- Pond 13 held water and was not discharging through its culvert. Some small algae mats floated around the waters edge.
- Pond 14 held water and was not discharging. Some algae was present on the water surface.

- Vegetation on the slopes above Pond 12 appeared adequate and appeared dormant..

*Photo 1: Pond 12, looking up the slopes along the old highwall.*

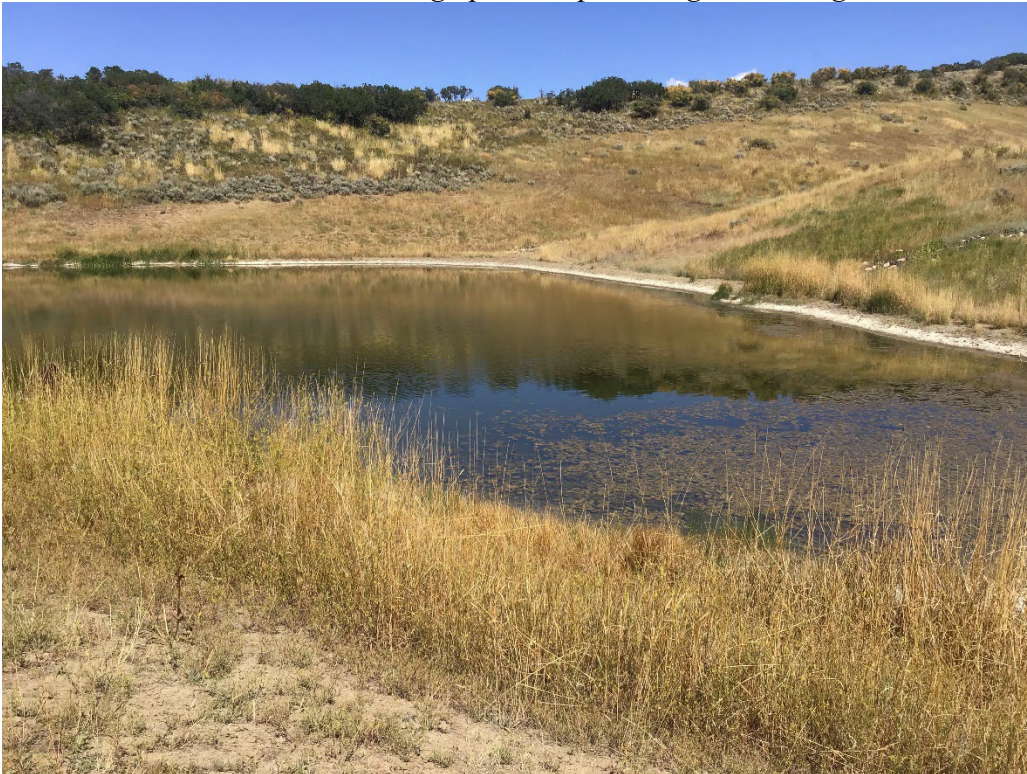
*Photo 2: Pond 13 holding water and not discharging.*

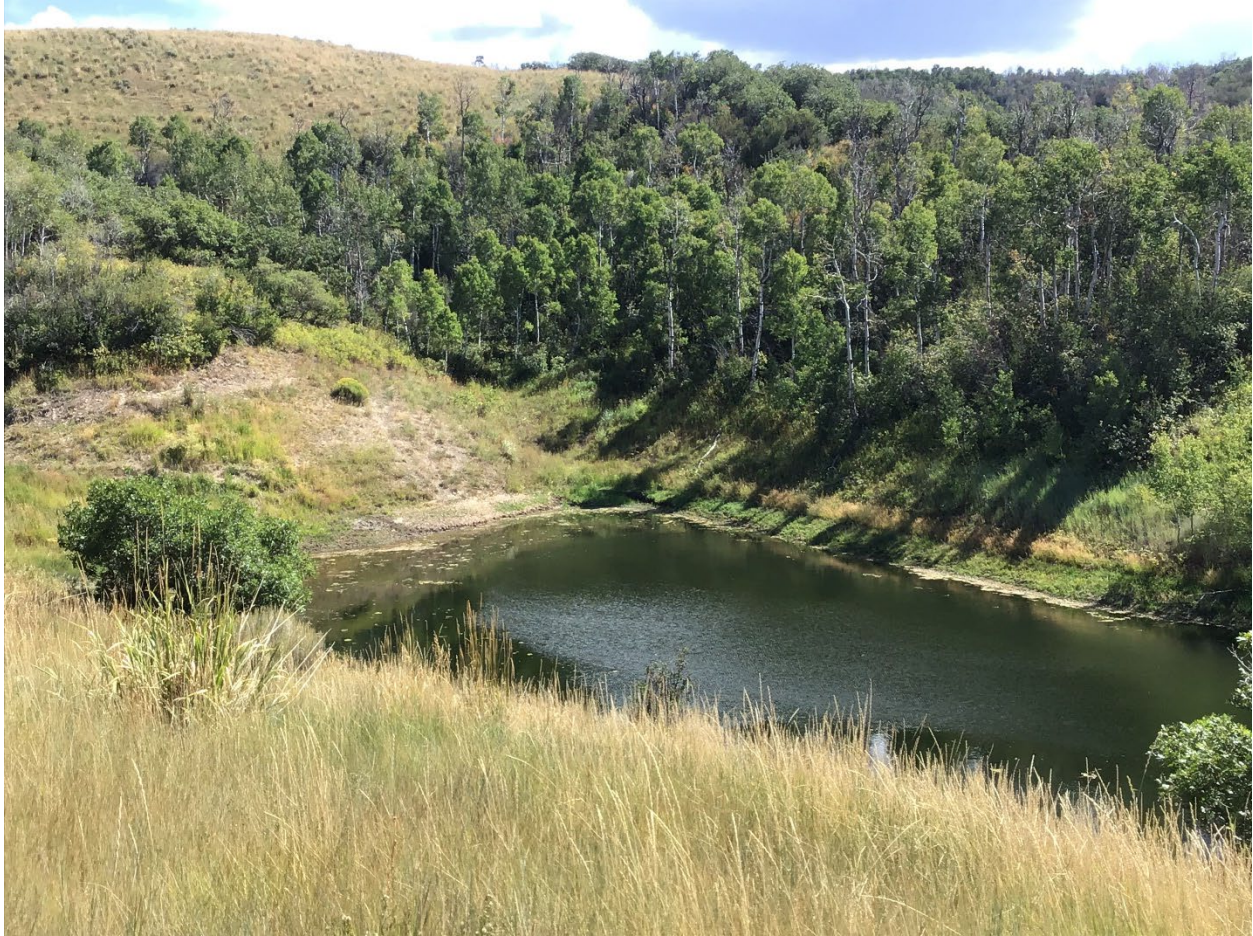
Pond 14 drop structure is cracked and water is flowing into structure. Structure requires sealing.

***Photo 3:** Pond 14 holding water.*
