## King Mine, C-1981-035, September 2023 Inspection Report

**King Mine, C-1981-035, September Complete Inspection Report\_CCW.pdf**

<b>Permit Number:</b> C-1981-035 <b>Mine Name:</b> King Coal Mine <b>Operator:</b> GCC Energy, LLC <b>Operator Address:</b> Mr. Jordan McCourt 6473 County Road 120 Hesperus, CO 81326	<b>County:</b> La Plata <b>Operation Type:</b> Underground <b>Permit Status:</b> Active <b>Ownership:</b> Private
	<b>Operator Representative Present:</b>  Jordan McCourt
<b>Operator Representative Signature: (Field Issuance Only)</b>

<b>Inspection Start Date:</b> September 6, 2023 <b>Inspection Start Time:</b> 09:40 <b>Inspection End Date:</b> September 6, 2023 <b>Inspection End Time:</b> 11:50		<b>Inspection Type:</b> Coal Complete Inspection <b>Inspection Reason:</b> Normal I&E Program <b>Weather:</b> Clear	
<b>Joint Inspection Agency:</b>  None		<b>Joint Inspection Contacts:</b>  None	
<b>Post Inspection Agency:</b>  None		<b>Post Inspection Contacts:</b>  None	
<b>Inspector(s):</b>  Clayton Wein	<b>Inspector's Signature:</b>  <i>Clayton Wein</i>		<b>Signature Date:</b>  9/18/2023

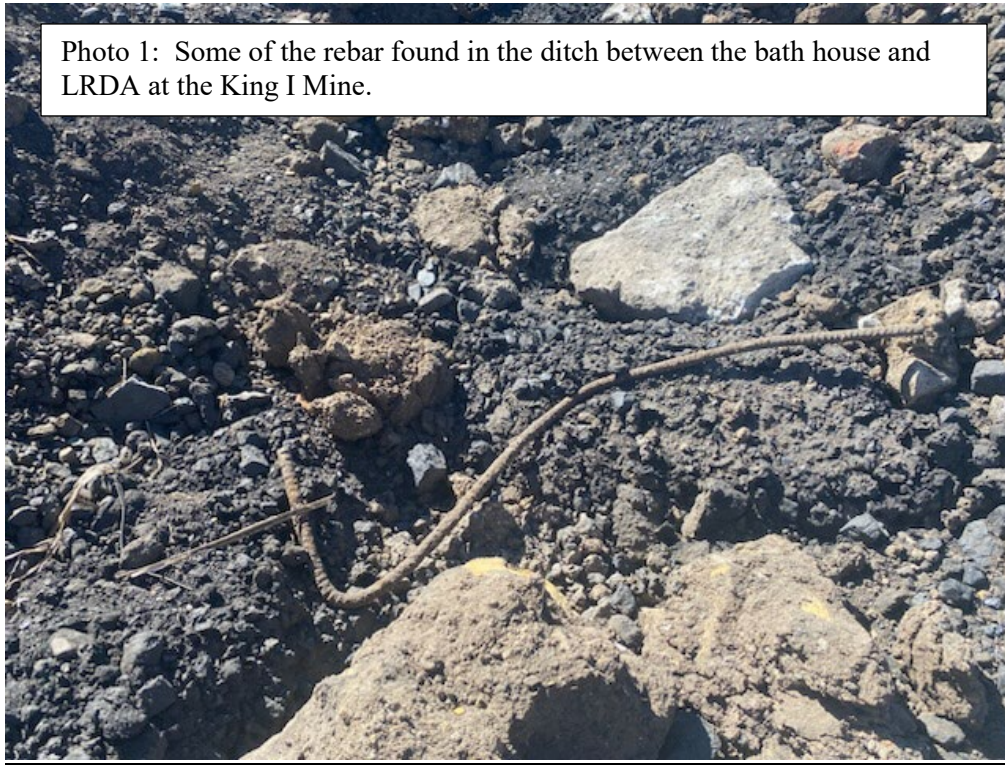
**1. Pieces of rebar were found in the bottom of the ditch between the bath house and LRDA at the King I area (Photo 1). GCC submitted photographs to the Division on September 6, 2023 documenting the completion of this maintenance item. The Division considers this maintenance item satisfied.**

Photo 1: Some of the rebar found in the ditch between the bath house and LRDA at the King I Mine.

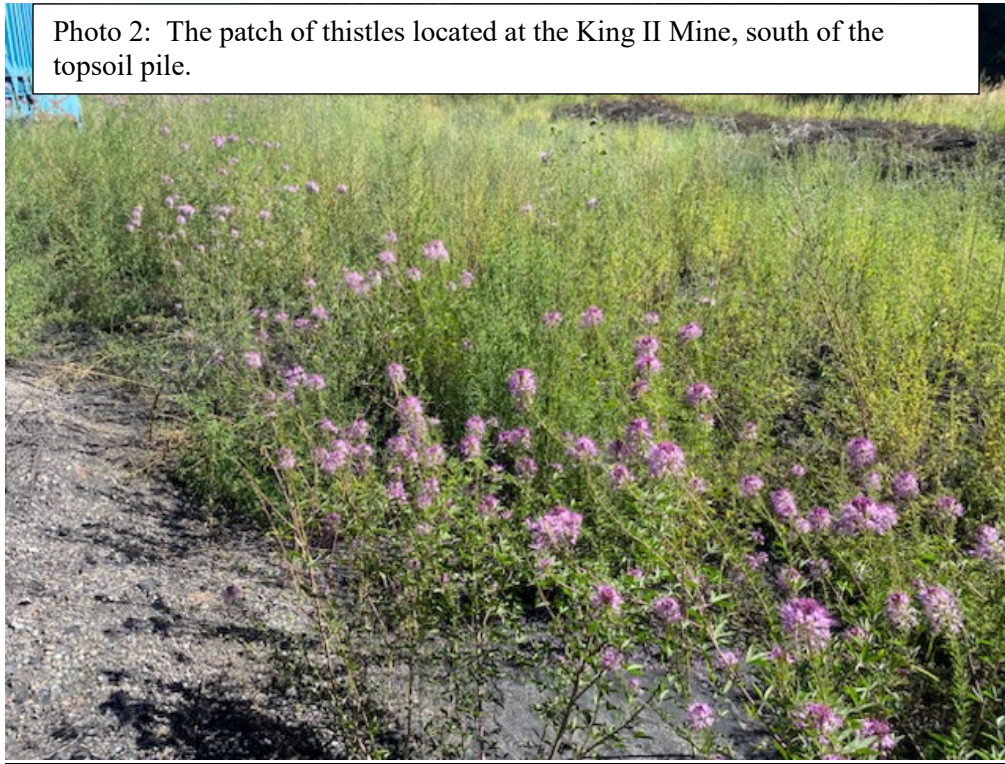
**2. A patch of thistle was identified to the southeast of the main topsoil pile at the King II Area (Photo 2). Please spray the thistle as soon as possible to prevent the spread of the plant onto the topsoil pile.**

Photo 2: The patch of thistles located at the King II Mine, south of the topsoil pile.

Topsoil stockpiled at the King I Mine was stable with vegetative cover. The pile had no indications of erosional features or loss of topsoil resource. The topsoil pile marker was on top of the pile. The topsoil pile at the King II Mine was also vegetated and stable. There were no erosional features identified. The topsoil pile marker was observed to be in place. No loss of topsoil resource had occurred. **A patch of thistle was identified to the southeast of the main topsoil pile at the King II Area (Photo 2). Please spray the thistle as soon as possible to prevent the spread of the plant onto the topsoil pile.**

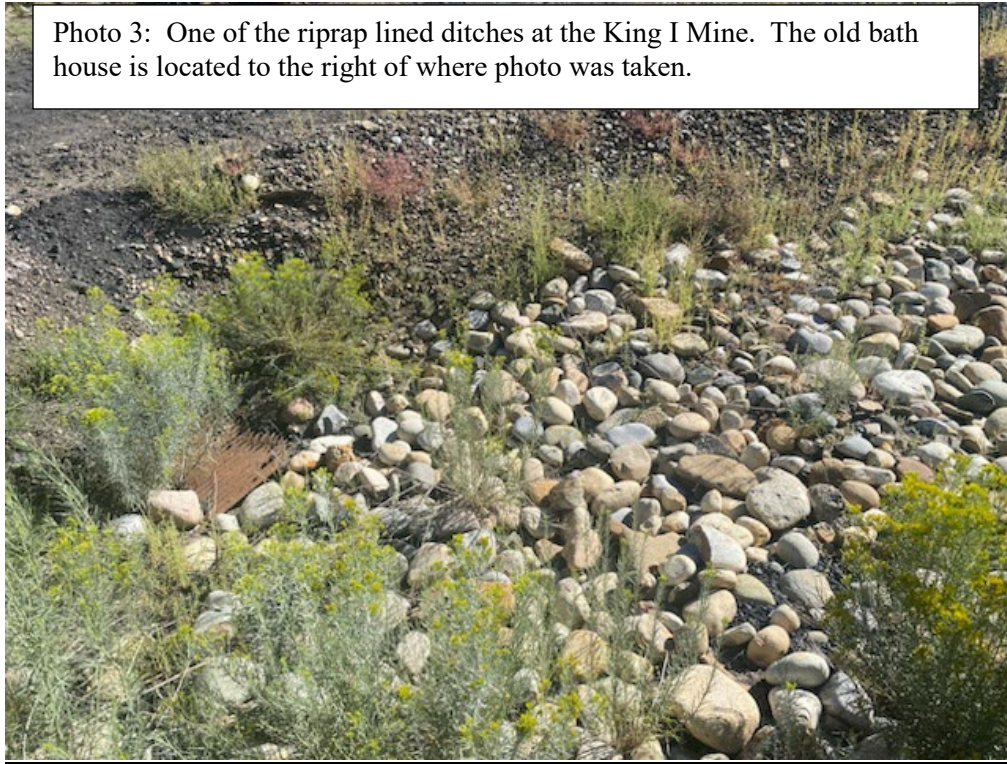
Ditches throughout the King I area were dry and stable during the inspection (Photo 3). No blockages were observed. Culverts located within the King I area were also free from debris and the culverts' inlets and outlets were unobstructed.

Photo 3: One of the riprap lined ditches at the King I Mine. The old bath house is located to the right of where photo was taken.

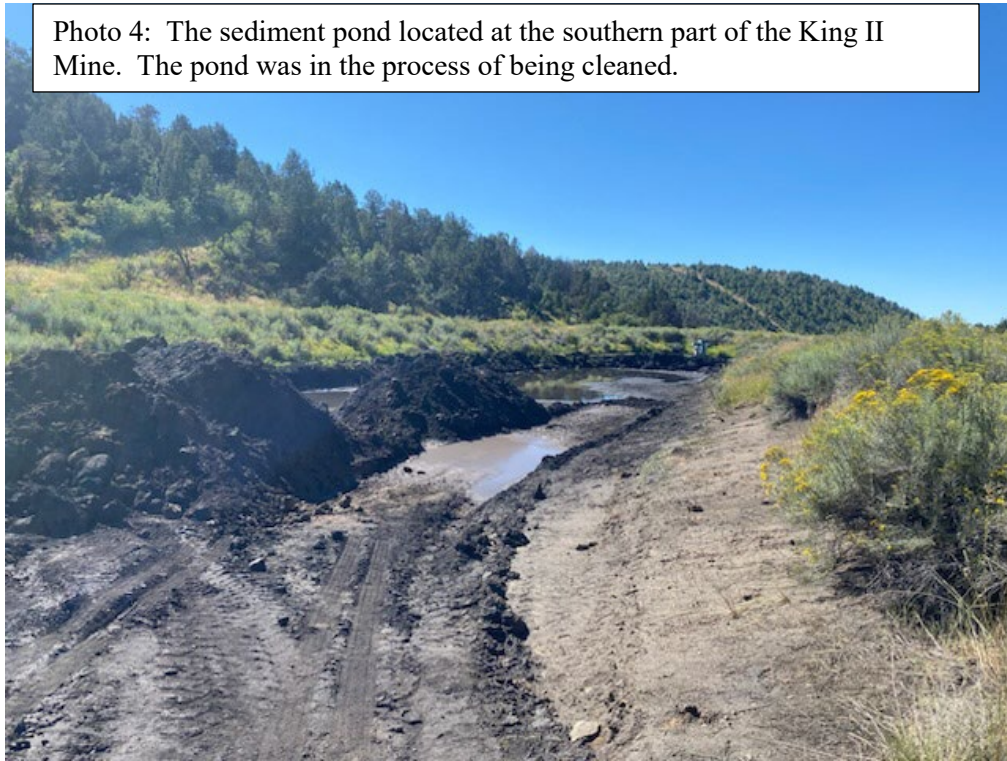
The sediment pond located at the southern port of the King II area was holding water during the inspection. The amount of water stored in the pond was below the level of the discharge outlet. The pond is undergoing cleaning when conditions allow. Some pond cleaning remained during the inspection due to the pond being too soft for equipment to access the cleanings (Photo 4). The operator stated that the remaining pond cleanings will be removed as soon as conditions allow. The sediment pond's embankment was stable with vegetative cover. There were no erosional concerns identified.

Photo 4: The sediment pond located at the southern part of the King II Mine. The pond was in the process of being cleaned.

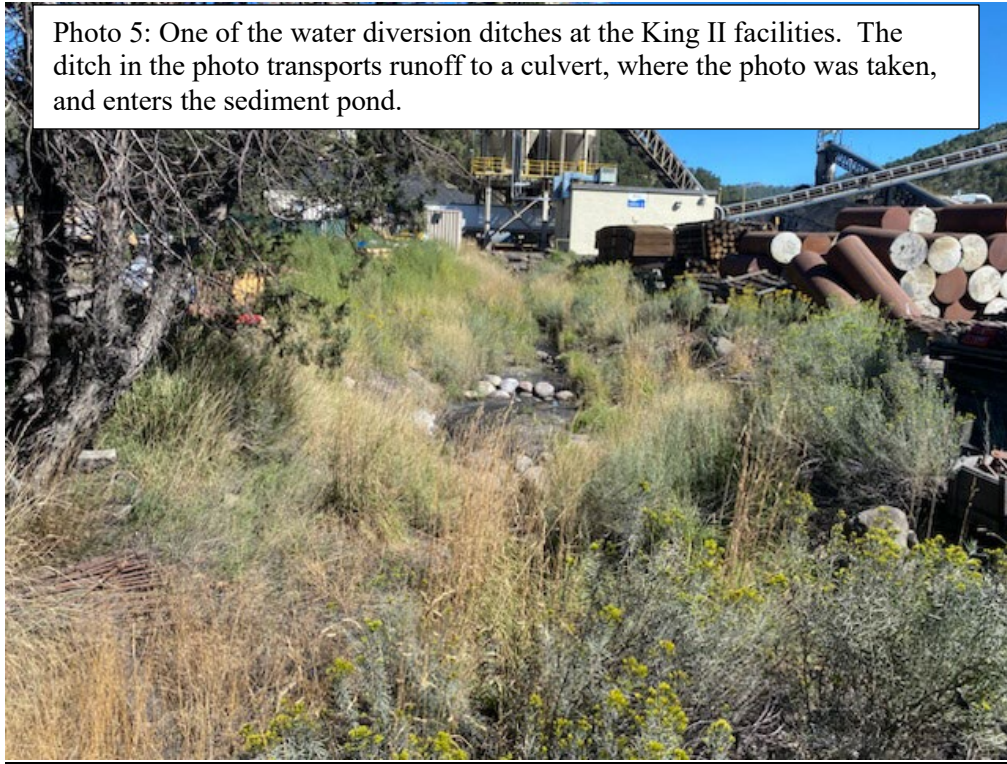
Ditches throughout the King II area were observed to be functioning as designed (Photo 5). A small amount of water was observed flowing in the ditches during the inspection. There were no sections observed to have blockages or other erosional issues. Culverts throughout the King II area were observed to be clear of debris and functioning as designed. The sump located behind the fuel storage shed was in good condition. The inlet to the sump was clear of blockages.

Photo 5: One of the water diversion ditches at the King II facilities. The ditch in the photo transports runoff to a culvert, where the photo was taken, and enters the sediment pond.

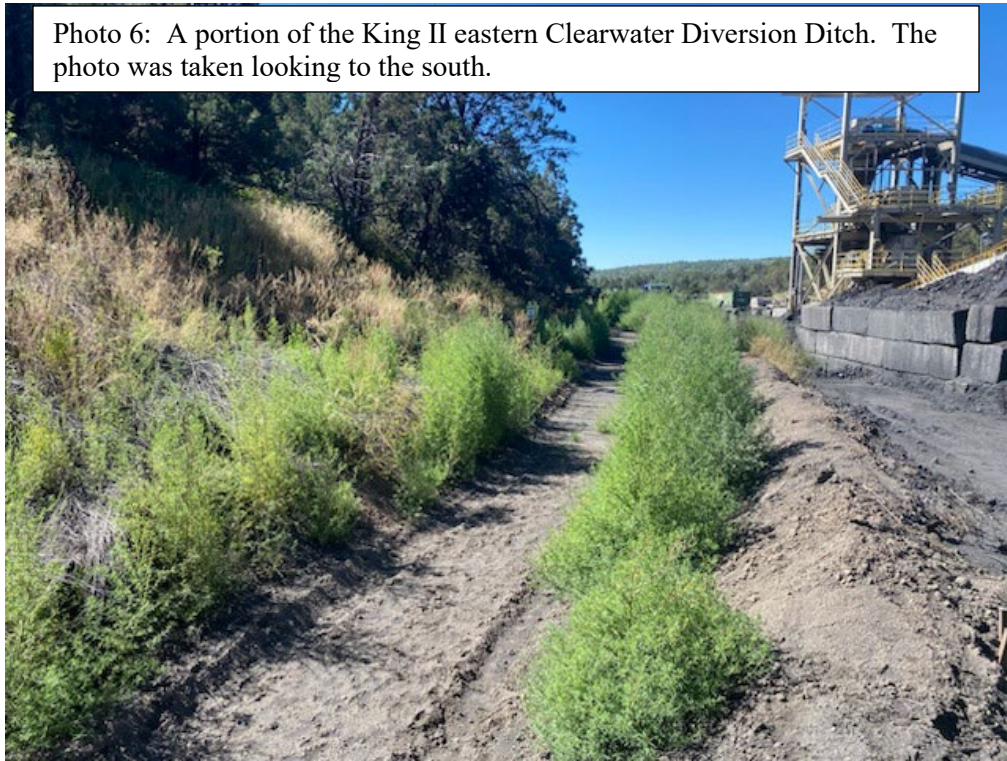
The clear water diversions were observed to be dry and clear of debris at the time of the inspection (Photo 6). There were no erosional concerns identified.

Photo 6: A portion of the King II eastern Clearwater Diversion Ditch. The photo was taken looking to the south.

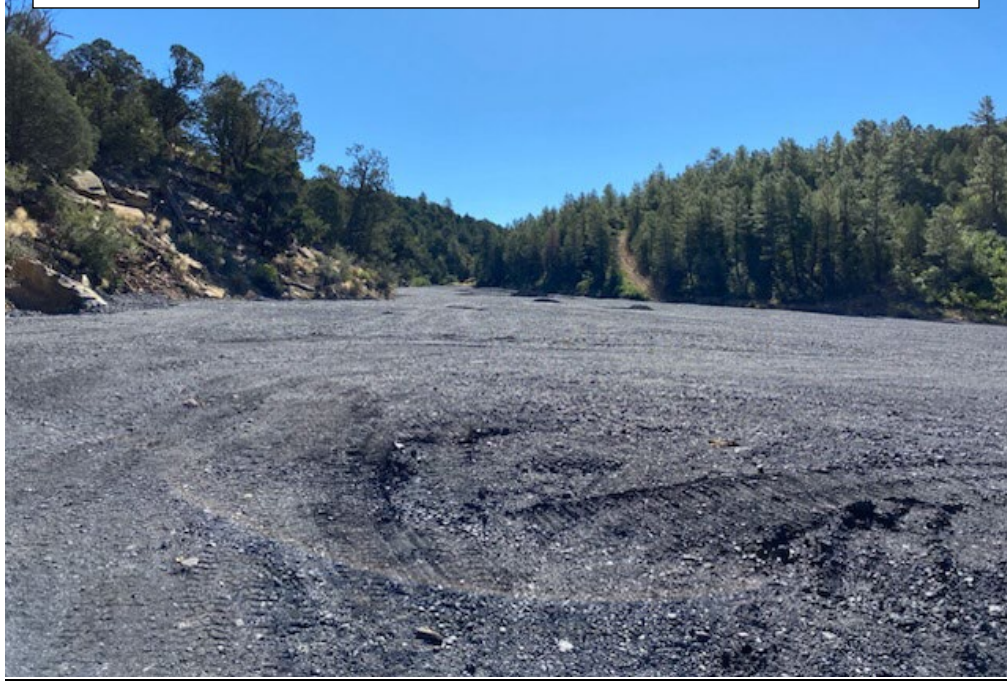
There are two refuse disposal piles located at the King I area. The Upper Refuse Disposal Area was stable with no indications or erosion. Refuse material on top of the pile had been spread and compacted (Photo 7). The pile gently slopes to the northwest to allow surface runoff to be collected in the drainage reporting to the sediment ponds. The face of the refuse pile was stable with no major rills or gullies.

Photo 7: The top of the URDA. The photo was taken at the norther edge of the pile looking to the south.

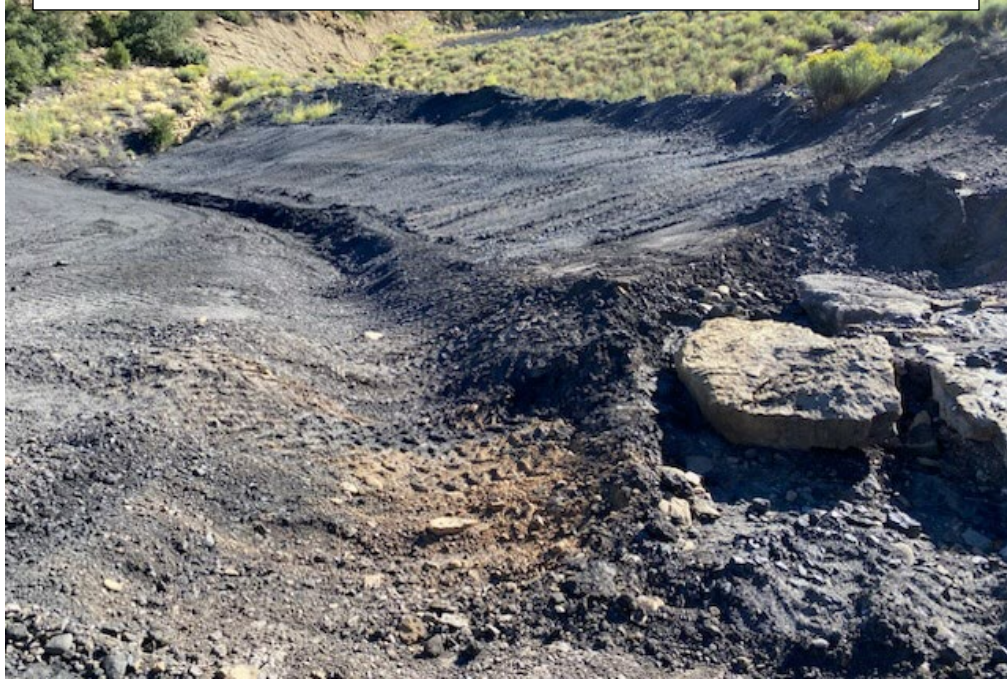
The lower refuse pile was stable with no erosional features identified. As outlined in the Division's August 30, 2023 letter, Reach 13 had been temporarily re-routed to connect the interface with the top of the Lower Refuse Disposal Area (LRDA) to Reach 10 (Photo 8 and 9). This will divert runoff from interacting with the northwest corner of the LRDA while maintenance items 7, 8 and 9 are completed. The ditch for Reach 13 met the design specifications for ditches as outlined on KI Map 007A. The ditch was stable with no blockages observed. The face of the LRDA was stable with no erosional features. Reach 10 had been returned to its design specifications and location as outlined on KI Map 007 (Photo 10). The ditch was clear of debris and stable. Reach 10's lowest section was returned to the Map 007 location as well (Photo 11). The ditch paralleled the haul road down the western side of the LRDA. The ditch was reconstructed to the design specifications outlined on KI Map 007B. The ditch was observed to be stable with no obstructions. **A small pile of pond cleaning material was on top of the LRDA. Please ensure that this refuse material is placed on the URDA before maintenance work is conducted on the northeast corner of the LRDA (Photo 12).** The ditch at the base of the LRDA was stable. **Pieces of rebar were found in the bottom of the ditch between the bath house and LRDA at the King I area (Photo 1). GCC submitted photographs to the Division on September 6, 2023 documenting the completion of this maintenance item.**

Photo 8: The temporary section of Reach 13 connecting to Reach 10. The photo was taken next to the junction of Reach 13 and Reach 10 looking east.

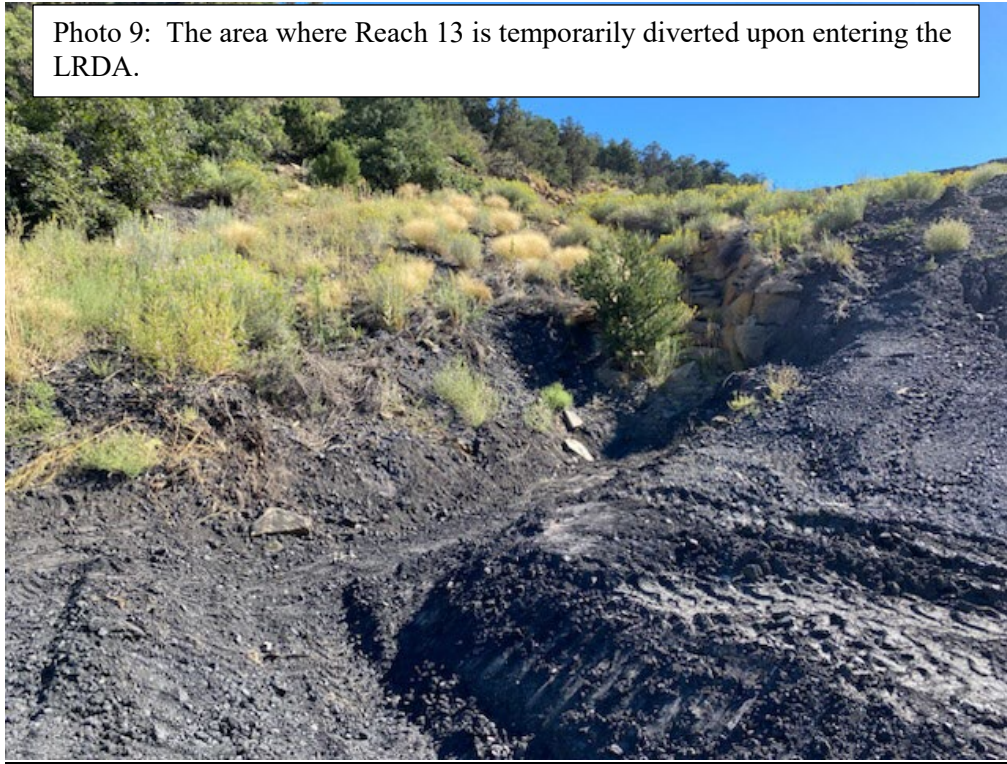
Photo 9: The area where Reach 13 is temporarily diverted upon entering the LRDA.

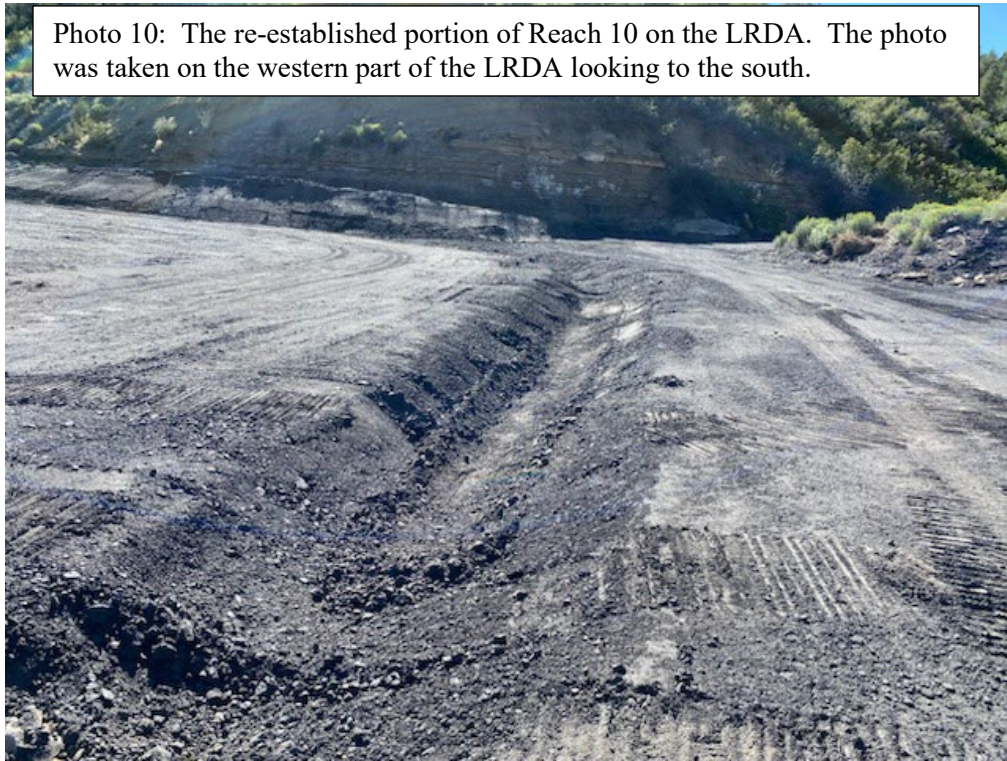
Photo 10: The re-established portion of Reach 10 on the LRDA. The photo was taken on the western part of the LRDA looking to the south.

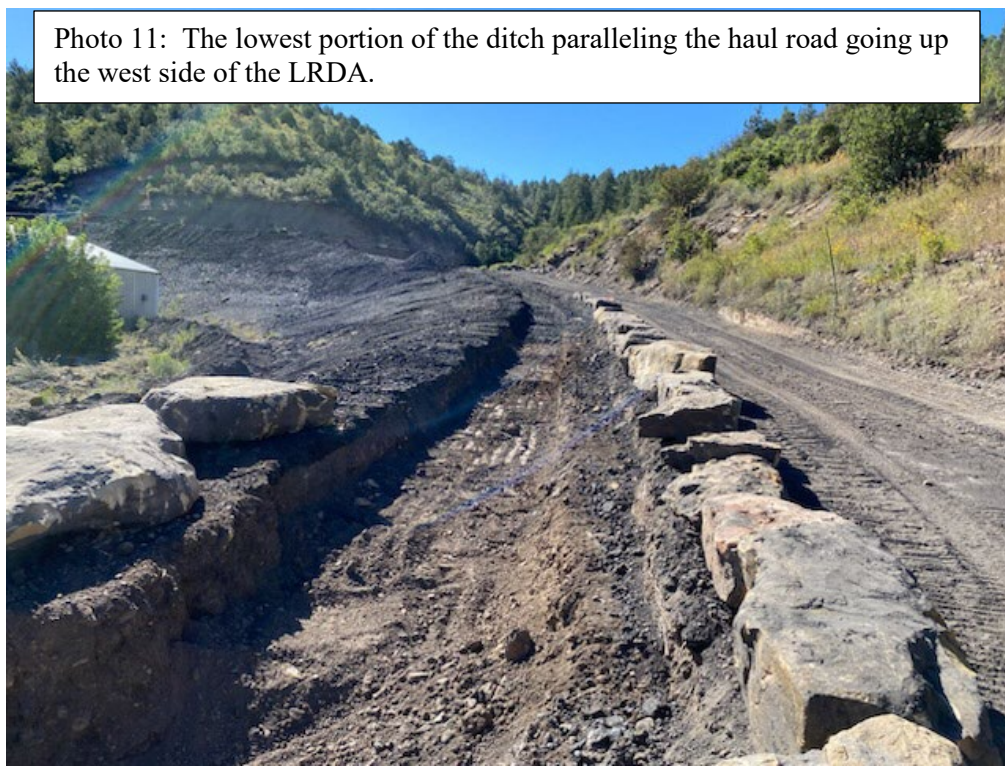
Photo 11: The lowest portion of the ditch paralleling the haul road going up the west side of the LRDA.

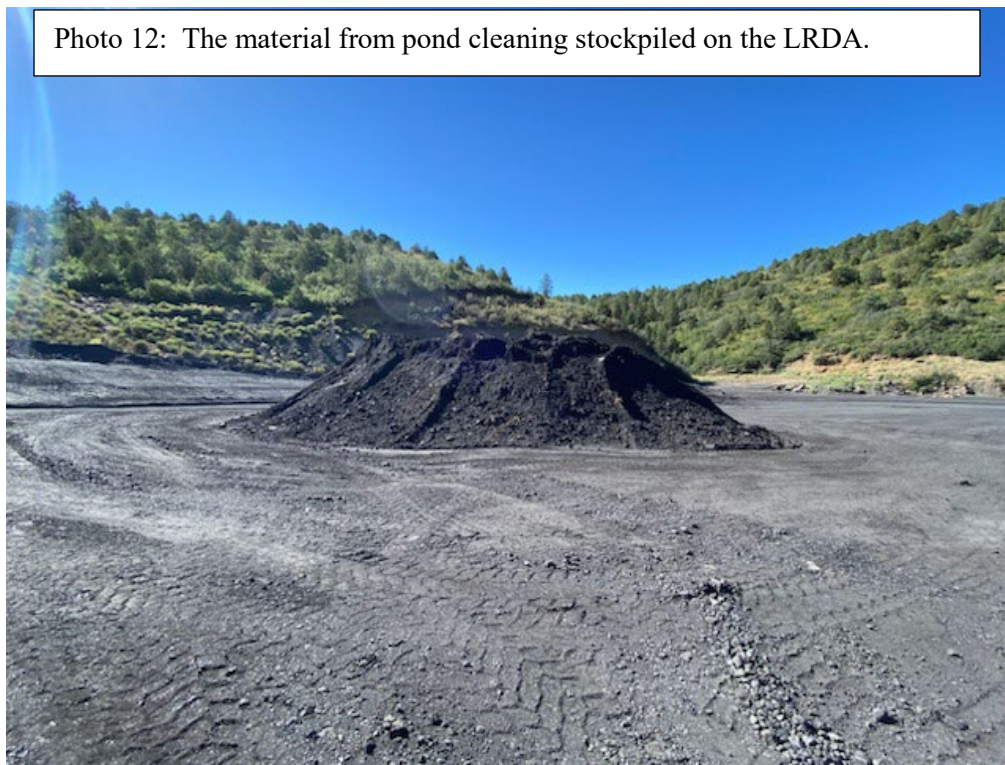
Photo 12: The material from pond cleaning stockpiled on the LRDA.

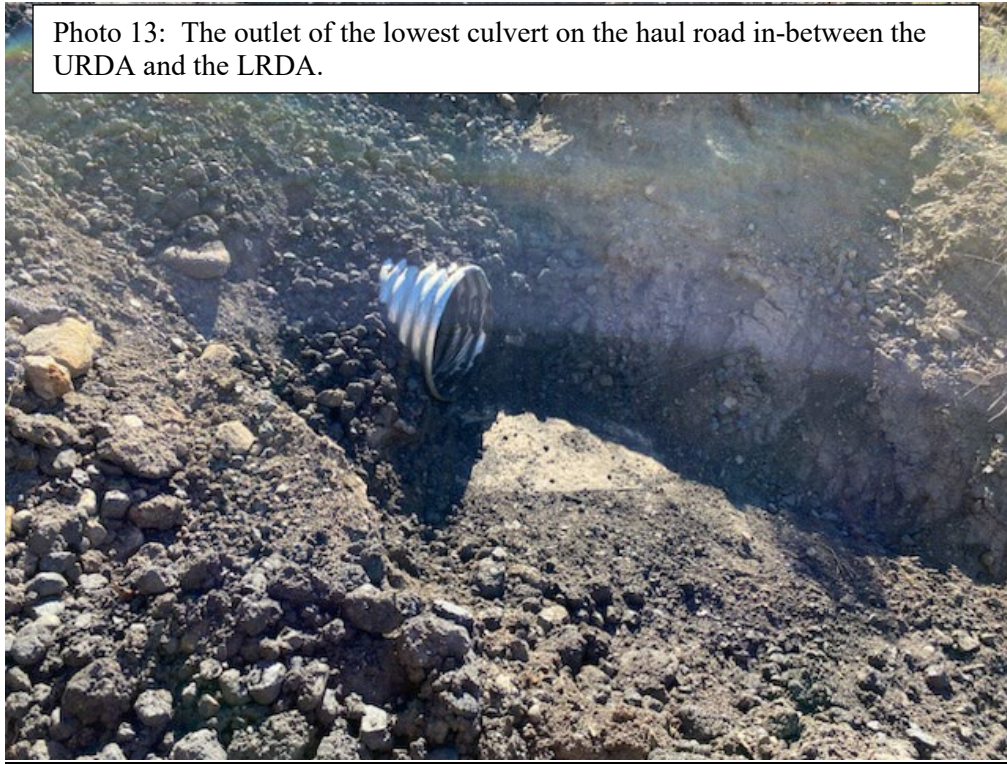
The haul road at the King I area was stable with no indications or erosional features. All three culverts between the URDA and the LRDA were clear of debris and functional (Photo 13 and 14). The ditches in the refuse disposal area were unobstructed and stable (Photo 15). The ditches were dry during the inspection.

Photo 13: The outlet of the lowest culvert on the haul road in-between the URDA and the LRDA.

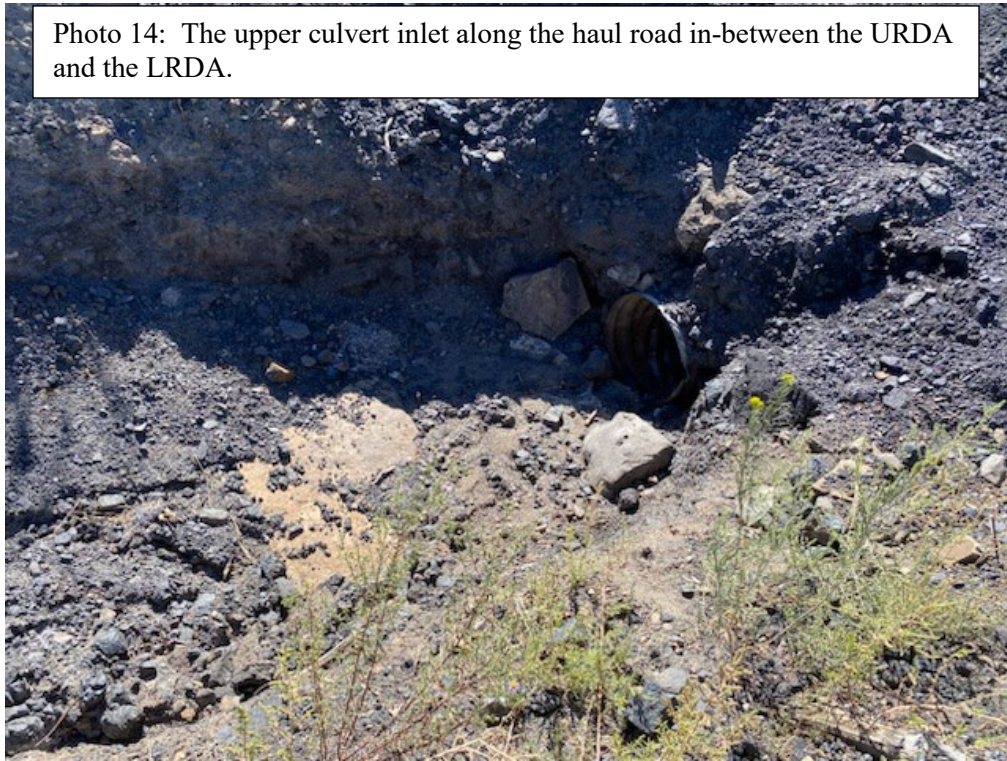
Photo 14: The upper culvert inlet along the haul road in-between the URDA and the LRDA.

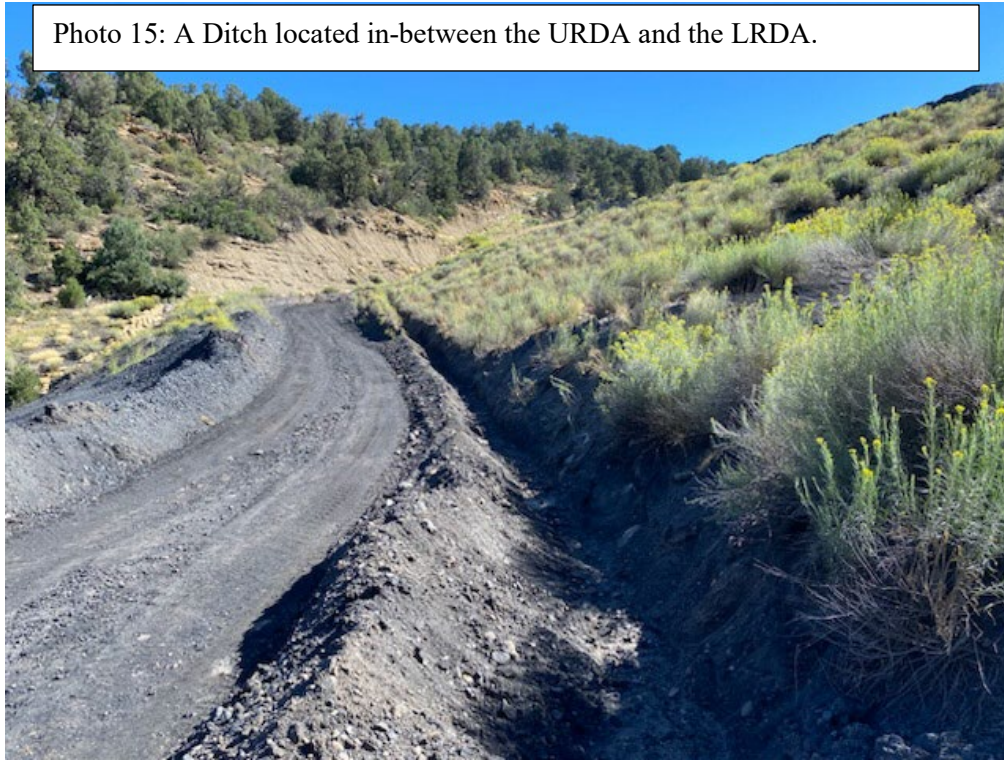
Photo 15: A Ditch located in-between the URDA and the LRDA.

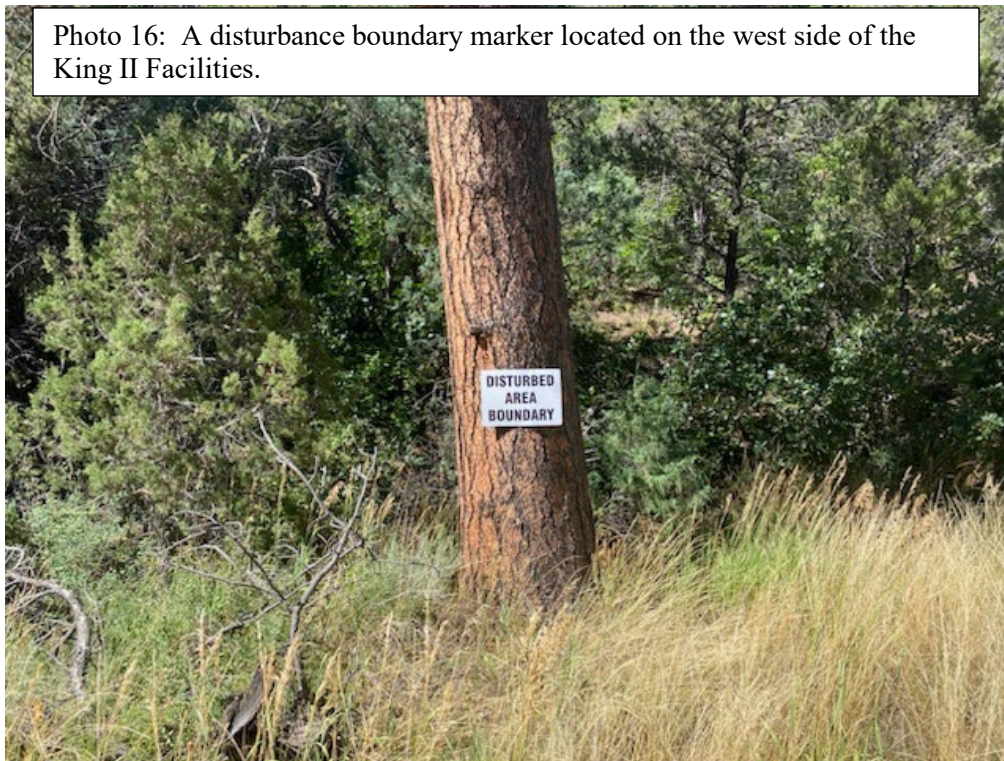
II Mine were identified on top of the piles. Disturbed area boundaries were marked by a combination of T-posts and disturbed boundary signs (Photo 16).

Photo 16: A disturbance boundary marker located on the west side of the King II Facilities.
