To: Jerald Schnabel
Riverbend Industries Inc.
File: August 2023 Monitoring Summary

Reference: August 2023 Geotechnical Monitoring Summary Pikeview Quarry

PIKEVIEW QUARRY SLOPE
MONITORING

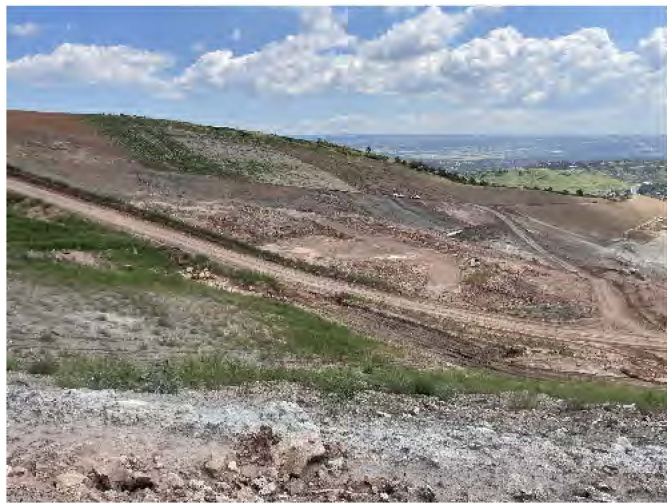
6. Vegetation growing in North Borrow Area.

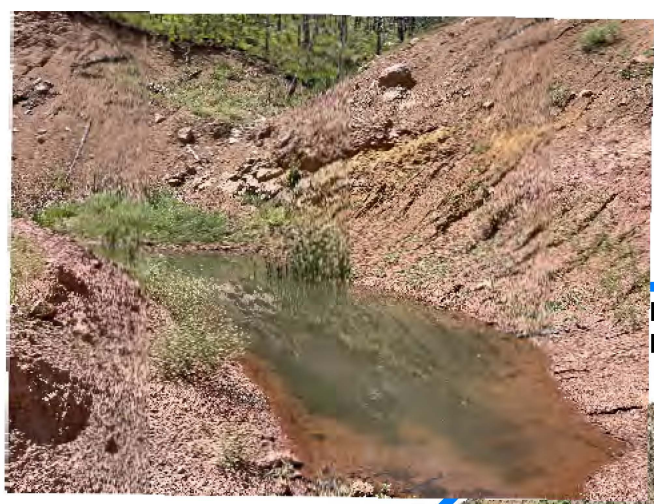
5. Sheep water hole.

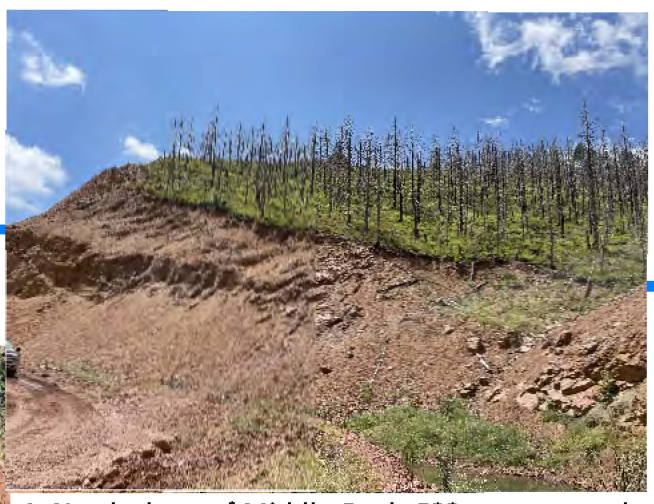
4. North slope of Middle Peak. P32 area - no cracks.

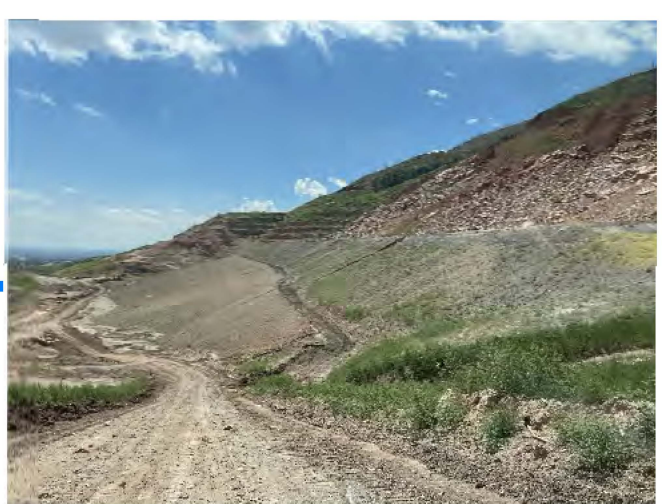
3. Reclamation benches and first bench slopes.

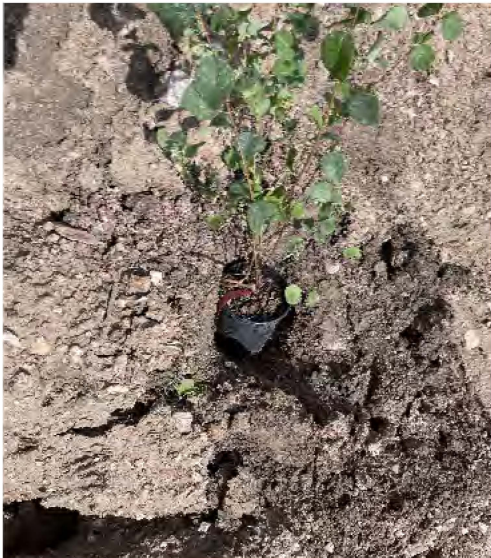
7. Tree planting on the North Borrow slopes.

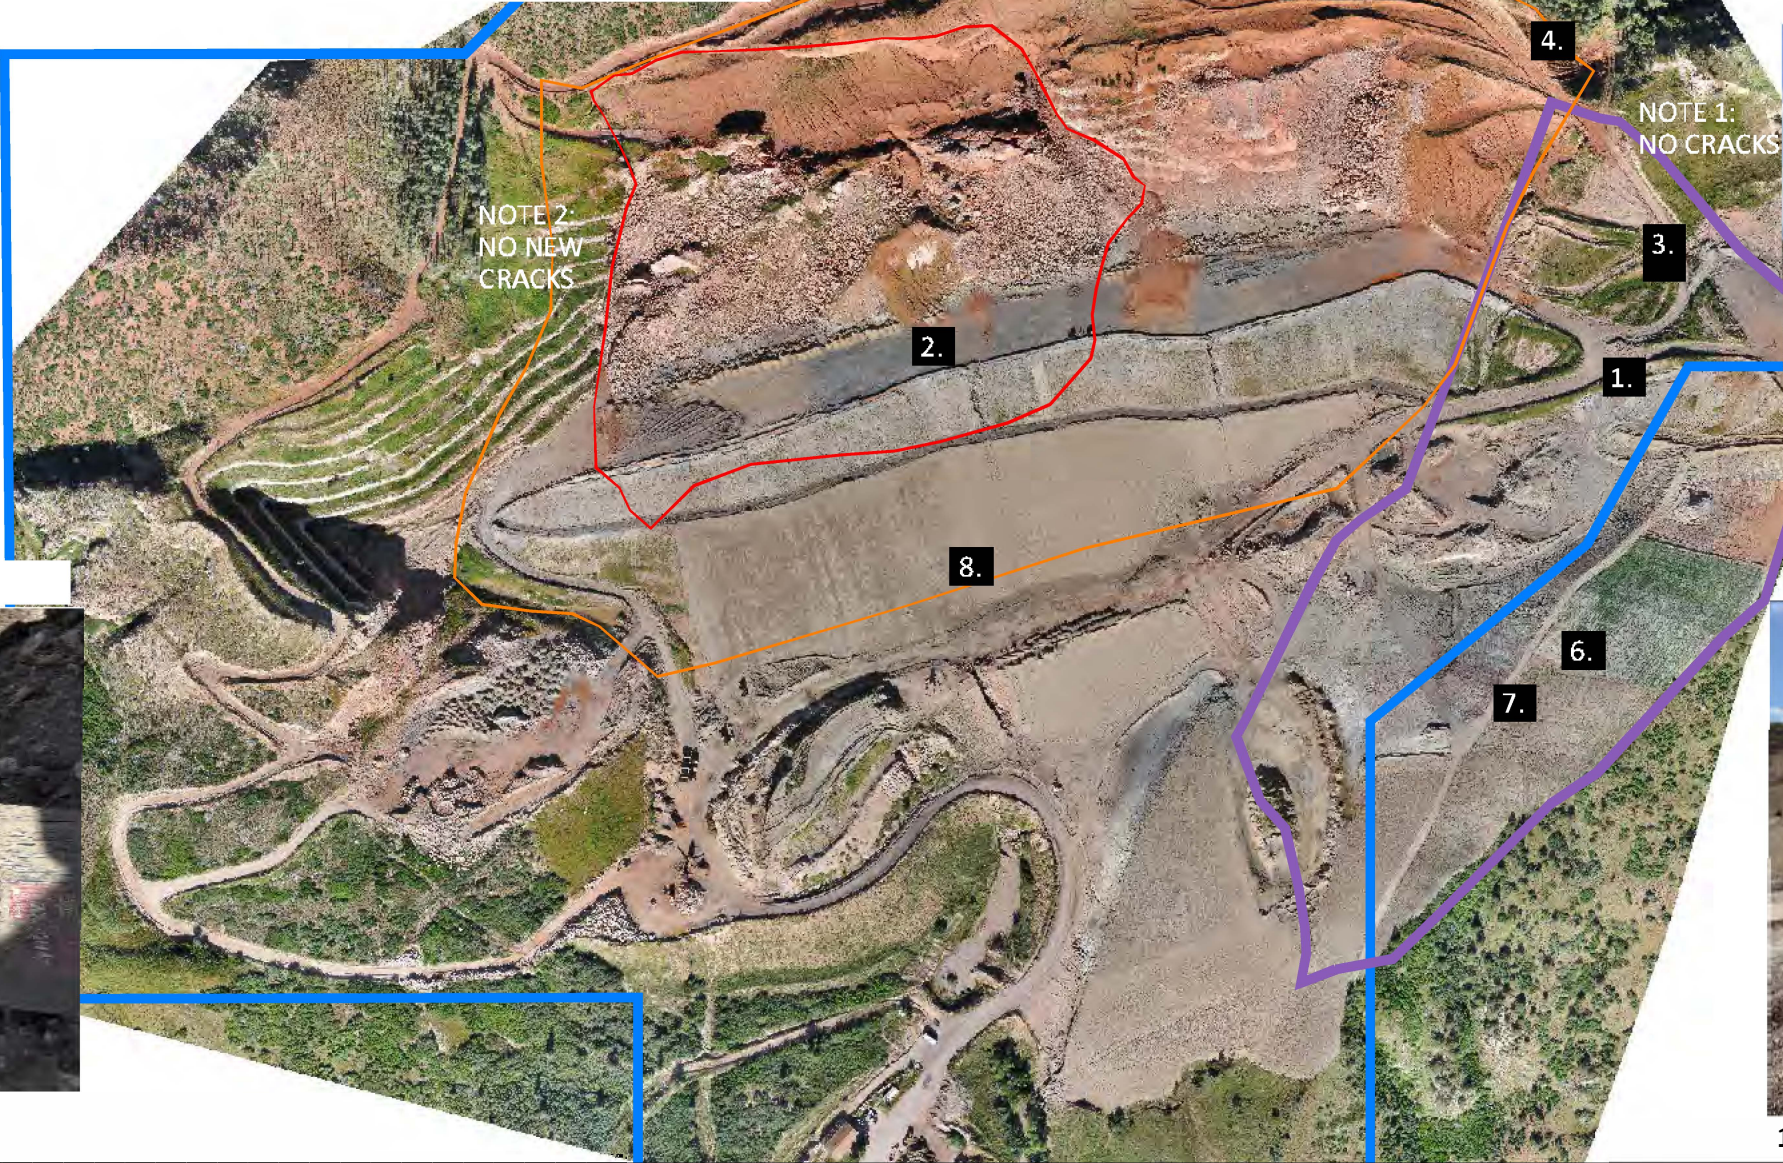
2

- Known cracks were monitored for changes. Currently the cracks are not growing in any of the areas on the slopes of the site. The hummocky field in the area immediately above the southern extent of the slide shows evidence of cracking, but they are not fresh or active. No new or open cracks were found immediately inside or next to the slide area.

1. NO CRACKS OBSERVED IN THIS AREA.
2. NO NEW CRACKS OBSERVED IN THIS AREA.
3. ALL PHOTOS TAKEN AUGUST 9, 2023.

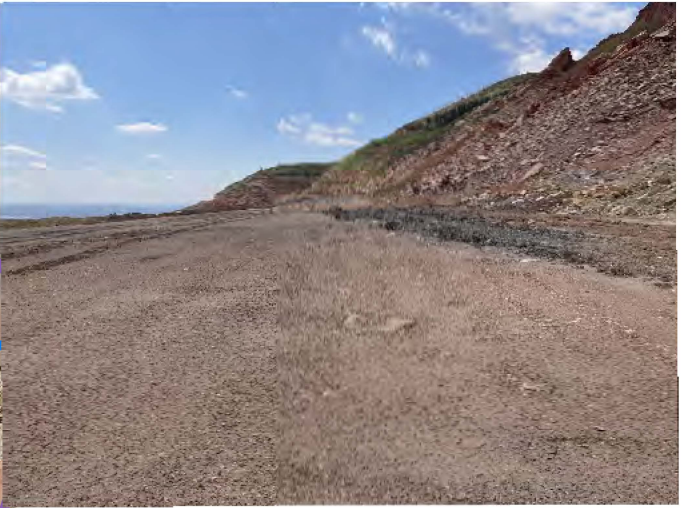
2. Compacted floor of first bench.

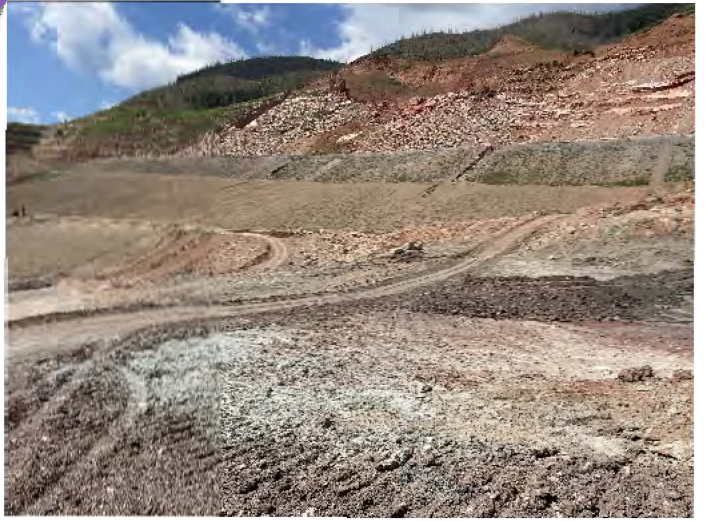
1. First bench slope seen from the North Borrow Area.

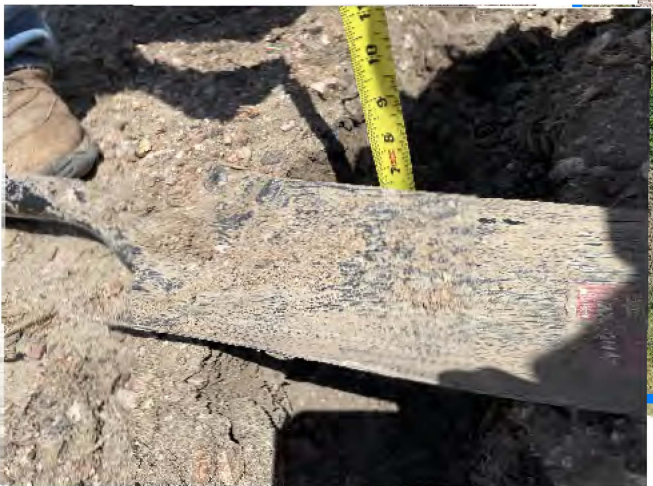
8. Measuring topsoil thickness.

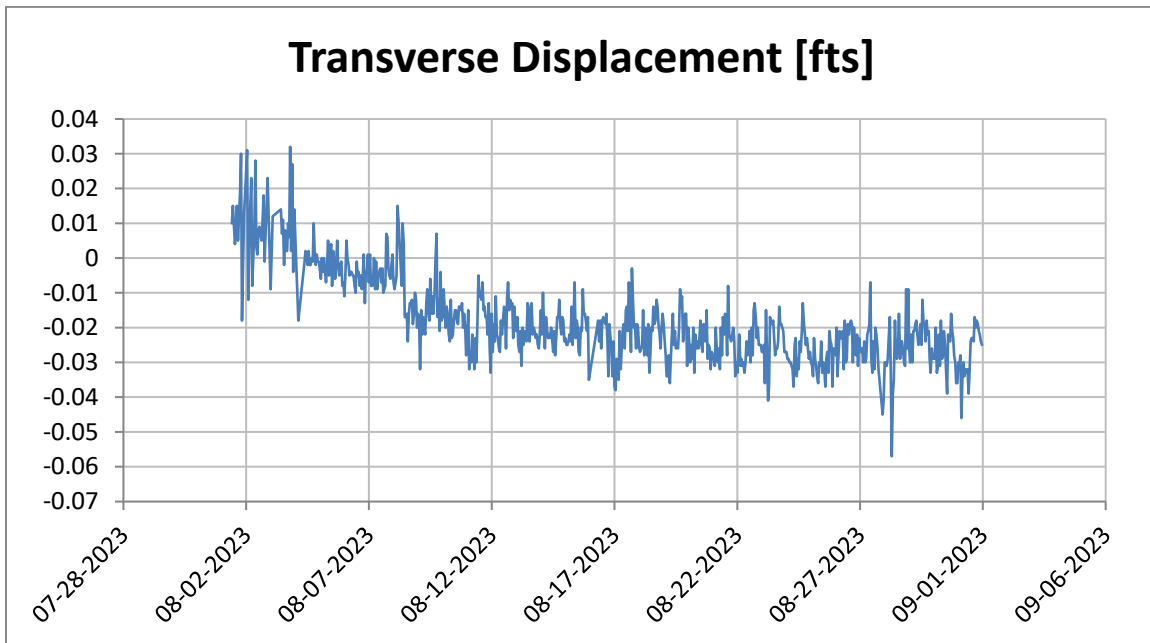
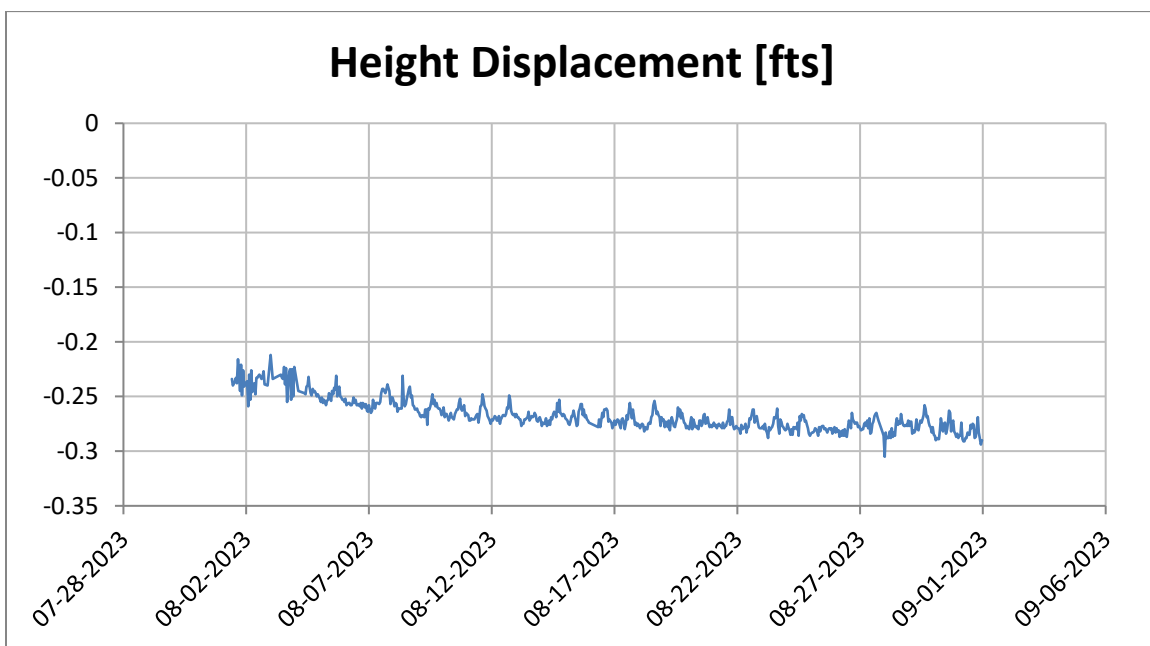
Prism BR1

landslide, and these prisms recorded slope creep movements at slow velocity. This settlement was likely related to loose fill or landslide material consolidating under its own weight. These prisms were placed in areas where slope creep movements are likely to occur; therefore, movements being recorded is expected. Plots of the transverse and height displacements for each prism are included in Appendix B.

1. Survey accuracy is +/-0.016 feet.
2. Alert threshold is +/-0.35 feet.
3. Transverse displacement is in the horizontal direction. Positive direction means closer to the robotic station.
4. Height displacement is in the vertical direction. Positive direction means higher in elevation.
5. Prism records slope creep movements.

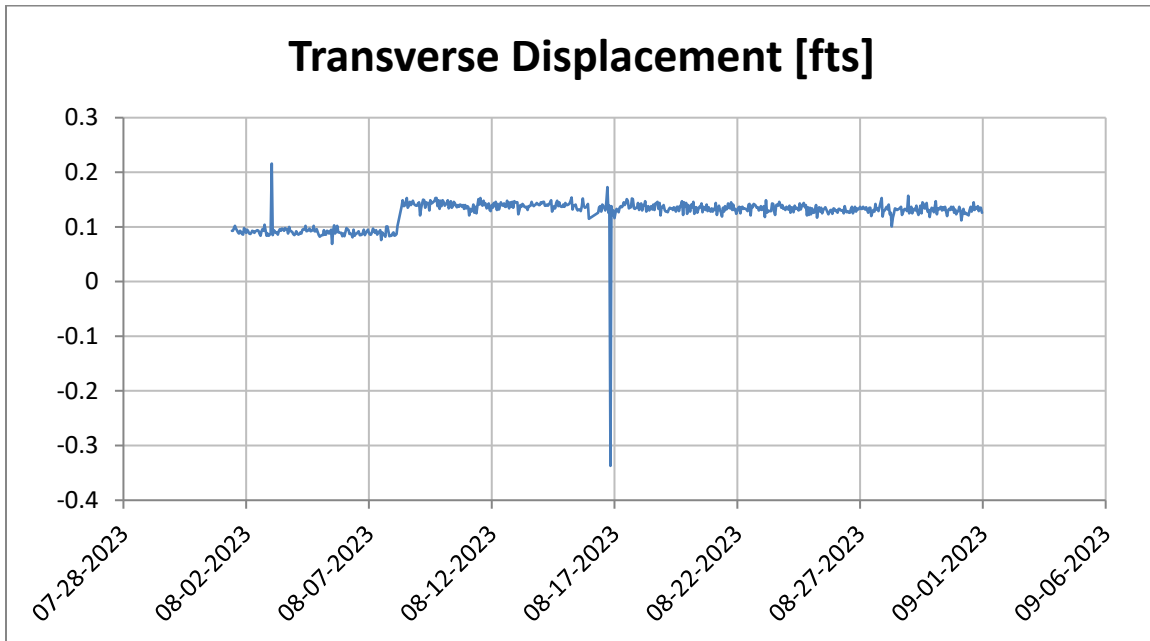
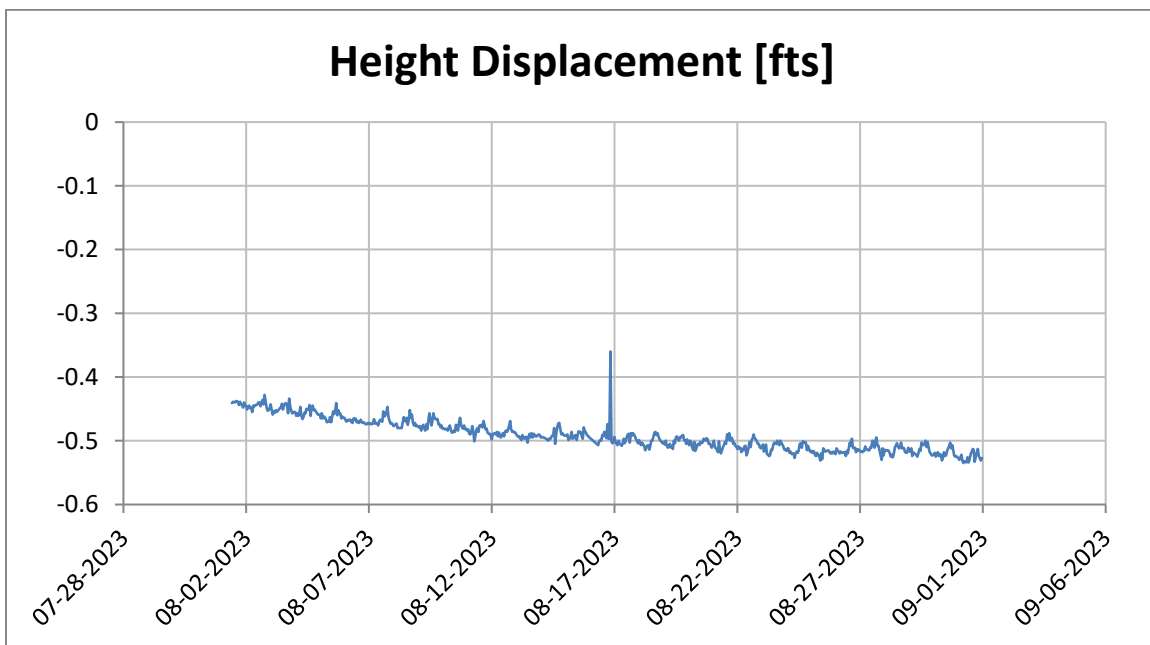
Prism BR2

1. Survey accuracy is +/-0.016 feet.
2. Alert threshold is +/-0.35 feet.
3. Transverse displacement is in the horizontal direction. Positive direction means closer to the robotic station.
4. Height displacement is in the vertical direction. Positive direction means higher in elevation.
5. Prism records slope creep movements.

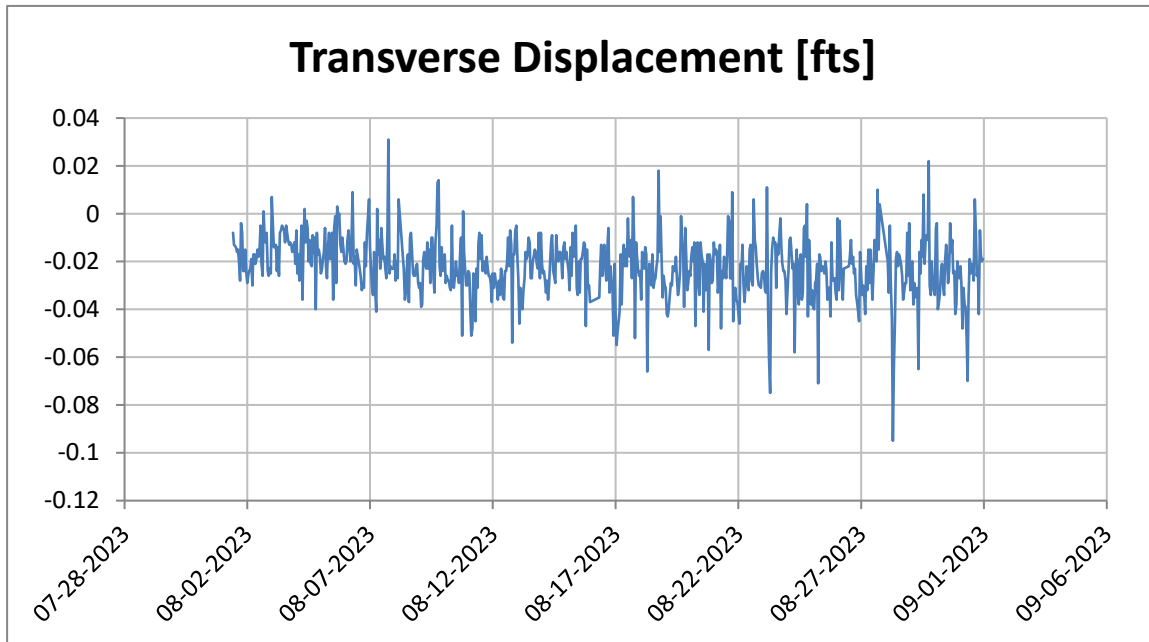
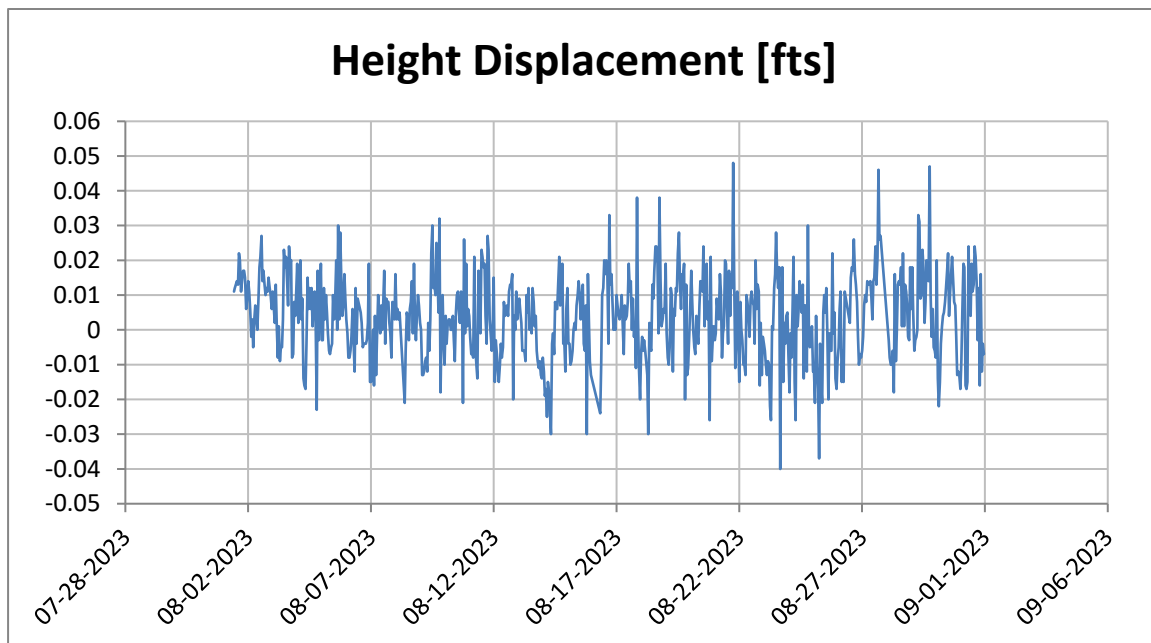
Prism P32R

Prism	Date	Action	Comment
P32	8/1/2023	Prism Removed	P32 was damaged by a falling rock. P32R was installed in the same location.
P32R	8/1/2023	Prism Added

1. P32R replaced P32 on August 1, 2023.
2. Survey accuracy is ± 0.016 feet.
3. Alert threshold is ± 0.35 feet.
4. Transverse displacement is in the horizontal direction. Positive direction means closer to the robotic station.
5. Height displacement is in the vertical direction. Positive direction means higher in elevation.

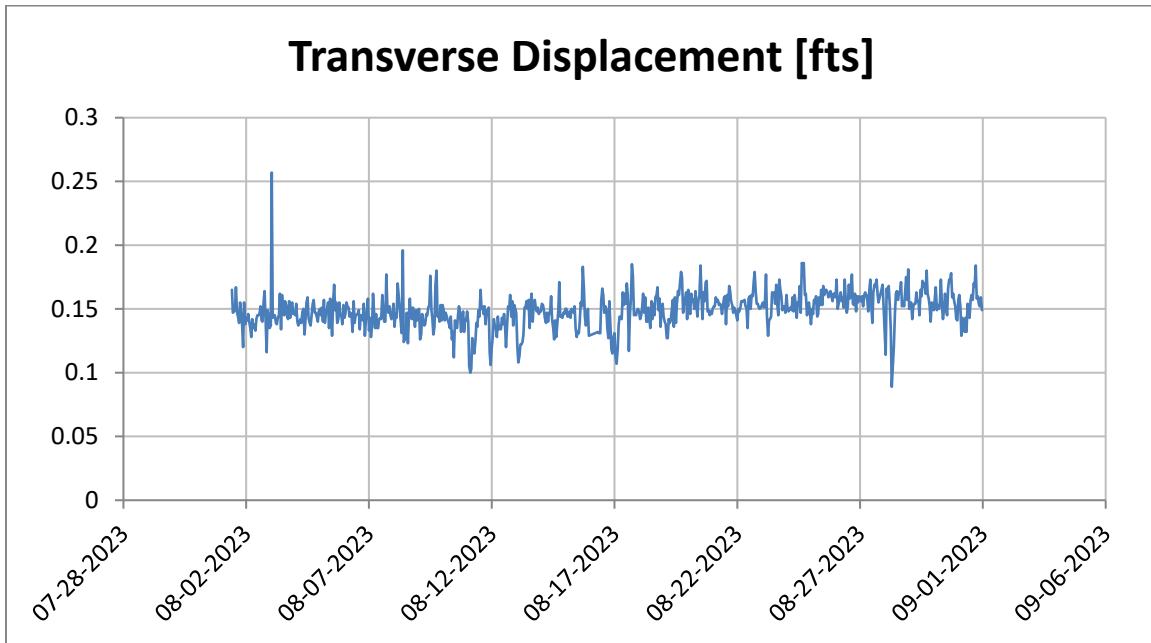
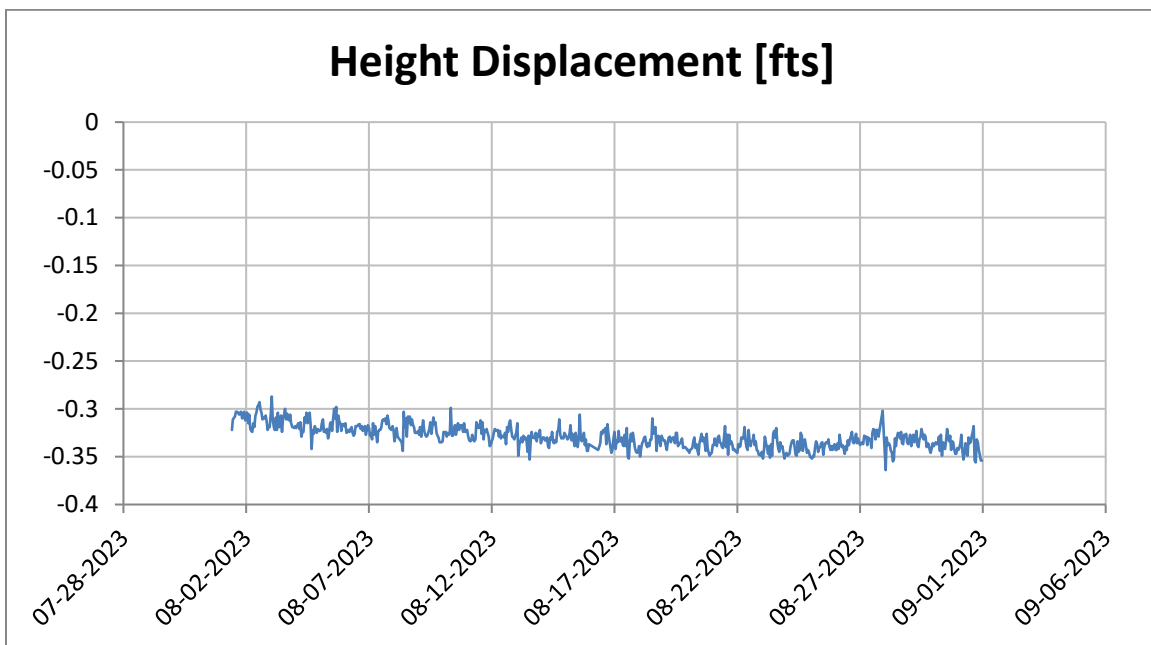
NP3

1. Survey accuracy is ± 0.016 feet.
2. Alert threshold is ± 0.35 feet.
3. Transverse displacement is in the horizontal direction. Positive direction means closer to the robotic station.
4. Height displacement is in the vertical direction. Positive direction means higher in elevation.
5. Prism records slope creep movements.

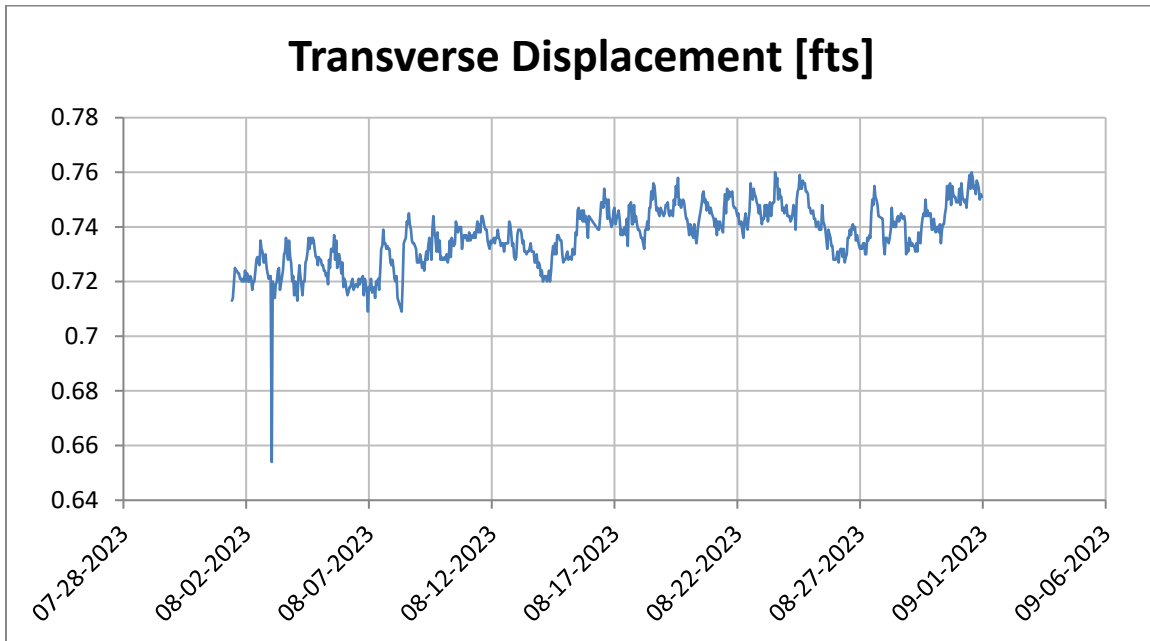
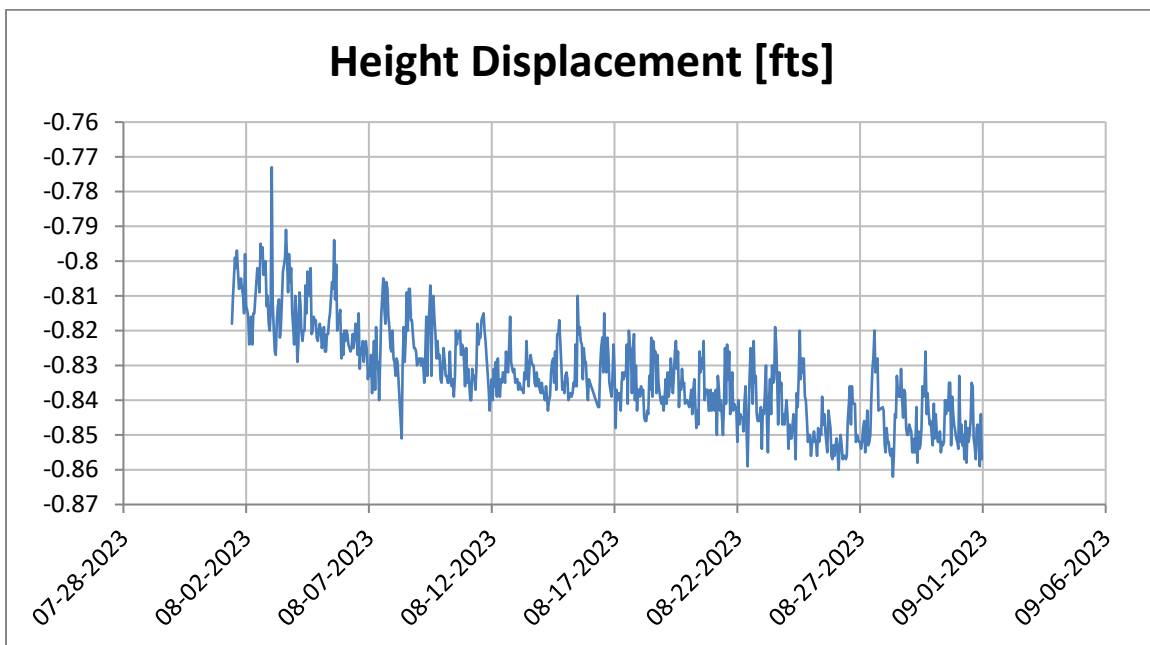
NP66

1. Survey accuracy is ± 0.016 feet.
2. Alert threshold is ± 0.35 feet.
3. Transverse displacement is in the horizontal direction. Positive direction means closer to the robotic station.
4. Height displacement is in the vertical direction. Positive direction means higher in elevation.
5. Prism records slope creep movements.

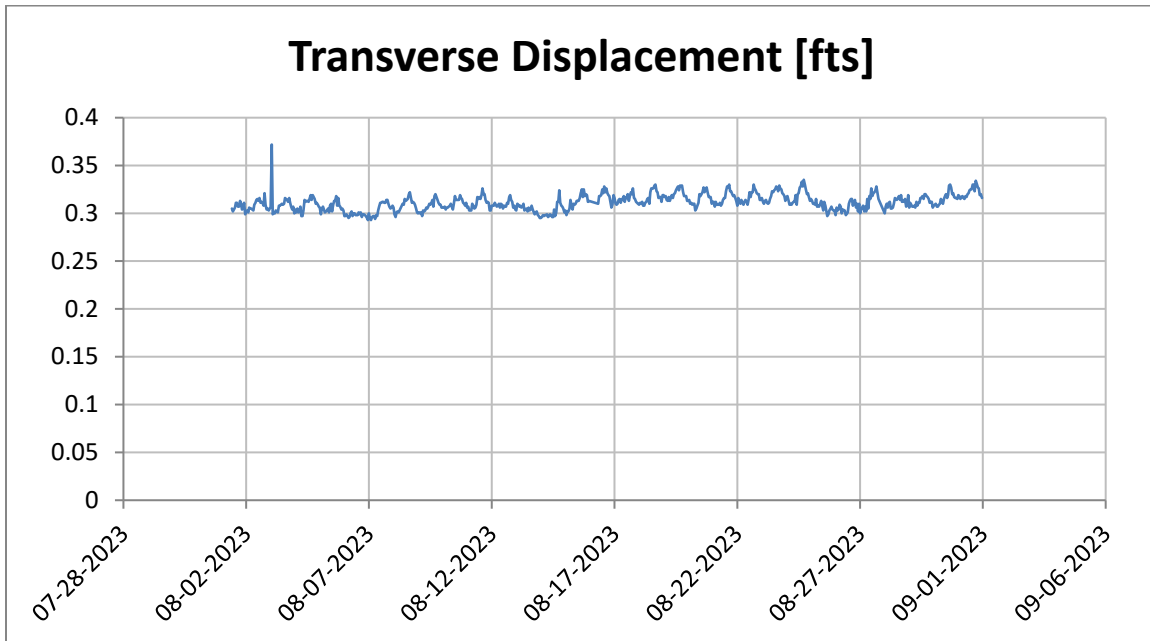
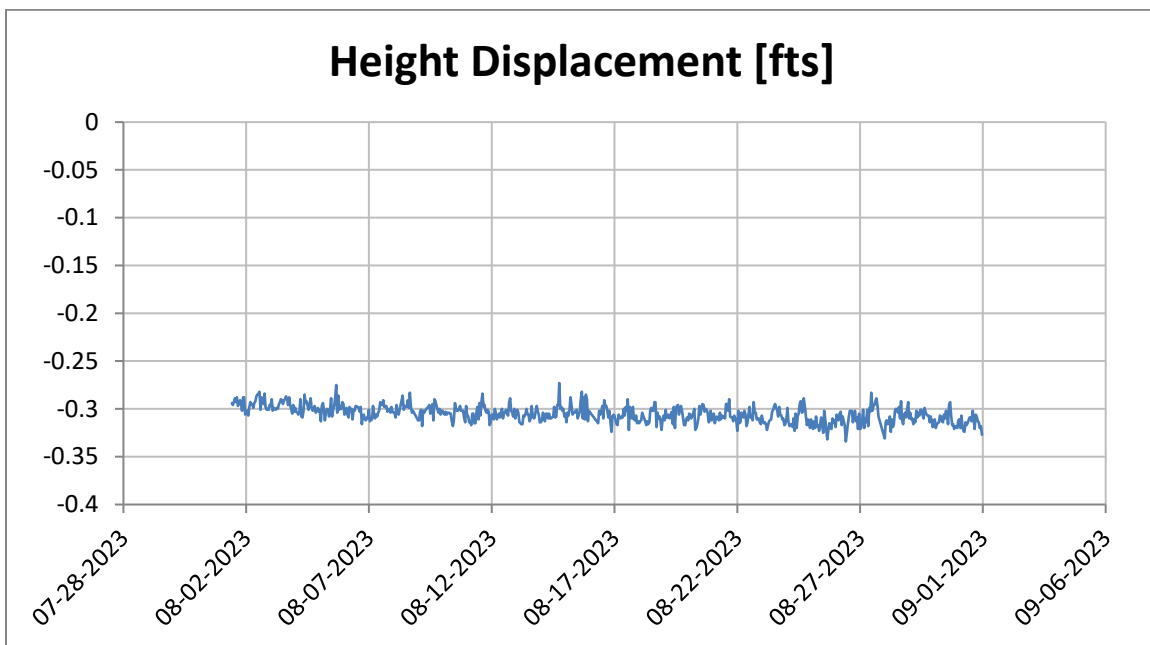
P69A

1. Survey accuracy is ± 0.016 feet.
2. Alert threshold is ± 0.35 feet.
3. Transverse displacement is in the horizontal direction. Positive direction means closer to the robotic station.
4. Height displacement is in the vertical direction. Positive direction means higher in elevation.
5. Prism records slope creep movements.
6. Regression limit alerts received on August 3.
