MINERALS PROGRAM INSPECTION REPORT
PHONE: (303) 866-3567

MINE NAME: Martin Pit 1-A	MINE/PROSPECTING ID#: M-1990-140	MINERAL: Sand and gravel	COUNTY: Moffat
INSPECTION TYPE: Monitoring	WEATHER: Clear	INSP. DATE: September 13, 2023	INSP. TIME: 08:30
OPERATOR: Duran & Pearce Contractors, Inc.	OPERATOR REPRESENTATIVE: Derek Duran	TYPE OF OPERATION: 112c - Construction Regular Operation	
REASON FOR INSPECTION: Normal I&E Program	BOND CALCULATION TYPE: Complete Bond	BOND AMOUNT: \$34,770.00	
DATE OF COMPLAINT: NA	POST INSP. CONTACTS: None	JOINT INSP. AGENCY: None	
INSPECTOR(S): Zach Trujillo	INSPECTOR'S SIGNATURE:

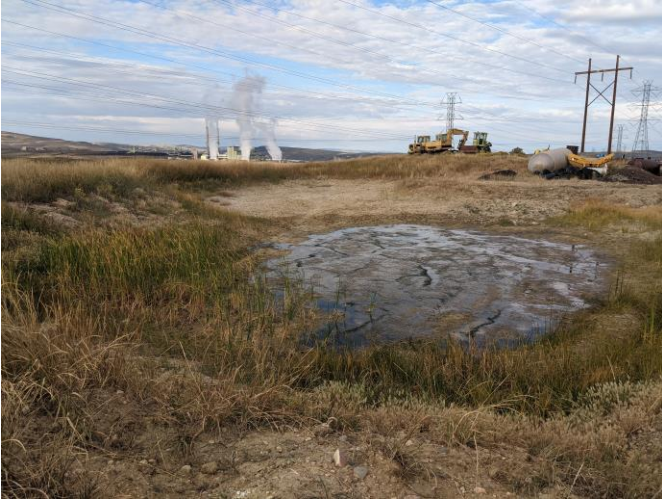
A single sediment pond exists south of the stockpile and laydown area. The area is sloped in the direction of the pond as well as additional berms to help direct surface runoff. The pond was recent cleaned with sediment deposited between the pond embankment and the water diversion berm. The sediment was within the bermed area however additional clearance is needed between the stacked material and the berm to ensure all material stays within the approved disturbance boundary. The Operator stated the material is to be removed from the area and used as backfill.

Sediment Pond.

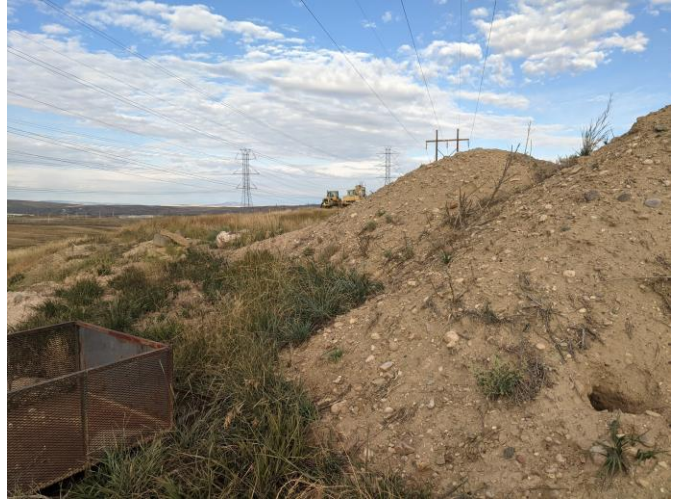
Pond cleanings.

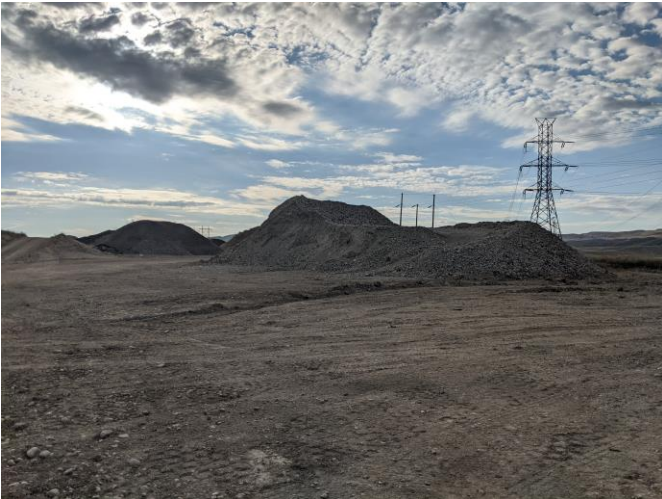
This site was not active at the time of the inspection but mining operations have been conducted prior to the inspection. There were several pieces of equipment on site. Several material stockpiles are located along the western end of the site. The Operator has also stockpiled crushed concrete and asphalt on site. It was noted in the previous Division's inspection report that the imported concrete material was intermixed with rebar and other non-inert materials. During the inspection, the concrete was inspected and all rebar has been removed from the concrete during the crushing process and removed from the site as stated by the Operator. The mining plan states that approximately 100 tons of imported material will be backfilled each year.

Material stockpile.

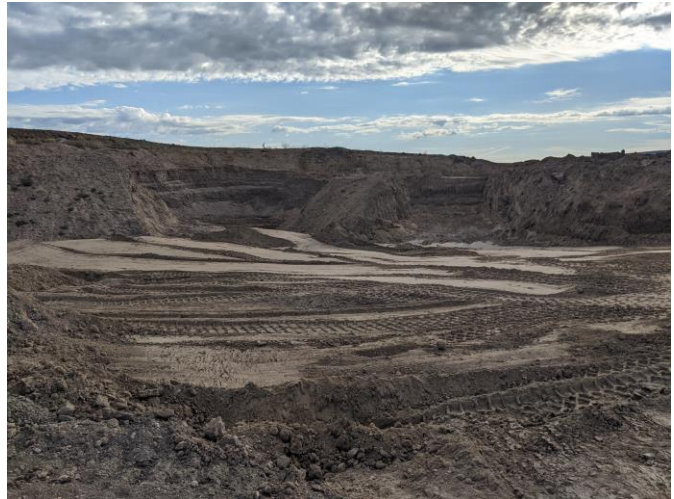
The pit excavation currently is located along the south eastern portion of the approved permit boundary and progressing to the north. Water was observed along some of the pit excavation. Water observed was isolated along the center area of the pit. No water was observed along the eastern or western ends of the active pit highwalls. Water within the pit should be monitored and mitigated as necessary. If water continues to be encountered the permit may need to be revised.

Active pit area.
