MINERALS PROGRAM INSPECTION REPORT
PHONE: (303) 866-3567

MINE NAME: Masters Pit #2	MINE/PROSPECTING ID#: M-2010-037	MINERAL: Clay (general), gravel	COUNTY: Washington
INSPECTION TYPE: Monitoring	WEATHER: Clear	INSP. DATE: September 12, 2023	INSP. TIME: 09:00
OPERATOR: Elva Masters	OPERATOR REPRESENTATIVE: Tony Niebur	TYPE OF OPERATION: 112c - Construction Regular Operation	
REASON FOR INSPECTION: Normal I&E Program	BOND CALCULATION TYPE: None	BOND AMOUNT: \$15,500.00	
DATE OF COMPLAINT: NA	POST INSP. CONTACTS: None	JOINT INSP. AGENCY: None	
INSPECTOR(S): Brock Bowles	INSPECTOR'S SIGNATURE:

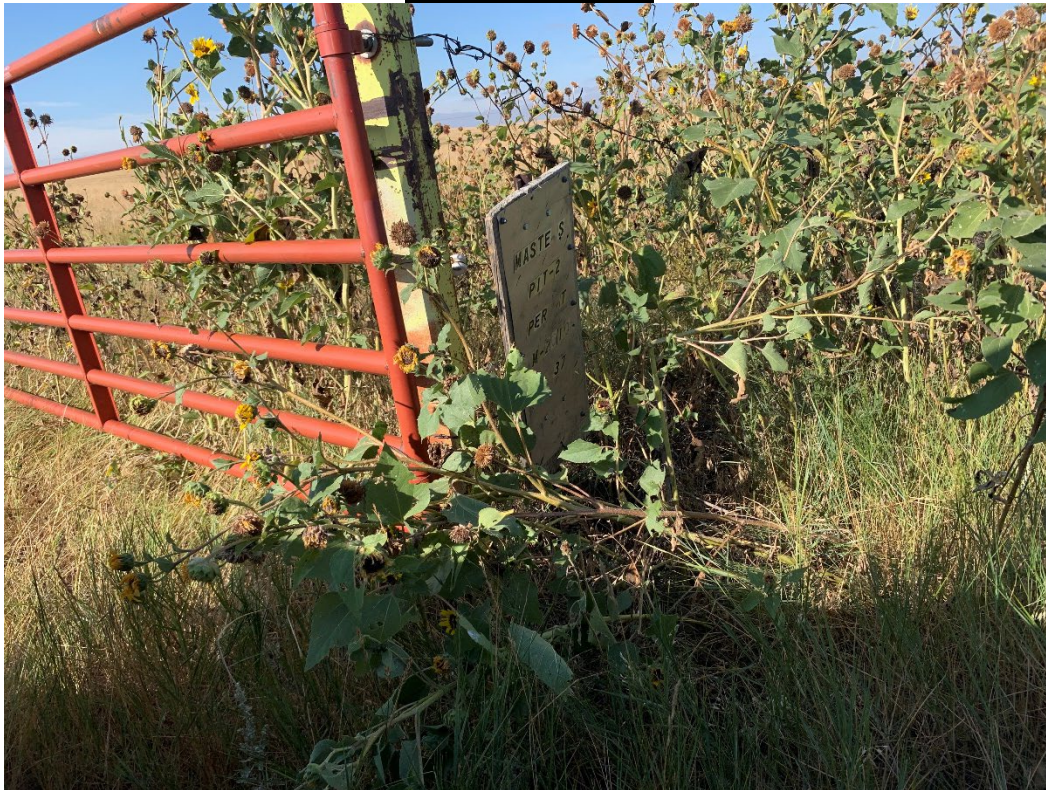
The mine entrance sign was in place at the entrance gate (photo 1) and the permit boundary markers were in place.

Photo 1 – Mine entrance sign facing CR JJ

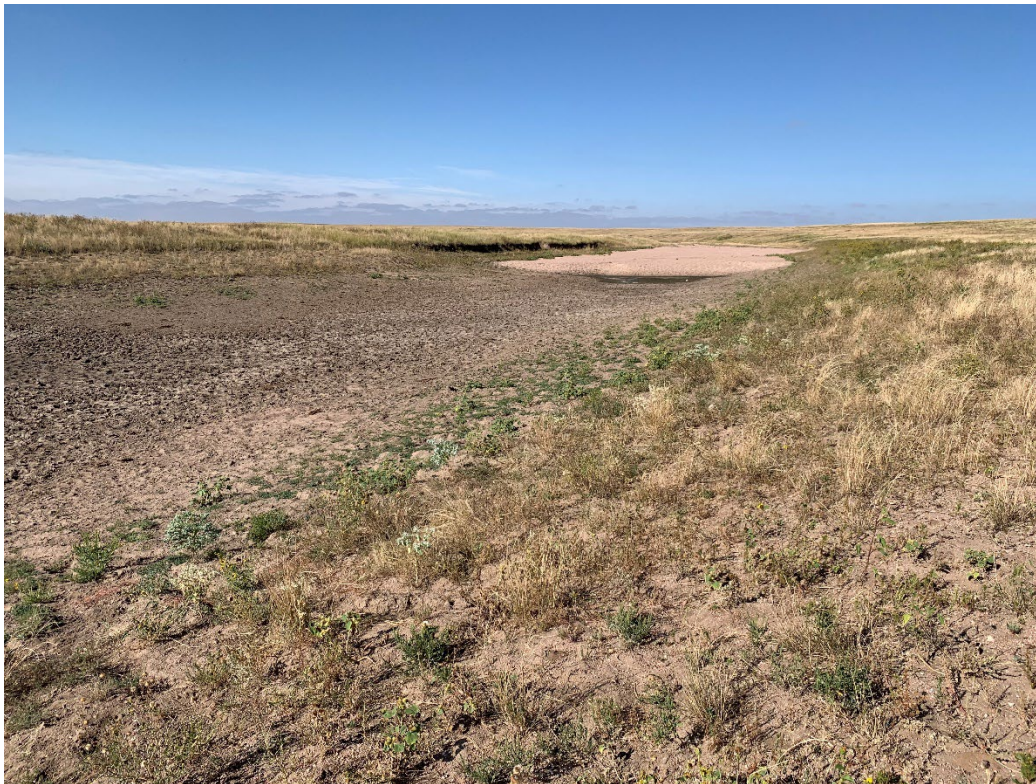
The surface area was graded to blend in with the surrounding landscape. The banks along the creek were sloped 3h:1v (photo 2). No rills or gullies were seen on the banks or upland areas.

Photo 2 – East end of mine facing west. Right bank reclaimed, left bank was not mined.

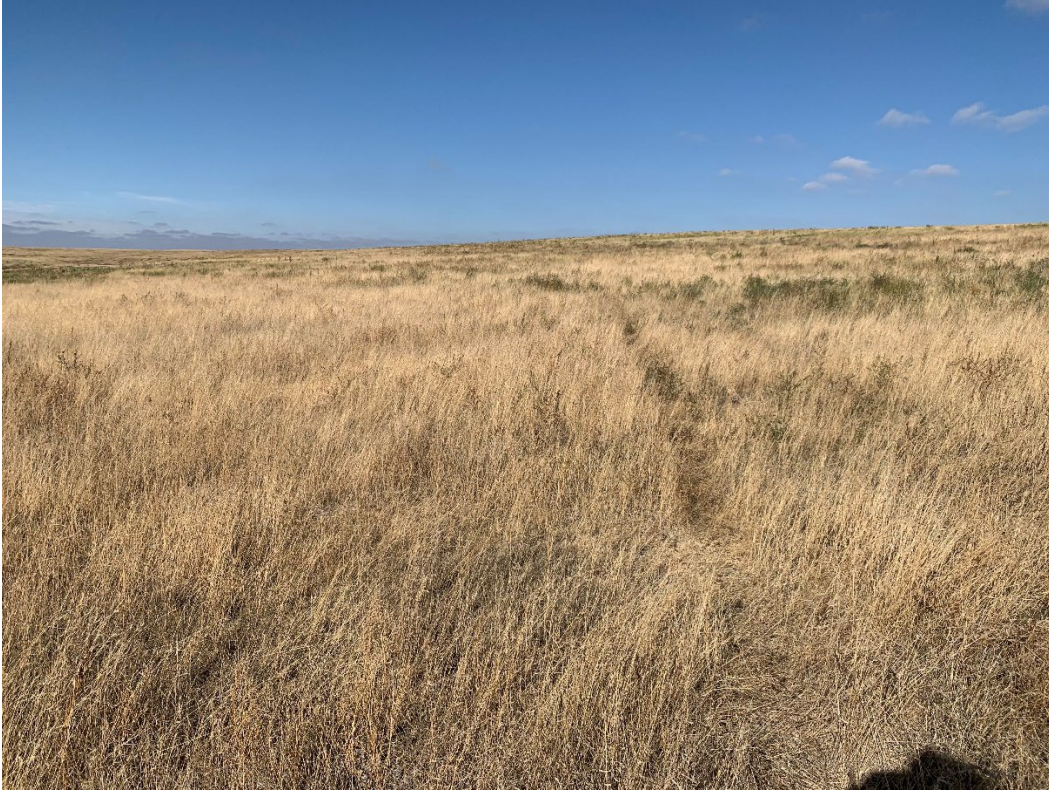
Photo 3 – Upland reclamation, old topsoil storage area.

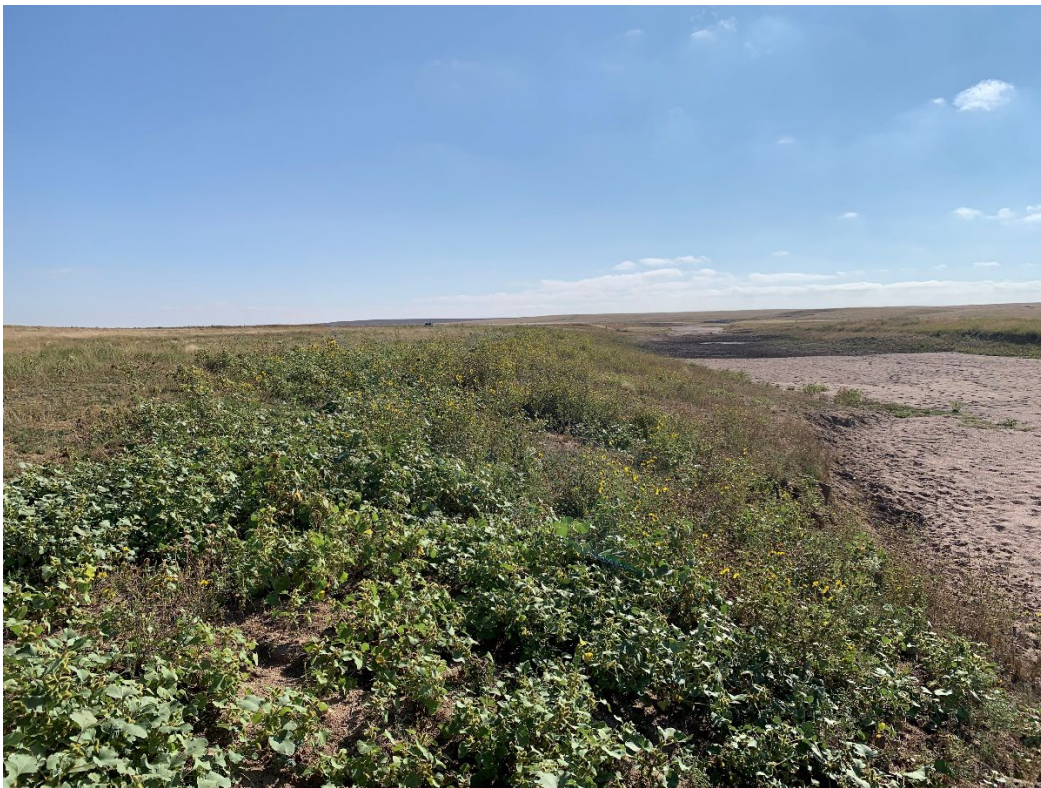
The upland areas were filling in with several species of grasses (photo 3). The creek banks had some alfalfa, common cockleburs (*xanthium orientale*), sunflowers, Indian ricegrass and wheatgrasses. A small patch of cockleburs and sunflowers were on the west end of the reclaimed creek bank (photo 4). Both of these plants are native annuals, and the patch will most likely decrease in size as the surrounding well-established grass community takes over.

Photo 4 – West end of mine facing east. Left bank reclaimed, right bank not mined.
