**NEW ELK MINE**  
**Permit No. C-1981-012**

**QUARTERLY COAL WASTE BANK INSPECTION REPORT**  
**September 8, 2023**

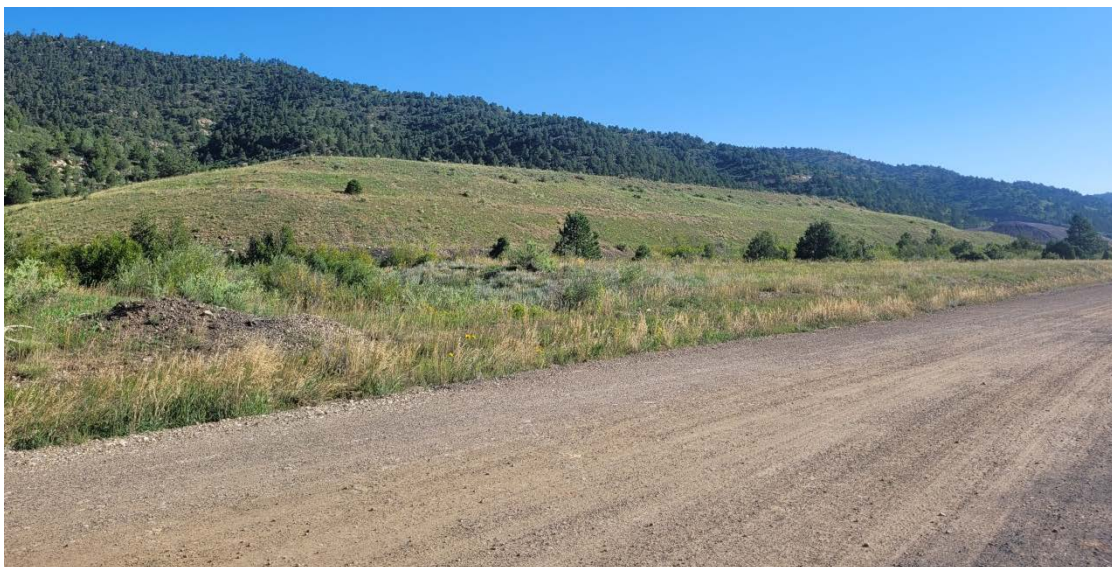
### **DWDA #1**

Overall the disposal area is in good condition.

None at this time.

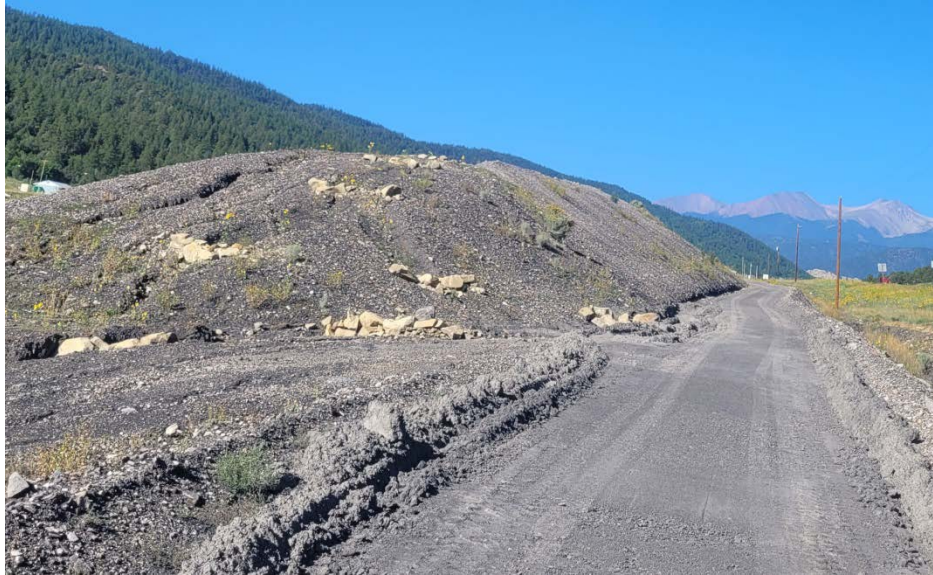
**DWDA #2**

Surface and out slopes of the pile were inspected for visible signs of potential failure or instability. There was some surface erosion but not enough to make the area unstable. In all no signs of failure or instability were observed.

Overall the disposal area is in good condition. The sign with the name of the area was recently replaced.

The Rills are being monitored and have not gotten any bigger and there is no sediment loading. Operator is evaluating either reclamation of the area or permitting alternative uses of the land north of the Purgatoire River and south of Highway 12. The ditches and sumps leading to the large sump at the end of the area was cleaned in the past quarter as well as some maintenance to the berm of the sump. Some further maintenance to the berm is planned. A rill on the East end of the pile is being monitored closely and some BMPs might have to be put in place if necessary.

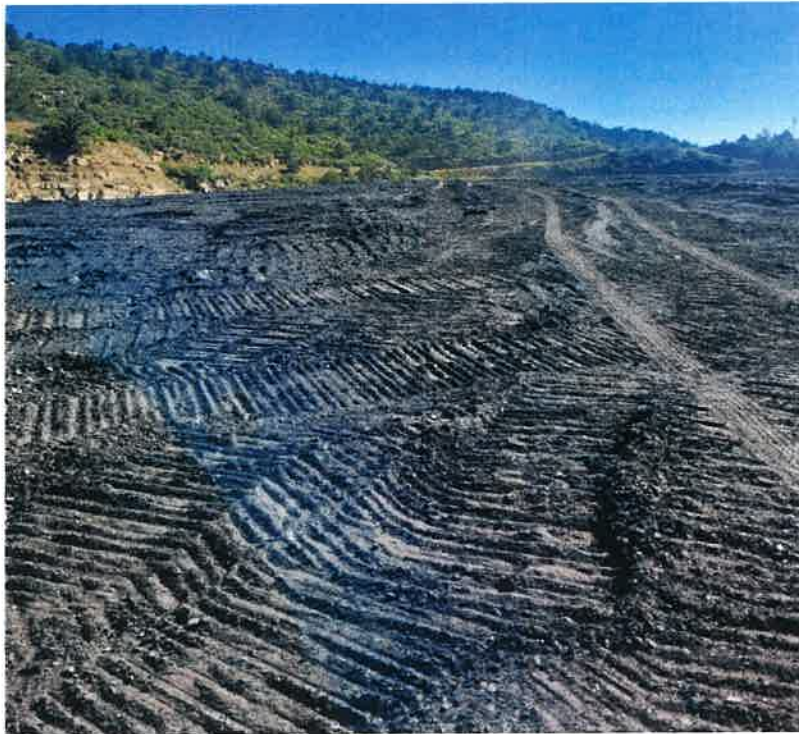
**Top Bench of Refuse Disposal Area**

Overall the site is in good condition.

Work was completed in the Northwest corner of the top bench of the RDA to better define the ditch that wraps around the back of the RDA to the armored ditch. The ditch was not flowing correctly, but that has been corrected. On the top bench in the Southwest corner above the West sump some rills were forming, so NECC placed some material in the rills. The West sump was cleaned after a heavy rain event. No other maintenance required at this time.
