QUARTERLY SEDIMENTATION POND INSPECTION REPORT

Mine: New Elk

Inspection Period: Third Quarter 2023

**March Inspection Report
New Elk Mine- September 8, 2023**

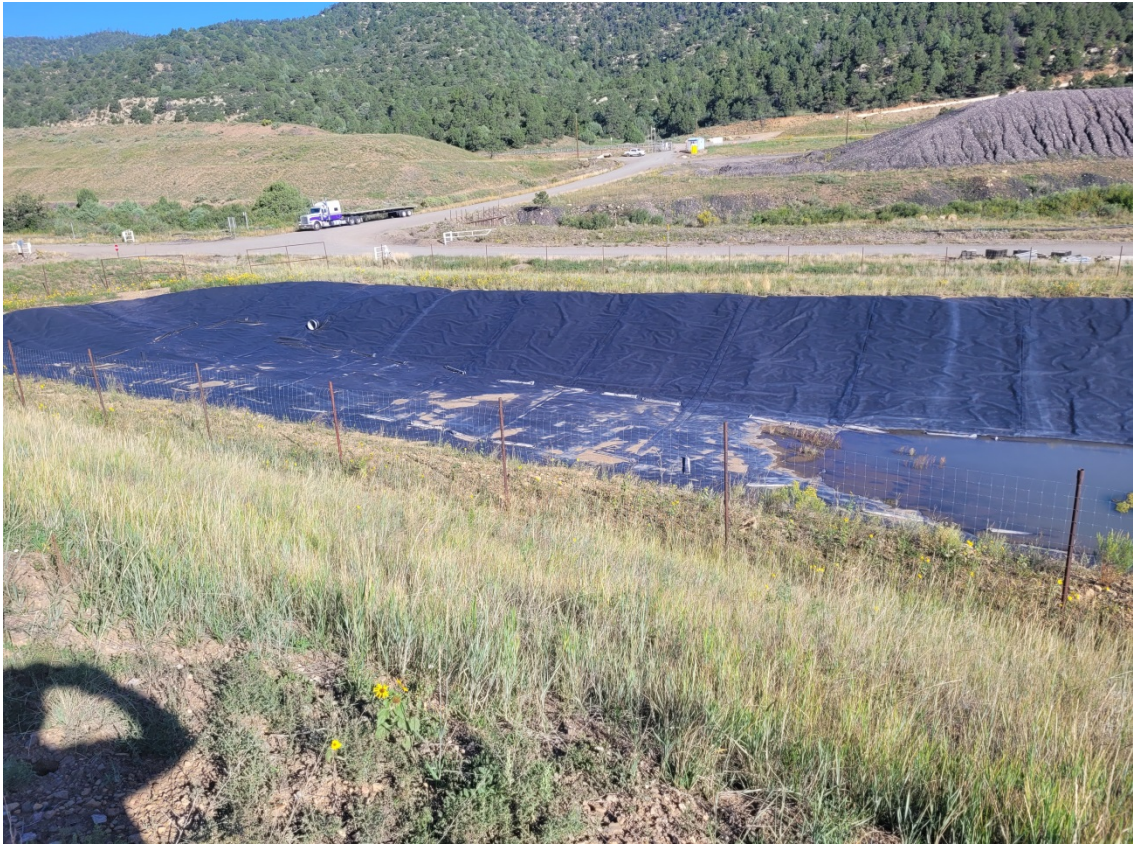
Pond 1 looking West

Pond liner is in good working condition at time of inspection. Pond was holding water at time of
inspection. The mine is putting water into the pond. No issues observed.

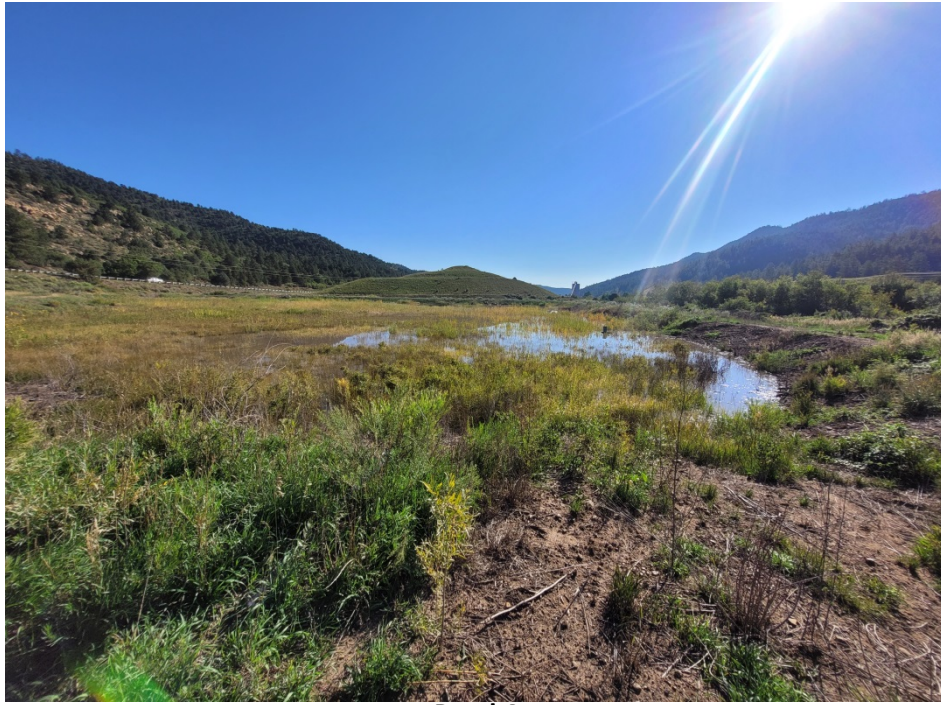
Pond 4

Pond was water at the time of inspection, not near the discharge level. No Issues observed.

Water has been pumped into the pond recently from pond 7 and pond 6.

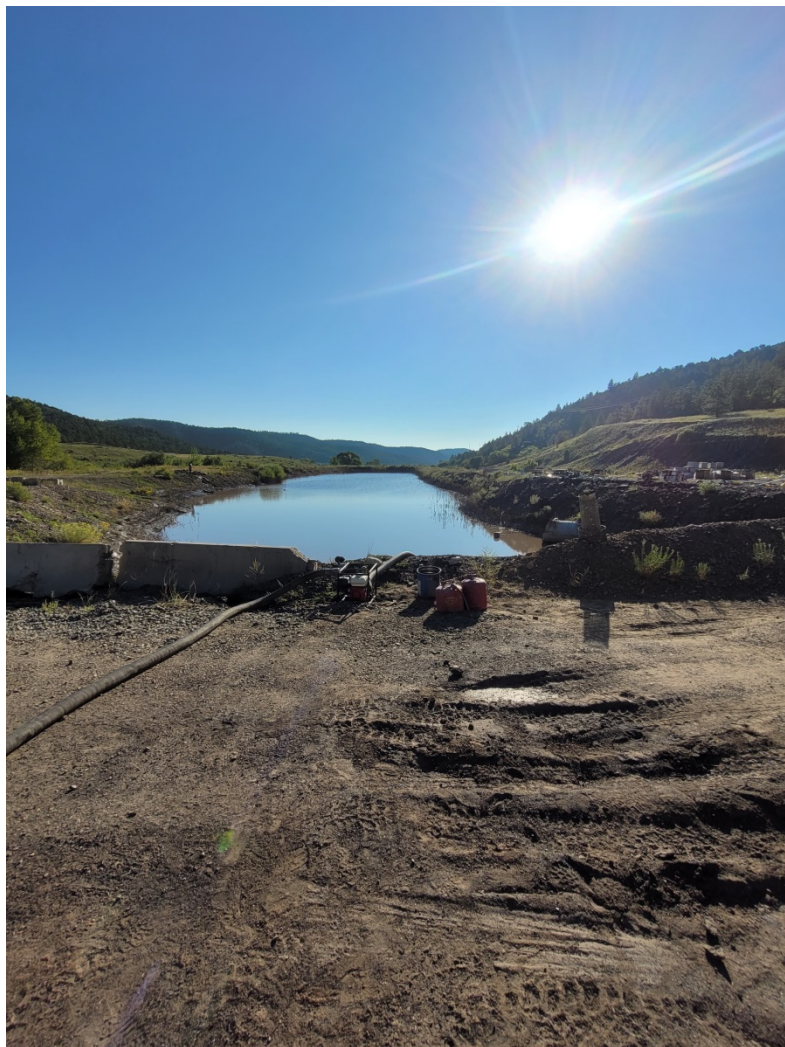
Pond 7

Pond is holding water at time of inspection, water is being pumped to pond 4. No issues observed.

No discharges have occurred.

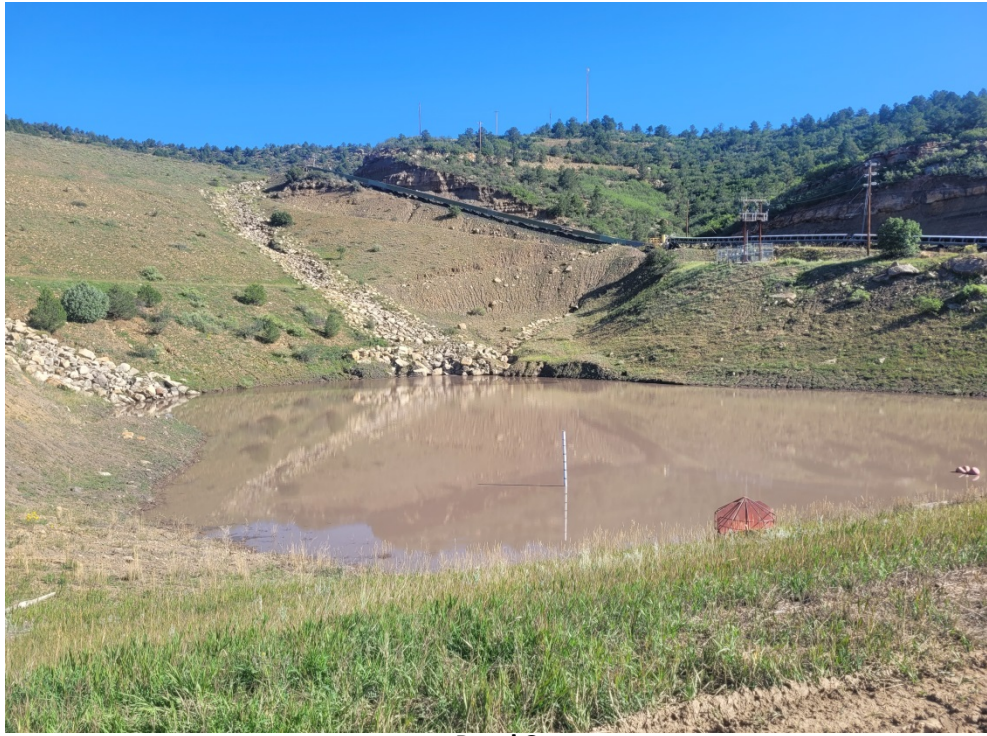
Pond 8

Pond is holding significant water and is planned to be pumped down in the near future. The water
Level is about 7 to 8 feet below the decant. No discharges have occurred and No issues found
during the inspection.

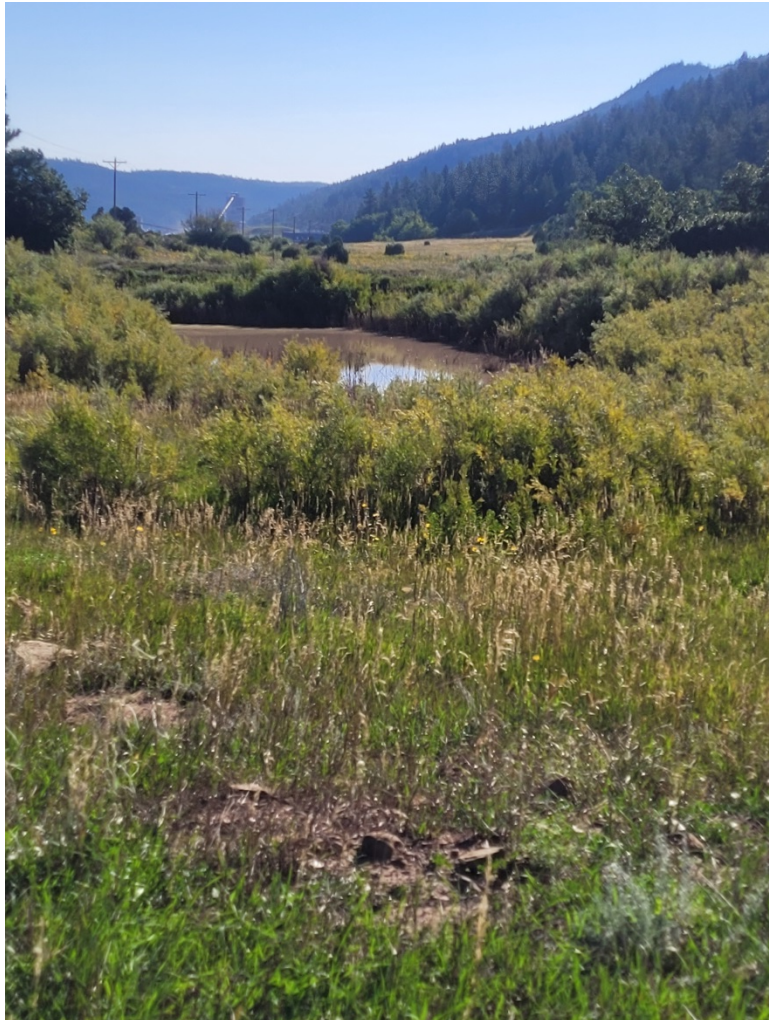
Containment Area #1

Containment was holding water at the time of inspection.

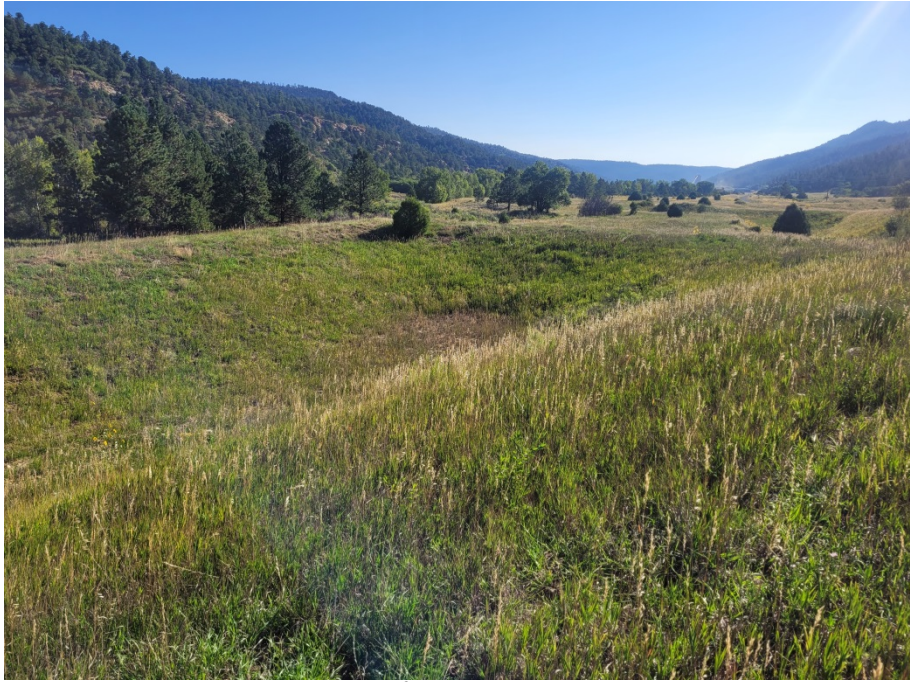
Containment Area #2

Containment was empty at time of inspection.

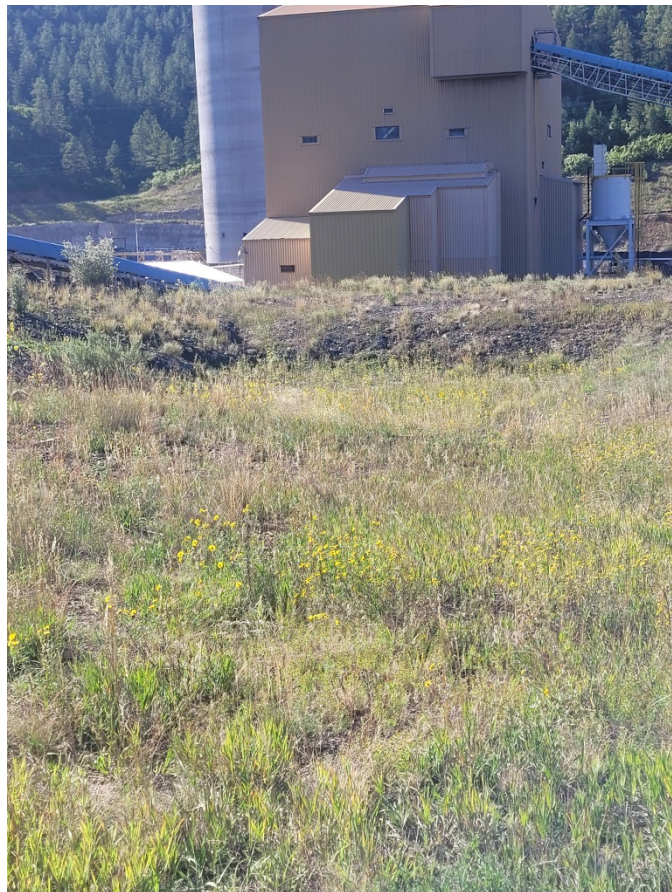
Containment Area #3

Containment Area was dry at time of inspection.

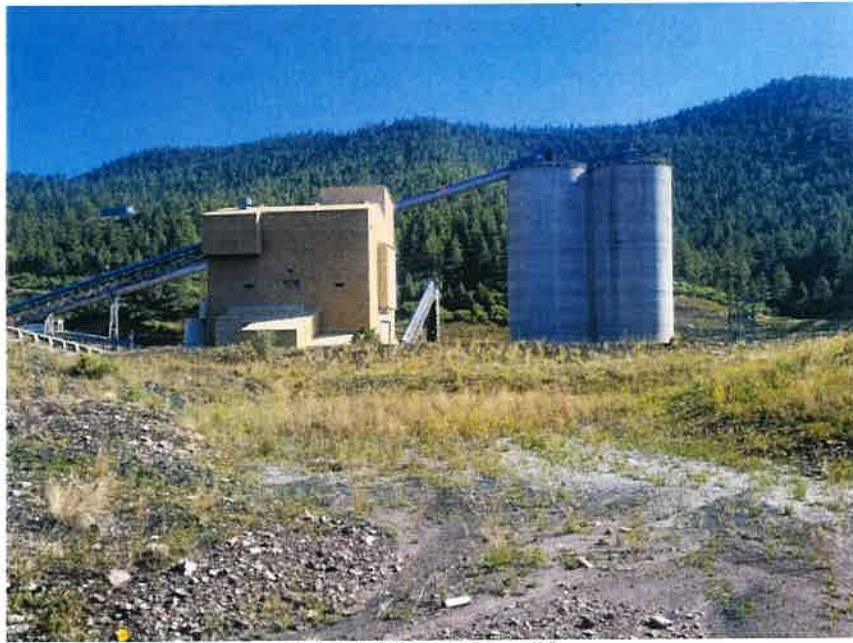
Containment Area #4

Containment Area was dry at time of inspection.

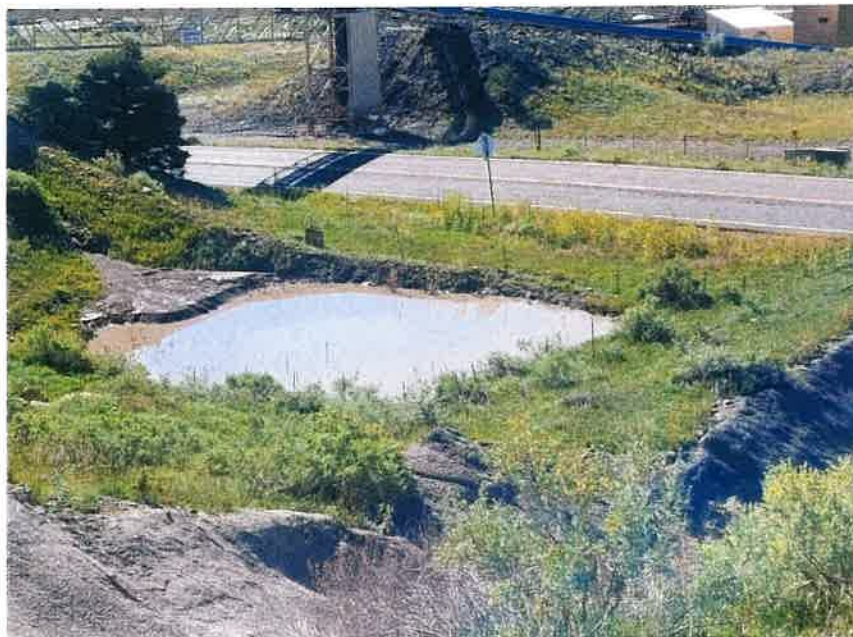
Containment Area #5

Containment Area was holding water. It was cleaned in 2022 and will need to be cleaned of sediment in the coming months.
