QUARTERLY SEDIMENTATION POND INSPECTION REPORT

Mine: Lorencito

Inspection Period: Third Quarter 2023

QUARTERLY SEDIMENTATION POND INSPECTION REPORT
Lorencito Canyon Mine- September 8, 2023

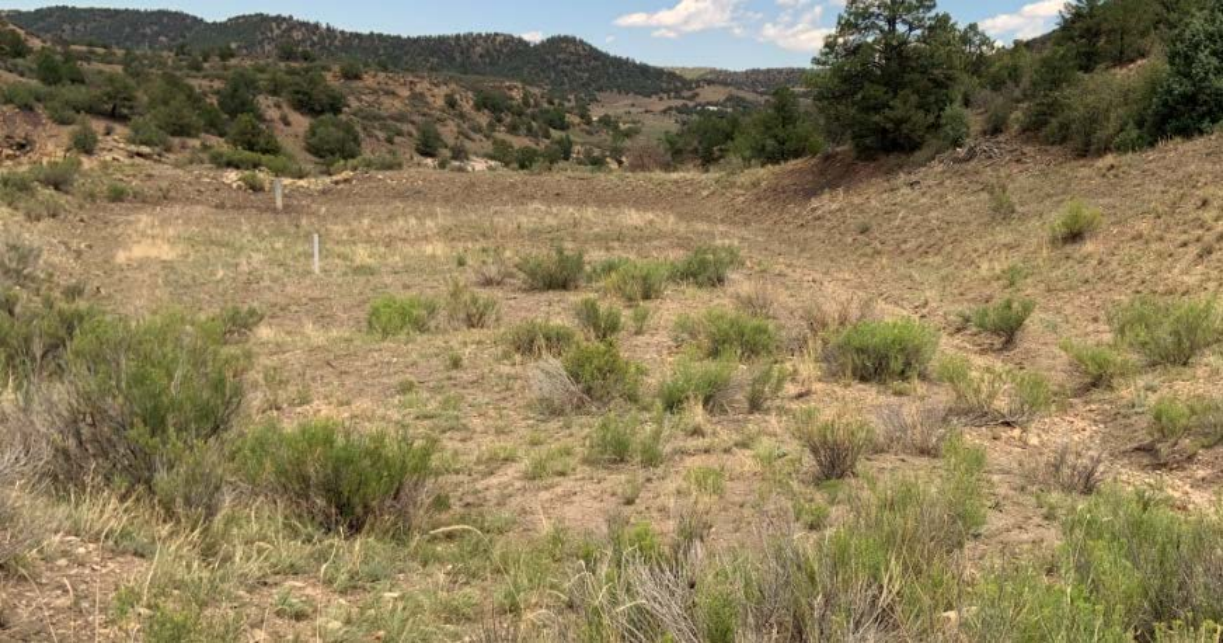
Pond 5

Explain: Sediment in pond does not appear to be over capacity by visual inspection.

Pond was empty at time of inspection, but was damp.

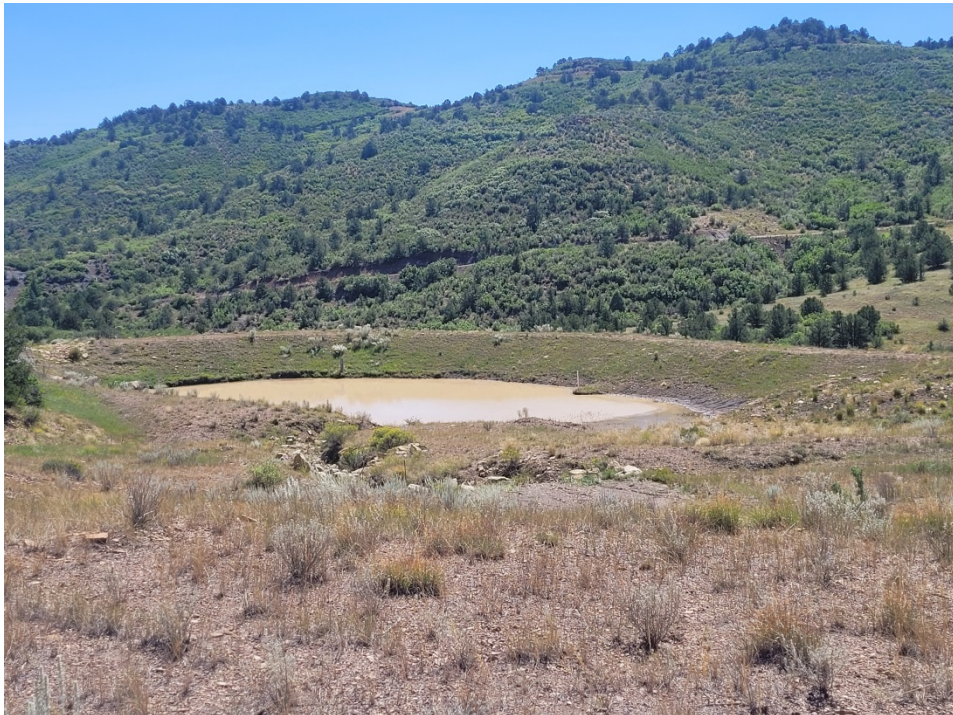
Pond 6

Pond was holding water at time of inspection, not near the bottom of the decant.

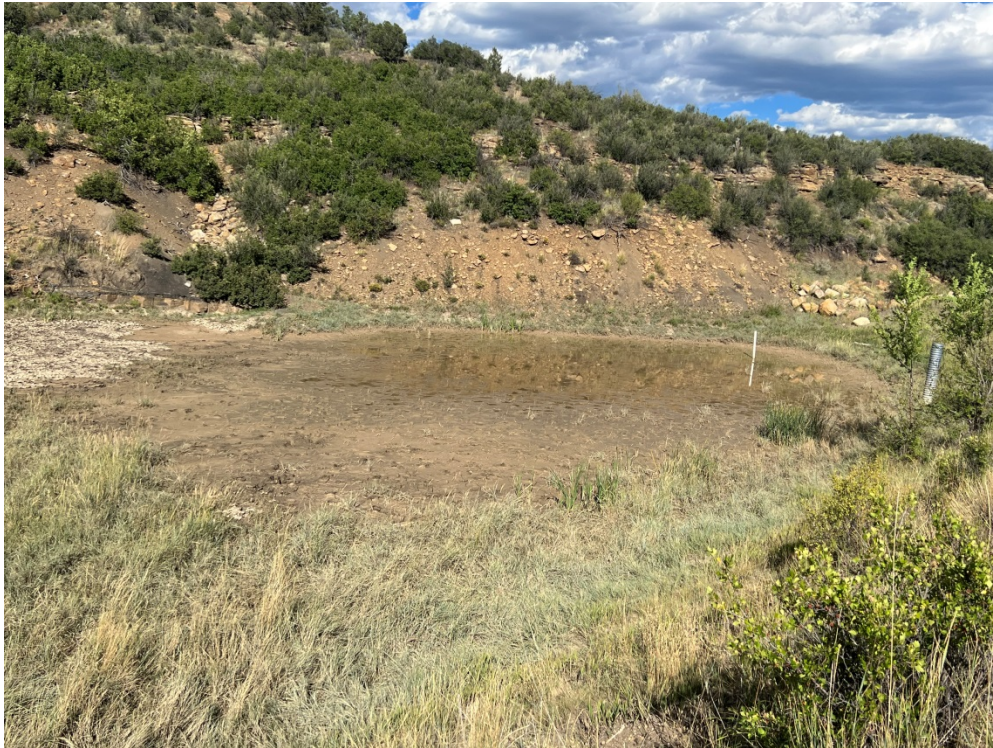
Pond 7

Pond was holding a small amount of water at time of inspection. Not discharging.

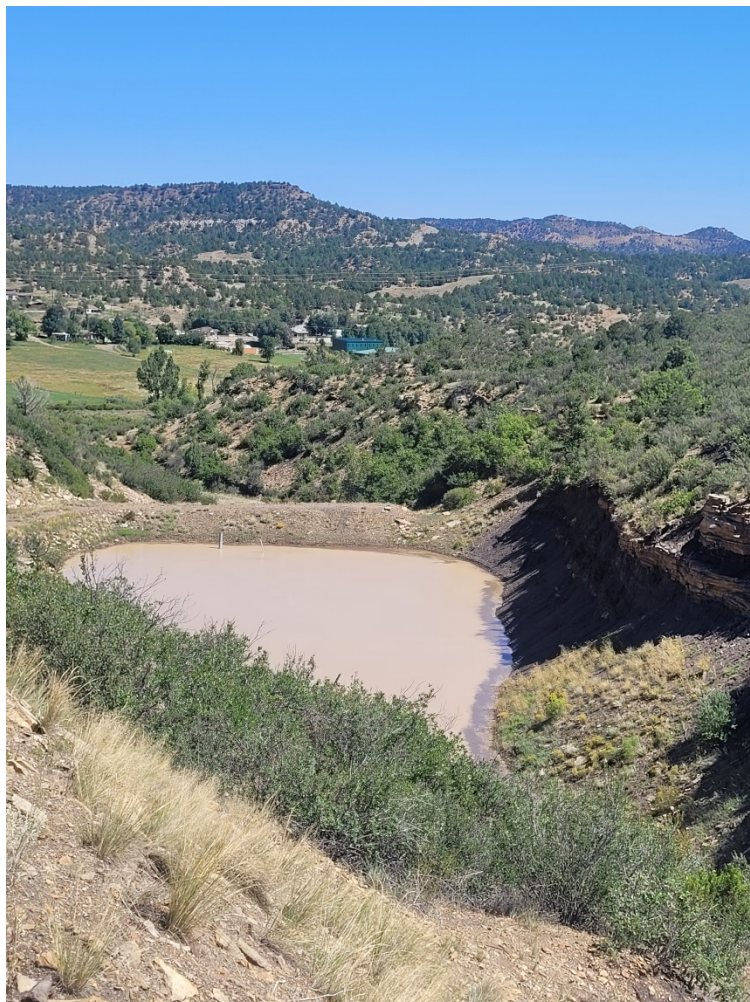
Pond 8

Pond was holding water at the time of inspection. Appears to have discharged some water recently.

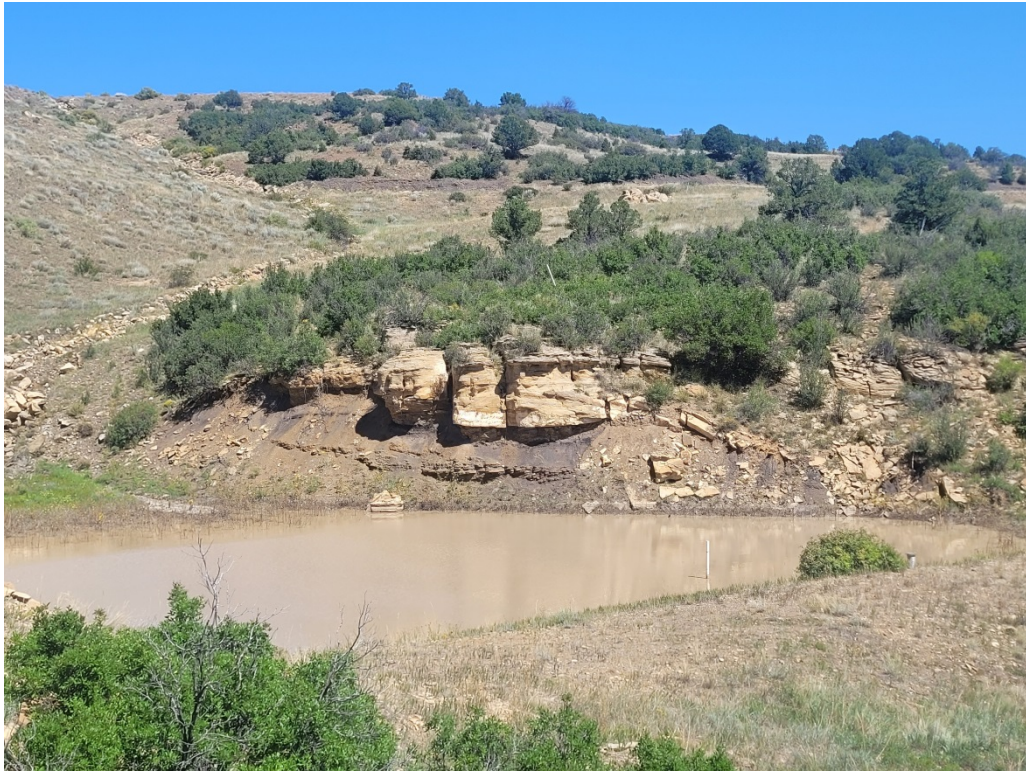
Pond 9A

Pond was holding water at time of inspection. Does not appear to have recently discharged.

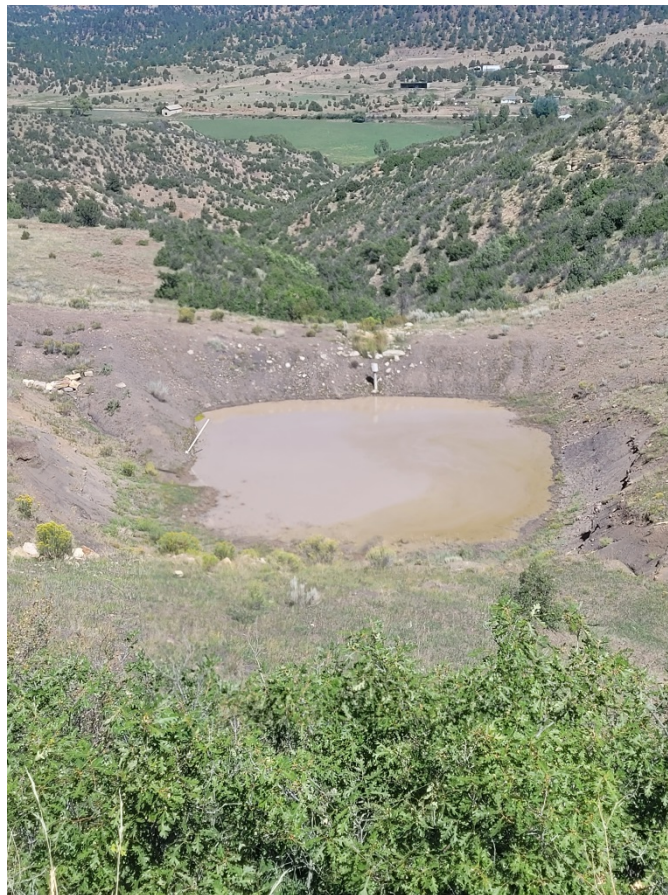
Pond 9

Pond was holding some water at time of inspection. Not near the level of the decant.
