**LORENCITO CANYON MINE**  
**Permit No. C-1996-084**

**INSPECTION OF EXCESS SPOIL-FILLS 7, 8, & 9**  
**September 8, 2023**

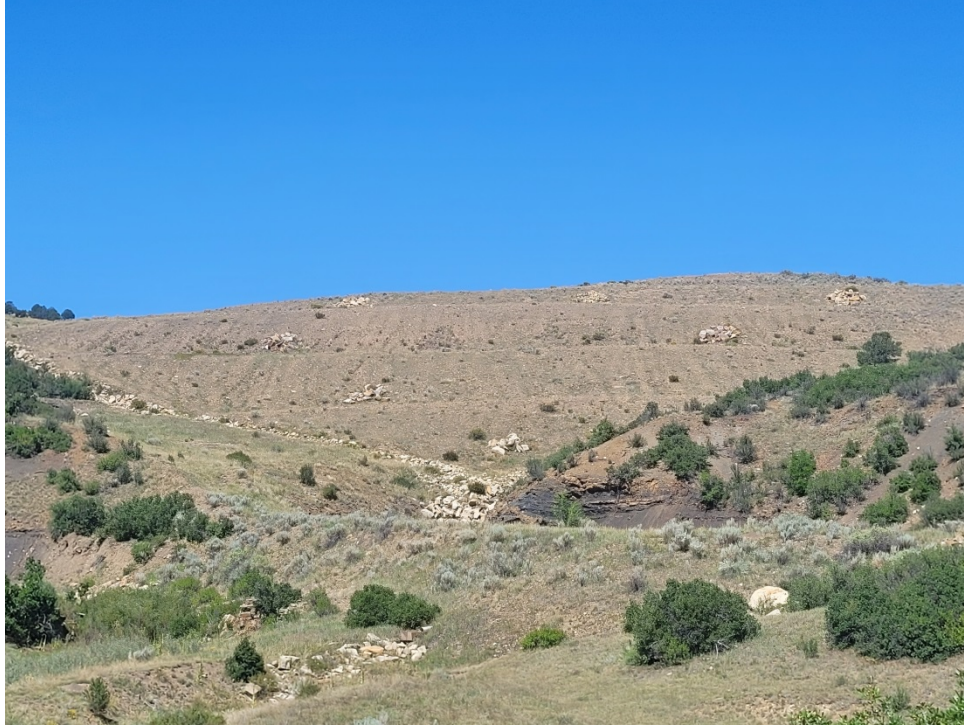
**Fill #7**

East armored down drain needs to be monitored and might need a spot that is washed out to be re-armored. All else looks good.

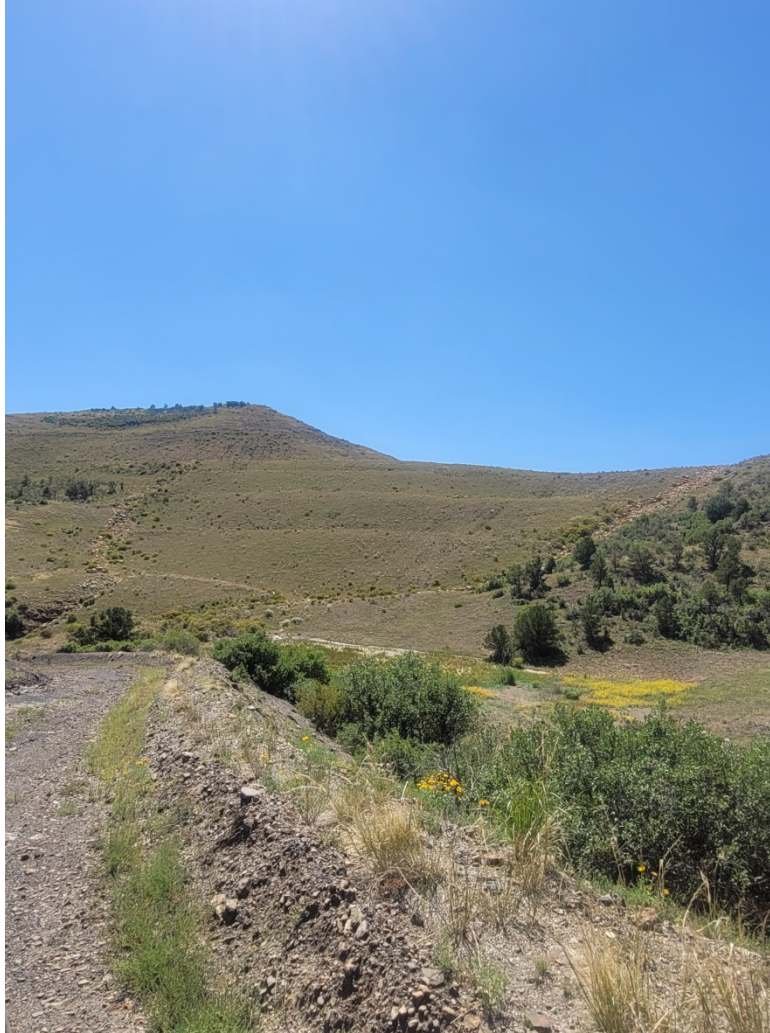
**Fill #8**

Lower portion of East down drain needs to be monitored and may need additional rock in bare spots. All else is in good condition.

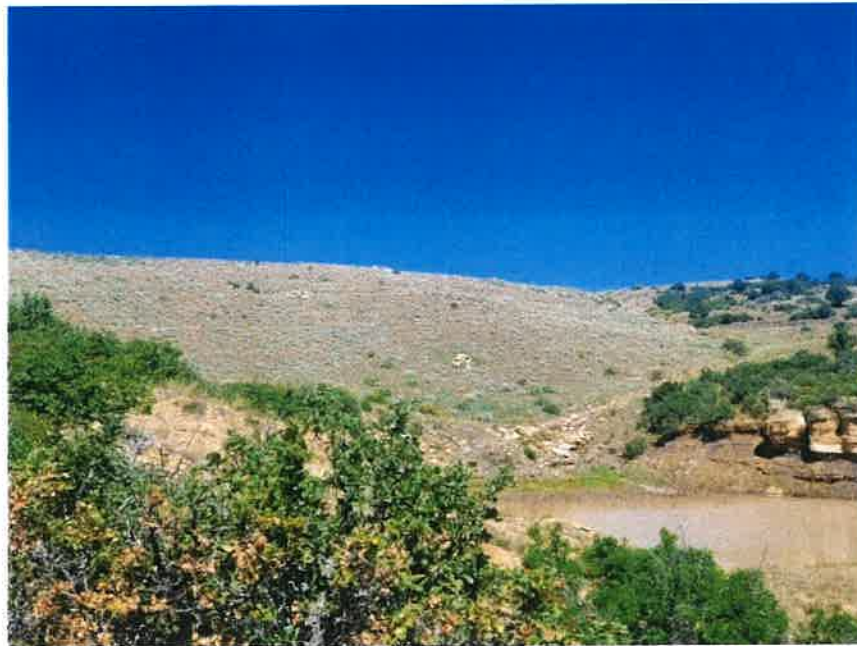
Fill #9

Overall the site is in good condition.
