**MINERALS PROGRAM INSPECTION REPORT**  
**PHONE: (303) 866-3567**

<b>MINE NAME:</b> Liberty Mine	<b>MINE/PROSPECTING ID#:</b> M-2013-070	<b>MINERAL:</b> Uranium and vanadium	<b>COUNTY:</b> Mesa
<b>INSPECTION TYPE:</b> Monitoring	<b>WEATHER:</b> Clear	<b>INSP. DATE:</b> August 23, 2023	<b>INSP. TIME:</b> 13:15
<b>OPERATOR:</b> Liberty Mining, LLC	<b>OPERATOR REPRESENTATIVE:</b> None	<b>TYPE OF OPERATION:</b> 110d - Designated Limited Impact	
<b>REASON FOR INSPECTION:</b> Normal I&E Program	<b>BOND CALCULATION TYPE:</b> None	<b>BOND AMOUNT:</b> \$93,862.42	
<b>DATE OF COMPLAINT:</b> NA	<b>POST INSP. CONTACTS:</b> DRMS	<b>JOINT INSP. AGENCY:</b> U.S.BLM	
<b>INSPECTOR(S):</b> Amy Yeldell	<b>INSPECTOR'S SIGNATURE:</b>

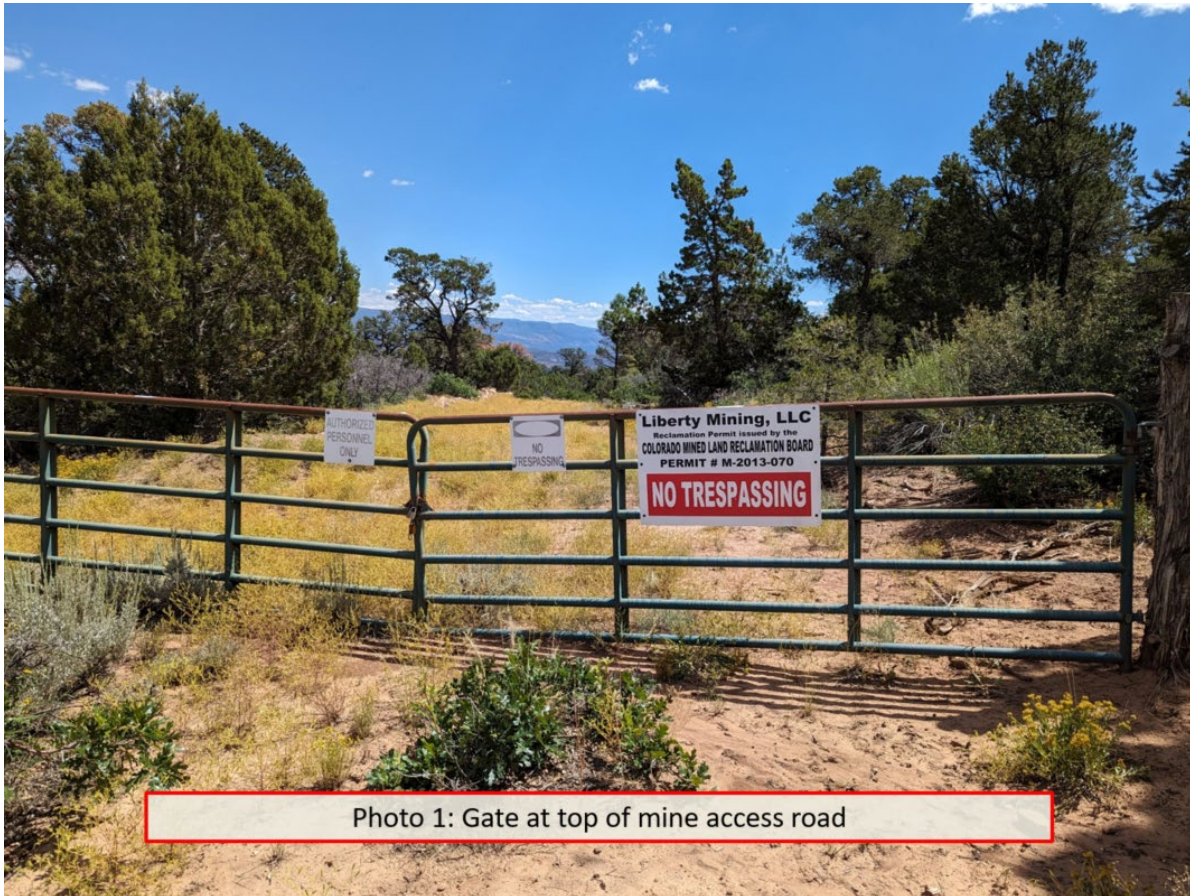
Site conditions similar as compared with the previous inspection. The mine sign and boundary markers remain in place and in compliance with Rule 3.1.12. The gate to the access road remains closed and locked (Photo One). The access road was stable, but is beginning to show signs of erosion. Sedimentation was observed at the pad entrance from where water traveled down the road (Photo Two). Erosion control features or some form of re-blading of the road will likely be necessary in the next few years. The road will require maintenance prior to commencement of mining. There is no evidence of recent use. Scrub Oak and other native vegetation has begun to volunteer on the road. The site was accessed on foot, access with a full size vehicle would be difficult.

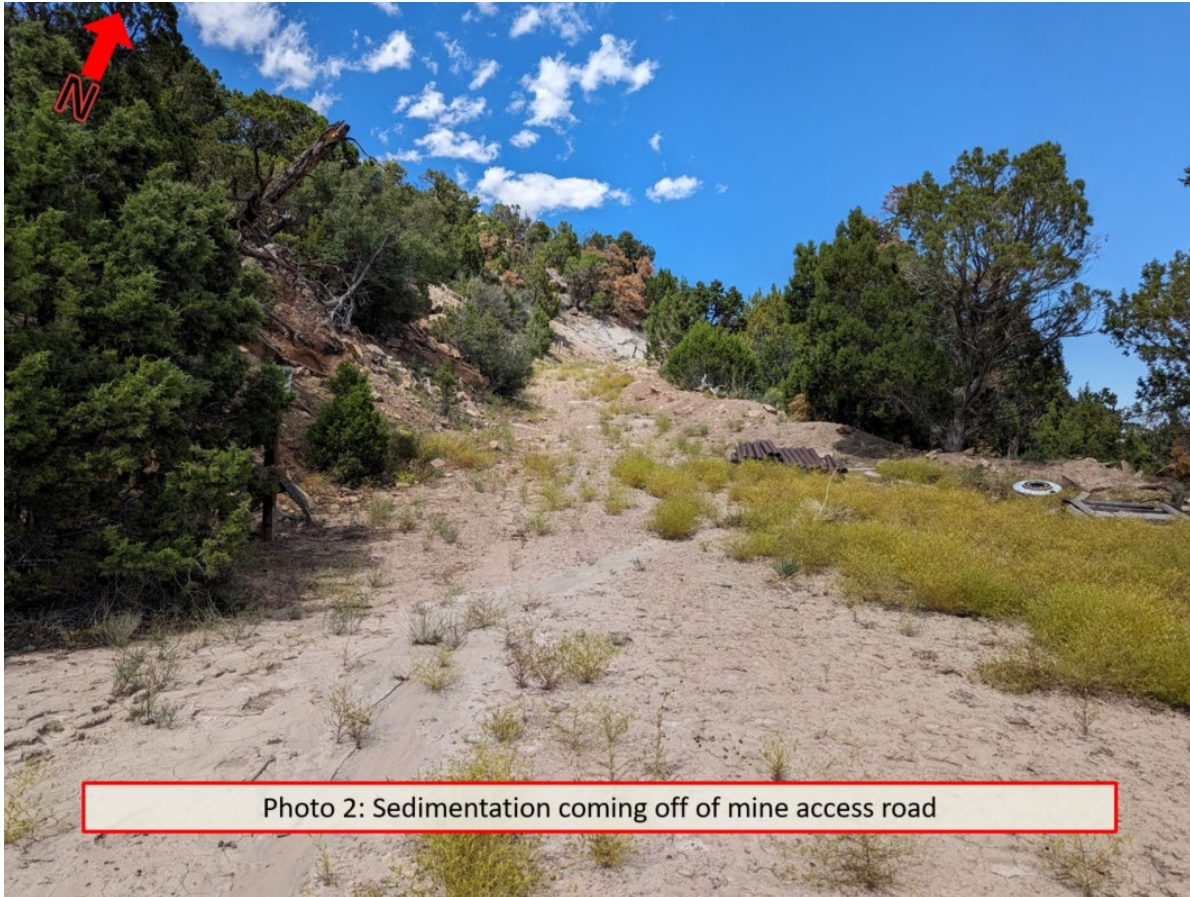
Photo 2: Sedimentation coming off of mine access road

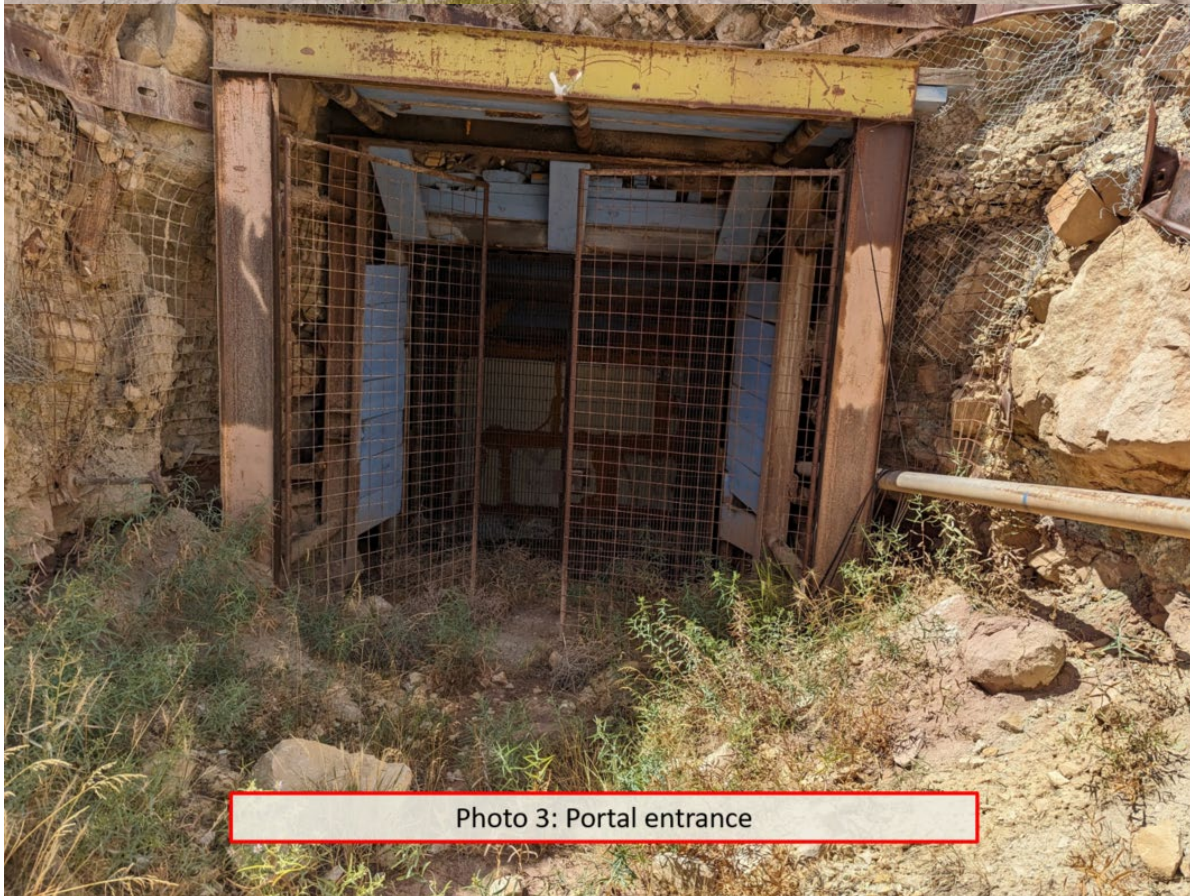
The portal is sealed with locked grates and PUFF (Photo Three). The exterior grate was partially opened at the time of the inspection but the inner grate was locked. The portal remains locked and secured. The cut walls along the ramp to the portal opening have begun to show signs of weathering/erosion. Some sluffing was observed. As well as sedimentation down the ramp (Photo Four). Additional bracing in the next few years will also probably become necessary regardless of mining activity/status.

Photo 3: Portal entrance

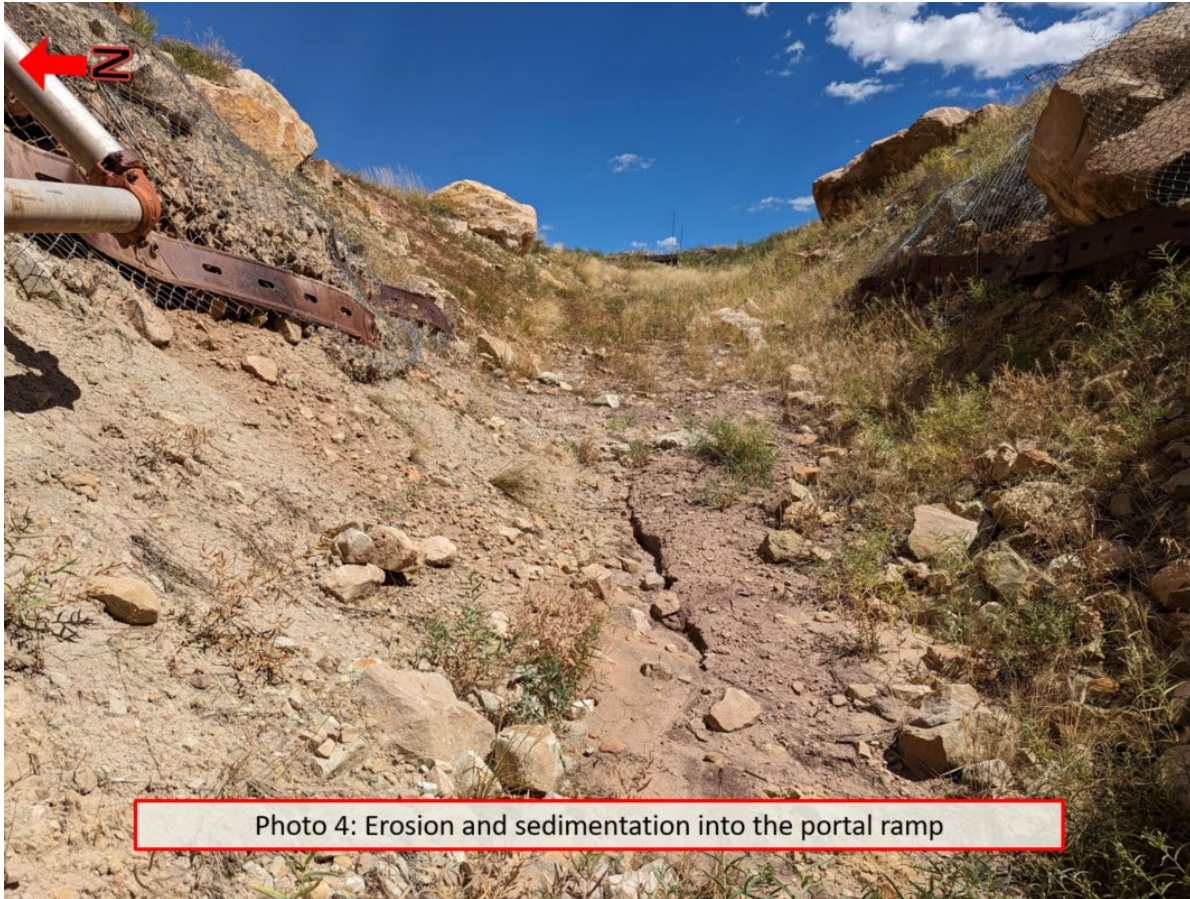
Photo 4: Erosion and sedimentation into the portal ramp

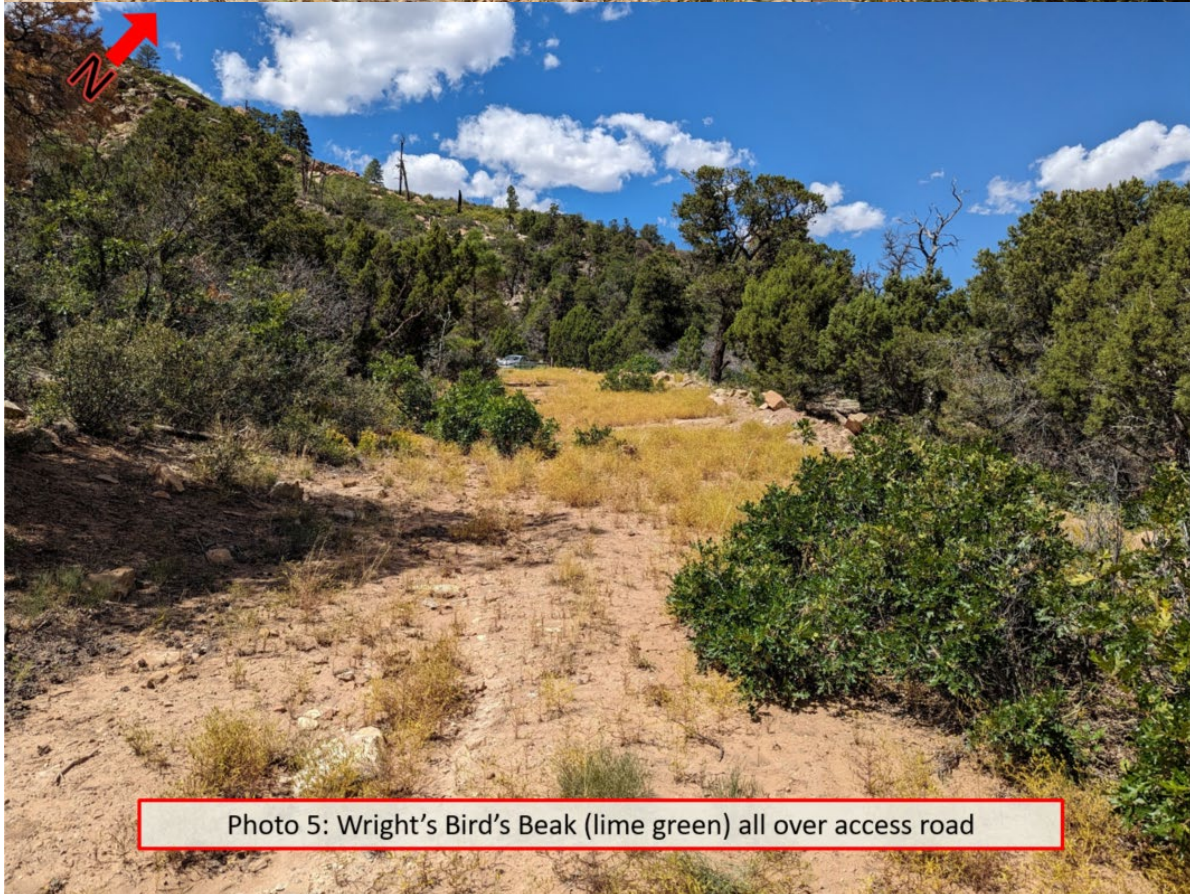
Some plants have volunteered throughout the site. Primarily scrub oak, rabbit brush and perennial grasses. As compared to previous inspections the site has become overwhelmed with Wright's Bird's Beak (*Cordylanthus wrightii*). This flower is native and seems to have a cyclical cycle, in that it is abundant one year then absent for many years (Photos Five and Six, the lime green plants). In addition to Wright's Bird's Beak lots of sunflowers and curlycup gumweed were observed as compared to previous inspections (Photo Seven). Noxious weeds appeared to be well controlled and no infestations were observed.

Photo 5: Wright's Bird's Beak (lime green) all over access road
