**MINERALS PROGRAM INSPECTION REPORT**  
**PHONE: (303) 866-3567**

<b>MINE NAME:</b> Whirlwind Mine	<b>MINE/PROSPECTING ID#:</b> M-2007-044	<b>MINERAL:</b> Uranium and vanadium	<b>COUNTY:</b> Mesa
<b>INSPECTION TYPE:</b> Monitoring	<b>WEATHER:</b> Clear	<b>INSP. DATE:</b> August 30, 2023	<b>INSP. TIME:</b> 10:30
<b>OPERATOR:</b> Energy Fuels Resources (USA) Inc.	<b>OPERATOR REPRESENTATIVE:</b> Todd Eldredge	<b>TYPE OF OPERATION:</b> 112d-1 - Designated Mining Operation	
<b>REASON FOR INSPECTION:</b> Normal I&E Program	<b>BOND CALCULATION TYPE:</b> None	<b>BOND AMOUNT:</b> \$375,078.00	
<b>DATE OF COMPLAINT:</b> NA	<b>POST INSP. CONTACTS:</b> U.S. Energy	<b>JOINT INSP. AGENCY:</b> U.S. BLM	
<b>INSPECTOR(S):</b> Amy Yeldell	<b>INSPECTOR'S SIGNATURE:</b>

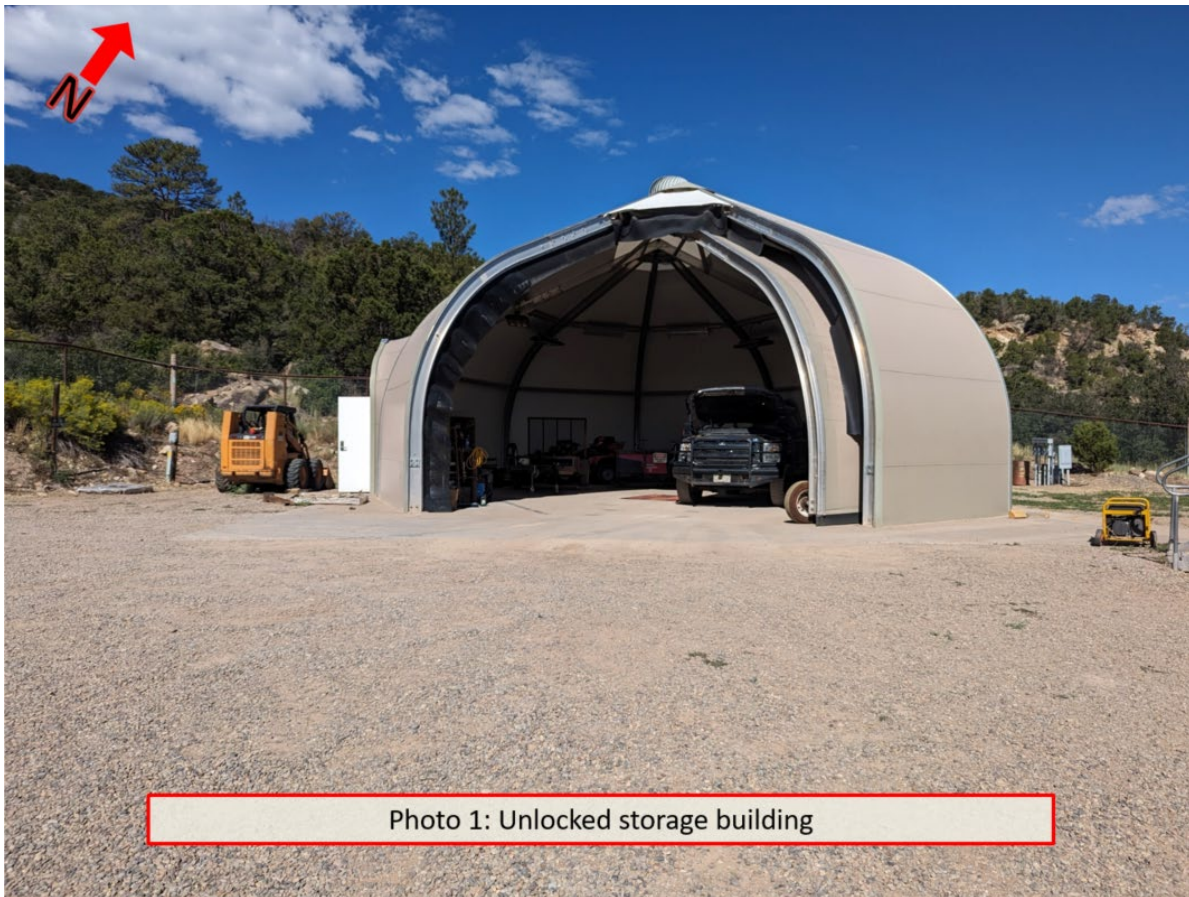
The mine identification sign and affected area boundary markers are in place and in compliance with Rule 3.1.12. The buildings and water treatment areas were fenced off. The buildings were unlocked at opened at the time of the inspection since crews were on site working (photo one). The water treatment area remains locked as no work in this area is occurring (photo two).

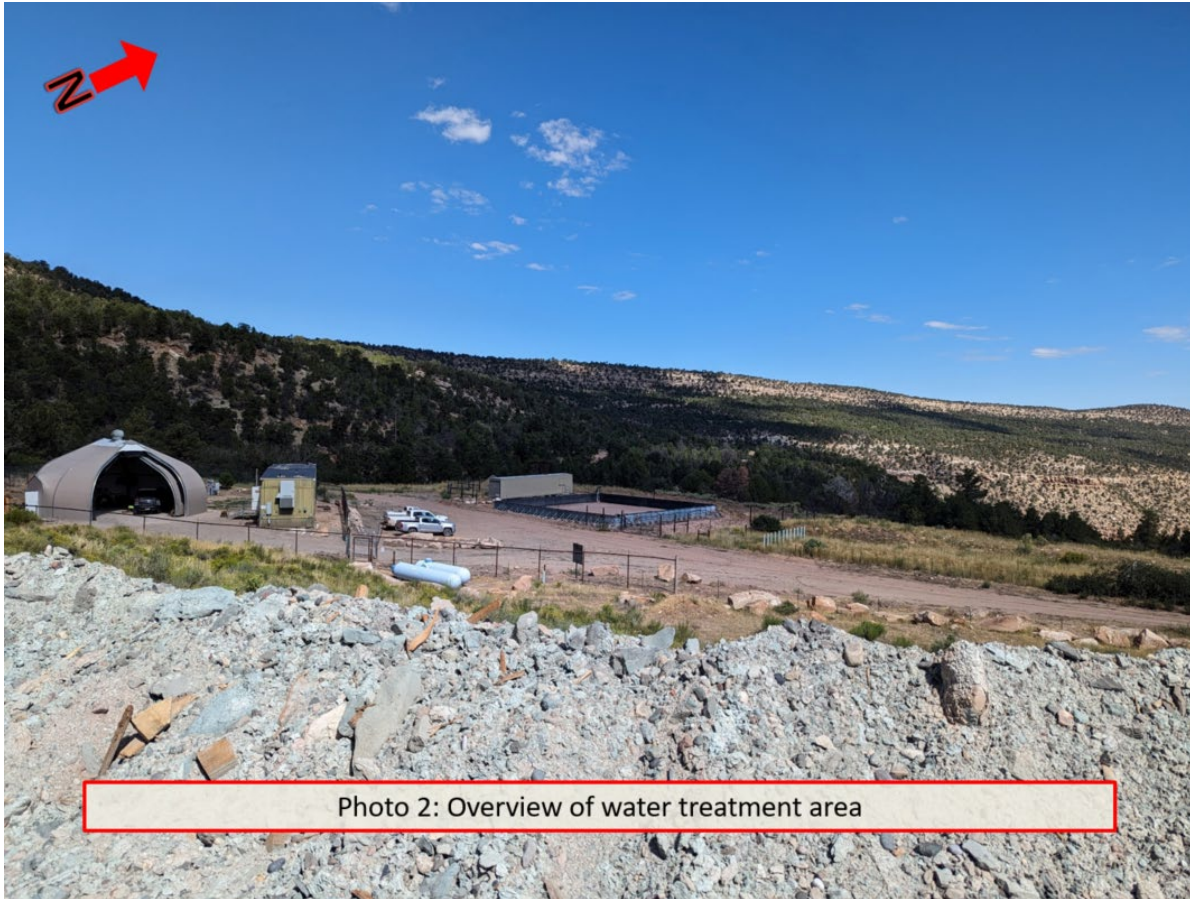
The site conditions around the water treatment system and stormwater ponds on the north side of the site remain unchanged. In order for mining to progress the underground workings must be dewatered and that water must be treated. Prior to the installation of a new system a technical revision will be required.

Photo 2: Overview of water treatment area

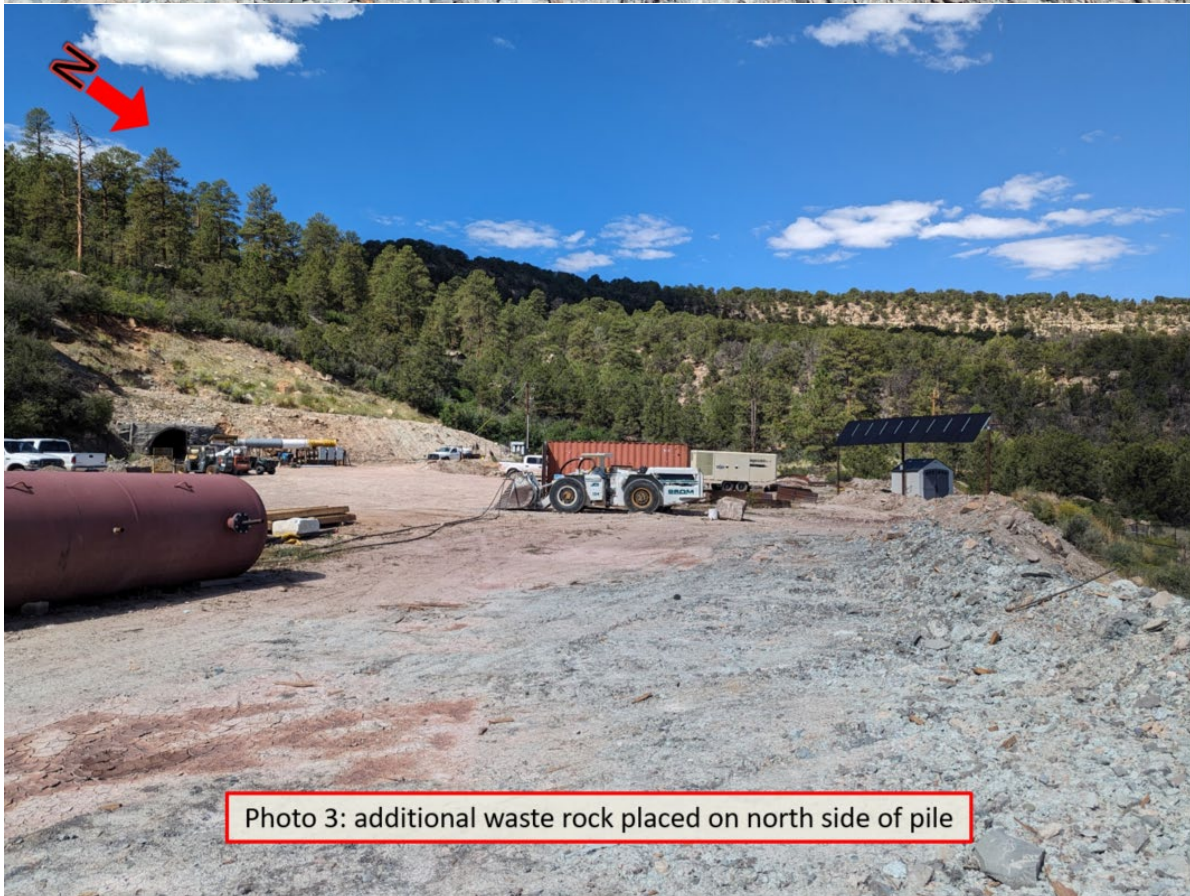
Photo 3: additional waste rock placed on north side of pile

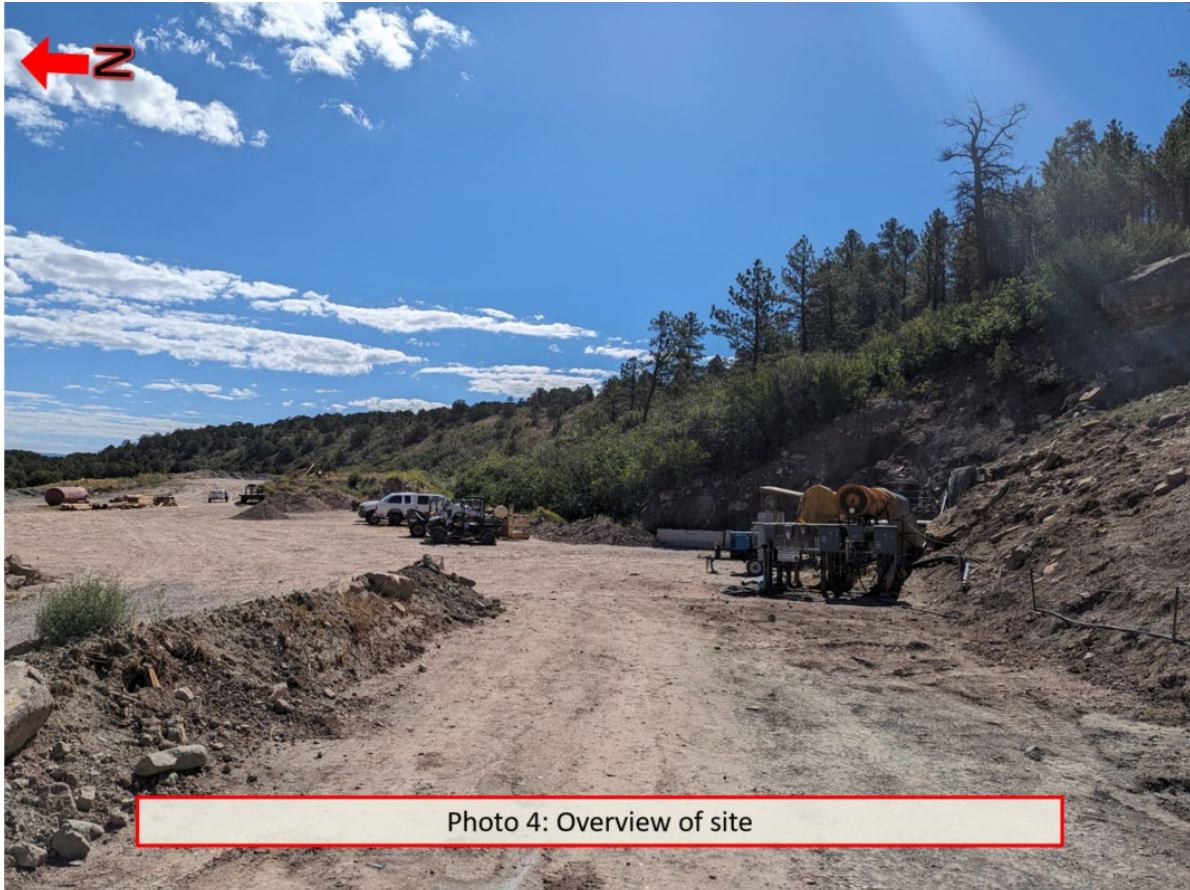
The refuge chamber and water tank are stored on the ore storage pad. Underground mining equipment is also being stored on the pad while rehab work is being conducted (photo four and five). Extra timbers and steel sets of varying sizes are on site and ready for use. Waste timbers (cut excess) will be burned on site this fall/winter as weather permits. No fuel is stored on site, all fuel for equipment is brought up in slip tanks. All storage buildings/ containers appeared well organized. Since the previous inspection hard line power has been brought in.

Photo 4: Overview of site

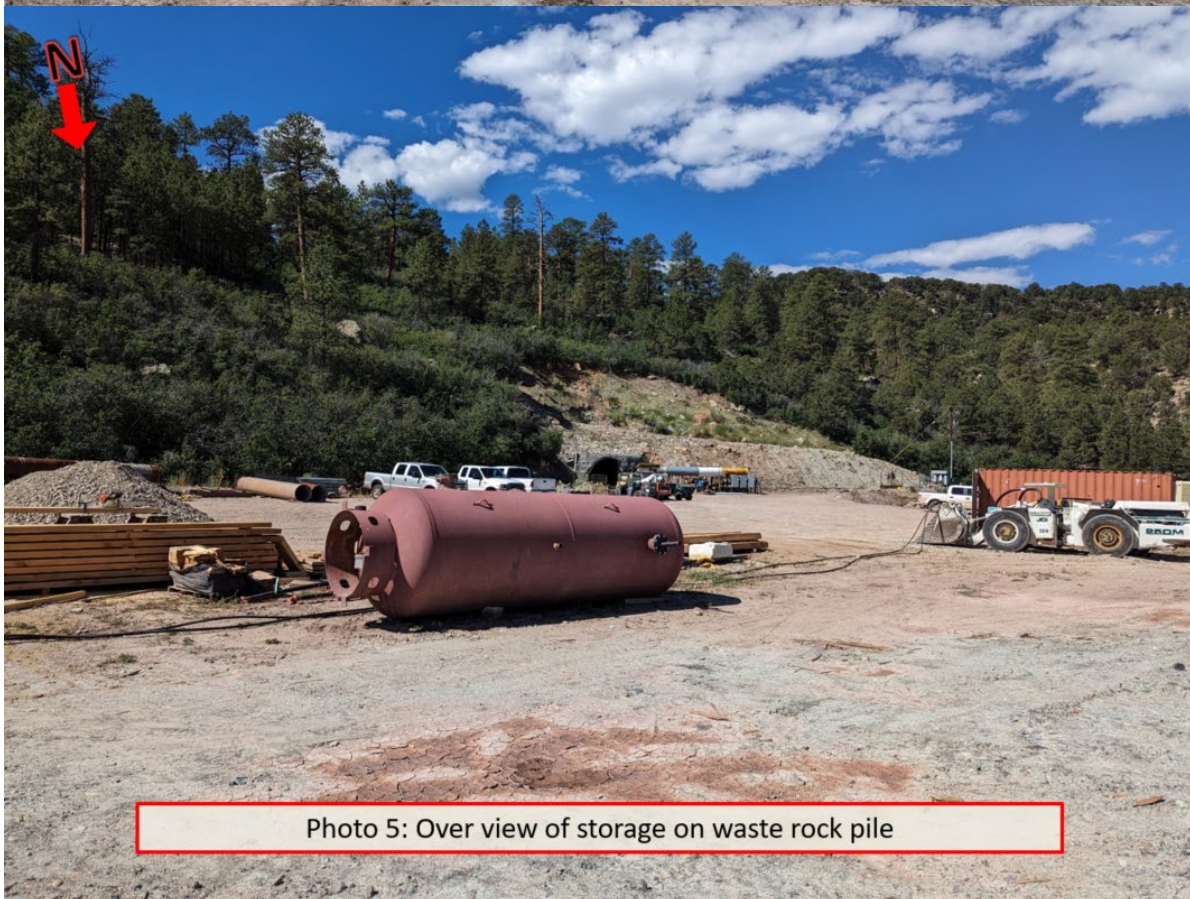
Photo 5: Over view of storage on waste rock pile

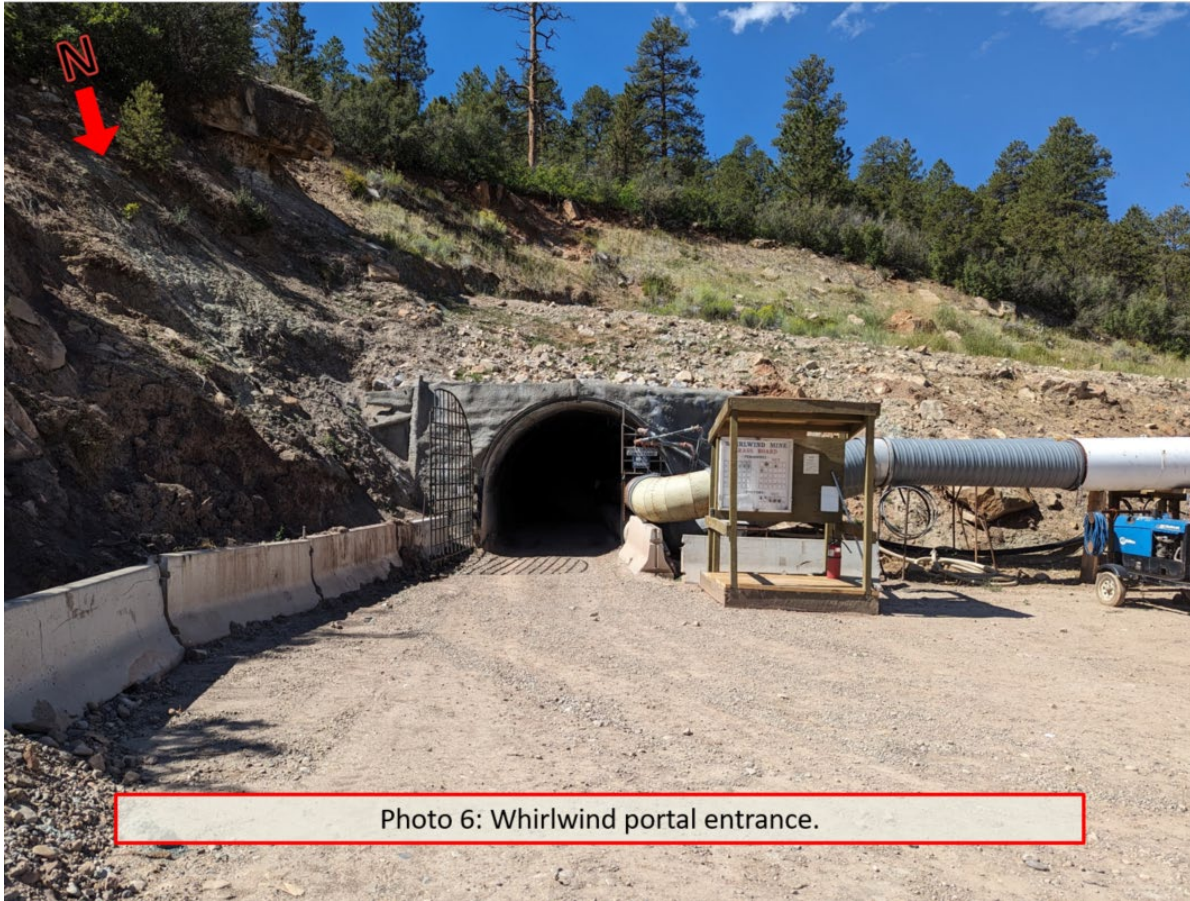
As of June 7, 2022 per CS-1 the site is in active status after having been in temporary cessation for an extended period of time. Crews resumed their second season of safety rehab work of the tunnel on April 25, 2023 (photo six). They will continue to work until weather shuts them down for the winter. Crews are estimated to be approximate 1400 LF down the existing tunnel so far. Waste rock is being removed from the tunnel as needed and stored on the waste rock storage pad. Since the previous inspection the pad has been pushed out to the north approximately 10 to 15 feet and is progressing to the east to meet with the rest of the waste rock pile (photo three). Damaged sections are being replaced and the pipe is being reinstalled as rehab work progresses down the decline. Crews will likely intercept water this year and have to stop work until the mine is dewatered. No ventilation shafts have been installed to date.

Photo 6: Whirlwind portal entrance.
