**MINERALS PROGRAM INSPECTION REPORT**  
**PHONE: (303) 866-3567**

<b>MINE NAME:</b> Henderson Mine	<b>MINE/PROSPECTING ID#:</b> M-1977-342	<b>MINERAL:</b> Molybdenum	<b>COUNTY:</b> Clear Creek, Grand
<b>INSPECTION TYPE:</b> Monitoring	<b>WEATHER:</b> Cloudy	<b>INSP. DATE:</b> September 14, 2023	<b>INSP. TIME:</b> 09:30
<b>OPERATOR:</b> Climax Molybdenum Company	<b>OPERATOR REPRESENTATIVE:</b> Geoff Niggeler	<b>TYPE OF OPERATION:</b> 112d-3 - Designated Mining Operation	
<b>REASON FOR INSPECTION:</b> Normal I&E Program	<b>BOND CALCULATION TYPE:</b> None	<b>BOND AMOUNT:</b> \$135,204,778.00	
<b>DATE OF COMPLAINT:</b> NA	<b>POST INSP. CONTACTS:</b> None	<b>JOINT INSP. AGENCY:</b> None	
<b>INSPECTOR(S):</b> Brock Bowles Joel Renfro	<b>INSPECTOR'S SIGNATURE:</b>

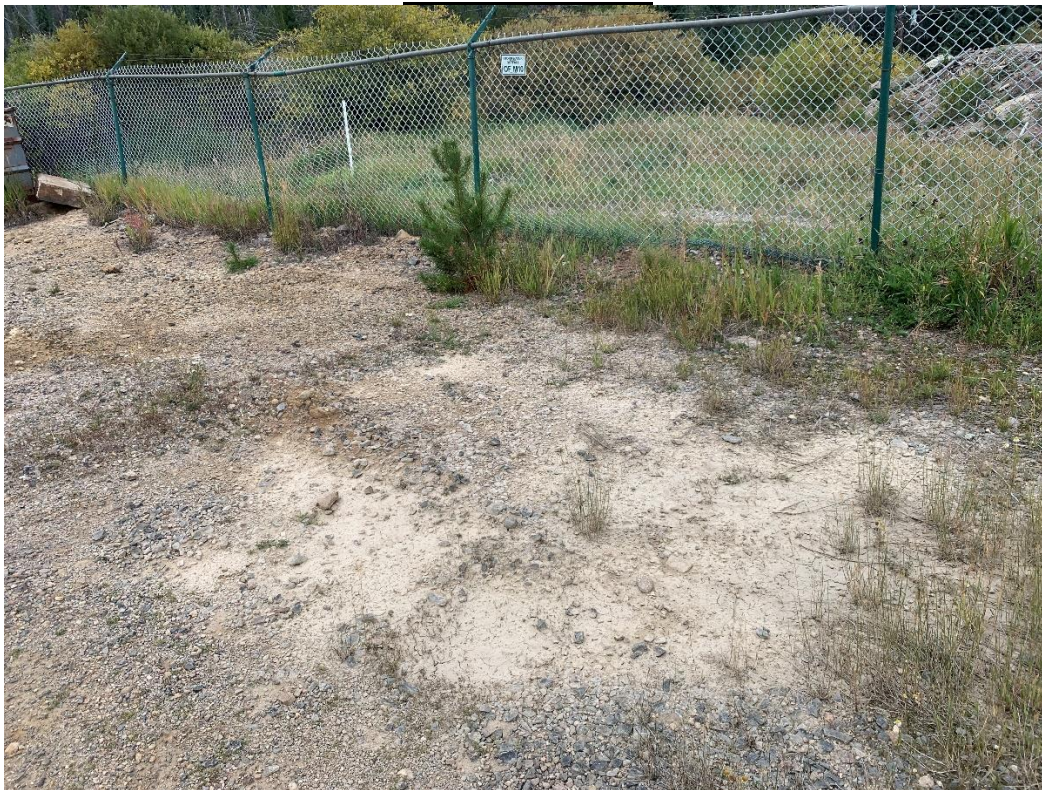
OF-M10 (photo 1) and OF-M15 are located on either side of the conveyor at the portal. Both were in good working order.

Photo 1 – OF-M10 by conveyor portal

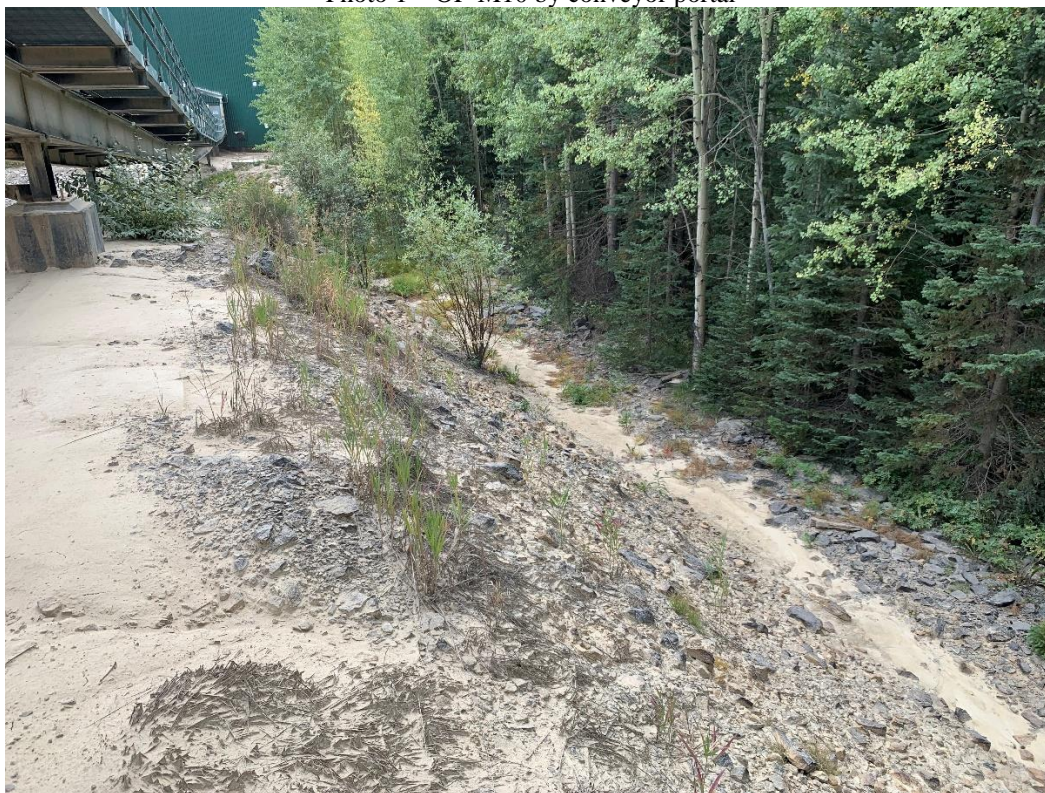
OF-M8 is located at the transfer station. It contains a series of ditches, culverts and a holding pond. These structures are used to control the sediment falling off the conveyor belt (photo 2). The ditches and pond were recently cleaned. Waddles were recently replaced and appeared to be installed correctly.

Photo 2 – Ditch at OF-M8 controlling dust from conveyor belt.

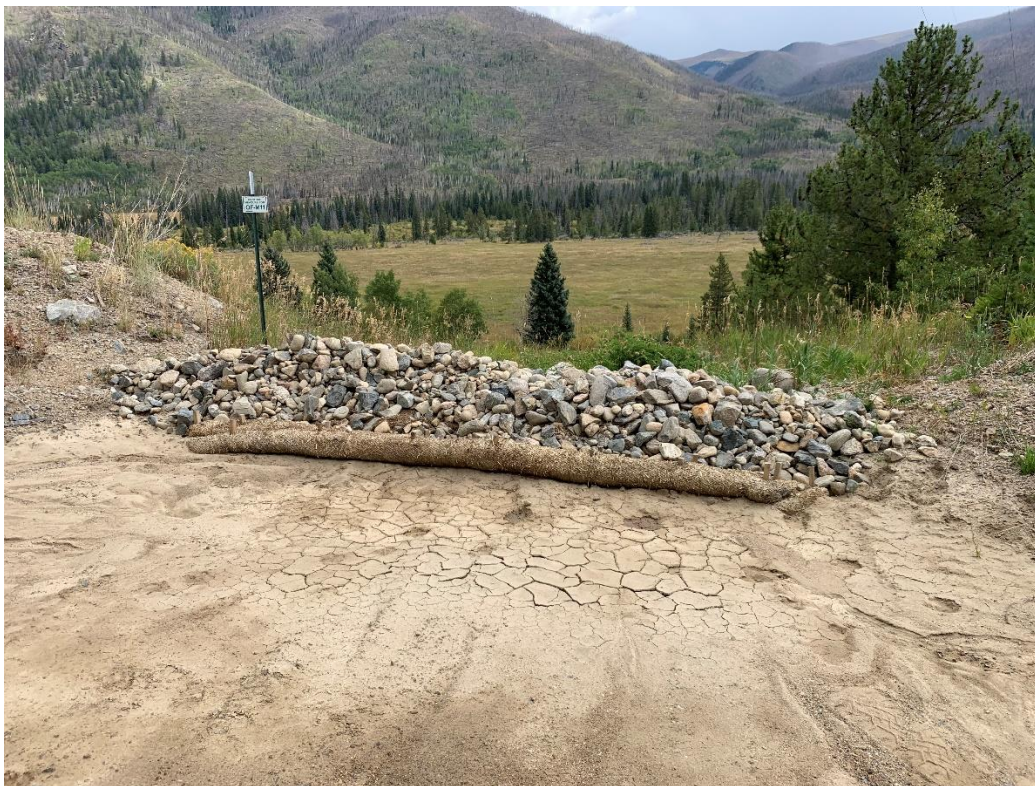
OF-M11, OF-M7, OF-M12, and OF-M6 are located along the conveyor road (photo 3). All these outfalls are constructed of a rock check dam placed within the roadside berm. In front of each rock check dam, two rows of waddles were staked in.

Photo 3 – OF-M11 along conveyor road

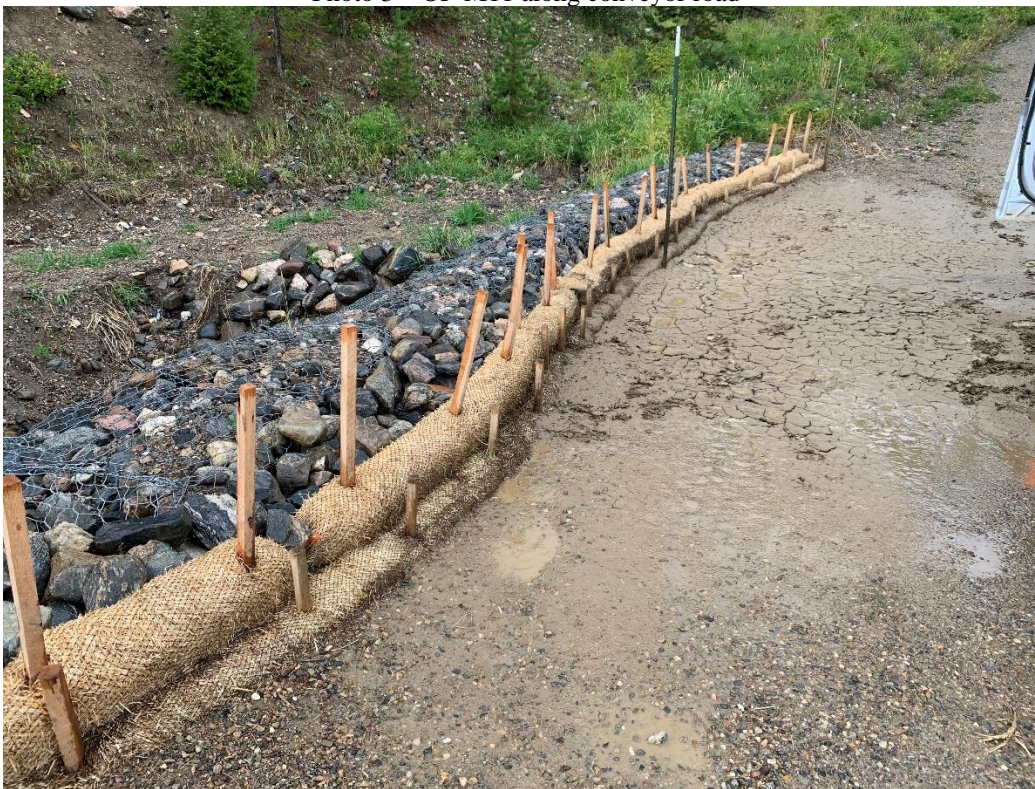
OF-M5 is located on the conveyor road at the intersection with the Forest Service Road (photo 4). Gabion cages are used to create a containment area with waddles placed along the length of the cages.

Photo 4 – OF-M5 has gabion cages create containment area.

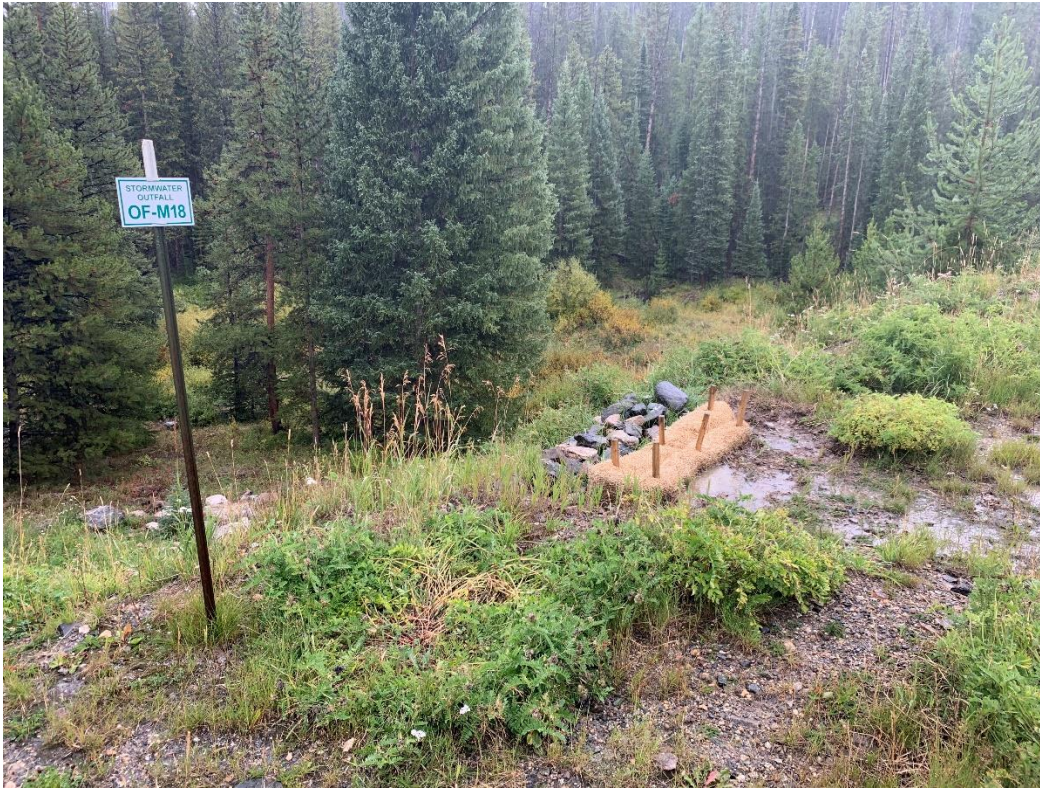
OF-M4 and OF-M18 (photo 5) are located on the conveyor corridor. Both have had new waddles installed.

Photo 5 – OF-M18 next to conveyor corridor
