TO : Lori Douglas, Tige Brown, Katie Blake,  
CC : Vivek Galla, Gloria Quispe  
DATE : Saturday August 5, 2023  
SUBJECT : ECOSA Stability Analysis

The present document summarizes the findings of a stability assessment of ECOSA. A rainfall event occurred at Cripple Creek on 31st July 2023 at an average total of 3 inches. Sloughing of material was recorded on ECOSA 10300 lift.

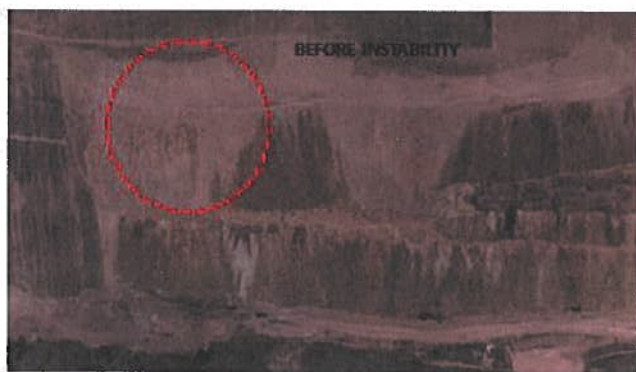
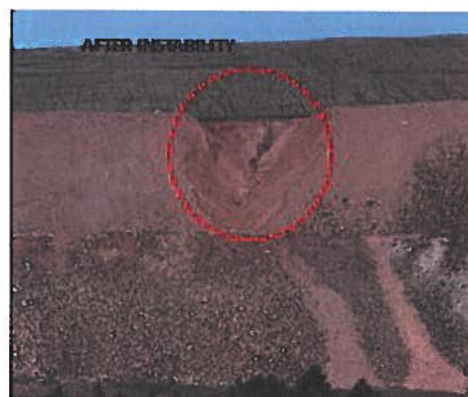
Figure 1 Area of instability

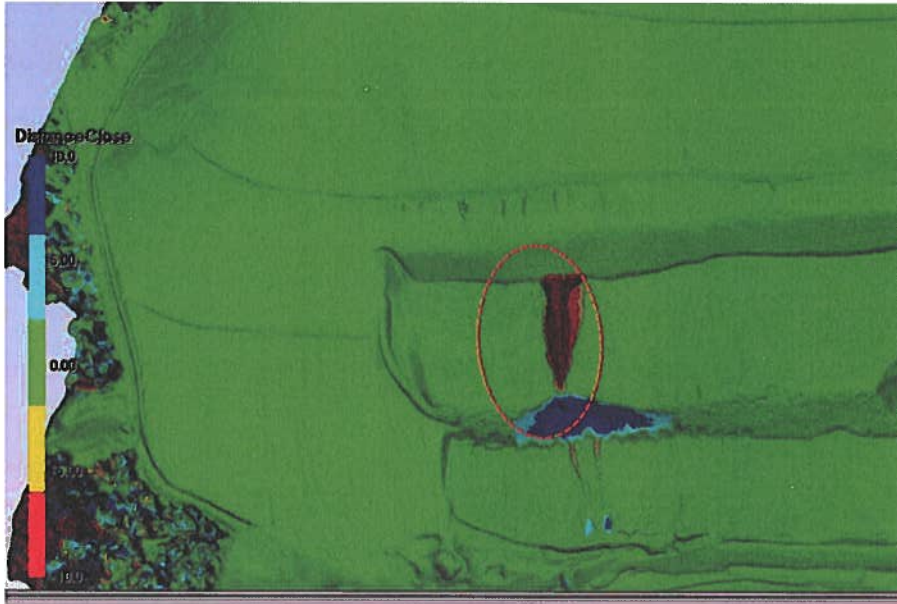
Figure 2 Drone flights comparison pre and post instability

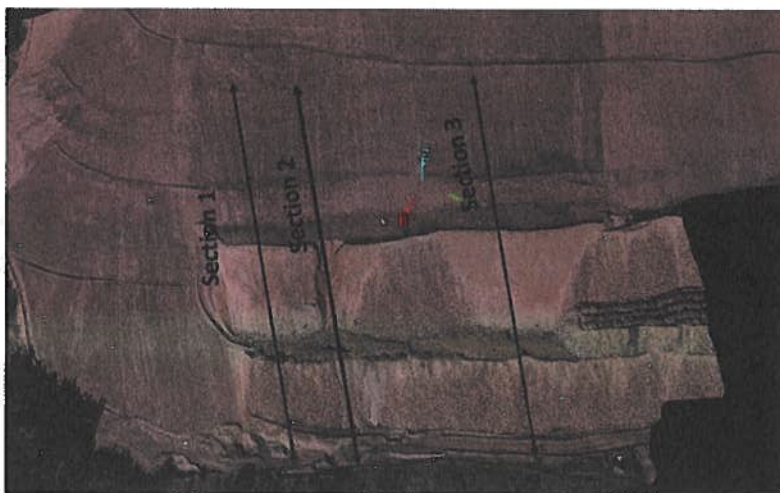
Figure 3 Three sections under review at ECOSA

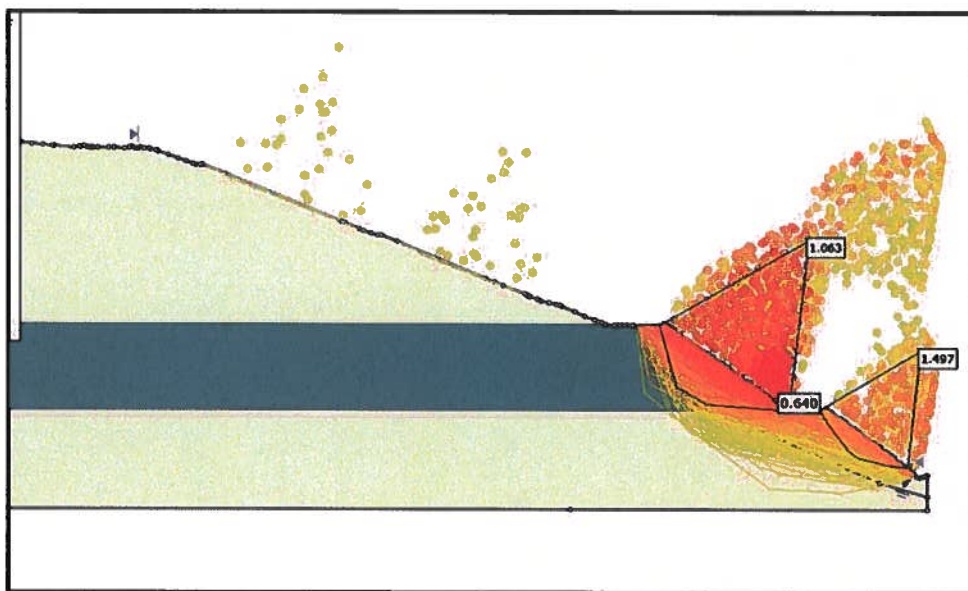
Figure 4 Stability Analysis of cross section 1

Cross Section #	FoS, 10300 lift
Section 1	1.03
Section 2	0.789
Section 3	0.993

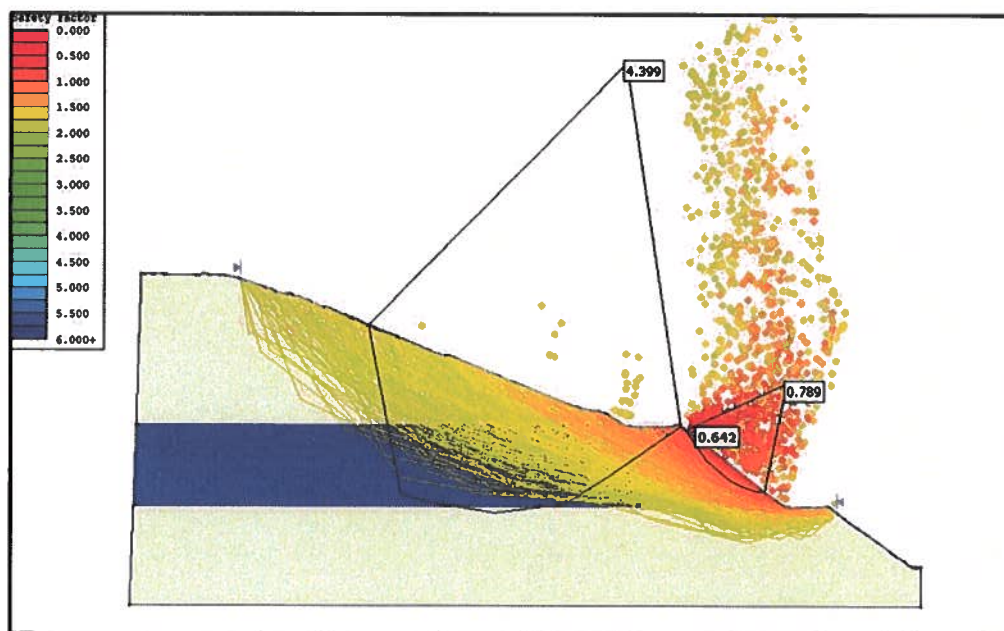
Figure 5 Stability Analysis of cross section 2

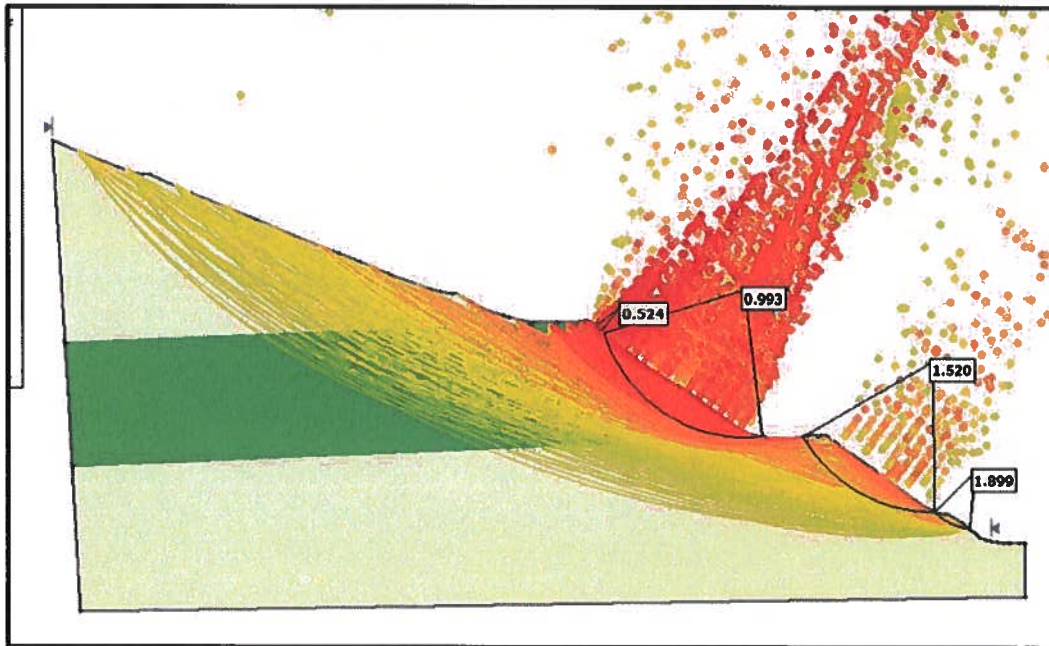
Figure 6 Stability Analysis of cross section 3

For the three Cross Sections the average FoS ranges between 0.7 and 1.03 which is the lower than the minimum allowable FoS of 1.2. The sections under review 3 show low Factors of Safety because of the weaker material properties assigned to the 10100 lift which also reflects a bench-scale failure type that does not affect the overall slope. This failure type is consistent with current field conditions and is being managed and monitored by the CC&V Geotechnical group.

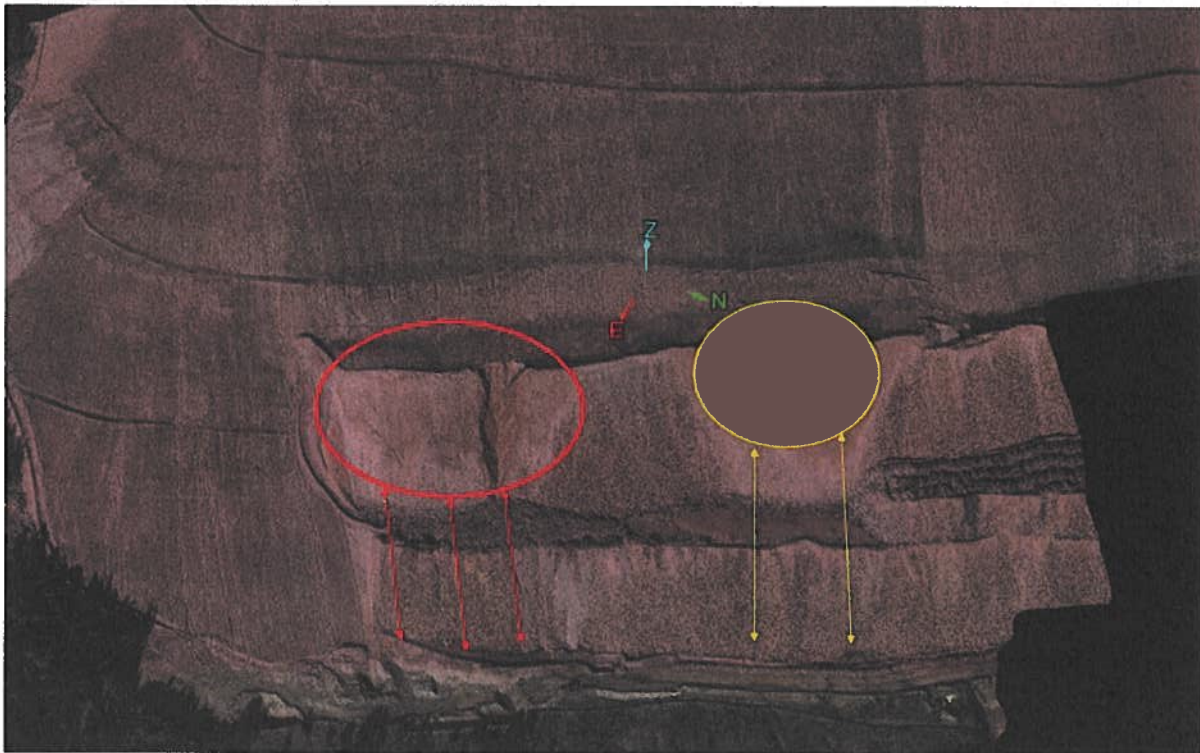
Figure 7 Risk map for ECOSA section under review
