MINERALS PROGRAM INSPECTION REPORT
PHONE: (303) 866-3567

MINE NAME: Pikeview Quarry	MINE/PROSPECTING ID#: M-1977-211	MINERAL: Limestone (general), granite gneiss and do	COUNTY: El Paso
INSPECTION TYPE: Monitoring	WEATHER: Clear	INSP. DATE: September 19, 2023	INSP. TIME: 10:00
OPERATOR: Riverbend Industries Inc.	OPERATOR REPRESENTATIVE: Jerry Schnabel	TYPE OF OPERATION: 112c - Construction Regular Operation	
REASON FOR INSPECTION: Normal I&E Program	BOND CALCULATION TYPE: None	BOND AMOUNT: \$13,389,784.00	
DATE OF COMPLAINT: NA	POST INSP. CONTACTS: None	JOINT INSP. AGENCY: None	
INSPECTOR(S): Zach Trujillo	INSPECTOR'S SIGNATURE:

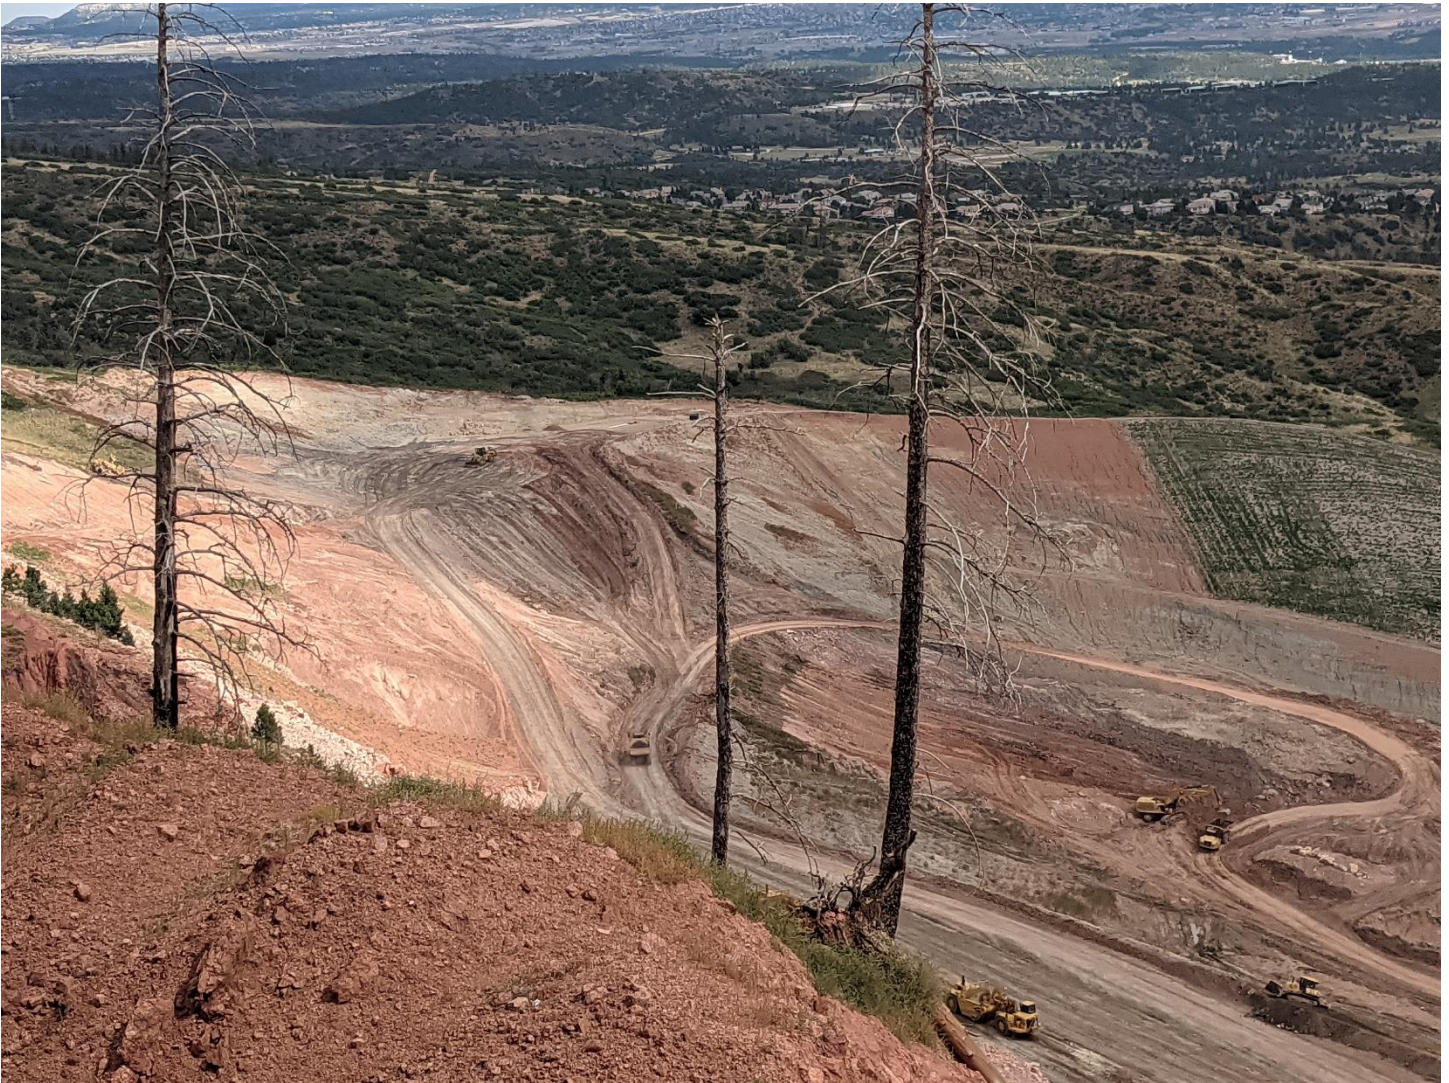
Backfill and compaction efforts were occurring during the inspection. The new contractor is now in place and begun backfilling operations the day prior to the inspection. Backfill is currently coming from the northern borrow area by scrapers and truck/excavator operations. Overall, the backfill remains stable.

North borrow area.

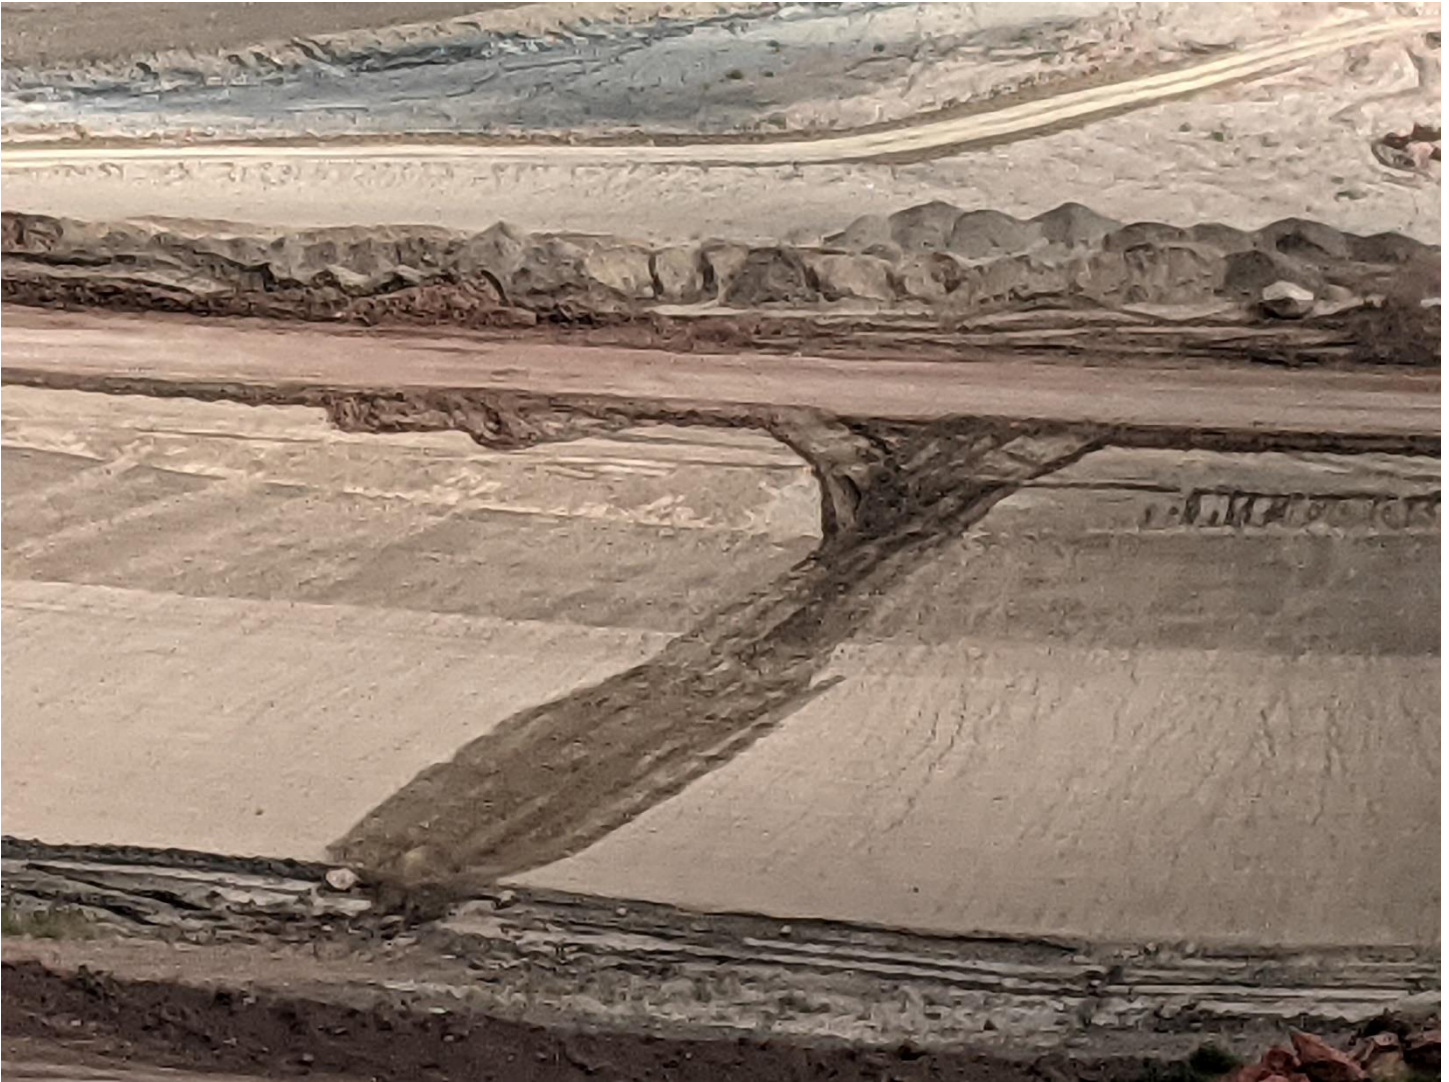
The gully that formed along the face of the buttress has been repaired. The area has been backfilled and topsoiled and conforms to the slope.

Gully repair along buttress slope.

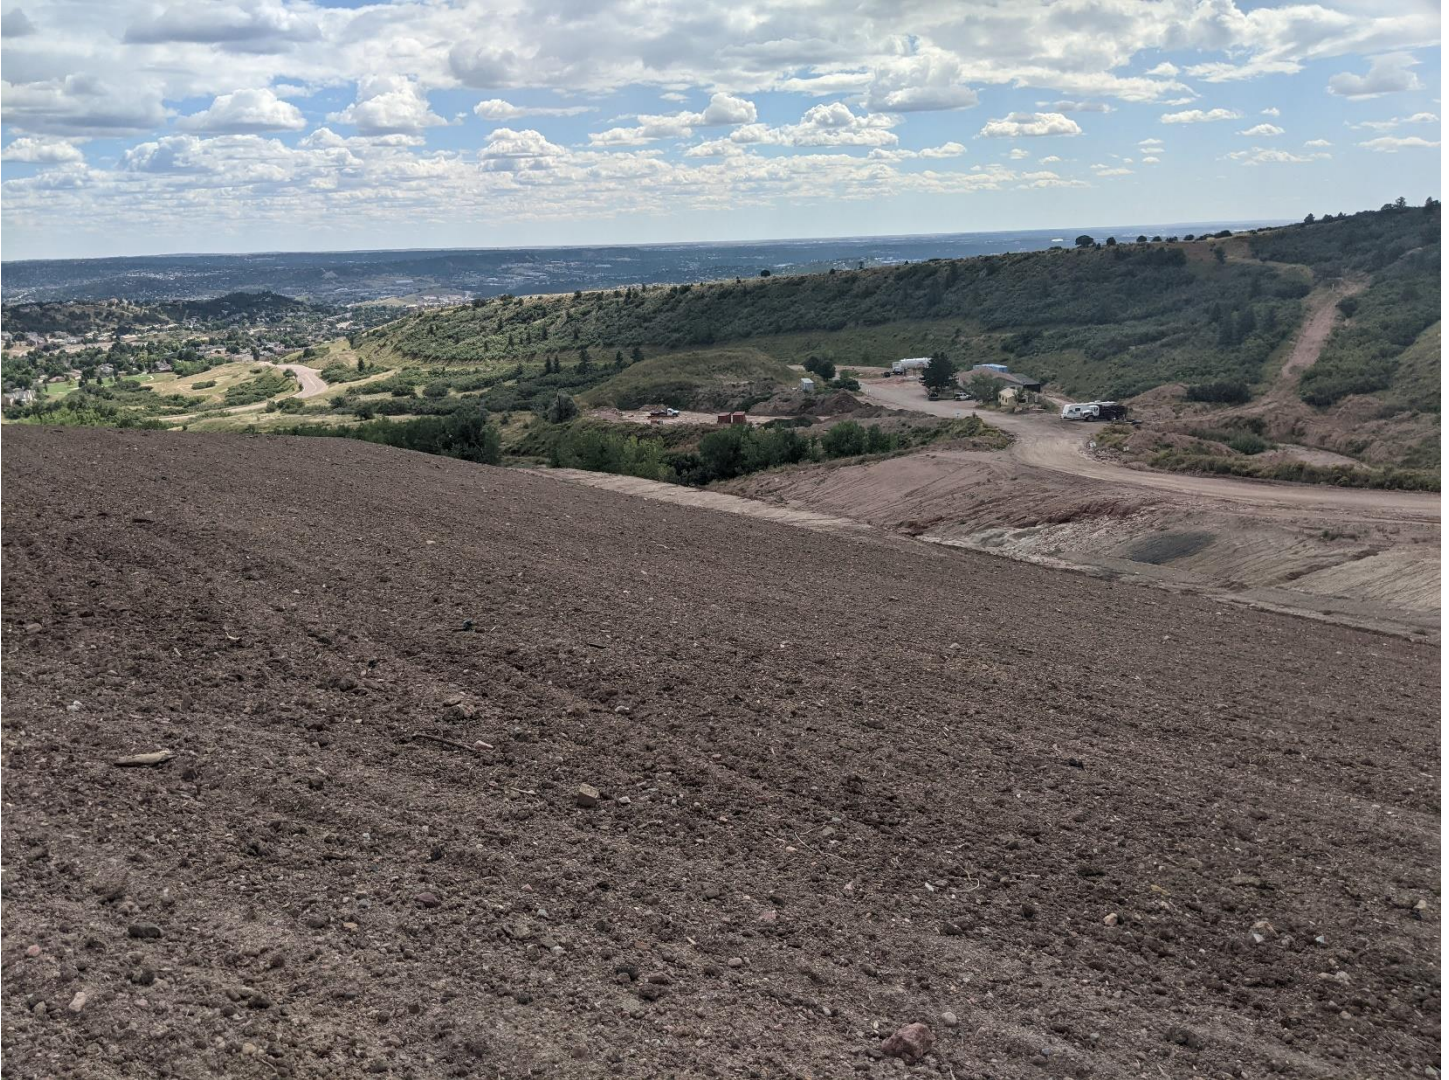
The first bench of the buttress has been fully topsoiled and roughened by cross-ripping to help minimize the potential for erosion. The north-eastern portion of the side has also been fully topsoiled as well. Small terrace like benches have been created for future tree planting along the slope.

Northern slope topsoiled and benched for future trees.

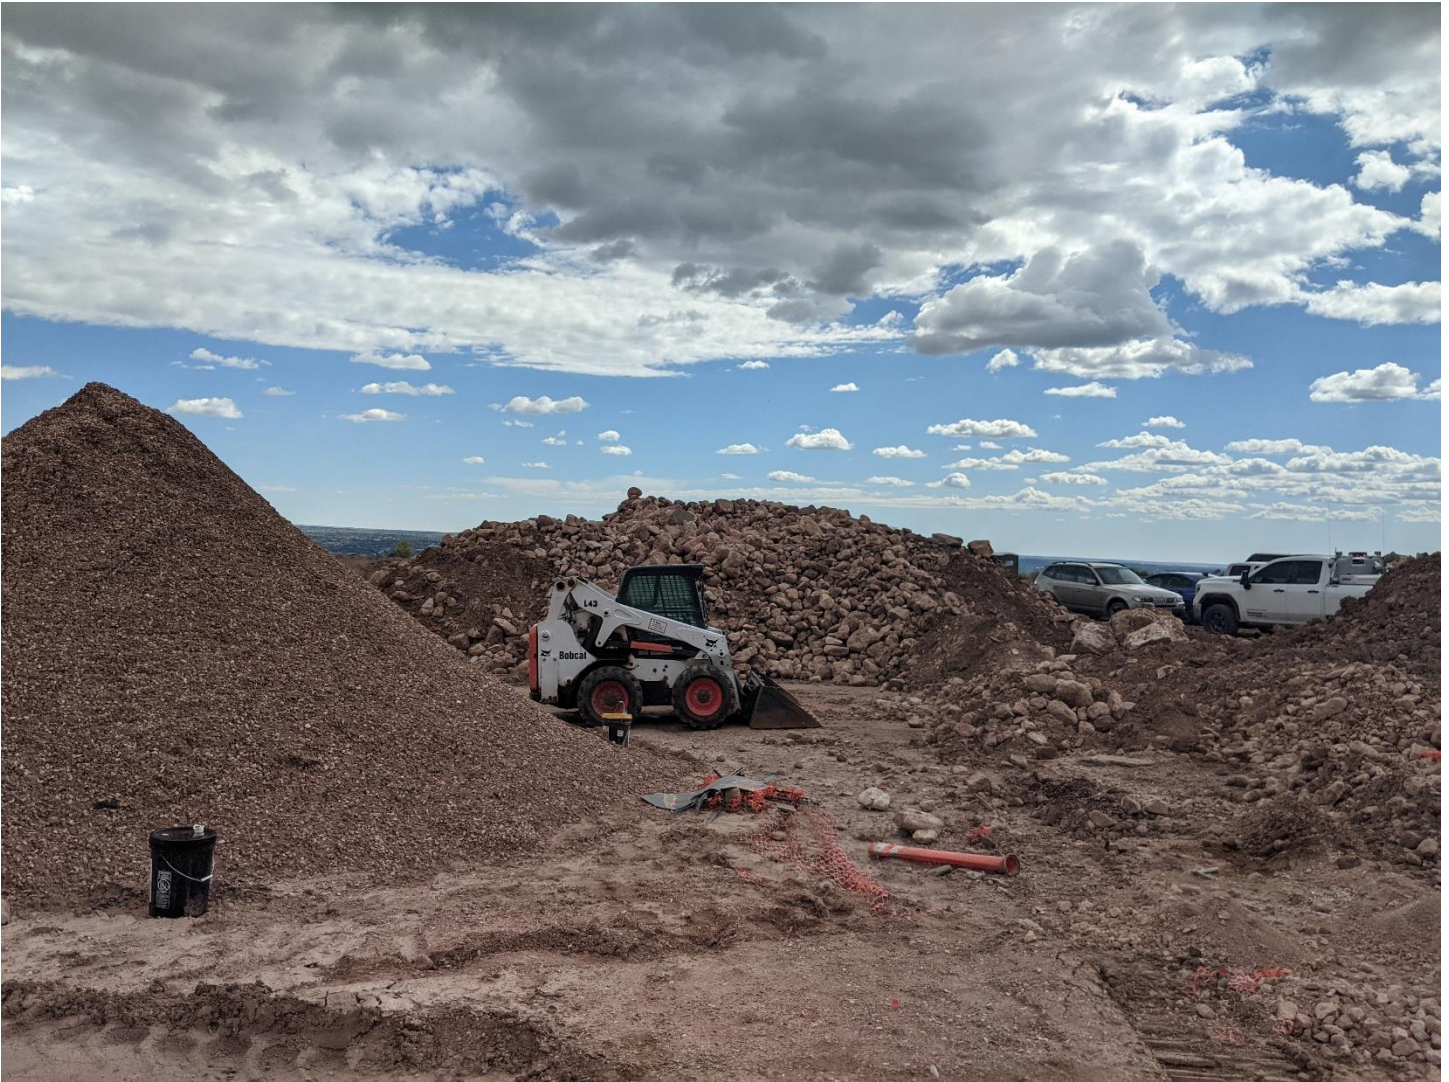
A Technical Revision (TR) was recently received by the Division to update the reclamation plan to match the current construction of the buttress ditch. The TR adjusts the drainage from the buttress area to route to the north and eliminate the southern channel. Rip-rap has been staged below the buttress in varying sizes in preparation for lining of the finalized ditches. No placement has occurred to the date of this inspection.

Riprap segregation and storage.
