**MINERALS PROGRAM INSPECTION REPORT**  
**PHONE: (303) 866-3567**

| <b>MINE NAME:</b><br>Climax Mine | <b>MINE/PROSPECTING ID#:</b><br>M-1977-493 | <b>MINERAL:</b><br>Molybdenum | <b>COUNTY:</b><br>Lake, Summit |
| <b>INSPECTION TYPE:</b><br>Monitoring | <b>WEATHER:</b><br>Clear | <b>INSP. DATE:</b><br>September 19, 2023 | <b>INSP. TIME:</b><br>09:45 |

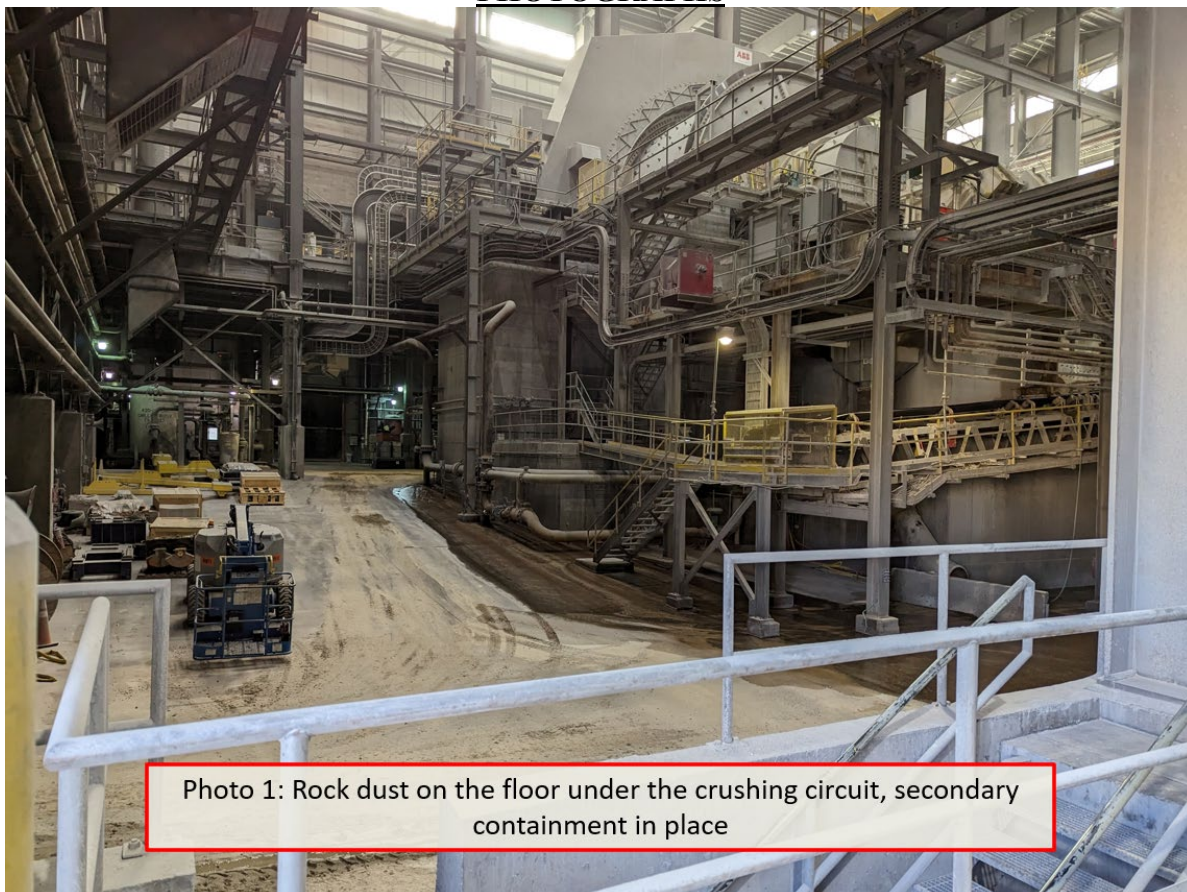
Containments under the crushing circuit had some wet rock dust. Periodically the containments are hosed out and the material is added back into the system (Photo One). No cracks, fractures or evidence of compromise was noted. Some chemicals are stored under the floatation circuit in IBC Totes (Photo Two). The floor in this area was mostly dry and the sump was clean at the time of the inspection. The floor beneath the lower floatation circuit was wet. All sumps observed were free from obstruction and able to function as designed with sprayers directing materials into the sumps (Photo Three).

Photo 1: Rock dust on the floor under the crushing circuit, secondary containment in place

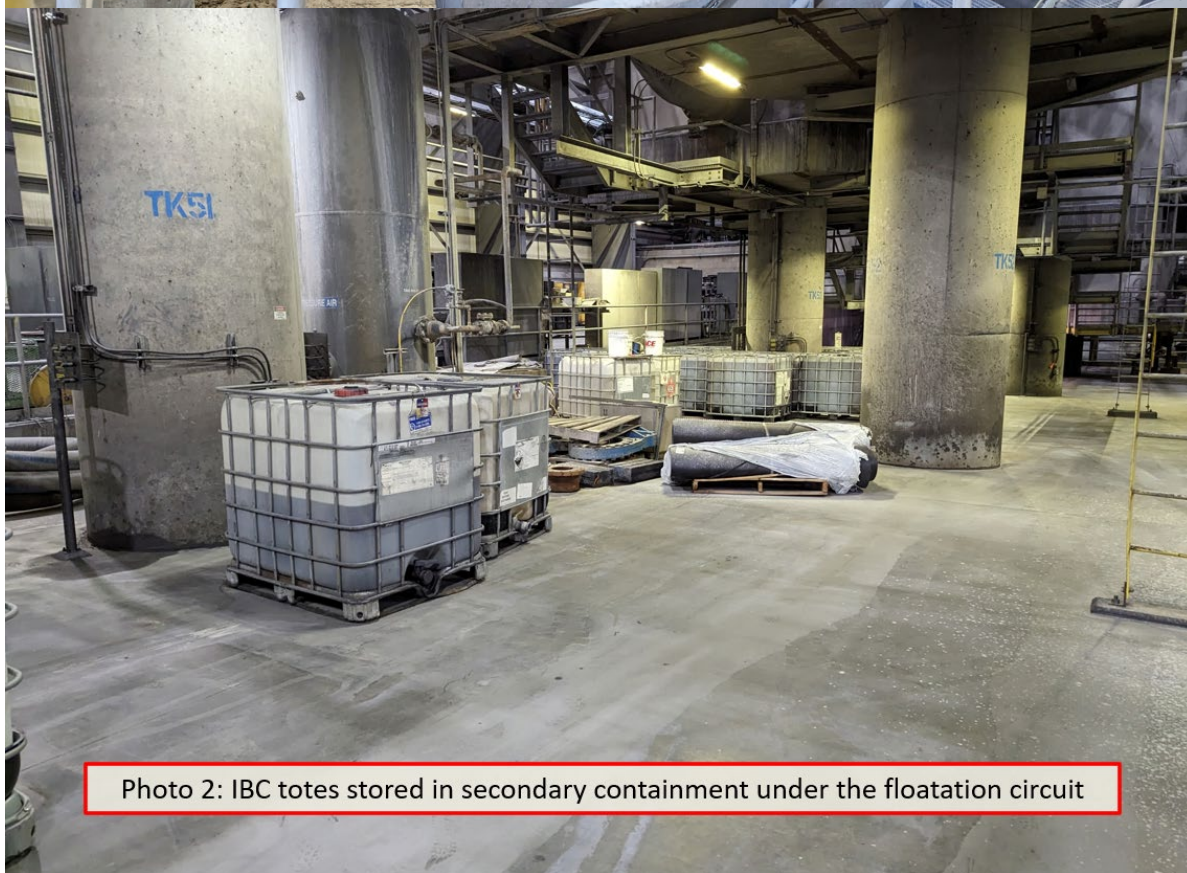
Photo 2: IBC totes stored in secondary containment under the floatation circuit

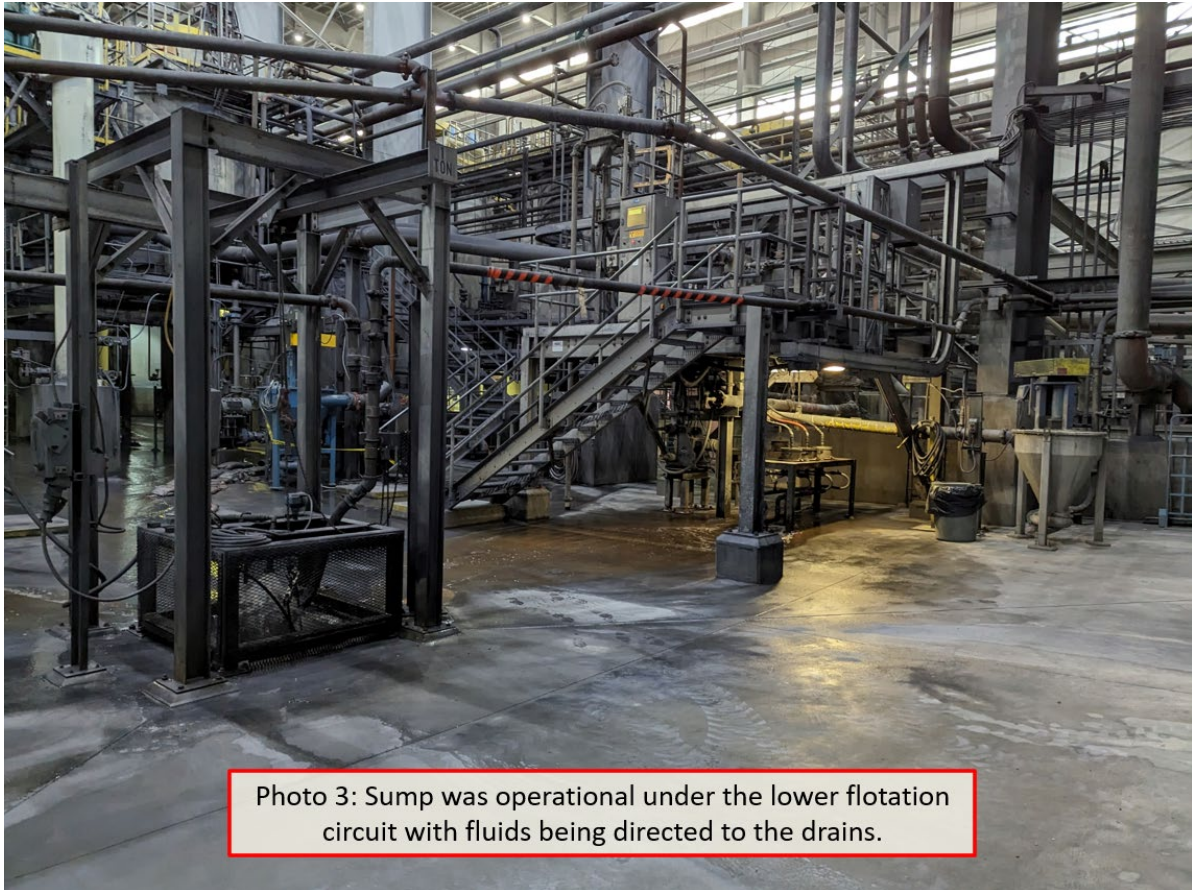
Photo 3: Sump was operational under the lower flotation circuit with fluids being directed to the drains.

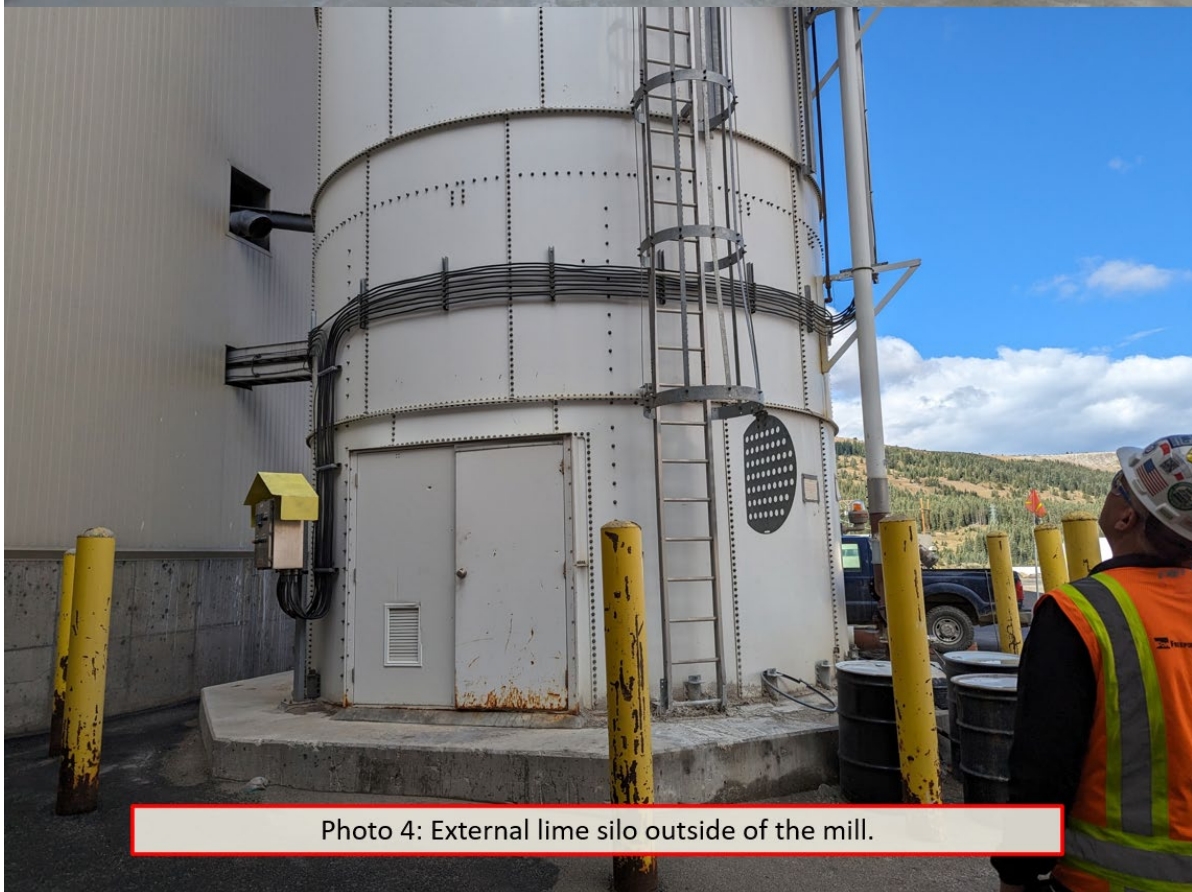
The external lime storage silo was also observed to be in excellent condition and can be seen in (Photo Four). No evidence of spillage or lime scaling was observed on or around the silo. Secondary containment for the silo is achieved by the pads surrounding the Mill Facility that would contain any possible spillage.

Photo 4: External lime silo outside of the mill.

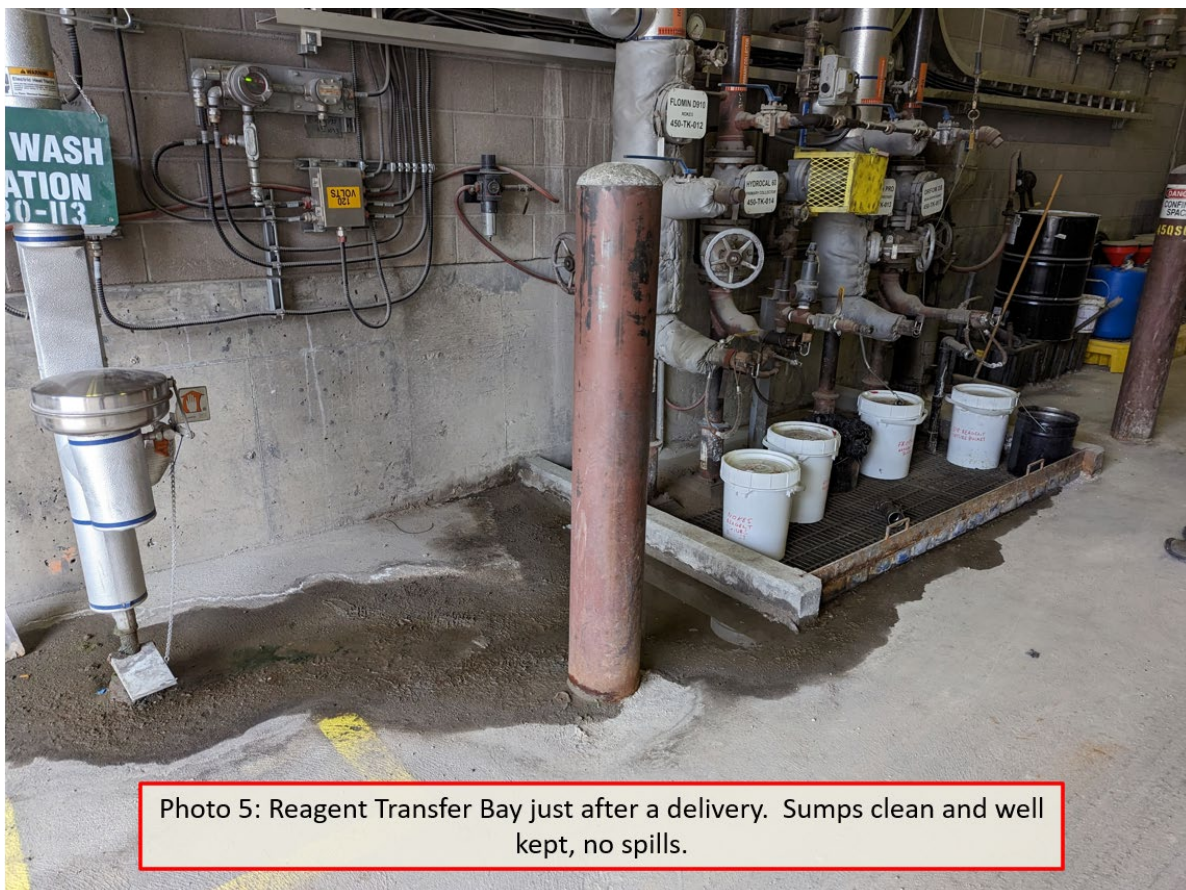
The Reagent Storage Room and transfer bay were observed to be in excellent condition. The transfer bay was clean, neat and well kept. The pipes and delivery systems appeared to be in good working order and no evidence of spillage during transfer was noted (Photo Five). The sump associated with the transfer station was clean and free from obstruction. The transfer bay is sloped towards the interior of the mill facility providing for secondary containment should any spillage occur.

Photo 5: Reagent Transfer Bay just after a delivery. Sumps clean and well kept, no spills.

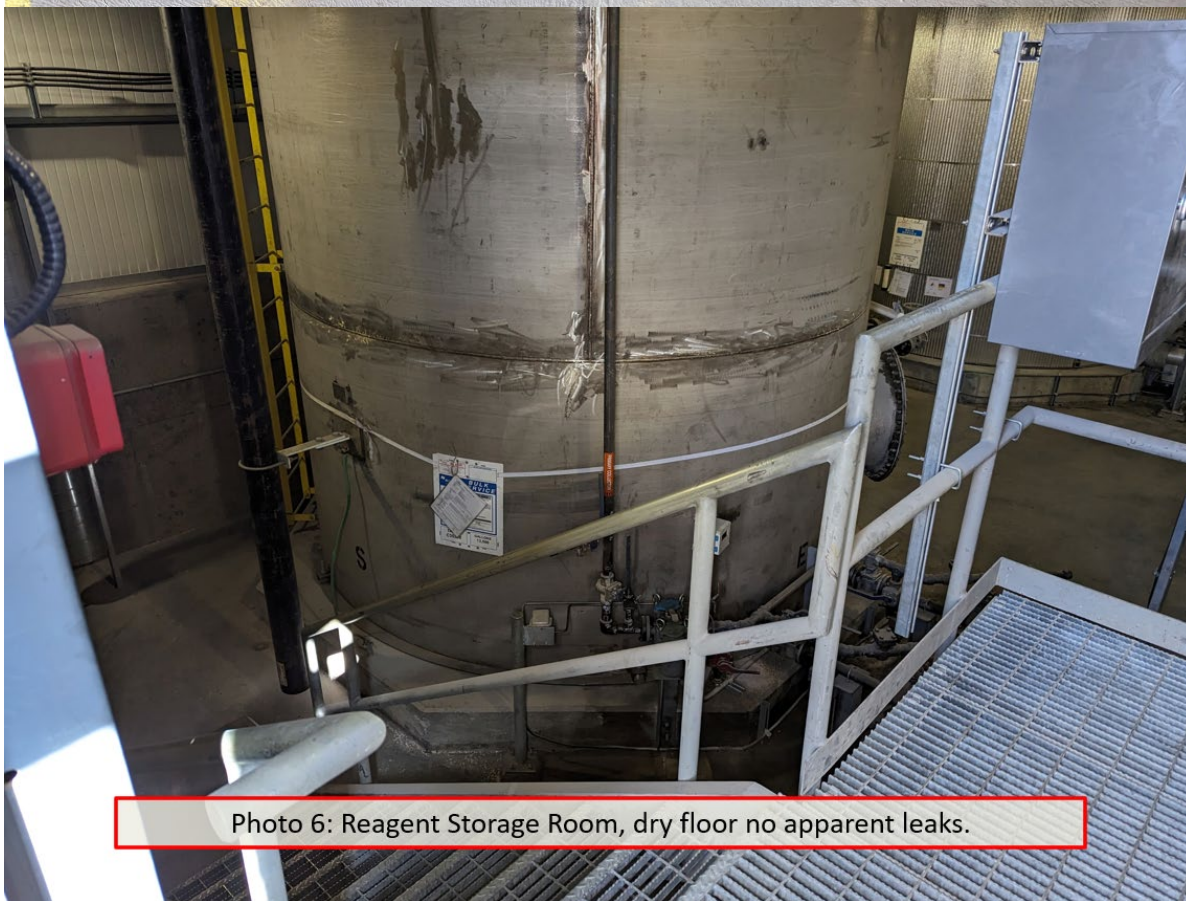
The Reagent Storage room is a separate room attached to the Mill Facility to provide containment of the chemicals and is accessed from an exterior man door. No evidence of spillage or containment concerns were observed, the sump is clean and clear from obstructions (Photo Six). No cracks, fractures or evidence of compromise were noted.

Photo 6: Reagent Storage Room, dry floor no apparent leaks.

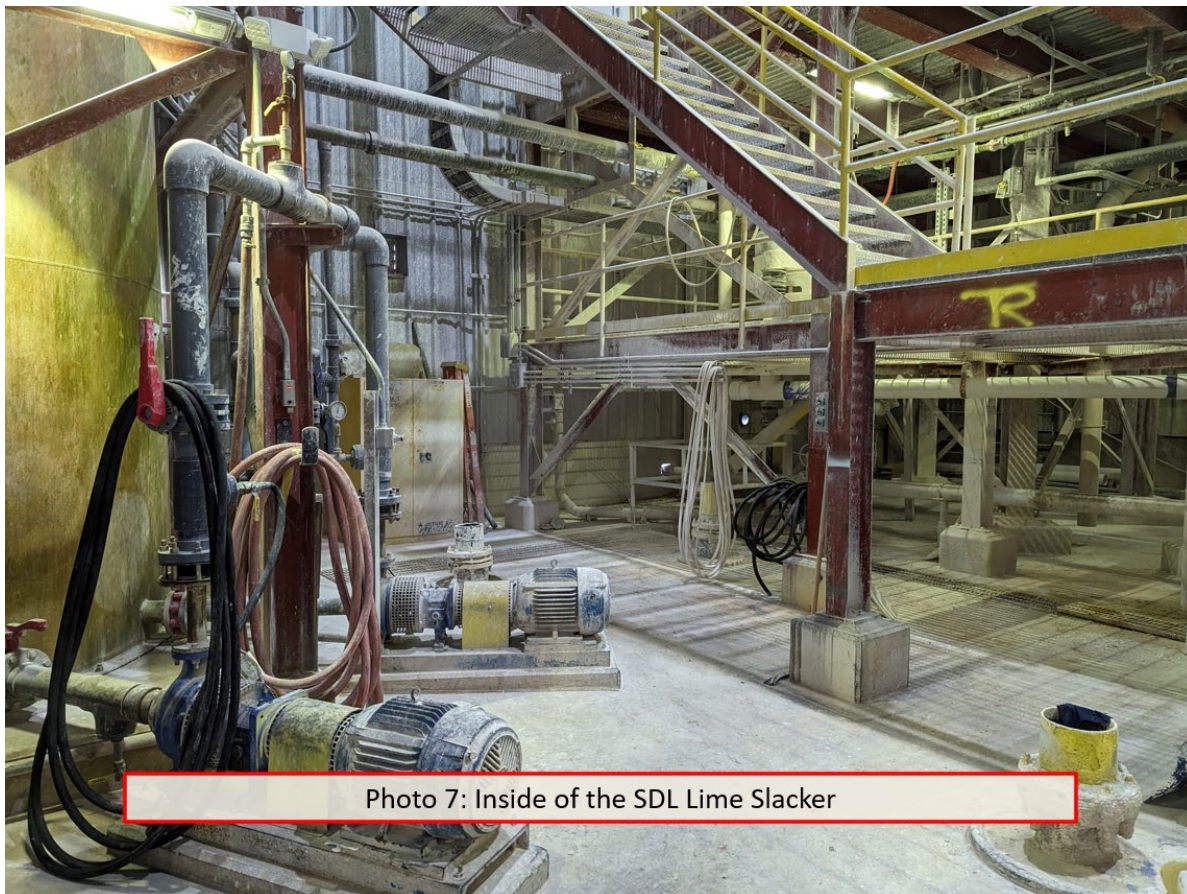
Residual dried lime is present throughout the building as everything was covered in a white layer. All floors within the buildings were dry indicating no recent spills or loss of containments (Photo Seven). Floor drains and sumps were also dry.

Photo 7: Inside of the SDL Lime Slacker

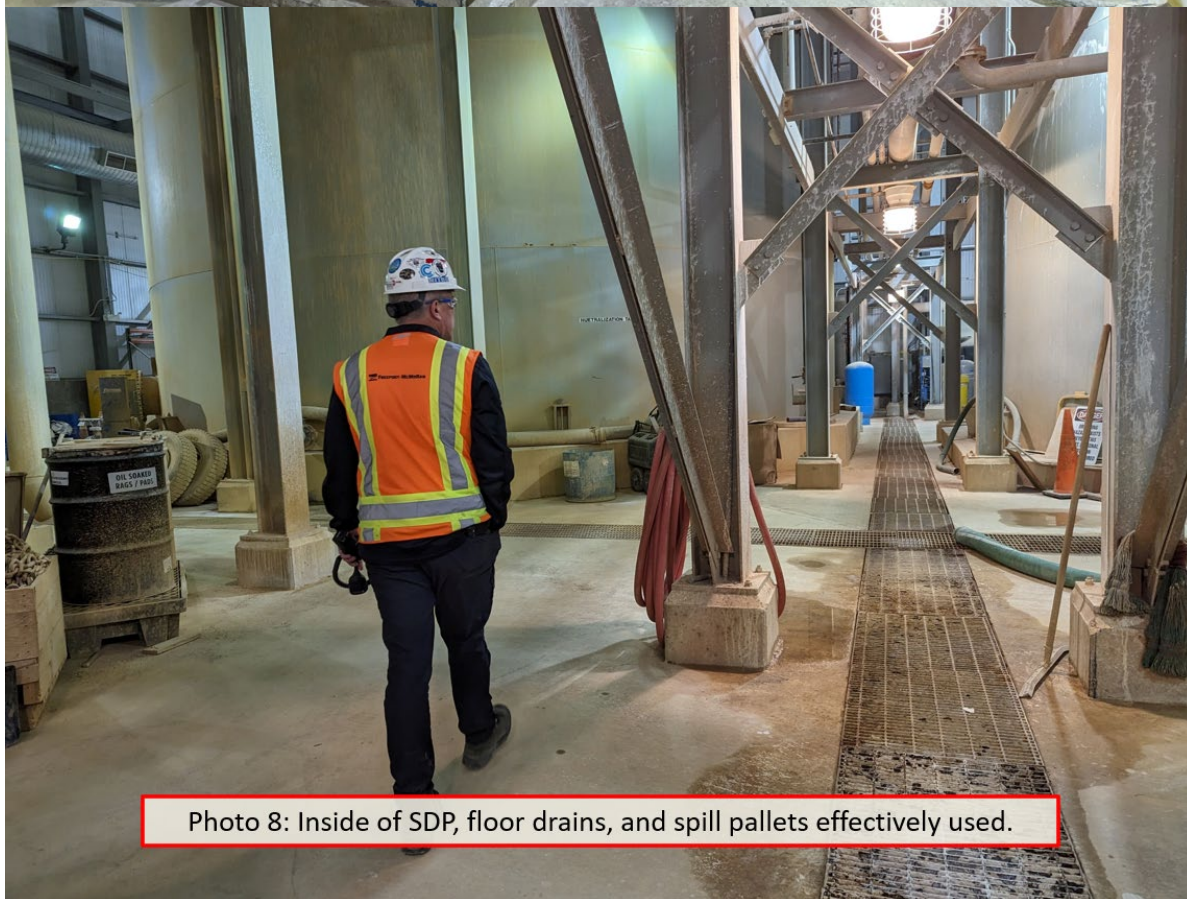
Contained within the SDP building is a small spill pallet for storage of hazardous materials. Used oil and other hydrocarbons were stored on this pallet (Photo Eight). No other materials were observed outside of containment within the SDP. Throughout the SDP, the facility is well kept, clean, neat and organized. Located throughout the SDP are floor drains. Spills go into floor drains and overall are contained within the drainage area of the Tenmile TSF. All floors within the buildings were dry indicating no recent spills or loss of containments. Floor drains and sumps were also dry.

Photo 8: Inside of SDP, floor drains, and spill pallets effectively used.

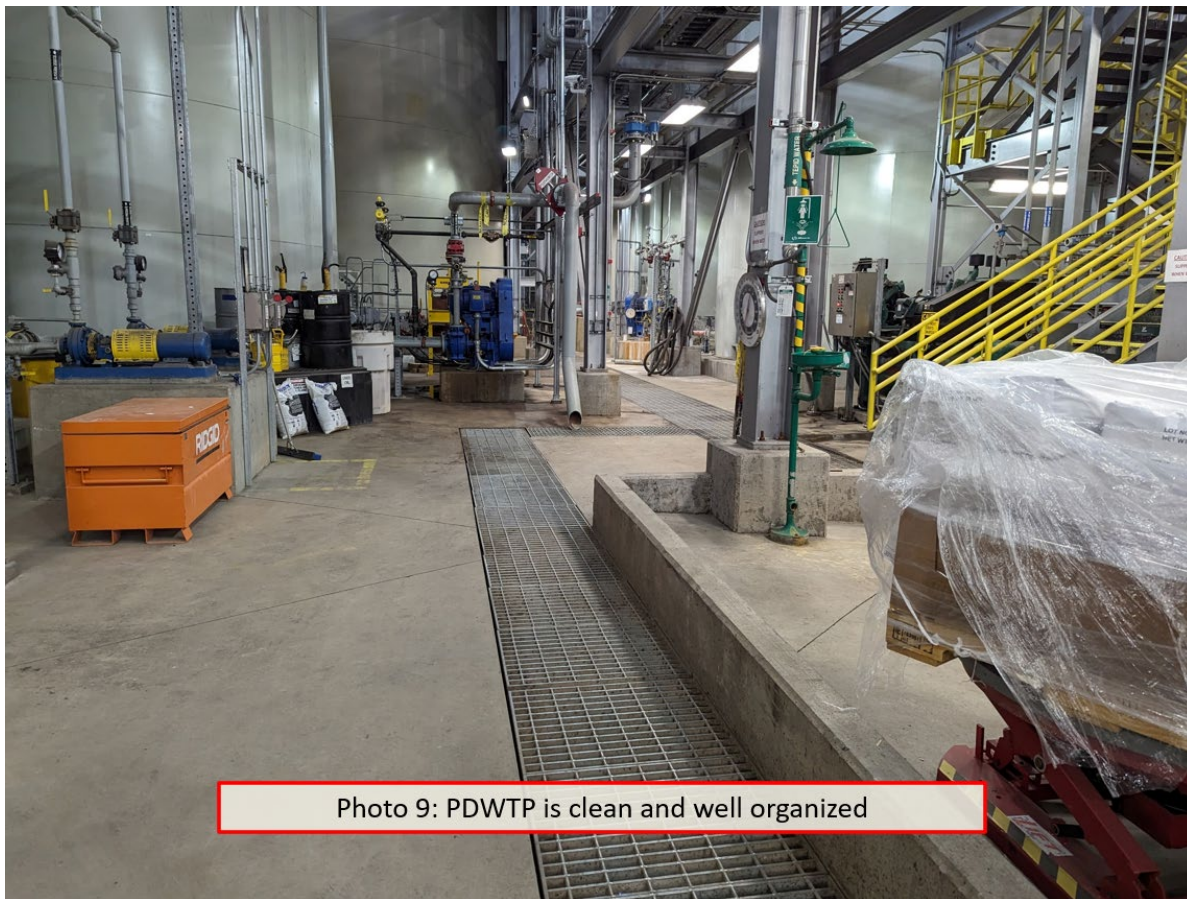
A lime silo is located outside of the PDWTP to feed pebbled lime into the Lime slacker within the PDWTP. Raw water from the Mayflower Pond and the slacked lime are fed into the Metals Reactor tank where it's mixed. There are two Metals Reactor (neutralizer) tanks in series within the PDWTP. The resulting slurry/precipitate then goes into the one of two Metals Thickeners (clarifiers) that are in parallel. The clarifiers are located outside of the PDWTP under an enclosed dome that is connected via walkways. Within the clarifiers the sludges are further thickened/precipitated and then the overflow water will proceed to the Metals Filter building. All tanks, reactors and mixing facilities are in excellent condition, the main facility is very well kept, clean, neat and organized (Photo Nine). The main facility has a series of troughs leading to the main sump for secondary containment.

Photo 9: PDWTP is clean and well organized

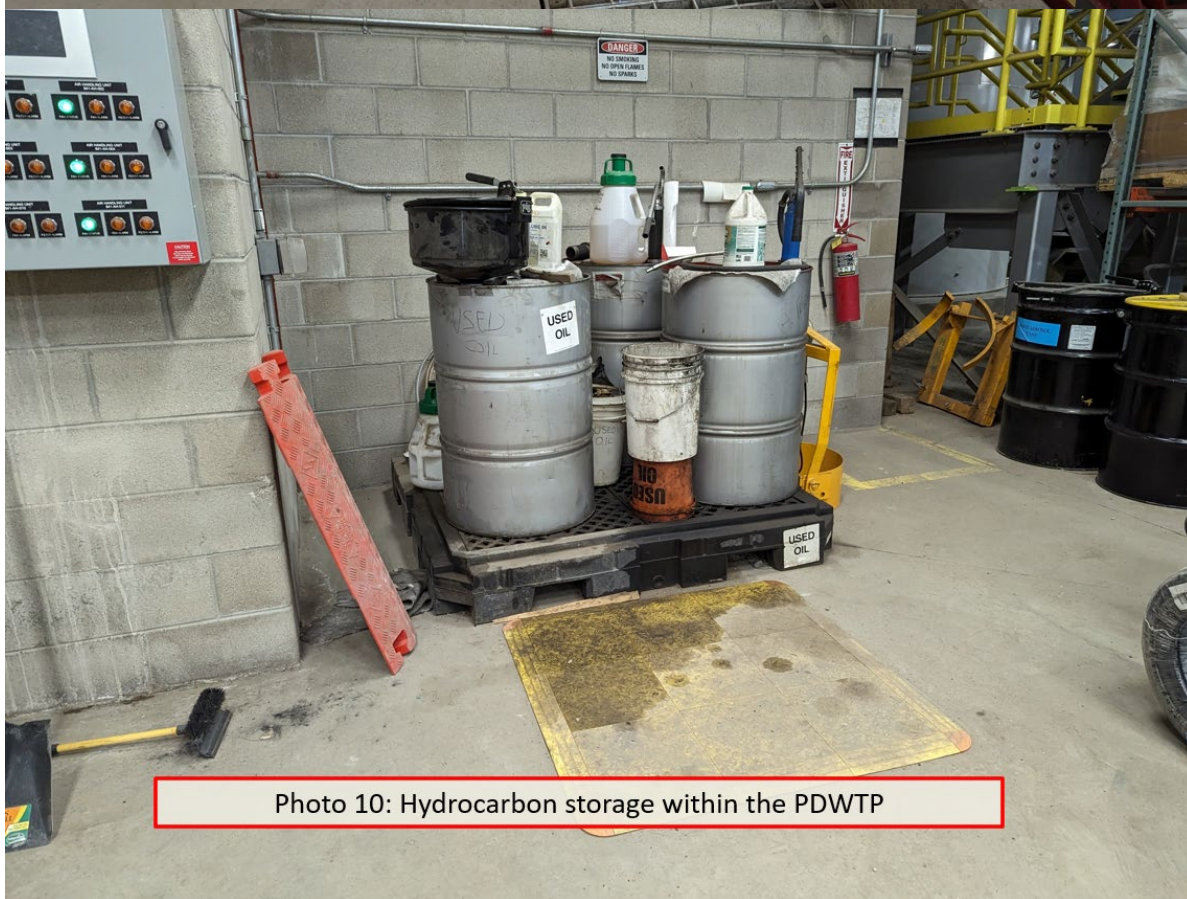
Photo 10: Hydrocarbon storage within the PDWTP

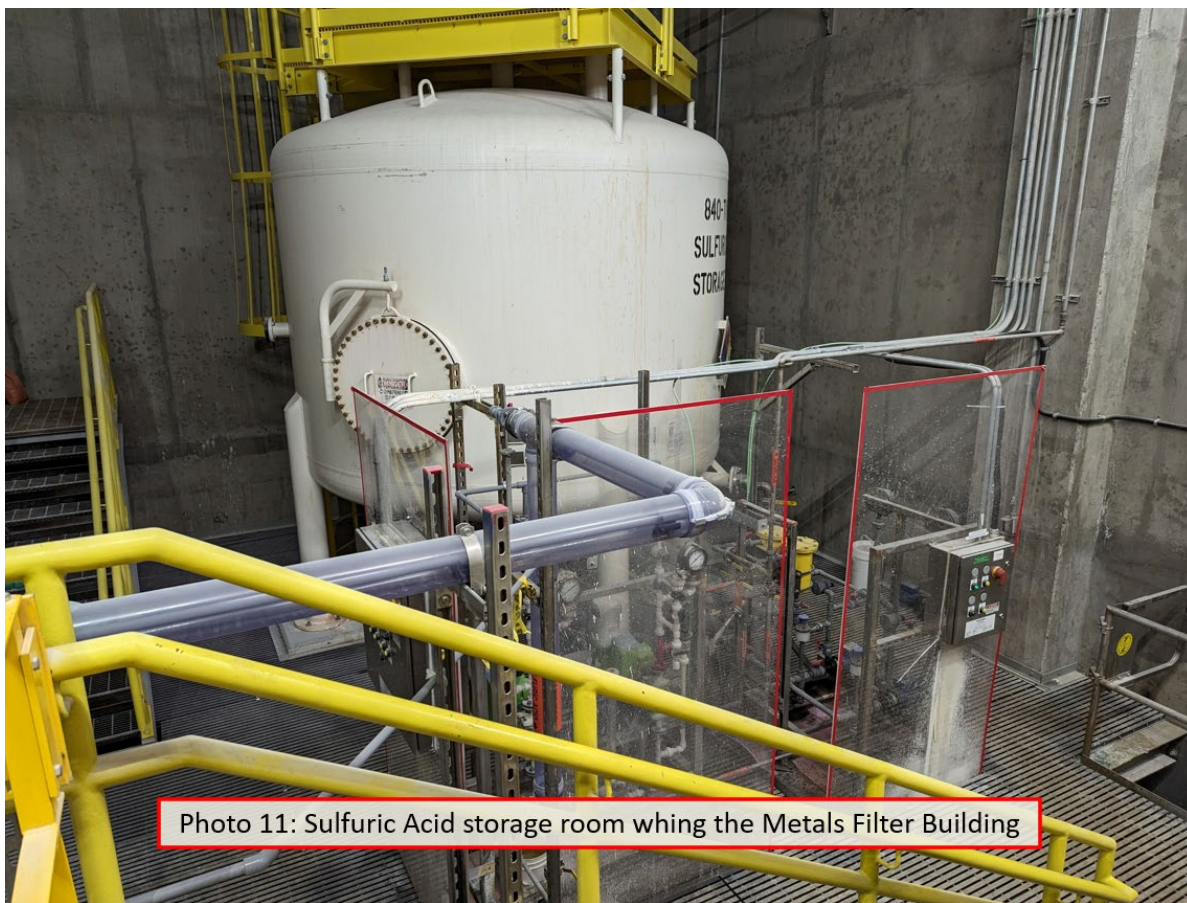
Photo 11: Sulfuric Acid storage room whing the Metals Filter Building

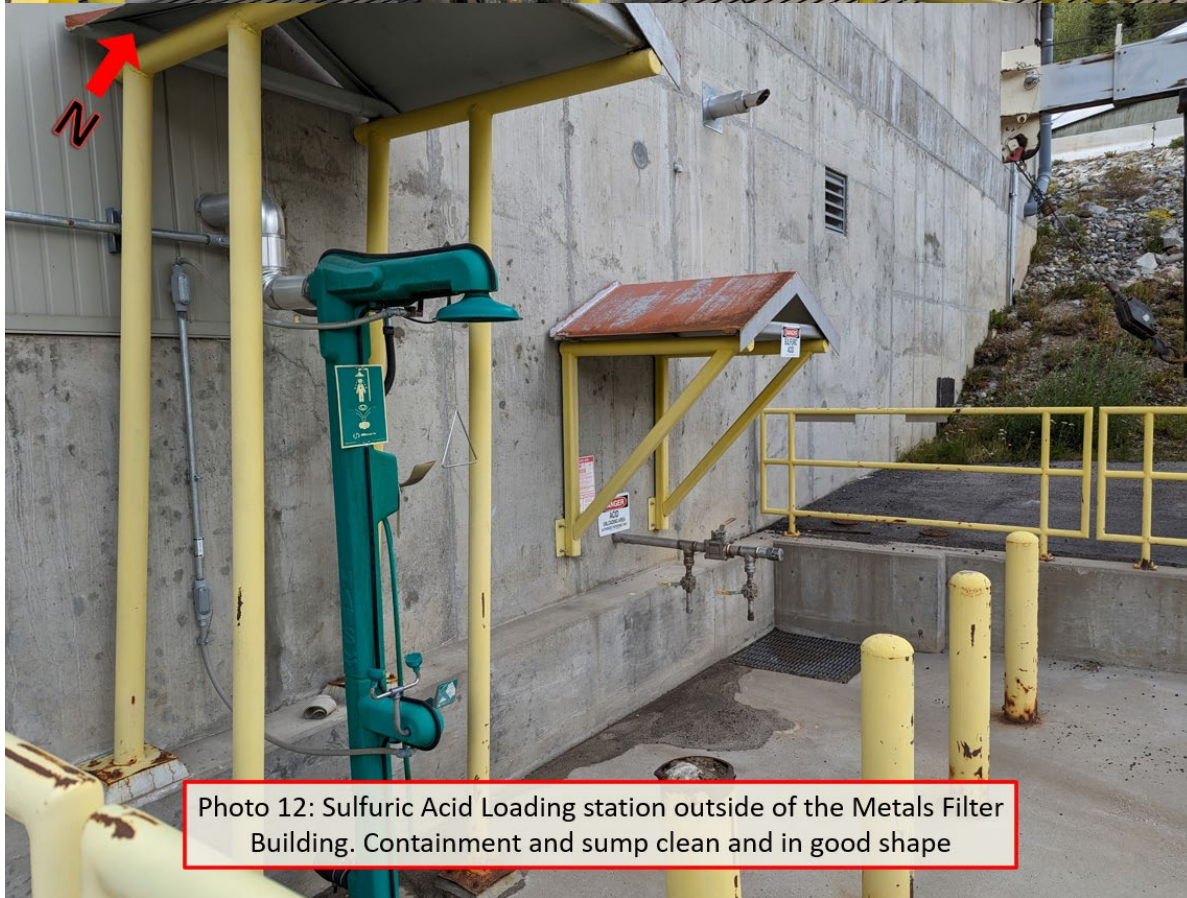
Also located within the PDWTP building are the Metals Sludge Tanks, Metals Filtrate Tank, a Metal Flocculent Storage Tank, Metals Mixed Flocculent Tank and a Fresh Water Tank. There is a large sump built into the foundation of the PDWTP. All floor drains discharge into the cellar which was dry at the time of the inspection. Miscellaneous hydrocarbons are stored on spill pallets located throughout the building (Photo Ten). There is a sulfuric acid room located within the Metals Filter Buildings and the reagent is transferred throughout the system via a double walled pipe. The tank and sump are in excellent condition (Photo Eleven). Located just outside the filter building is the sulfuric acid loading station. The loading station is equipped with secondary containment for possible spills that may happen during the unloading process (Photo Twelve). The station is clear of debris, well-kept and appears to be in good operating condition.

Photo 12: Sulfuric Acid Loading station outside of the Metals Filter Building. Containment and sump clean and in good shape

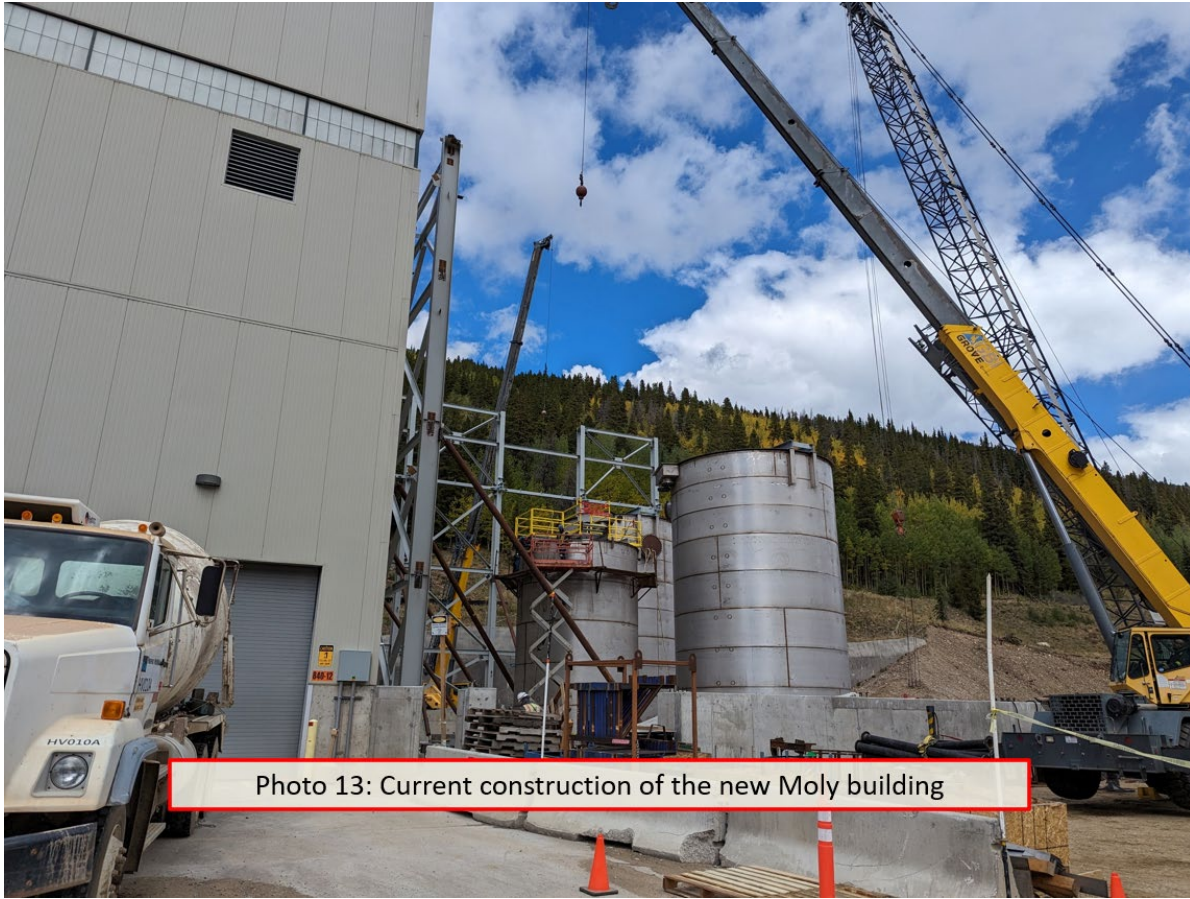
The new molybdenum building (TR-34) is under construction. This is a supplementary process to Climax's existing Property Discharge Water Treatment Plant (PDWTP). A crane and several crews were on site actively working on this new EPF. Steel for the walls was being erected and three tanks have been constructed to date (Photo Thirteen). The building is slated to be online in the first quarter of 2025. Once online the raw water will first go into the Moly building, then water will go to the existing PDWTP building and finally the existing Metals Filter Building before discharge.

Photo 13: Current construction of the new Moly building
