## MINERALS PROGRAM INSPECTION REPORT

| <b>MINE NAME:</b><br>Cresson Project | <b>MINE/PROSPECTING ID#:</b><br>M-1980-244 | <b>MINERAL:</b><br>Gold and silver | <b>COUNTY:</b><br>Teller |
| <b>INSPECTION TYPE:</b><br>Monitoring | <b>WEATHER:</b> Clear | <b>INSP. DATE:</b><br>August 24, 2023 | <b>INSP. TIME:</b><br>09:30 |

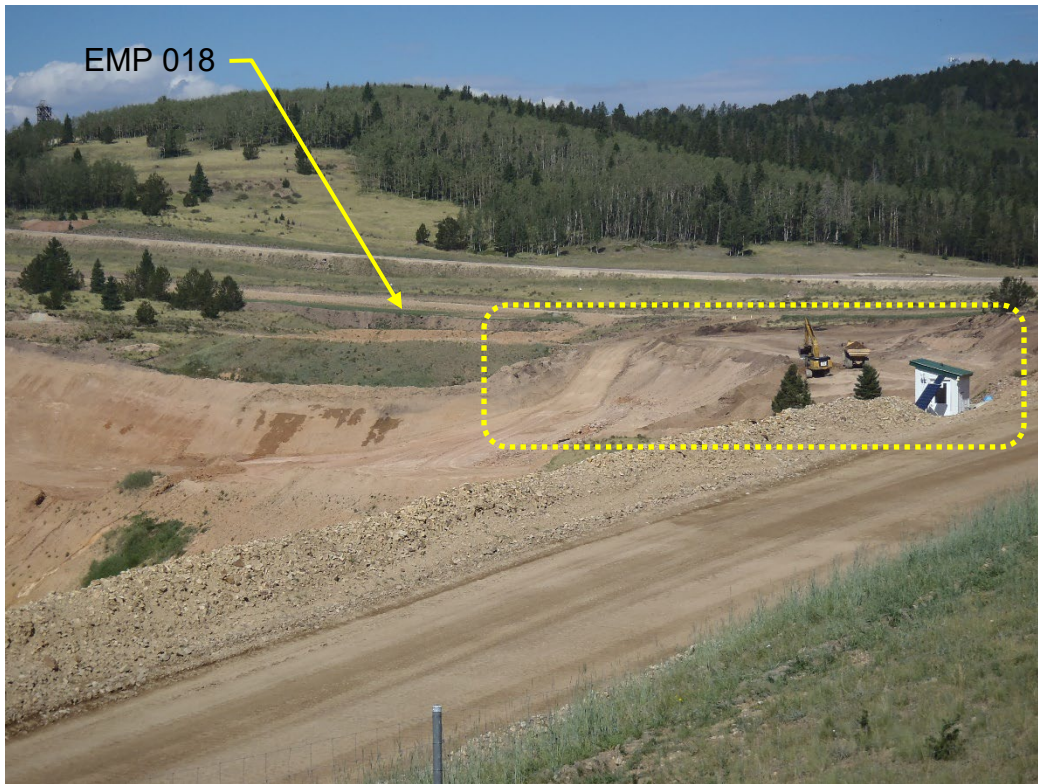
**WHEX Clay Borrow Source:** Ms. Blake and Messrs. Doering and Adams accompanied the DRMS to the WHEX Clay Borrow Source, along with two additional CC&V staff members. CC&V was continuing to extract clay from the borrow source (see **Photo 1**). Site representatives pointed out topsoil from this borrow source had been stripped and added to Topsoil Stockpile #38 (see **Photo 2**). They confirmed the additional salvaged topsoil would be included in the annual report topsoil accounting summary.

Photo 1. WHEX Clay Borrow Area (Excavation on east end, looking NW)

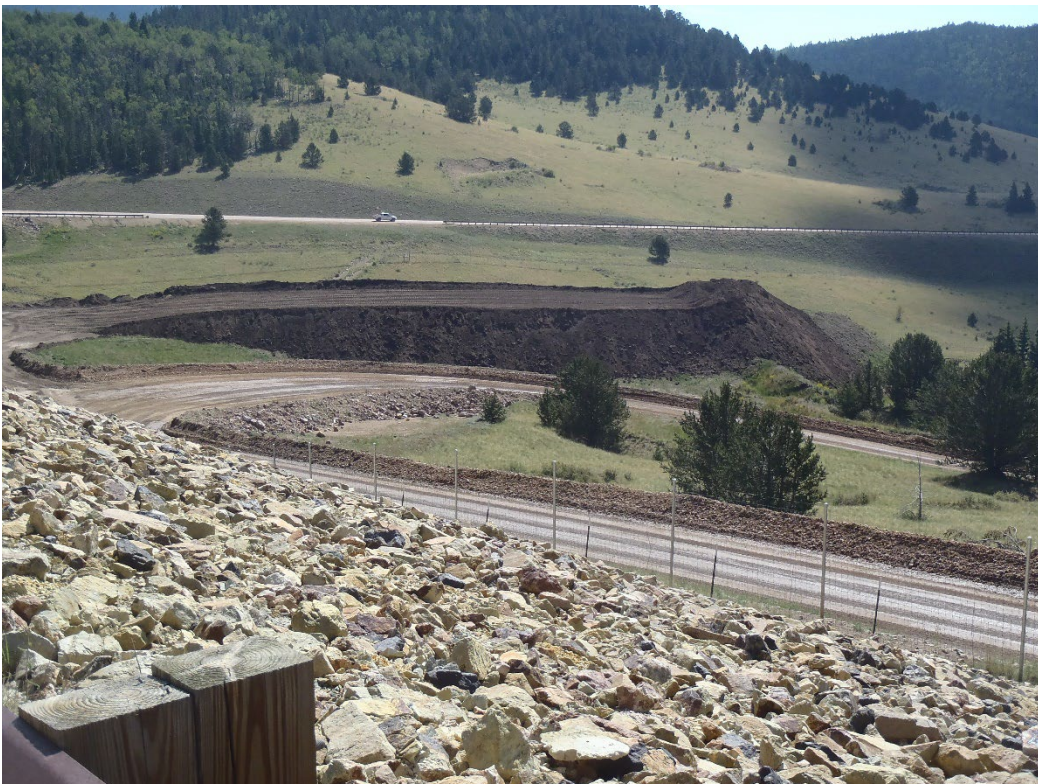
Photo 2. Newly placed salvaged topsoil from WHEX Borrow on TS #38 (looking south).

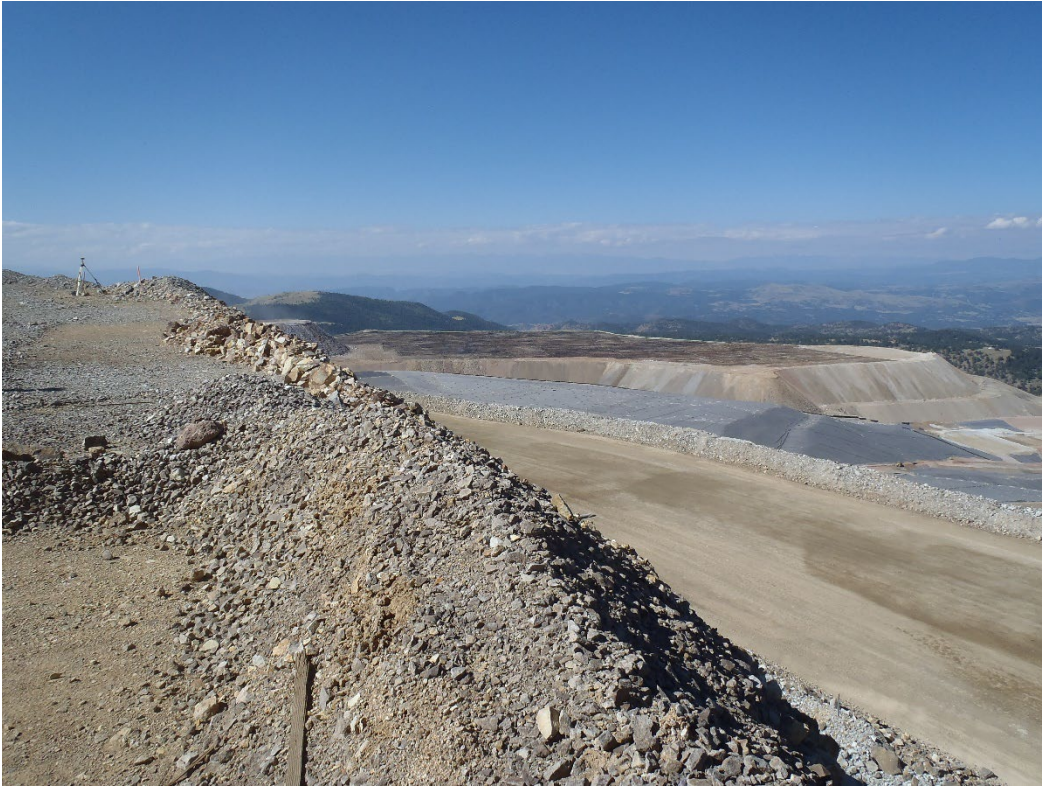
**VLF 2 Phase III Construction:** Geomembrane liner was observed to have been installed to near the south end of the proposed Phase III area (see **Photo 3**). Drain cover fill (DCF appeared to be installed on most, if not all the PSSA area. A significant amount of water was ponded in the PSSA area (see **Photo 4**). Site representatives confirmed this was meteoric water. Subsequent to this inspection, photos from the DRMS July inspections were reviewed and found to show significant ponding in the PSSA was present on July 10<sup>th</sup> and 26<sup>th</sup>. The DRMS intends to investigate this further during the September inspection. The installation of the leak detection trench included in the TR-135 CQA report was discussed. Site representatives indicated they could demonstrate the trench was installed on or very near bedrock.

Photo 3. Geomembrane placement on the south end of VLF2, Phase III (looking SW).

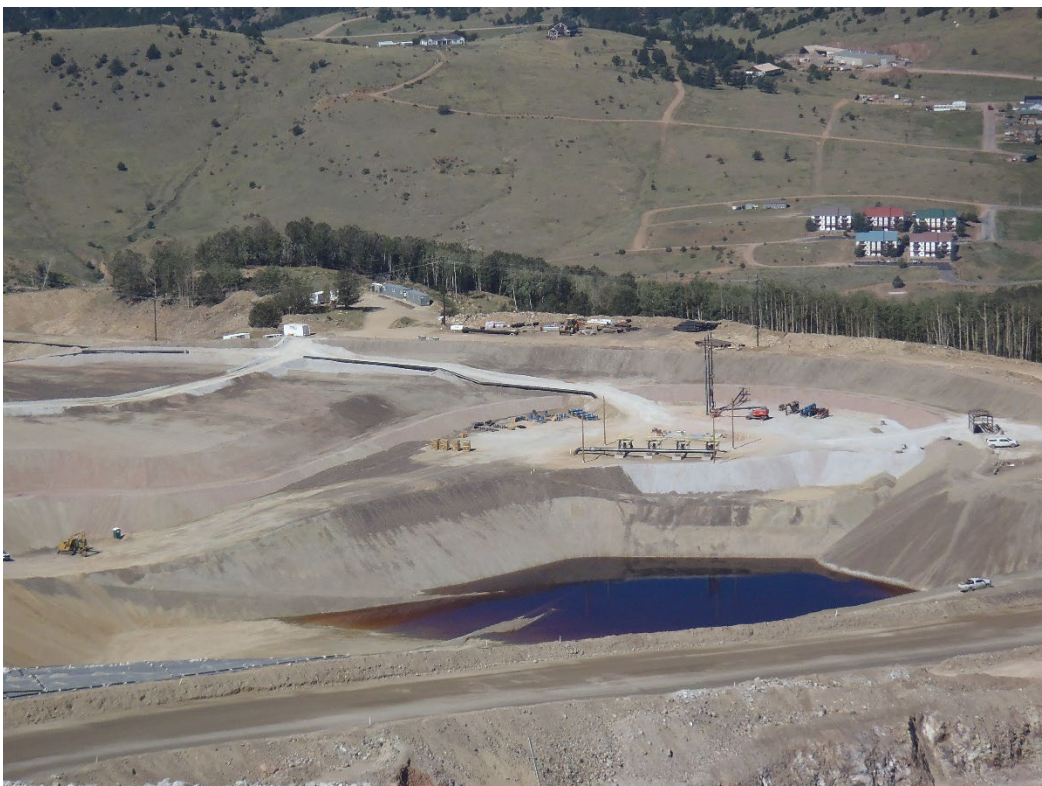
Photo 4. Meteoric water in VLF2 Phase III PSSA.

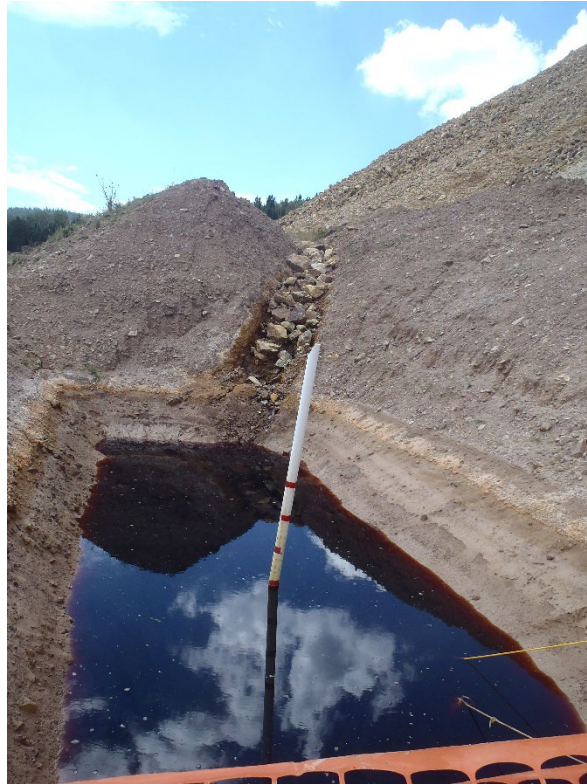
**ECOSA Seeps and Washout:** Both ECOSA Seeps 1 (see **Photo 5**) and 2 (see **Photo 6**) were visited. Neither sump was receiving any seepage water.

Photo 5. ECOSA Seep #1 (looking south – no inflow).

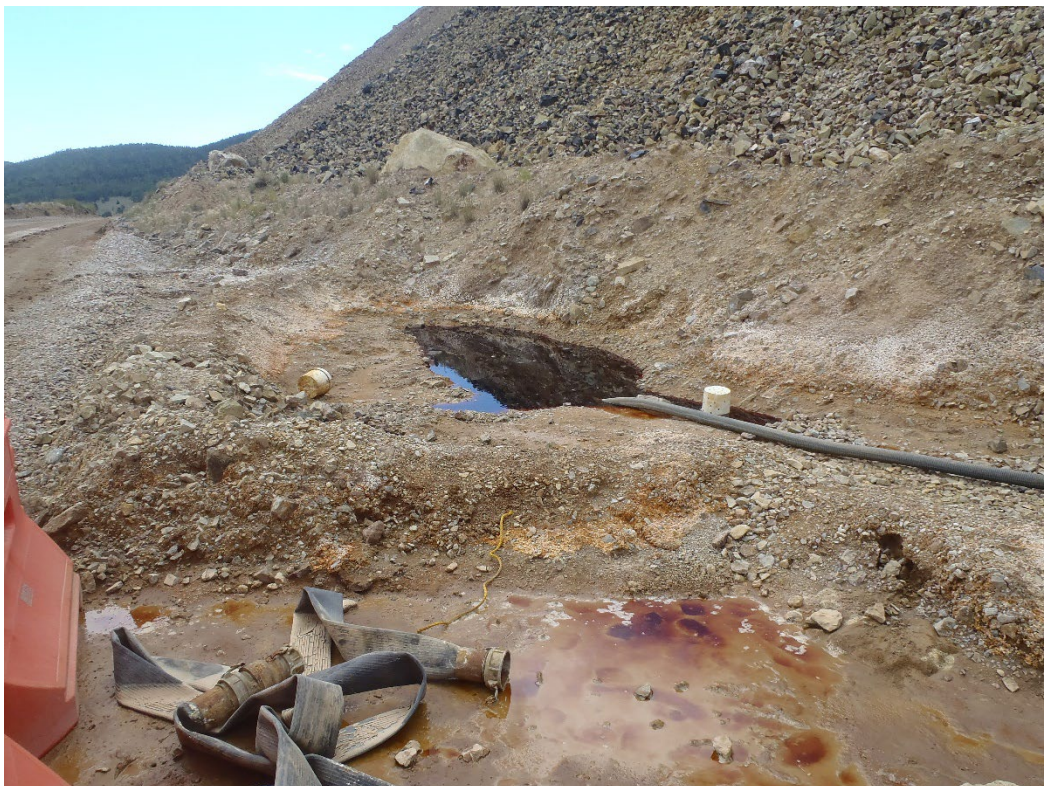
Photo 6. ECOSA Seep #2 (looking south – no inflow).

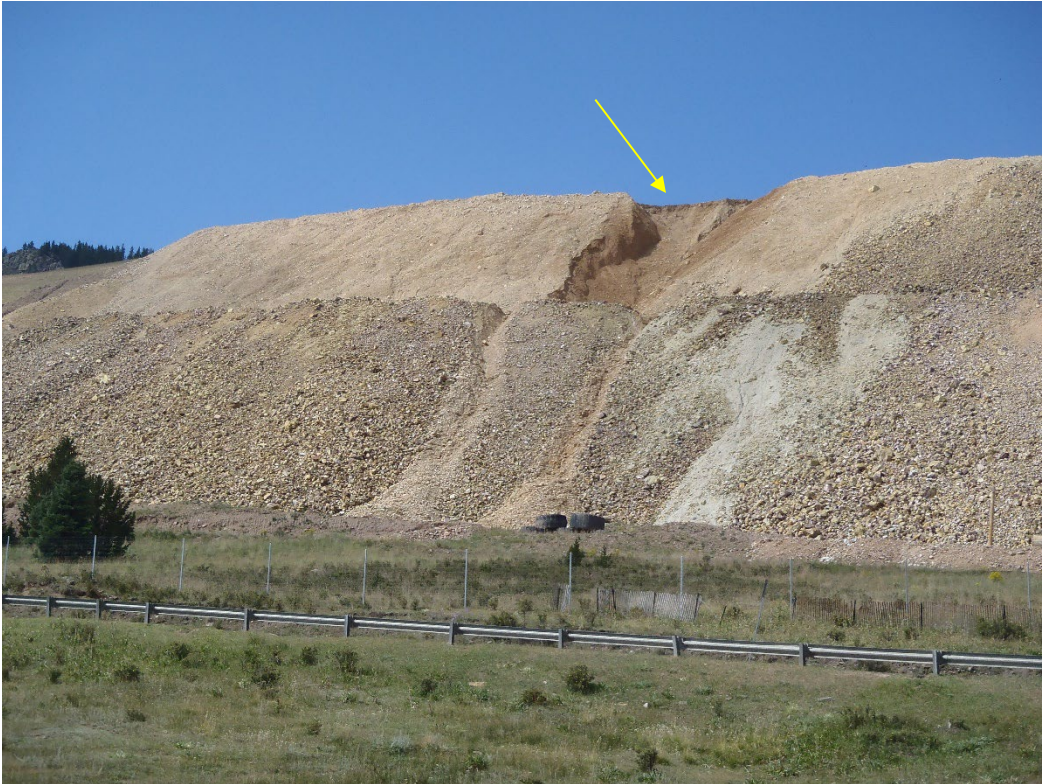
The ECOSA washout area was observed from CR 82 (see **Photo 7**) and at the toe of the ECOSA. Site geotechnical engineer, Marian Boatema provided an overview of her stability assessment along with a copy of her internal report showing the results of her stability analyses for three different cross sections in the vicinity of the failure. She explained the Factor of Safety (FoS) for local failures (i.e., inter bench sloughing with no expected offsite impact) ranged from 0.52 to 0.64 (*an FoS less than 1.0 indicates the slope is not stable*). She indicated any such failure would result in material remaining in the currently disturbed ECOSA area, including the bench above the toe of the slope.

Photo 7. ECOSA washout (looking SW from CR 82).

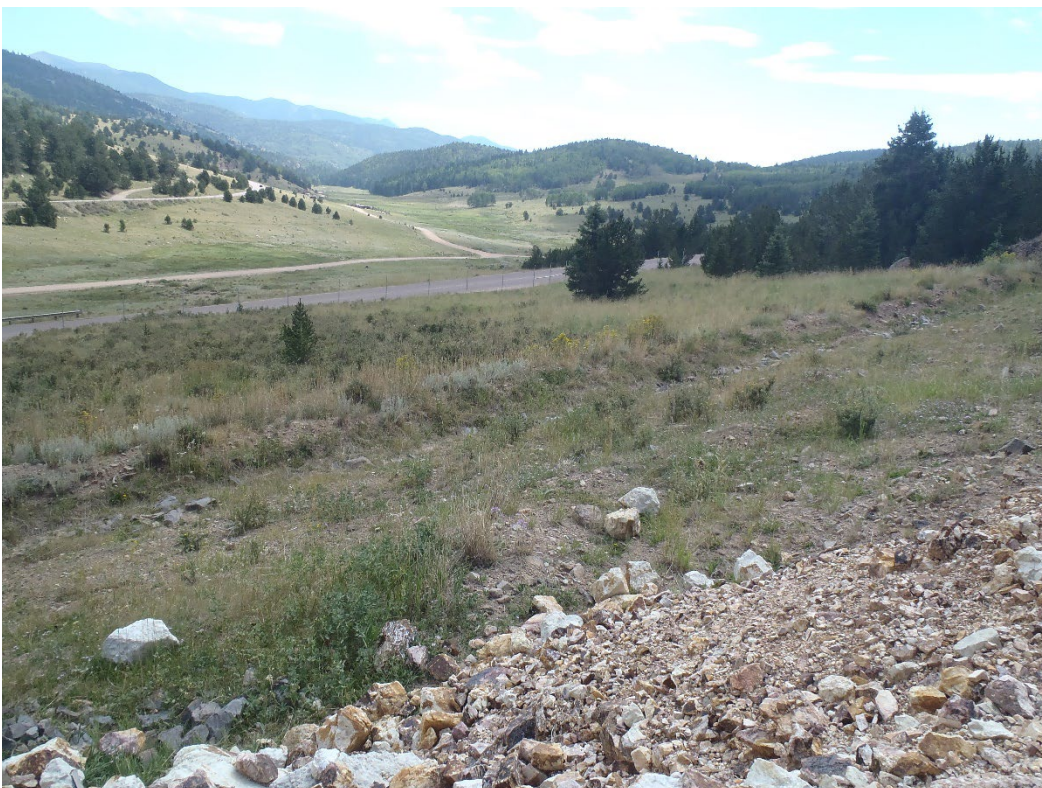
The recent washout was all contained in the ECOSA disturbance area. There was no evidence of material crossing the ECOSA toe road or into undisturbed areas (see **Photo 8**).

Photo 8. Stormwater channel east of ECOSA – no washout material made it to the channel (looking SE).

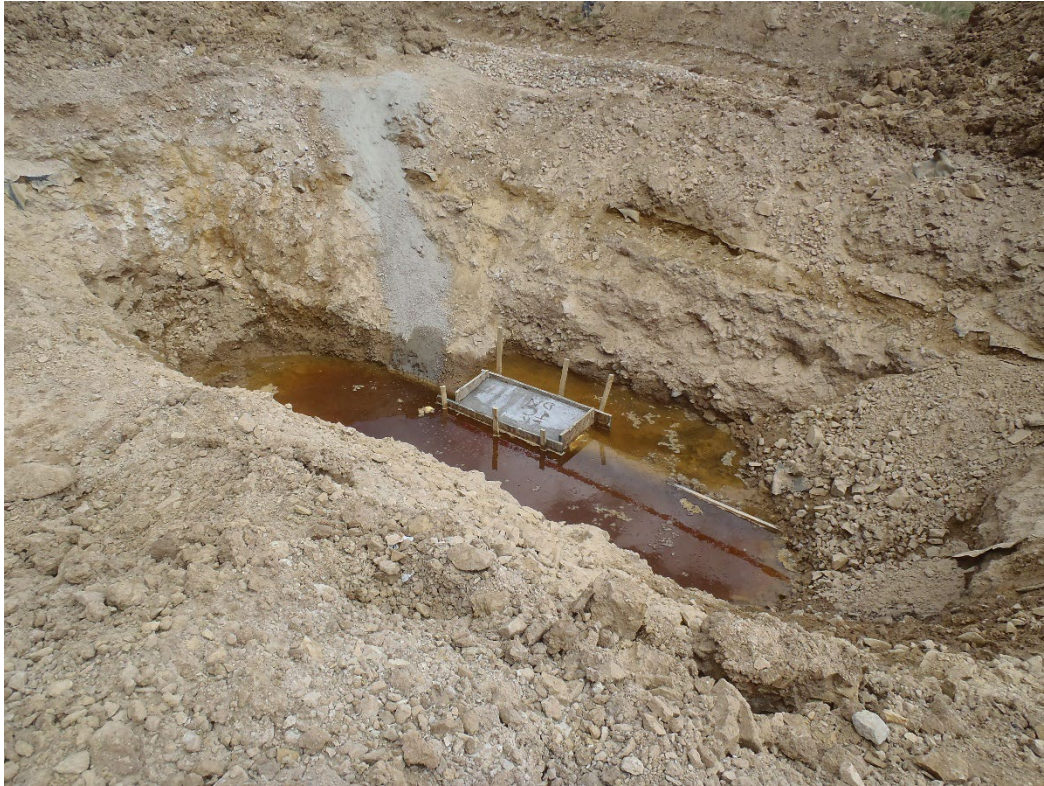
Site representatives revealed a new problem at the toe of the ECOSA. CC&V discovered a leak in the new waterline (TR-85) that is buried along the toe of the ECOSA. They'd excavated a hole in the toe road and had performed a temporary fix by surrounding the leak area with cast-in-place concrete (see **Photo 9**).

Photo 9. Temporary fix for leaking waterline along toe of ECOSA.

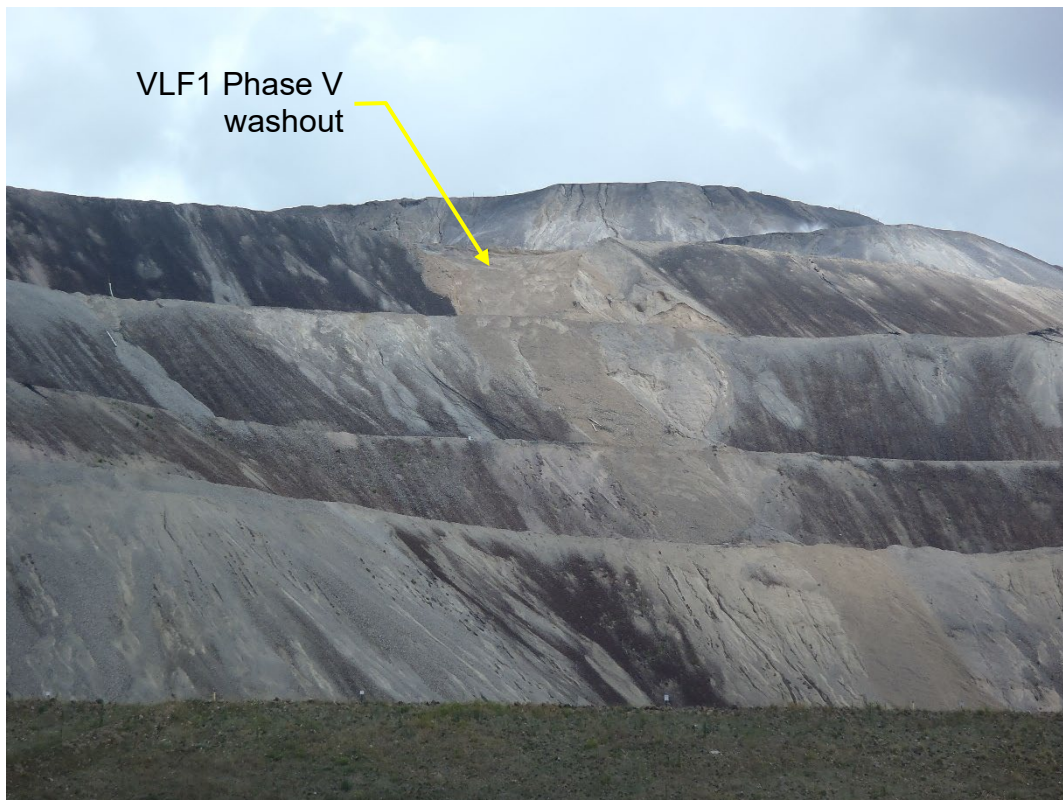
**VLF 1 Phase V Washout:** The VLF1 Phase V washout (see **Photo 10**) had been mostly repaired. A large amount of material from the washout ended up very close to the Phase V pumps (see **Photo 11**). Some of the washout material had been regraded to create a large "capture" berm to keep potential future washouts from impacting

Photo 10. Mostly repaired VLF1 Phase V washout (looking NE from SH 67).

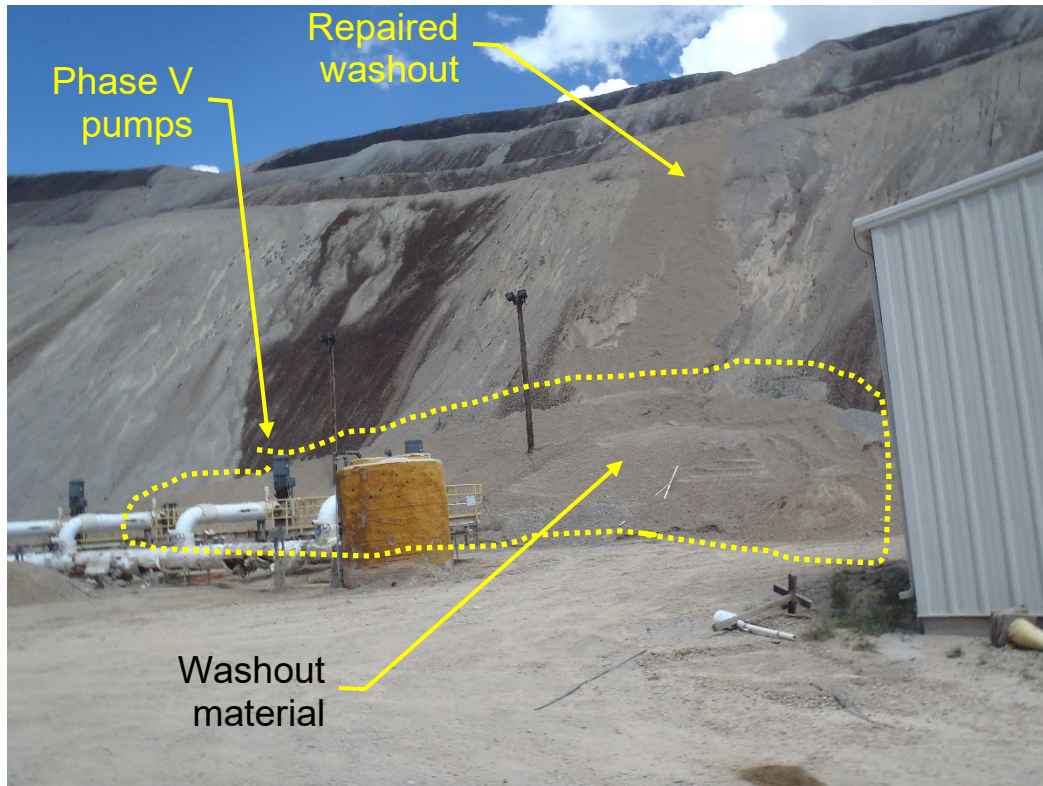
Photo 11. VLF1 Phase V washout material near Phase V pumps.

the Phase V PSSA riser pipes. CC&V stated they were looking at the other PSSA riser locations for similar protection. A priority was thought to be the Phase IV risers, while the Phases I & II risers/pumps were not likely at risk. Mr. Dylan Noble (CC&V Projects) said CC&V was also moving header lines on VLF1 back away from the crests in feasible areas and grading the tops of the flats back away from the crests (again where feasible) so that that solution from future pipe failures would drain towards the center of the pad and away from the crest. I pointed out that although a good idea, it would have the potential to create large ponding areas that would conflict with the approved wildlife protection plan. He indicated they were aware of that potential.
