Inspection Report, Foidel Creek Mine, C-1982-056

PERMIT INFORMATION

Permit Number: C-1982-056 Mine Name: Foidel Creek Mine Operator: Twentymile Coal, LLC Operator Address: Ms Miranda Kawcak 29515 Routt County Road No. 27 Oak Creek, CO 80467	County: Routt Operation Type: Underground Permit Status: Active Ownership: Private
	Operator Representative Present:
Operator Representative Signature: (Field Issuance Only)

Inspection Start Date: September 12, 2023 Inspection Start Time: 09:00 Inspection End Date: September 12, 2023 Inspection End Time: 12:30		Inspection Type: Coal Complete Inspection Inspection Reason: Normal I&E Program Weather: Clear	
Joint Inspection Agency: None		Joint Inspection Contacts:	
Post Inspection Agency: None		Post Inspection Contacts:	
Inspector(s): Hunter Ridley	Inspector's Signature: <i>Hunter Ridley</i>		Signature Date: 9/26/2023

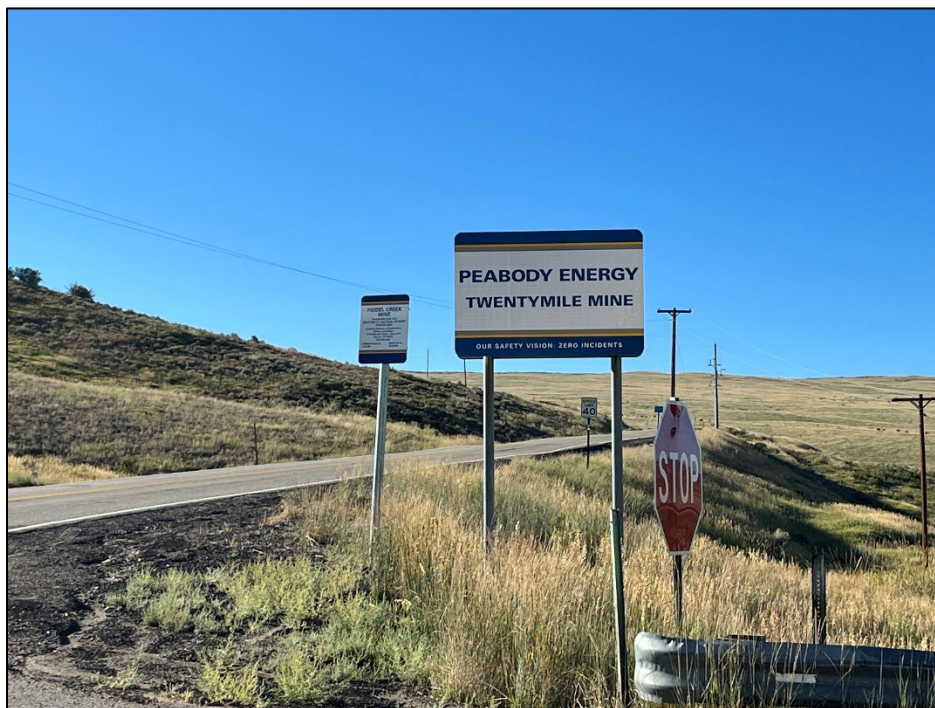
Mine identification markers were observed throughout the site (Photo 1). All information for compliance was present across all signs.

Photo 1: Appropriate signage located at the mine entrance.

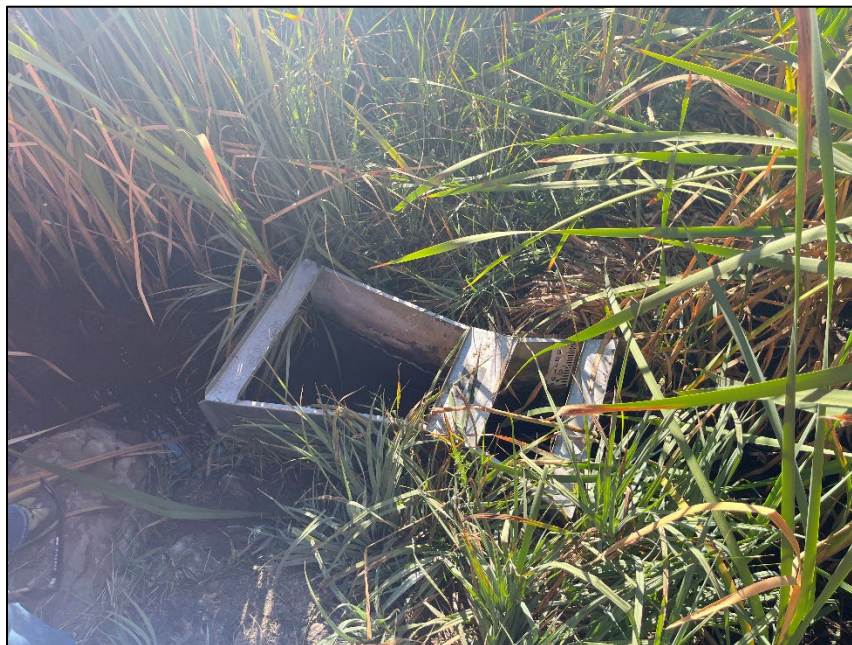
Photo 2: Discharge and water sampling collection point for Pond D.

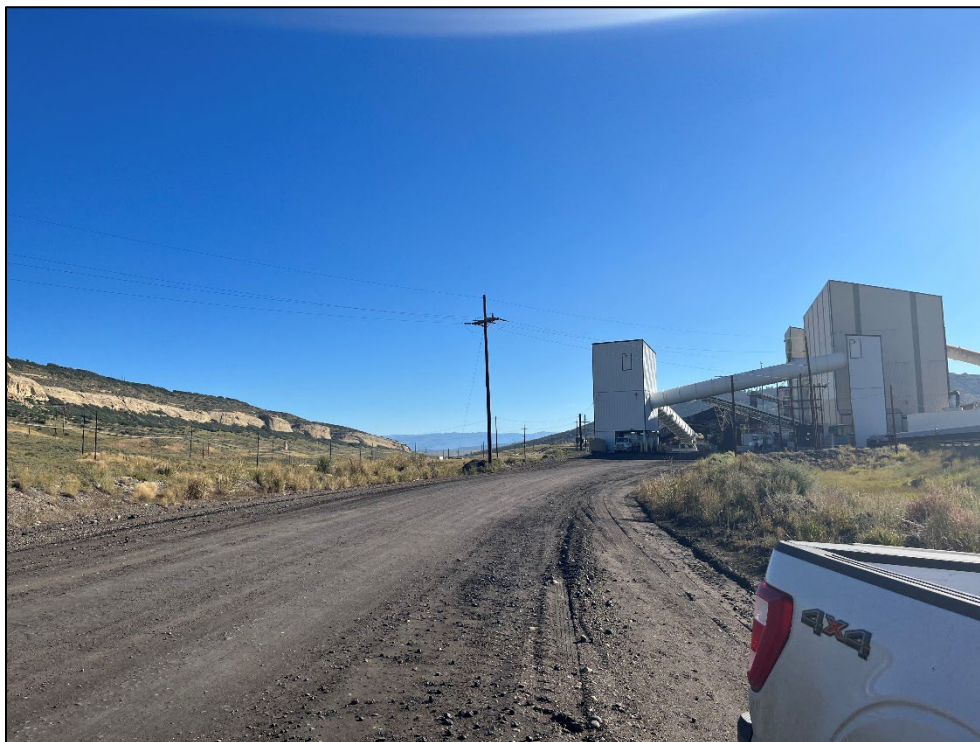
In the inspection report dated 8/23/23 the Division requested that BMPs around the stoker coal loadout facility be repaired and added to areas which are still having issues with sediment control and erosion down the northwestern slope behind the facility (Photo 3). The Division requires that these tasks be completed by 9/30/23 and that photos of the new and repaired BMPs be submitted to the Division by this date. The Operator stated that the stoker building was scheduled to be sprayed with a leak proof liner the week of 9/18/23 and that photos of this and the improved BMPs would be sent to the Division by the 9/30/23 due date. The stoker loadout area was free of coal spills at the time of inspection.

Photo 3: View north of the stoker coal loadout facility. Foidel Creek is located downslope to the west.

- Repair silt fence located behind the stoker loadout building
- Protect topsoil piles from cattle
- Spray weeds and Reseed the waste pile topsoil pile
- Protect topsoil piles along the 6MN road during maintenance and snow plowing activities during the winter months
- Seal support building near Wash Plant (2023)

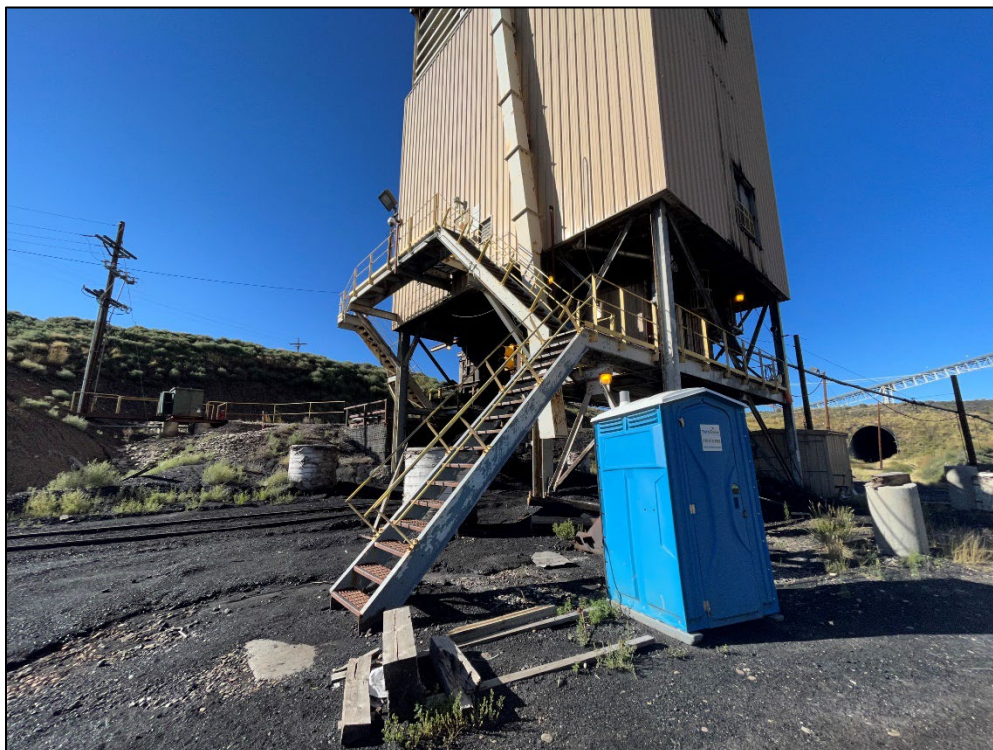
The buffer zone for Foidel Creek is being maintained at the train loadout facility (Photos 4-7). Berms here are well maintained and buffer zone signs are in place. As noted in the 6/28/23 report, CDPHE has restricted the use spraying of de-icer on incoming trains in the winter season in an effort to mitigate runoff to the nearby Foidel Creek buffer zone. TC is still working with the Town of Hayden and CDPHE to address the situation.

Photo 4: Train loadout facility.

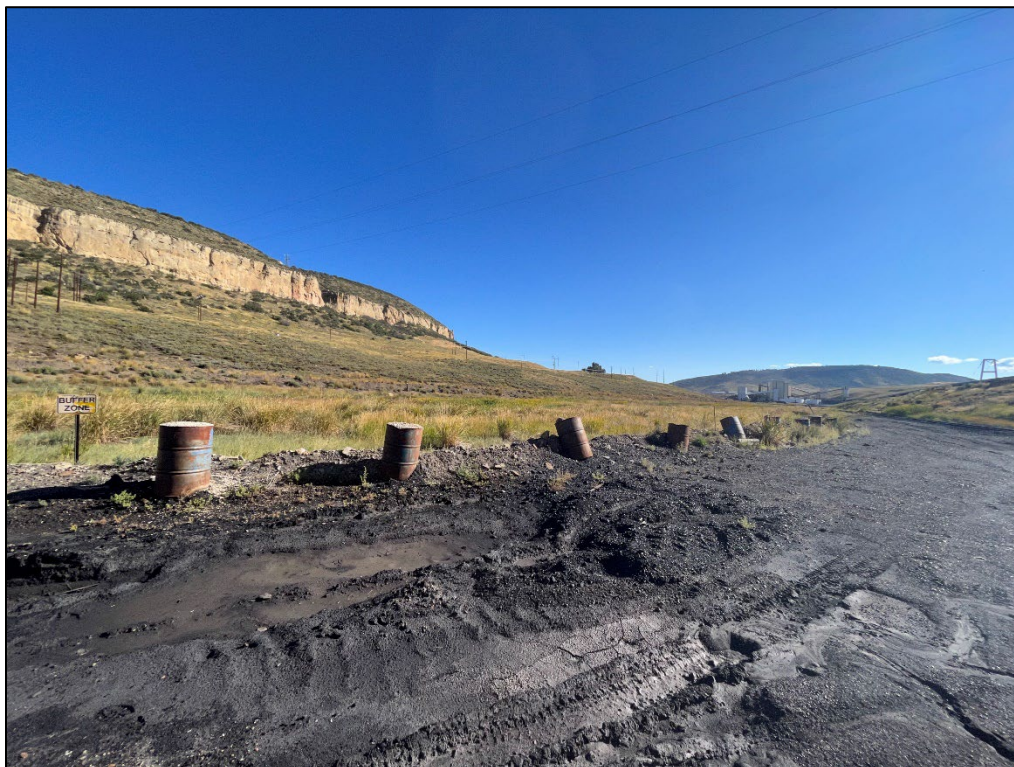
Photo 5: Buffer zone signage and berms are in place.

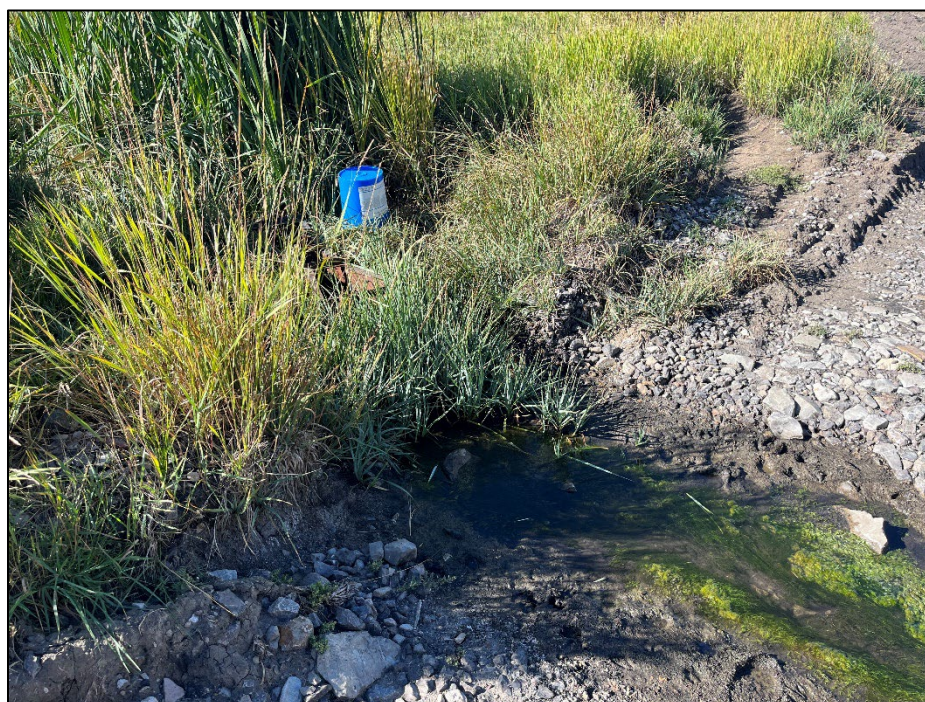
Photo 6: Water sampling collection point for Ponds B.

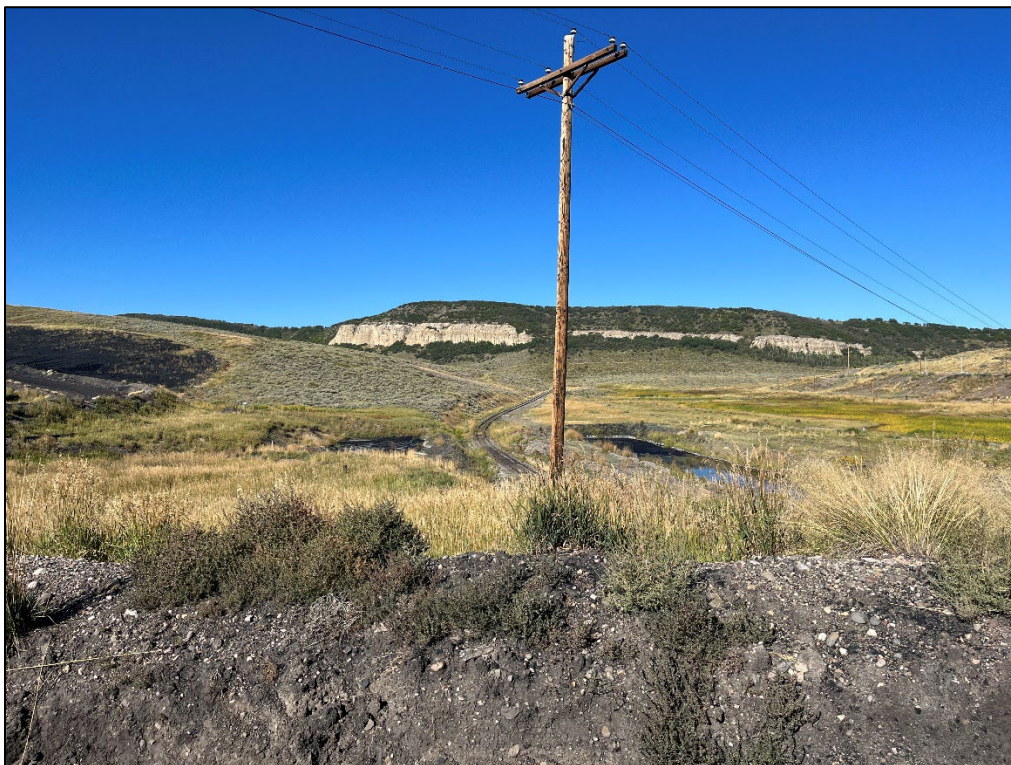
Photo 7: View south of Ponds B and rail line.

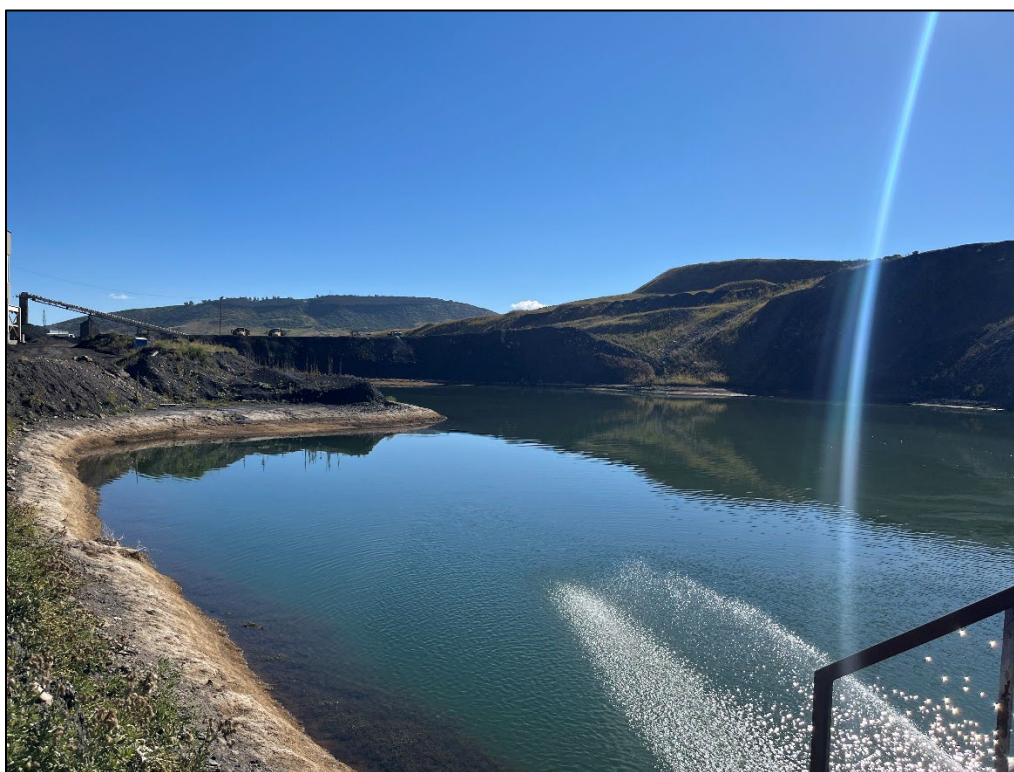
Photo 8: Eastern half of Pond D, currently at a low water level.

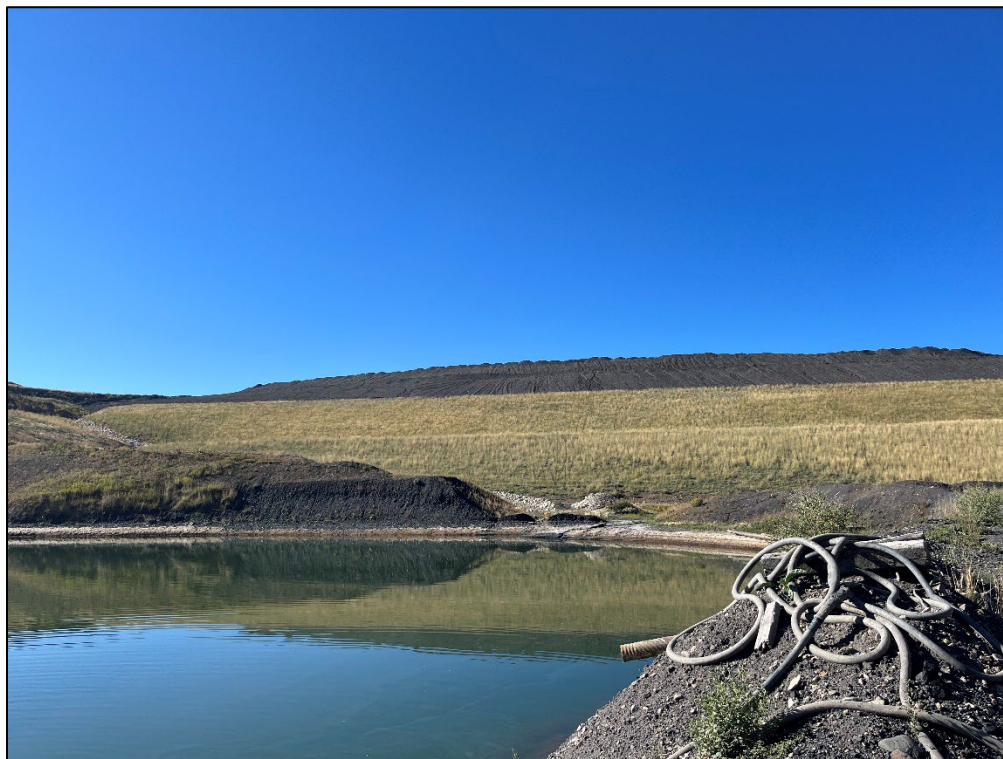
Compaction of refuse material piled throughout the winter continues (Photos 9 and 21). Lifts three and four are under construction, with plans to face and seed these two lifts in the current season. Lifts are built facing downslope to encourage proper drainage into Pond D. Clay overburden material is then taken from the

Photo 9: View south of the refuse pile from Pond D.

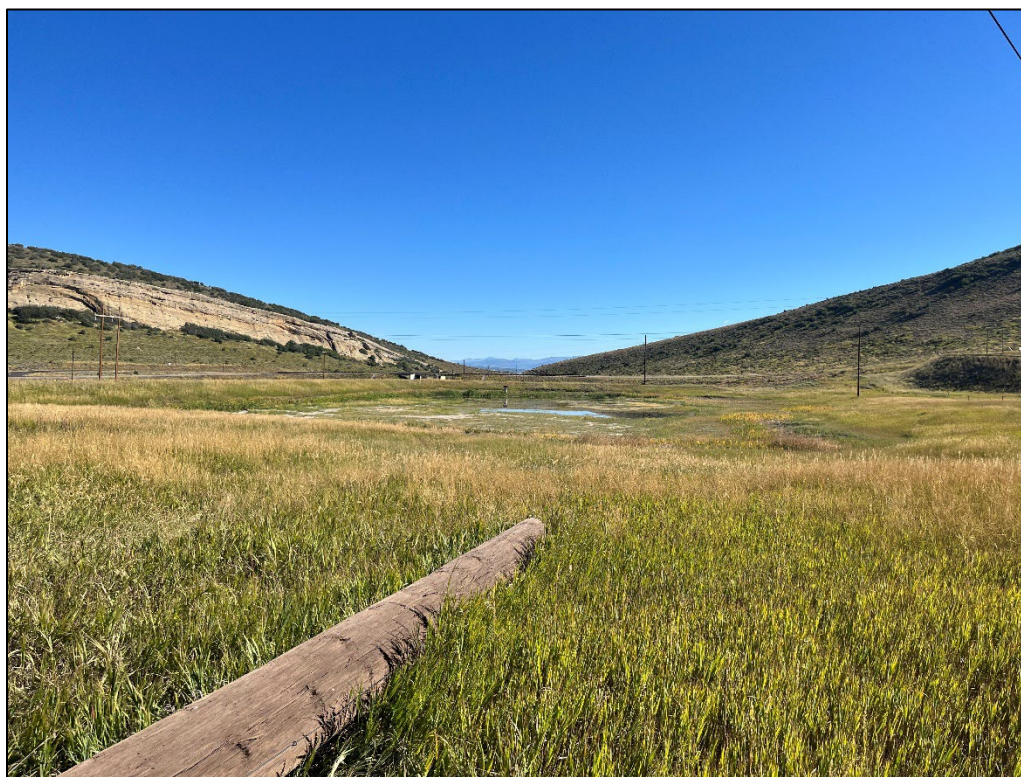
Photo 10: Pond G, nearly completely dry.

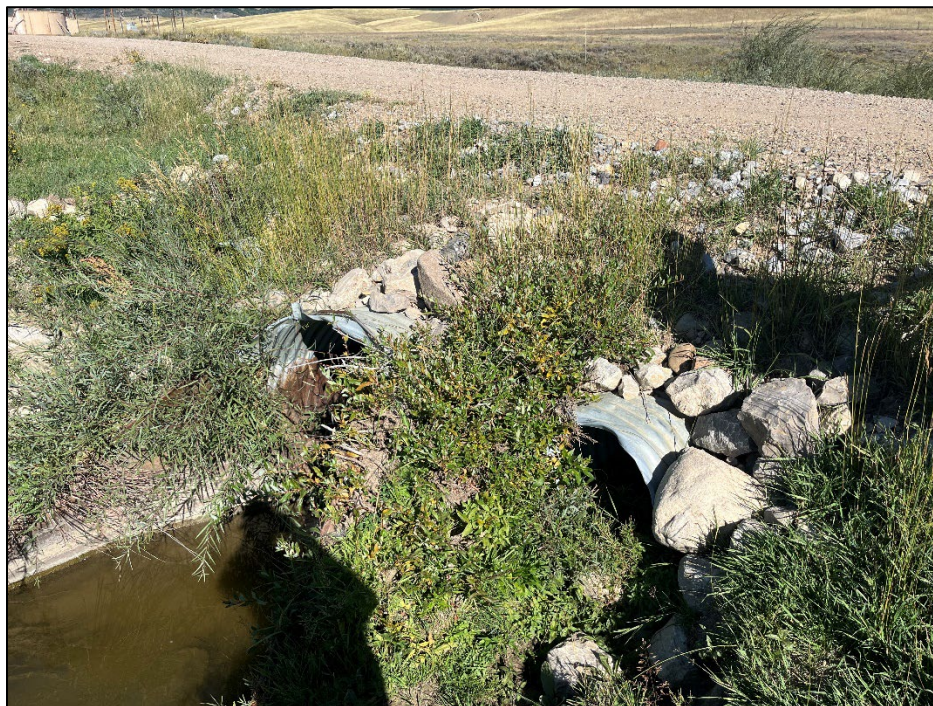
Facilities and ponds in the 6MN area were noted to be functioning properly and as usual (Photo 13). The weather station set up near the 6MN Reservoir was still present. Culverts in this area were clean and functioning (Photos 11 and 12).

Photo 11: Example of two culverts located near the 6MN Reservoir.

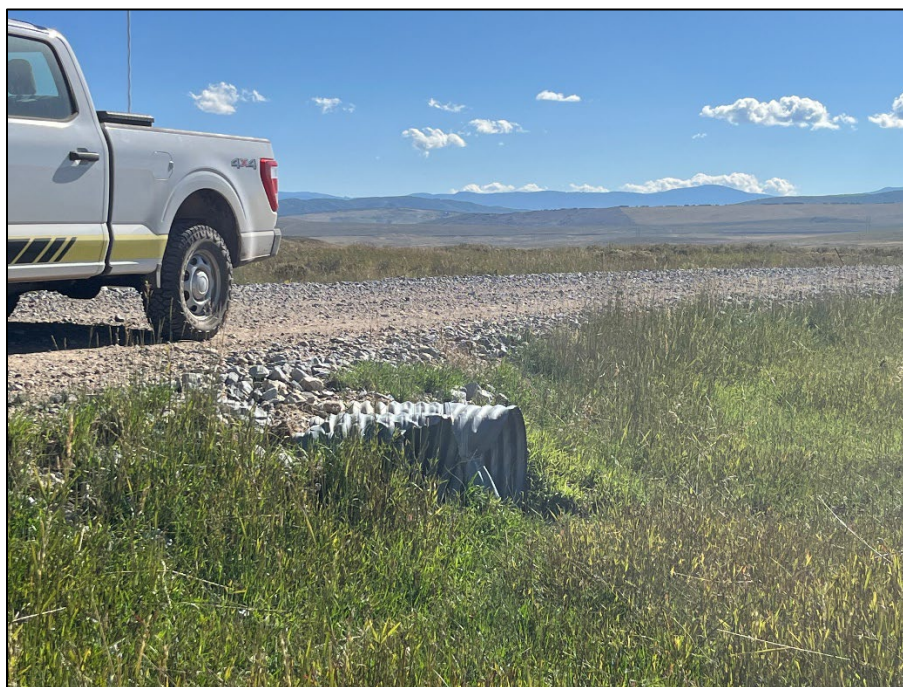
Photo 12: Example of two culverts located near the NW Mains Ventilation Shaft.

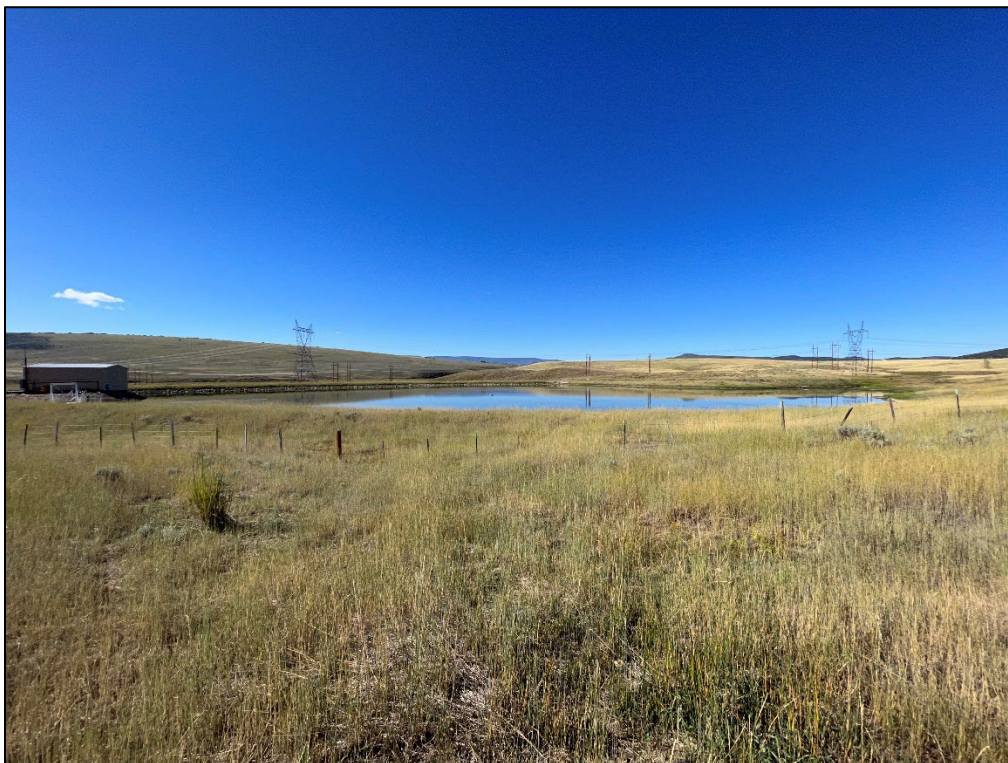
Photo 13: View west of the 6MN reservoir.

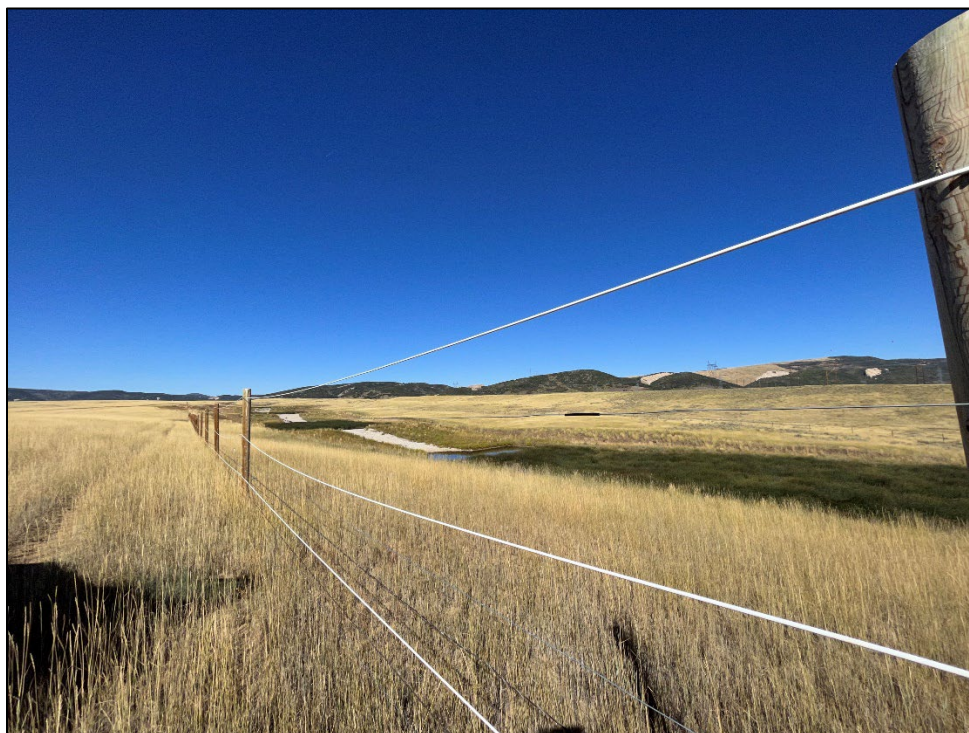
The Passive Treatment System Project in this area was fully vegetated and functioning at the time of inspection (Photo 14). This water does not currently discharge to Foidel Creek. Instead it is circled back to the 6MN reservoir. This wetland area will be closed during the winter season.

Photo 14: View northwest of the Passive Treatment System area.

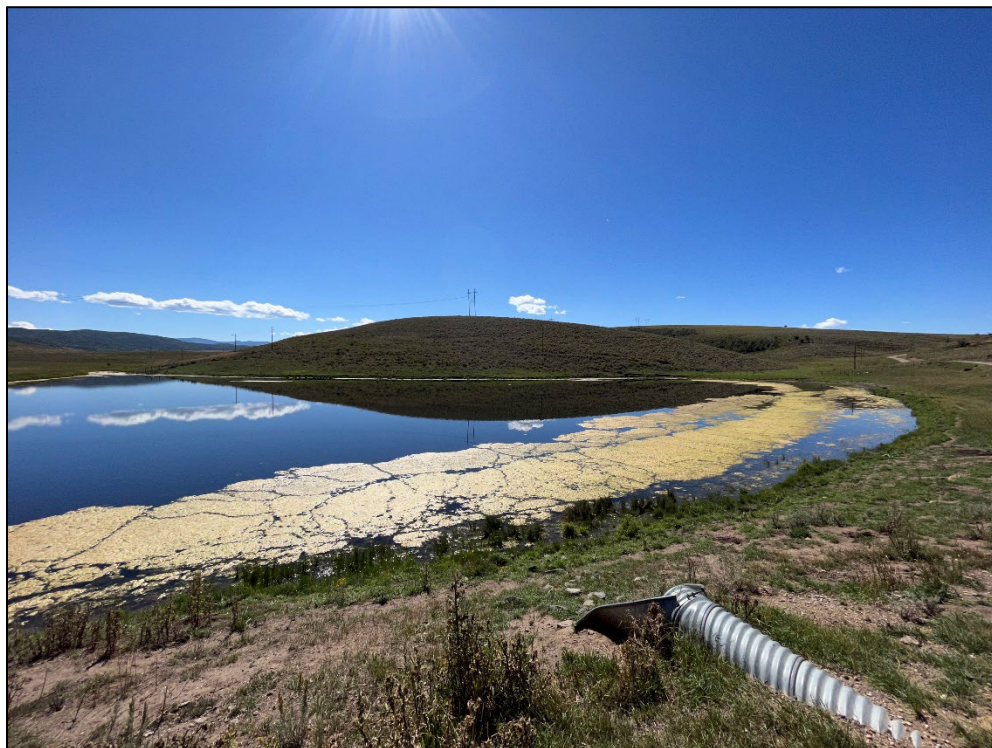
The Tipple Area is generally unused with some areas having already been reclaimed. Roads and the Tipple Pond were maintained and free of erosion (Photo 15). Several culverts in this area are in need of cleanout (Photo 16). **In order to maintain proper function, please ensure that cleanout is completed before the winter season.**

Photo 15: View east of the Tipple Pond and Culvert 6.

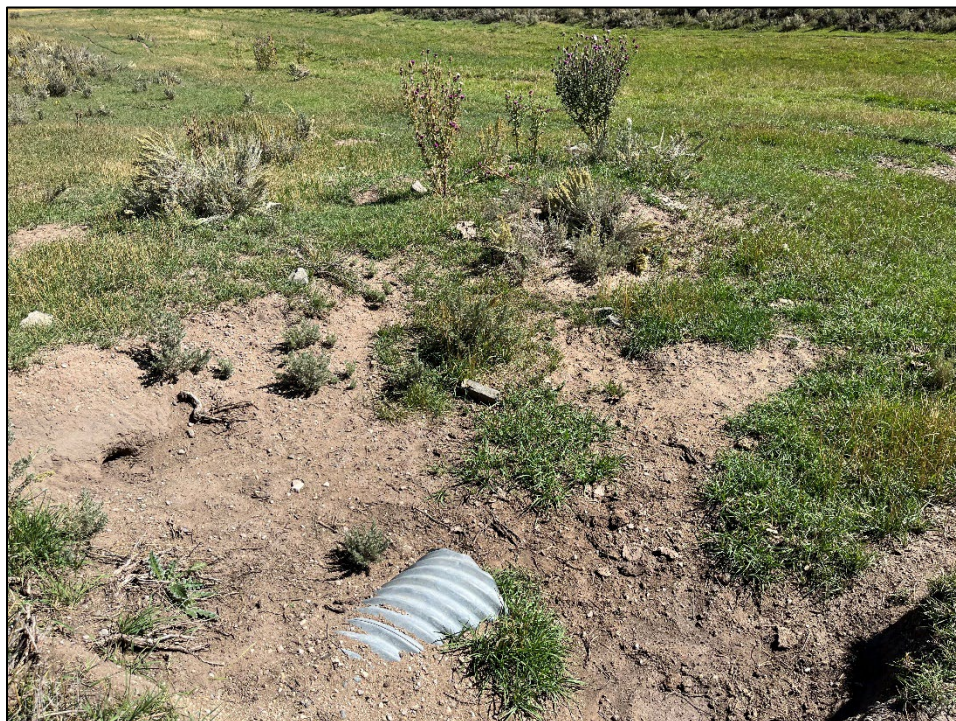
All ponds were checked for discharge and culverts were inspected for function. Most main culverts appear to be functioning, however culverts in some of the less used areas, such as the Fish Creek Borehole and Tipple Area, are in need of cleaning (Photos 16). Continue to clean out culverts when vegetation and sediment hinders function. Ponds and discharge points are represented in Photos 2, 6 - 8, 10, 13, 15 and 20.

Photo 16: Culvert 5 in the northwestern Tipple Area, in need of cleanout.

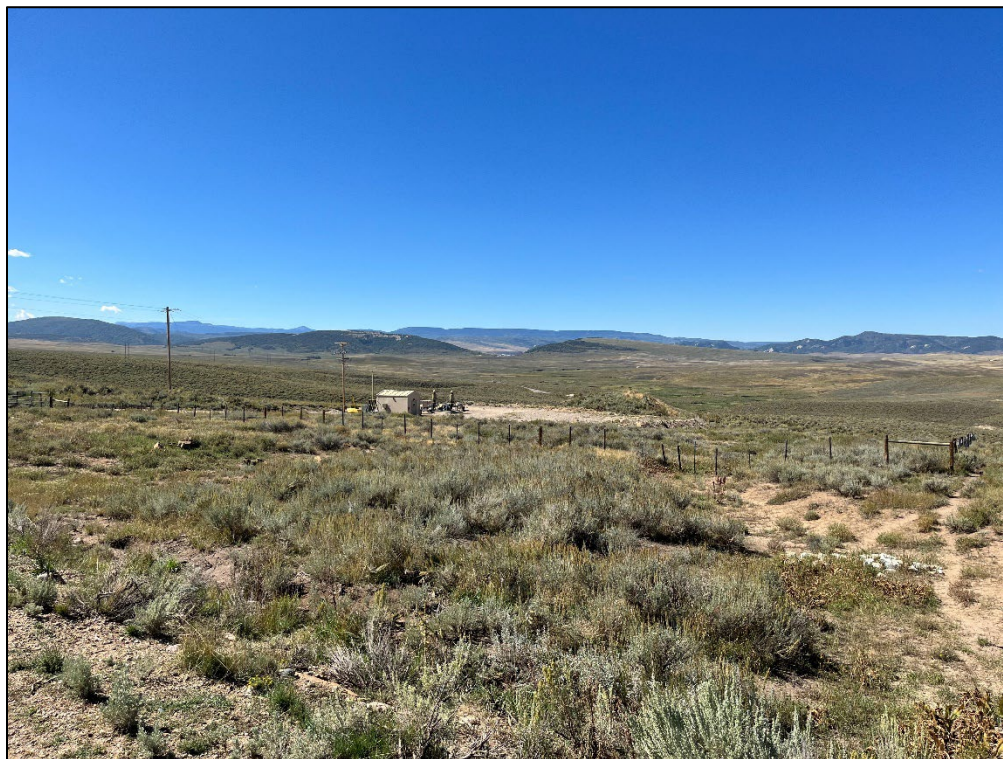
The 9 East Exhaust Blower Pad and reclaimed 18 Right borehole were also inspected in this area and found to be free of any issues. (Photos 17 and 18).

Photo 17: View south of the 9E Exhaust Blower Pad.

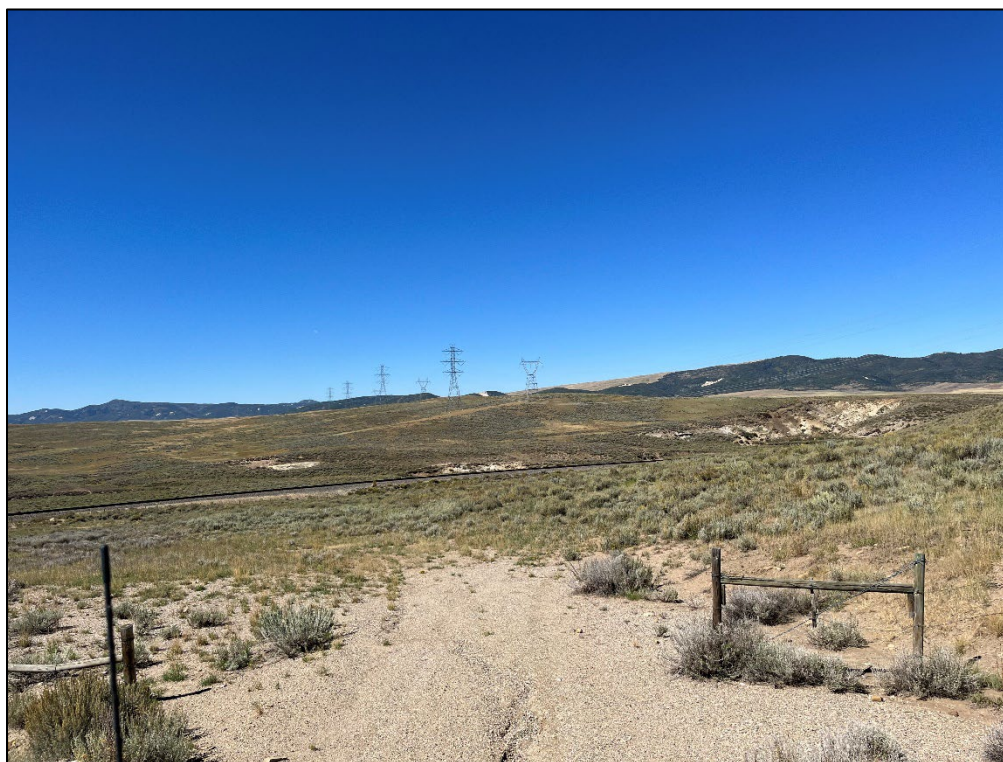
Photo 18: View west of the reclaimed 18R borehole.

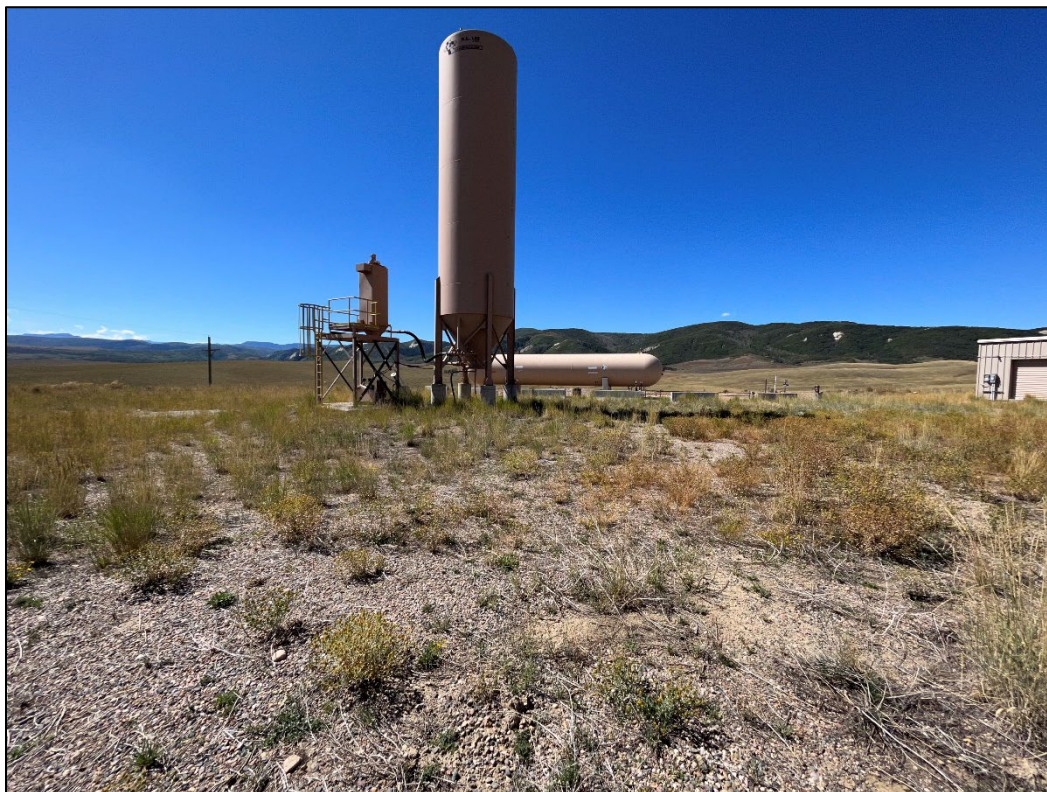
The 18L Area (Photo 19) is currently unused. Two ponds, which are mostly dry throughout the year except for in snowmelt, are located in this area as well (Photo 20). This area has not yet been reclaimed as TC will use the area's facilities to tie into Peabody Sage Creek Mine operations in the future.

Photo 19: View west of the unused 18L borehole area.

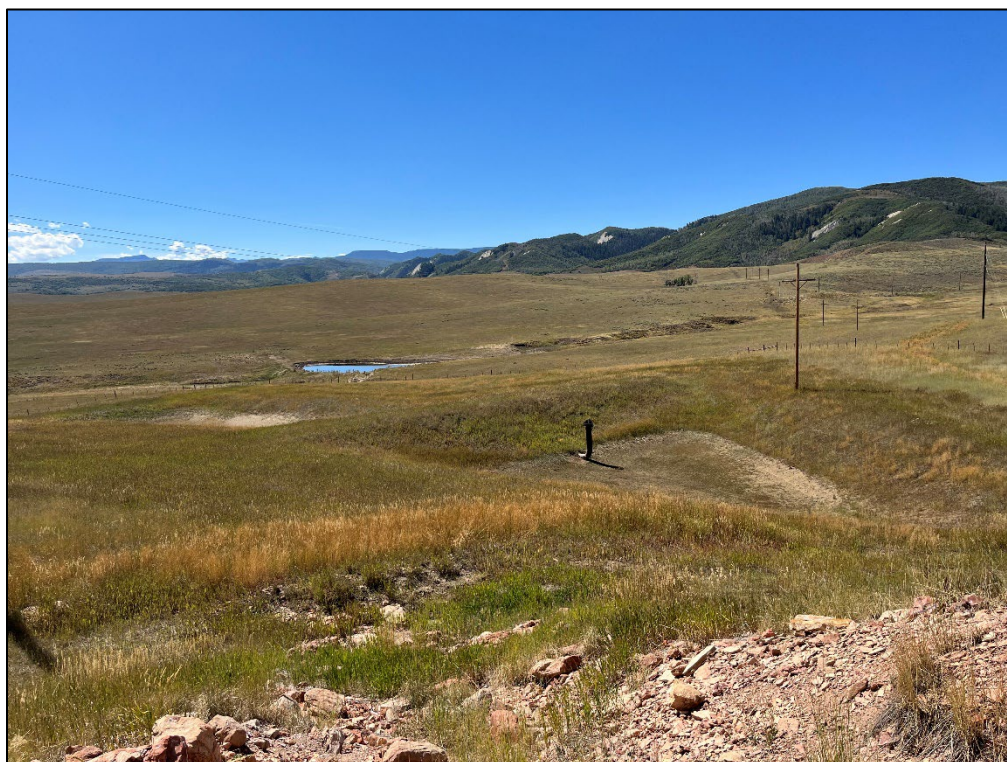
Photo 20: Two ponds, mostly dry year round, are located in the 18L area.

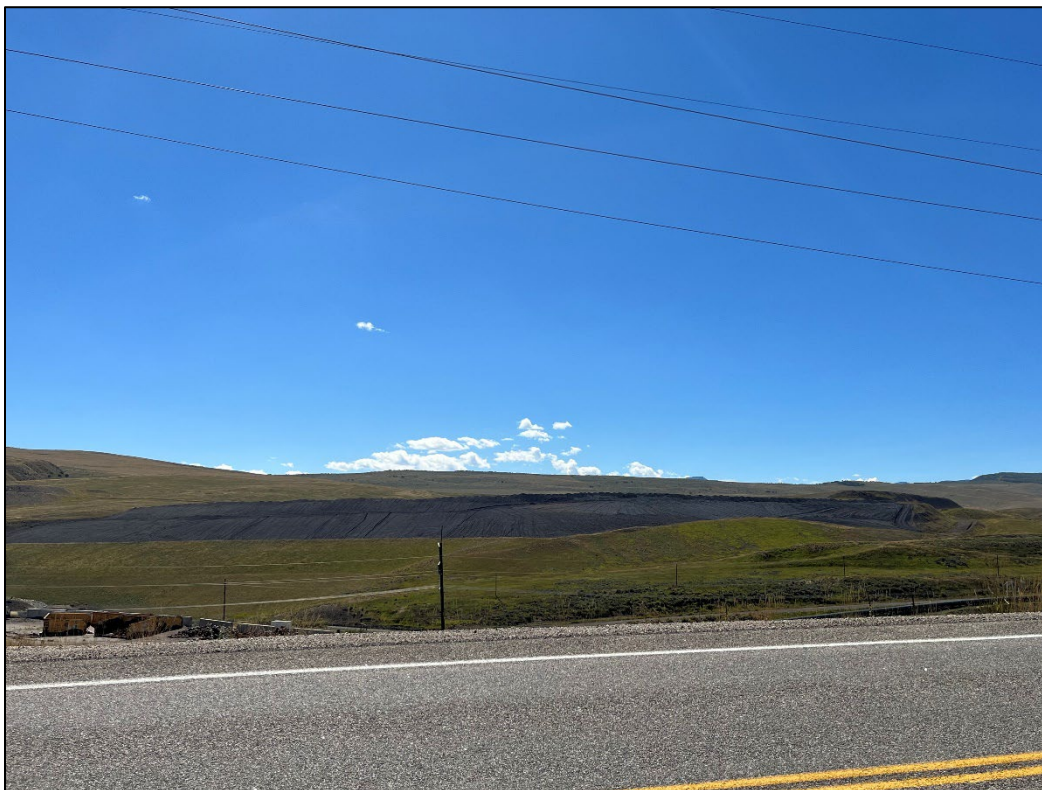
Photo 21: View south of the refuse pile from CR 27.
