Inspection Report, Hayden Gulch Loadout, C-1992-081

Division of Reclamation,
Mining and Safety

PERMIT INFORMATION

Permit Number: C-1992-081 Mine Name: Hayden Gulch Loadout Operator: Hayden Gulch Terminal, LLC Operator Address: Ms Miranda Kawcak 29515 Routt County Road 27 Oak Creek, CO 80467	County: Routt Operation Type: Loadout Permit Status: Active Ownership: Private
	Operator Representative Present: None
Operator Representative Signature: (Field Issuance Only)

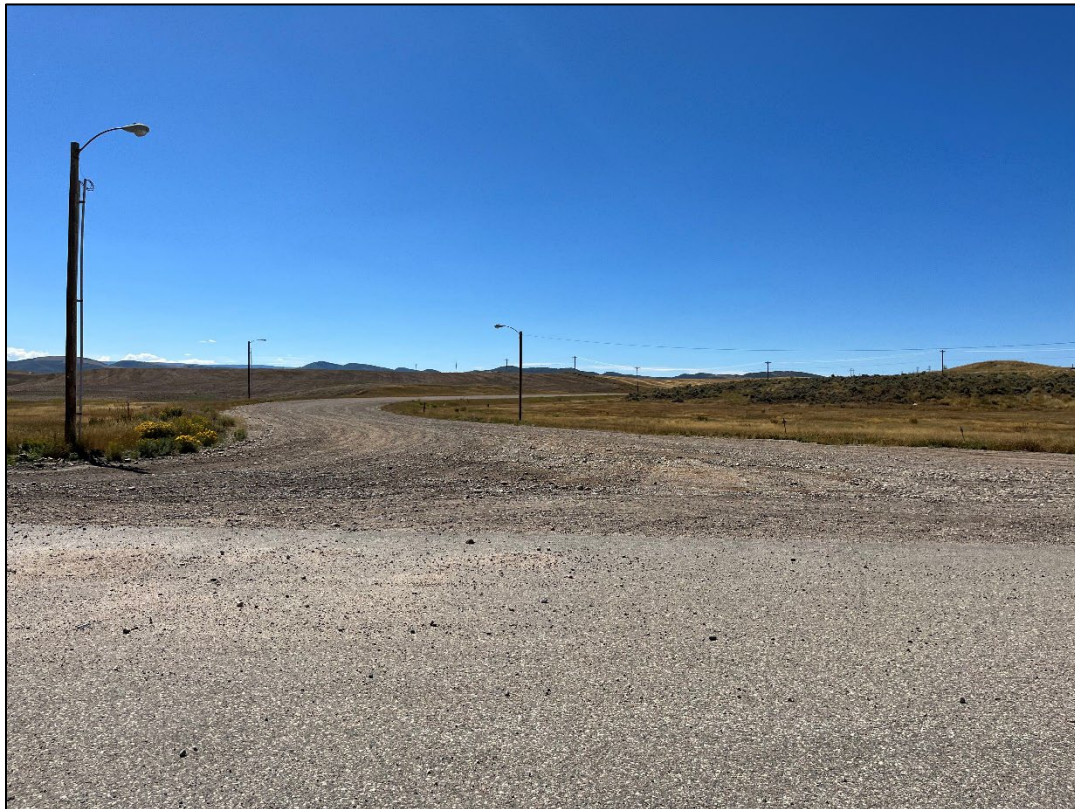
Areas not phase III bond released in the permit include the former haul road, maintained by Routt County (Photo 1). The haul road and associated area includes 214.1 acres, of which 96.6 are disturbed. Technical Revision No. 12 (TR-12) allows for permanent retention of this haul road. A release request (SL3) for Phase I, II, and III release of this haul road area was received by the Division on 9/5/2023 and found complete on 9/13/2023. The Division will conduct a release inspection for the site within the next 30 days.

Photo 1: Entrance to the Tie Across haul road, located off CR 27.

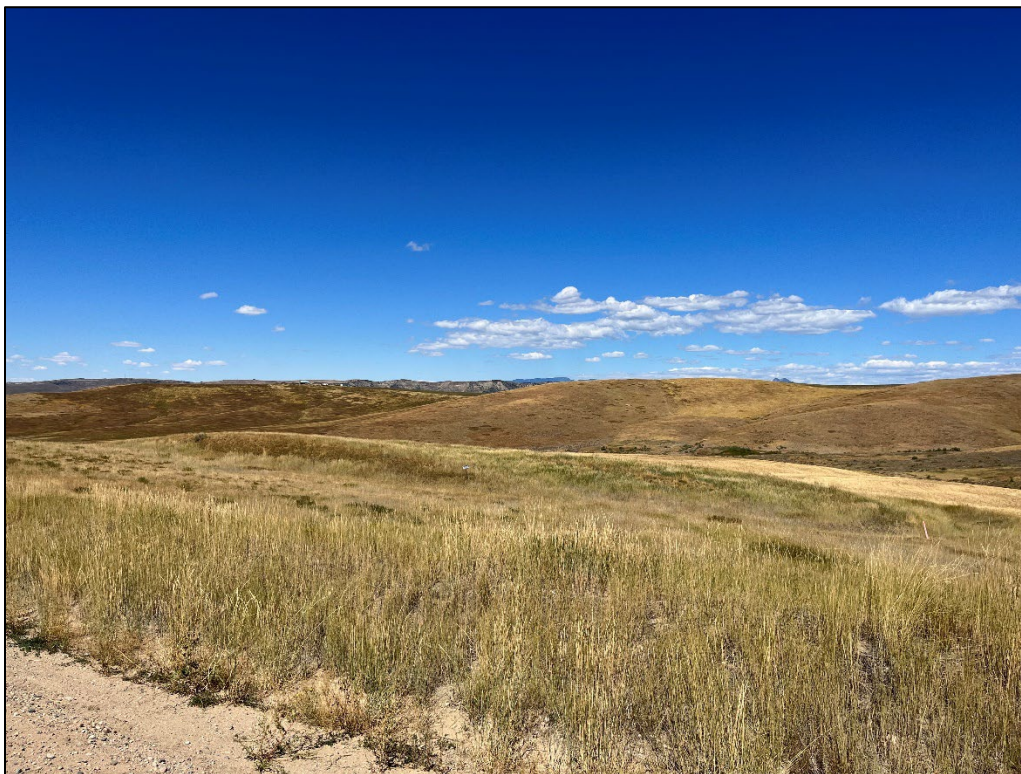
The haul road was free of erosional features and well maintained. This haul road and its associated permanent topsoil pile features, which are currently well vegetated and free of erosion (Photos 2 and 3), will be released with the approval of SL3 if reclamation is found to be fully completed.

Photo 2: Example of one of several permanent topsoil piles located along the Tie Across Haul Road.

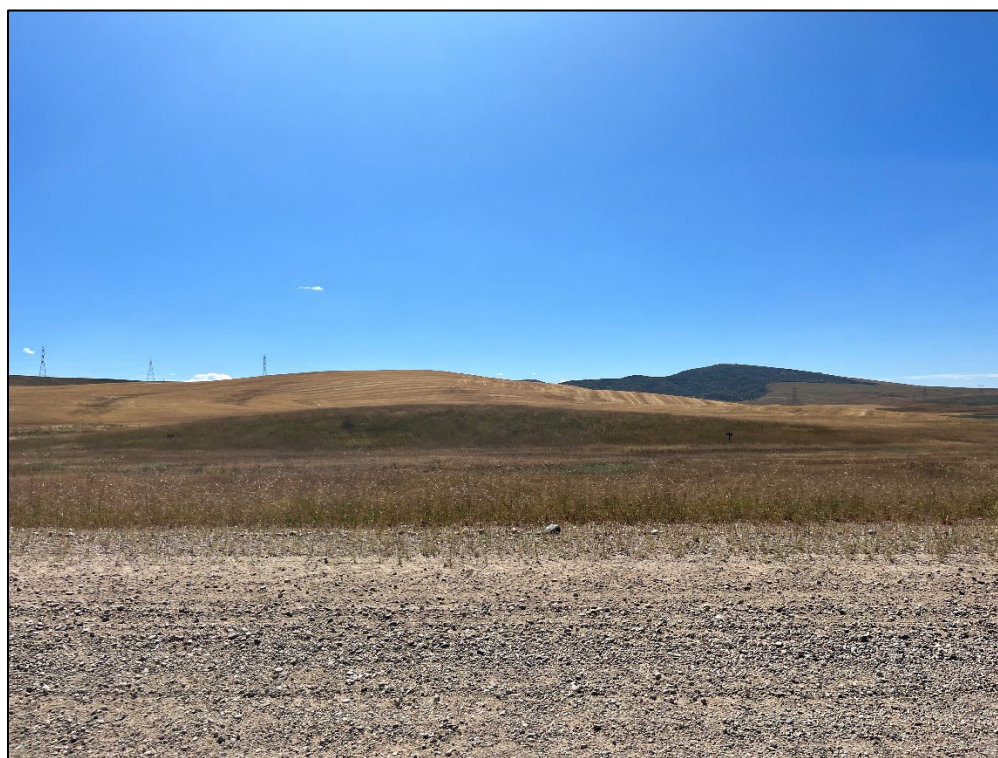
Photo 3: Another permanent topsoil pile feature along the haul road.

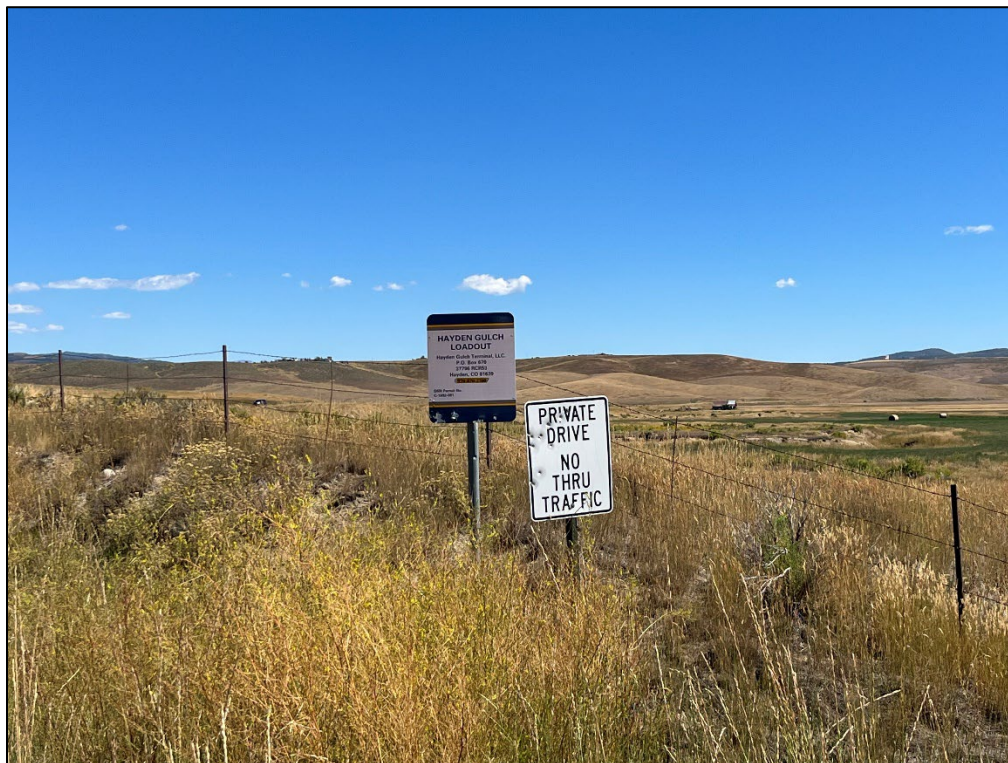
Mine identification markers were observed at the entrance to the unreleased haul road and adjacent to the unreleased agricultural section north and south of Hwy 40 (Photo 4).

Photo 4: Proper mine identification sign posted at the western haul road entrance off CR 37.

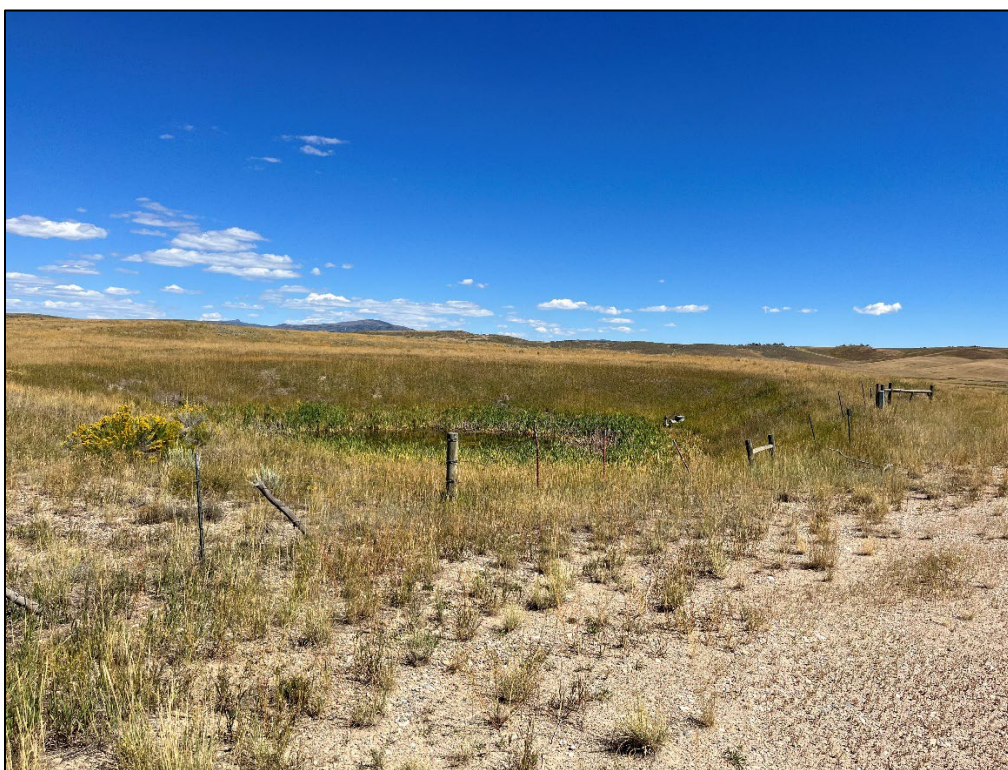
Truck Loop Pond 001 and Rail Loop Pond 002 were both partially full and functioning properly. Rail Loop Pond 002 is accessed by walking a portion of the Sage Creek Trail located on the site's previously released acreage (Photo 6 - 8). Truck Loop Pond 001 is accessed from the side of the southern unreleased haul road (Photo 5).

Photo 5: Truck Loop Pond 001 was at a low water level but functioning properly.

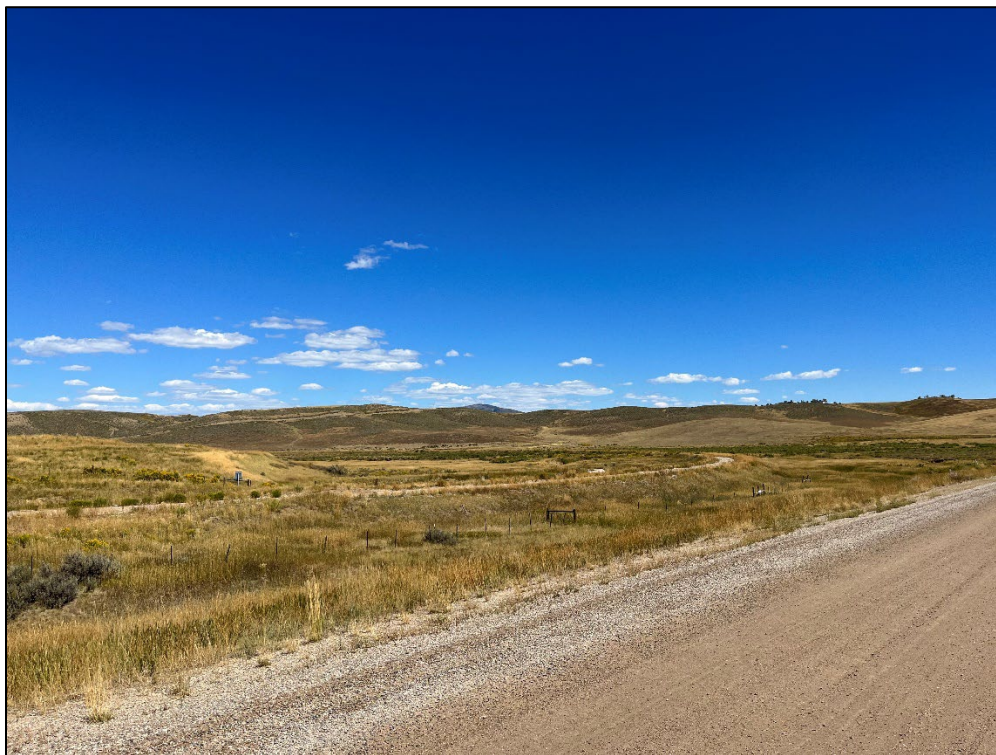
Photo 6: Rail Loop Pond 002 is seen just beyond the Sage Creek Trail.

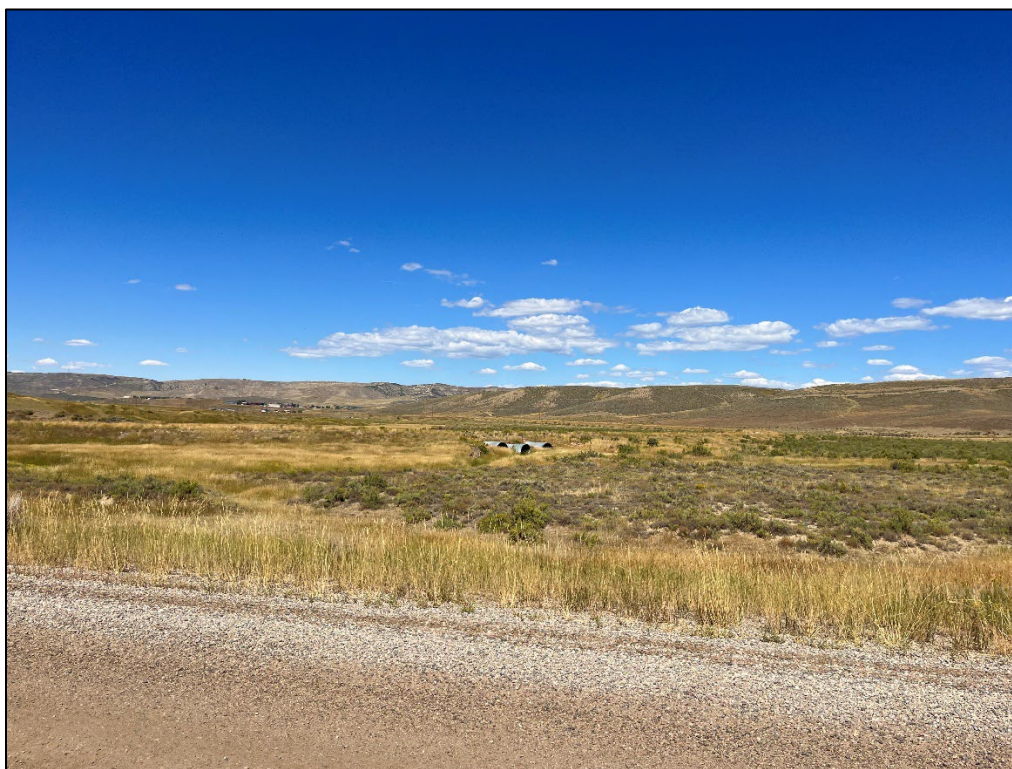
Photo 7: Three large culverts support the hydrologic function of Rail Loop Pond 002.

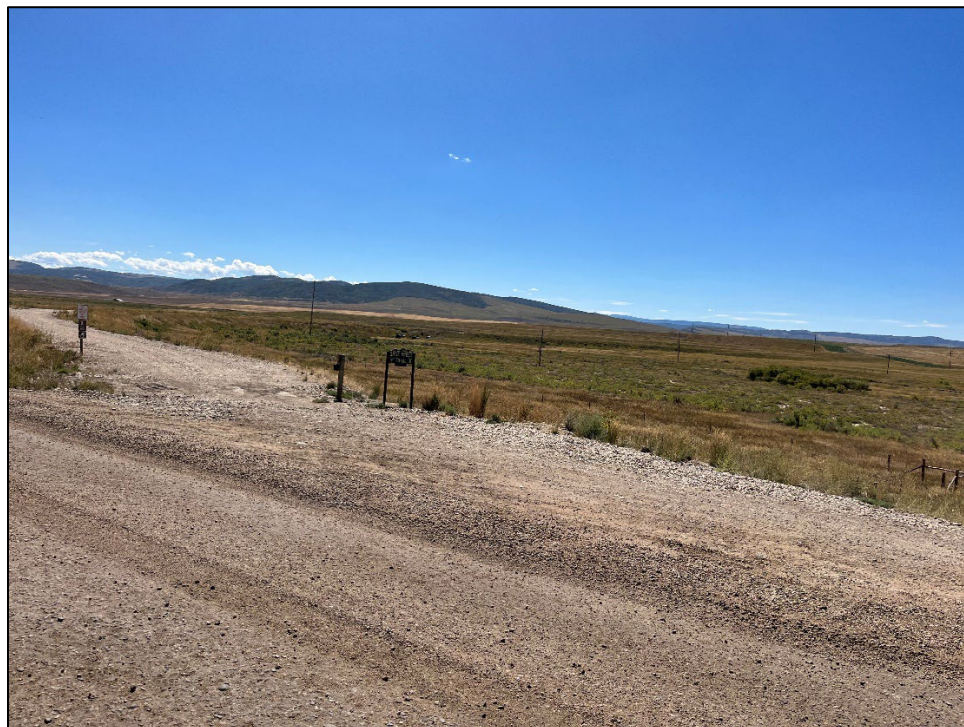
Photo 8: Rail Loop Pond 002 is accessed by walking this Sage Creek Trail.

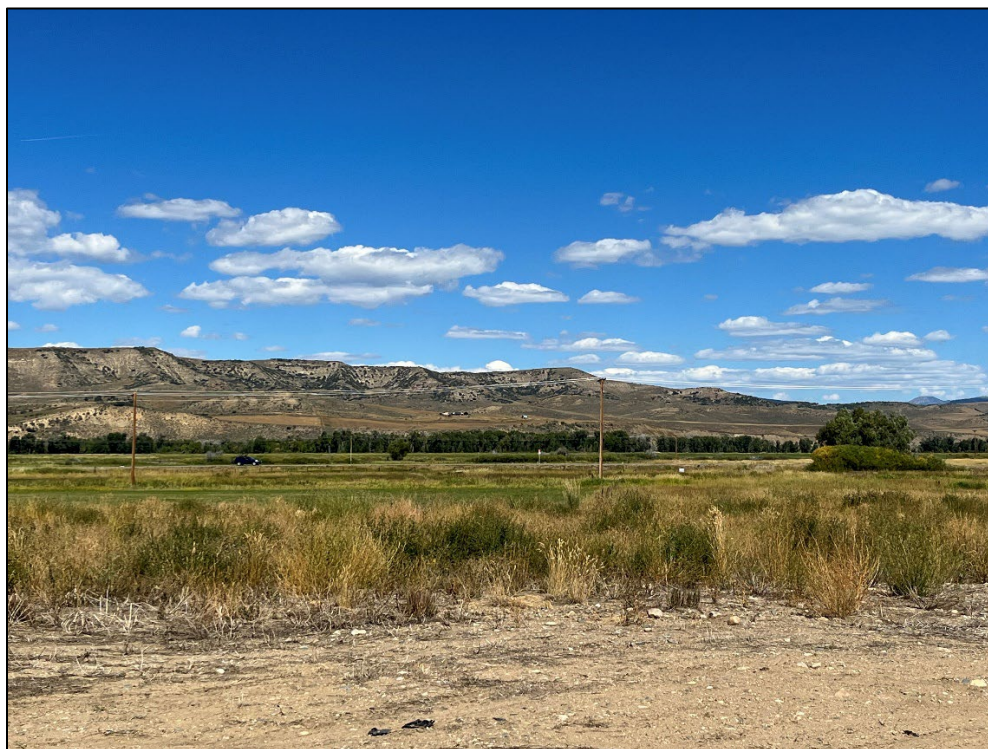
The other remaining, not yet bond released area is directly north and south of Hwy 40, to be reclaimed to agricultural use. It is the only part of the previous rail loop not donated to Routt County. This area includes 6.8 acres of which 2.3 are disturbed (Photo 9).

The remaining permit area North of Hwy 40 was well vegetated (Photo 9). This portion of the permit has been incorporated into the adjacent hay fields but is not yet bond released.

Photo 9: Hayfields in the northern portion of the permit are well vegetated and incorporated smoothly into surrounding agricultural fields.
