MINERALS PROGRAM INSPECTION REPORT
PHONE: (303) 866-3567

MINE NAME: Leone Gravel Pit #2	MINE/PROSPECTING ID#: M-2006-085	MINERAL: Sand and gravel	COUNTY: Las Animas
INSPECTION TYPE: Surety-Related Inspection	WEATHER: Clear	INSP. DATE: September 6, 2023	INSP. TIME: 10:45
OPERATOR: Leone Sand & Gravel LLC	OPERATOR REPRESENTATIVE: Wayne Leone	TYPE OF OPERATION: 112c - Construction Regular Operation

REASON FOR INSPECTION: Surety Release Requested	BOND CALCULATION TYPE: Complete Bond	BOND AMOUNT: \$157,399.00
DATE OF COMPLAINT: NA	POST INSP. CONTACTS: None	JOINT INSP. AGENCY: None
INSPECTOR(S): Amber Michels Jared Ebert	INSPECTOR'S SIGNATURE:

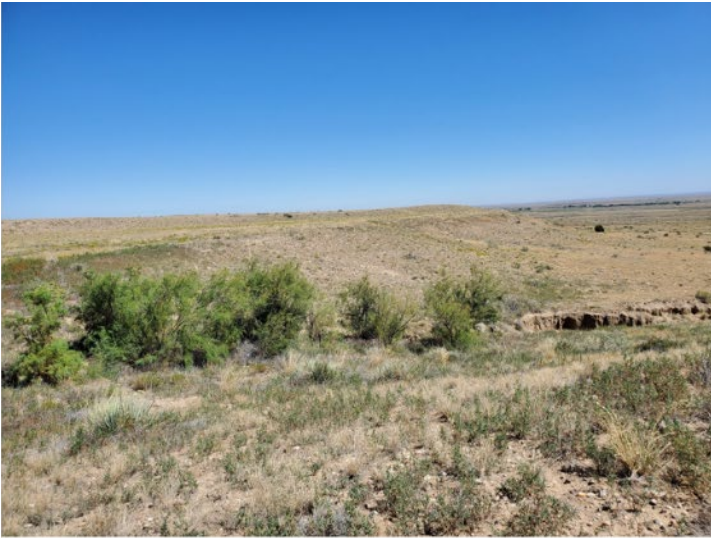
During the inspection, an establishment of the state noxious weed Tamarisk was observed along a crevice within the Howell Parcel. Additionally, a single Russian Olive tree was growing adjacent to this area (see Photos 5 and 6: Map 1). This was addressed in the field as a problem, and the Operator stated that they'd have them removed over the weekend. The following week, the Operator sent the Division photo evidence that this has been addressed, thus the problem is considered abated.

Photo 5: Looking east at Tamarisk trees established in a drainage way.

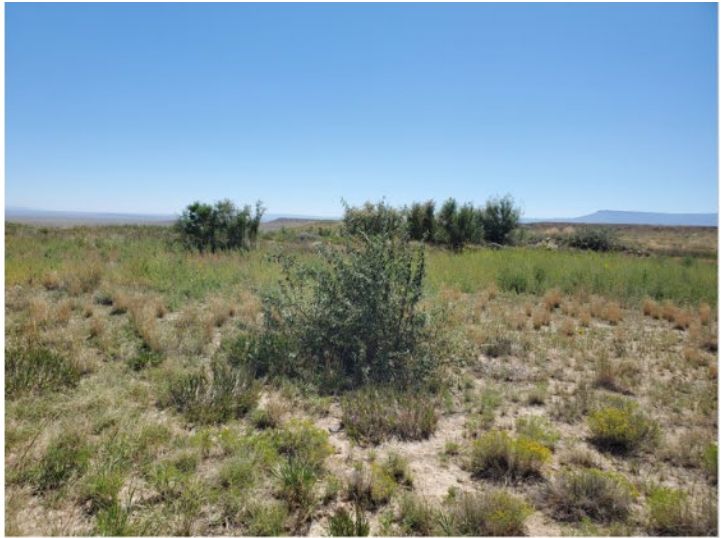
Photo 6: Looking south east at Tamarisk from Photo 5 in the background and an Russian Olive in the foreground.

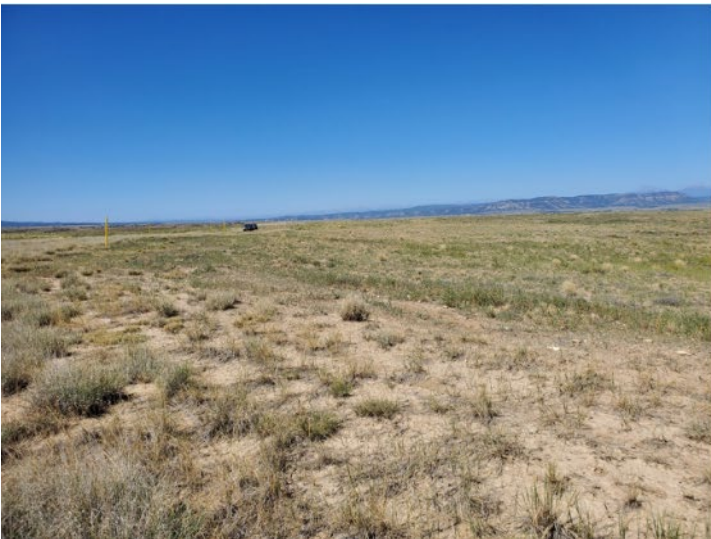
The slopes within the Howell Parcel have been reclaimed to a 3H:1V or shallower (Photos 11, 12, 14, 17, and 18: Map 1) in compliance with the approved reclamation plan. In the Biber Parcel, the areas that have been mined out have been, and are being, reclaimed concurrent with mining progression (Photo 31: Map 2). The approved mining plan states that areas will be backfilled and graded following each five acre area that has been mined out. From observations and conversation with the Operator during the inspection, it appears that this has been complied with.

Photo 11: Looking west along the gas line in the northern portion of the Howell Parcel.

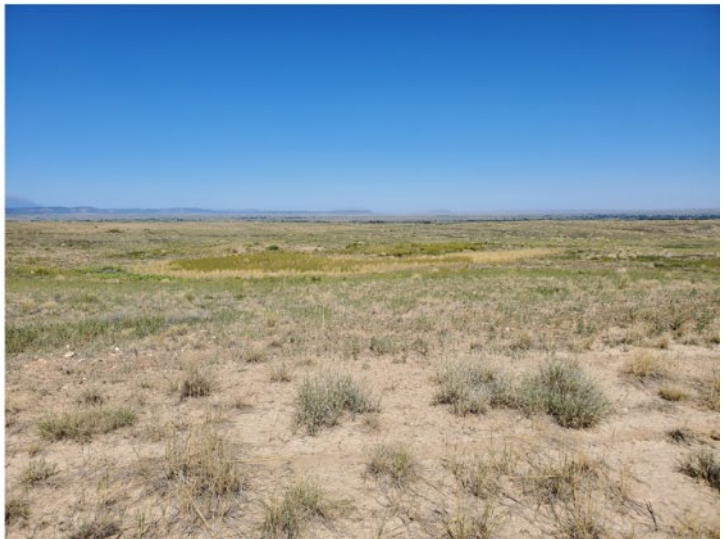
Photo 12: Looking north at a depression filled with vegetation in the northern portion of the Howell Parcel.

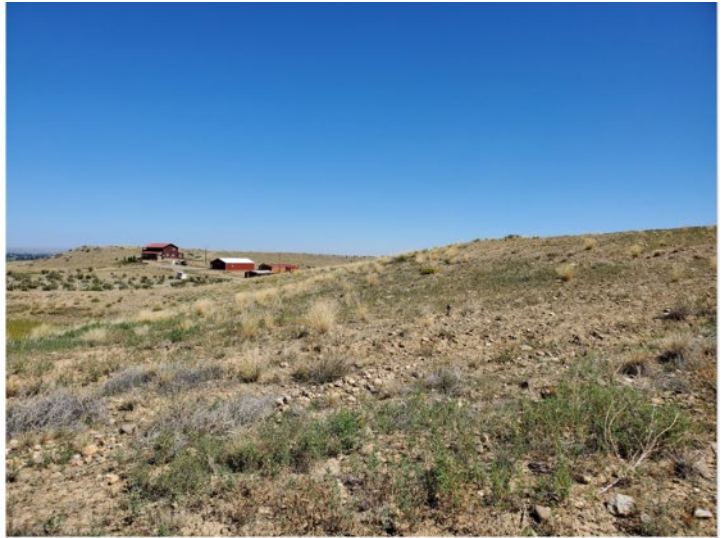
Photo 14: Looking east at a slope graded to a 3H:1V configuration.

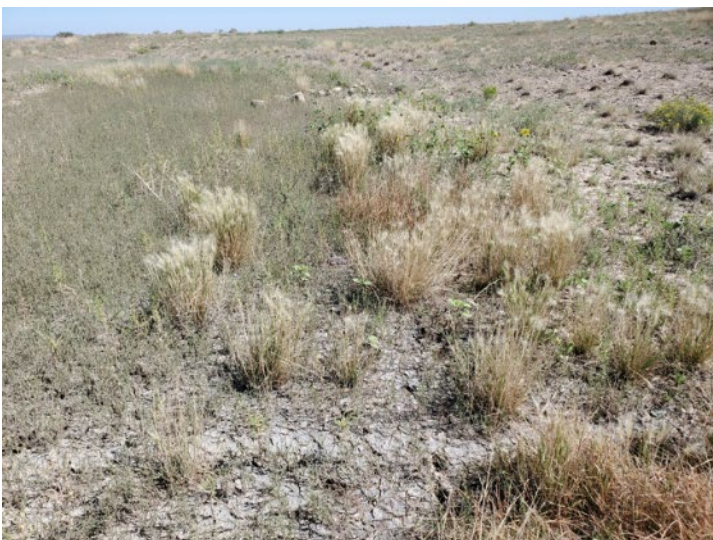
Photo 15: Looking at more bunch grasses. Signs of standing water observed as mudcracks. The vegetation appears to be stabilizing the soil and preventing erosion due to water movement.

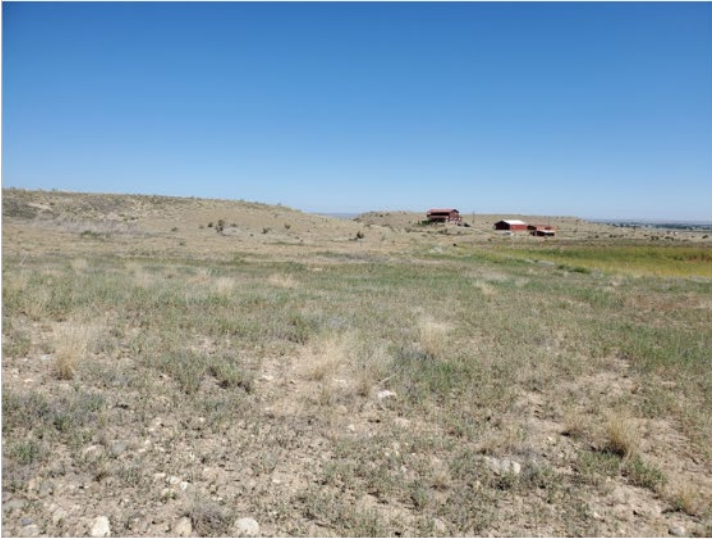
Photo 17: Looking north at graded slopes along the site's northern boundary.

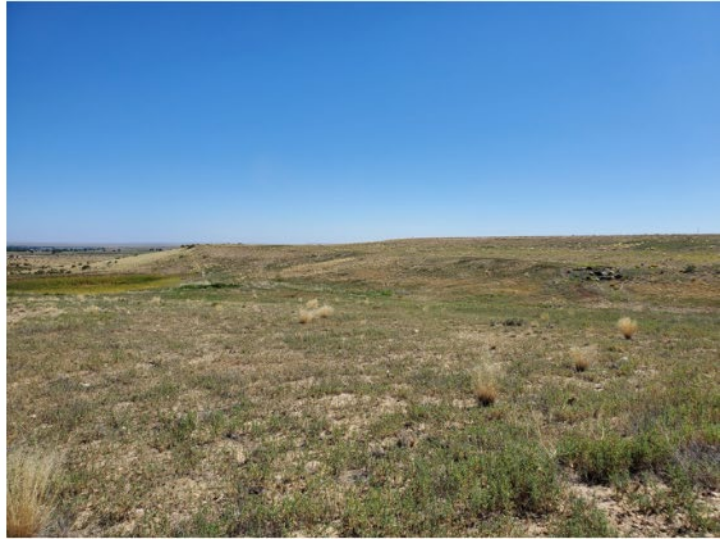
Photo 18: Looking south-east at graded slopes along the north side of the gas line easement.

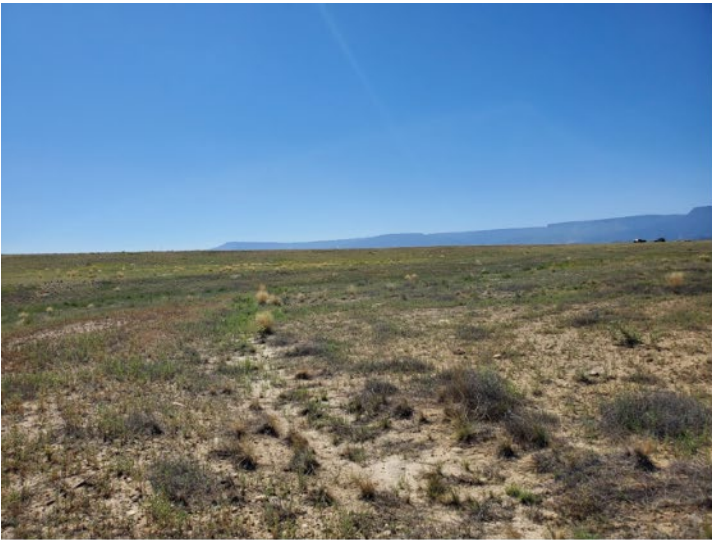
Photo 19: Looking north. Mudcracks observed in areas with bunch grasses. Grasses are stabilizing sediment and preventing erosion.

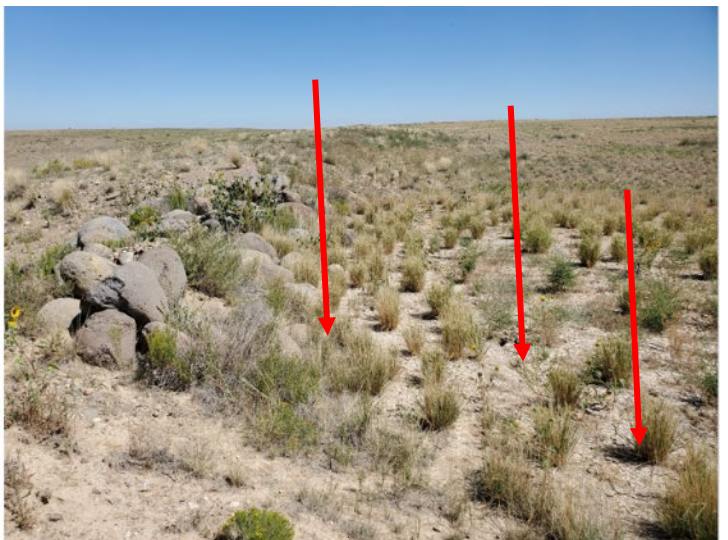
Photo 24: Mudcracks indicate that the combination of vegetation, berms, and check dams have slowed water movement enough to allow for brief periods of standing water.

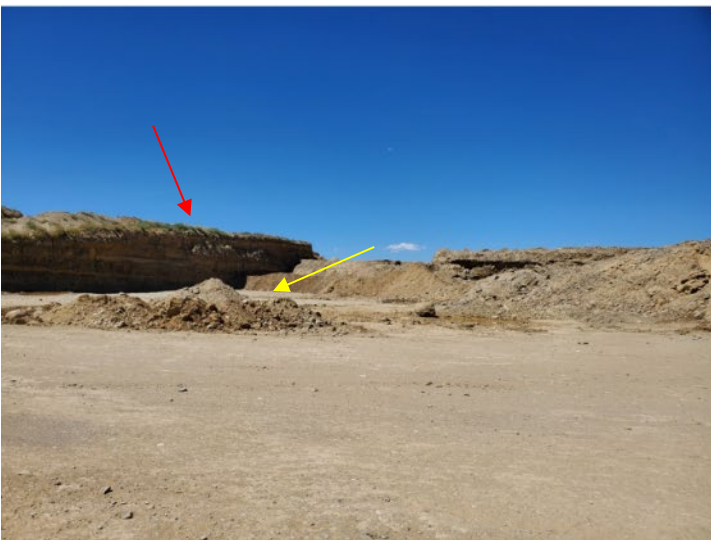
Photo 28: Looking south-west at the current mining highwall. Material is being extracted by pushing the material down-slope and loading it into a truck. The yellow arrow indicates the current direction of mining.

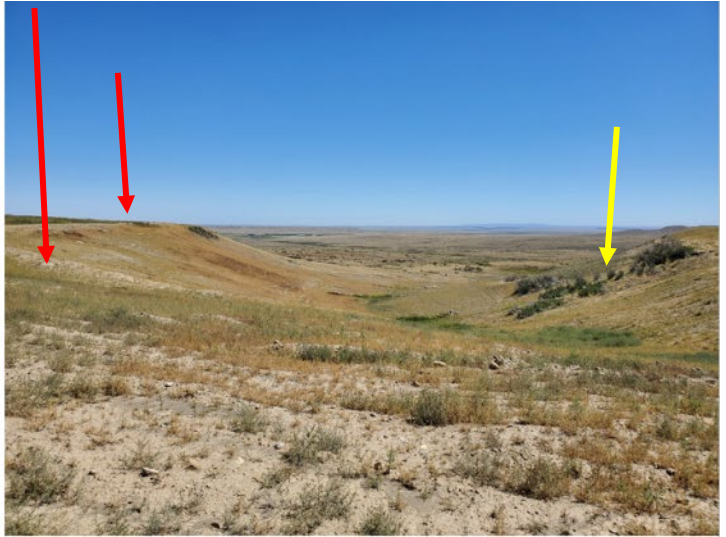
Photo 31: Looking east at a recently reclaimed area. The slopes have been backfilled, graded, and topsoiled. The Operator has installed berms (red arrows) surrounding the area that lead to check dams (yellow arrow) to encourage water to flow through controlled mechanisms.

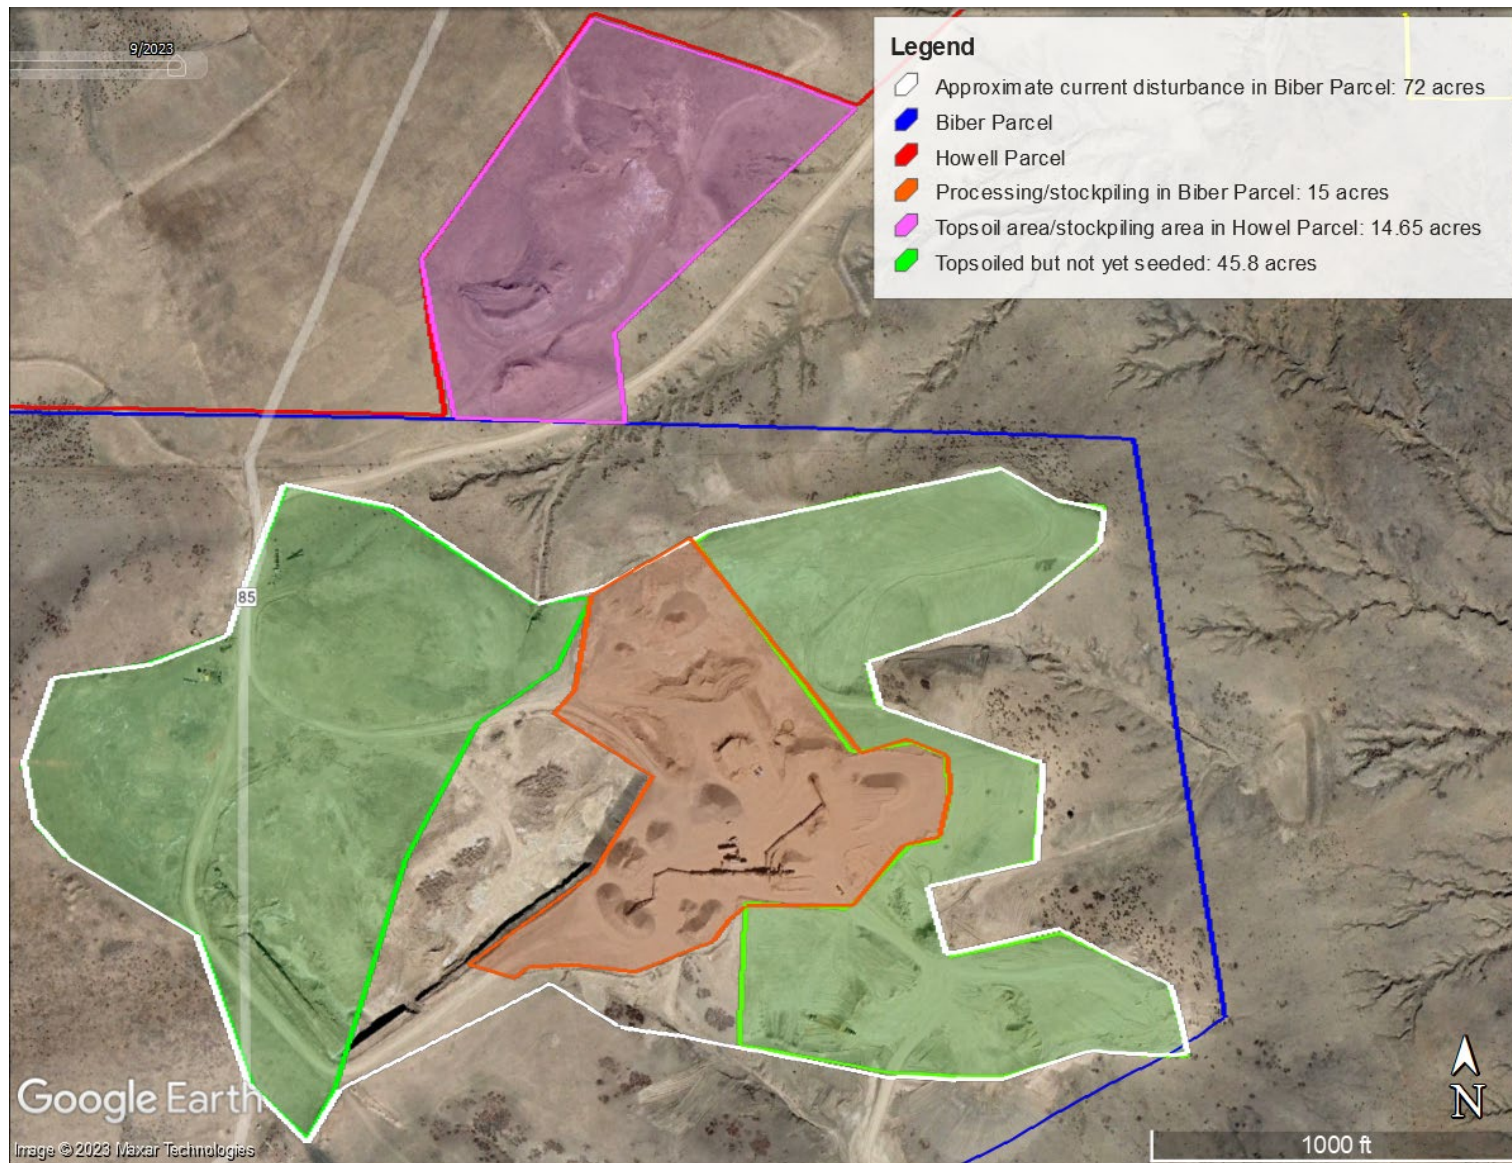
Due to the fact the current disturbance at the site exceeds what is approved at any one time, the reclamation liability is greater than the bond currently held. Therefore, the Operator is **not eligible** for a surety reduction.

Figure 2: Approximation of the currently disturbed acres on-site. Total disturbance is estimated as 86.65 acres. These acres contain disturbed acres that have not been reclaimed and acres that have been partially reclaimed that need to be seeded and establish vegetative covers (green polygons).
