## MINERALS PROGRAM INSPECTION REPORT

<b>MINE NAME:</b> Bear Ranch Gravel Mine	<b>MINE/PROSPECTING ID#:</b> M-2013-002	<b>MINERAL:</b> Sand and gravel	<b>COUNTY:</b> Gunnison
<b>INSPECTION TYPE:</b> Monitoring	<b>INSPECTOR(S):</b> Dustin Czaplá	<b>INSP. DATE:</b> September 19, 2023	<b>INSP. TIME:</b> 14:00
<b>OPERATOR:</b> Bear Ranch LLC	<b>OPERATOR REPRESENTATIVE:</b>	<b>TYPE OF OPERATION:</b> 110c - Construction Limited Impact	
<b>REASON FOR INSPECTION:</b> Normal I&E Program	<b>BOND CALCULATION TYPE:</b> Complete Bond	<b>BOND AMOUNT:</b> \$49,400.00	
<b>DATE OF COMPLAINT:</b> NA	<b>POST INSP. CONTACTS:</b> None	<b>JOINT INSP. AGENCY:</b> None	
<b>WEATHER:</b> Clear	<b>INSPECTOR'S SIGNATURE:</b>

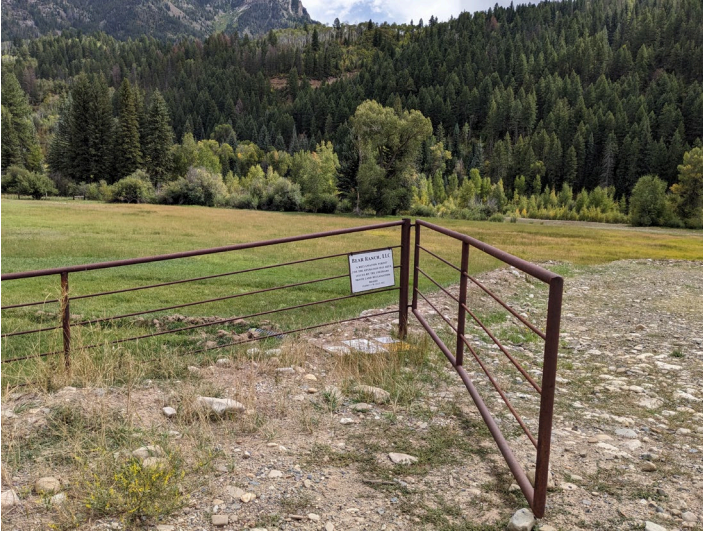
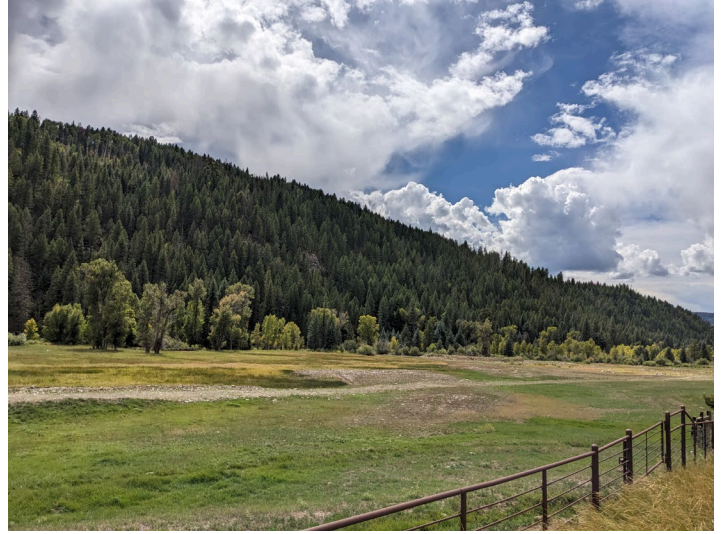
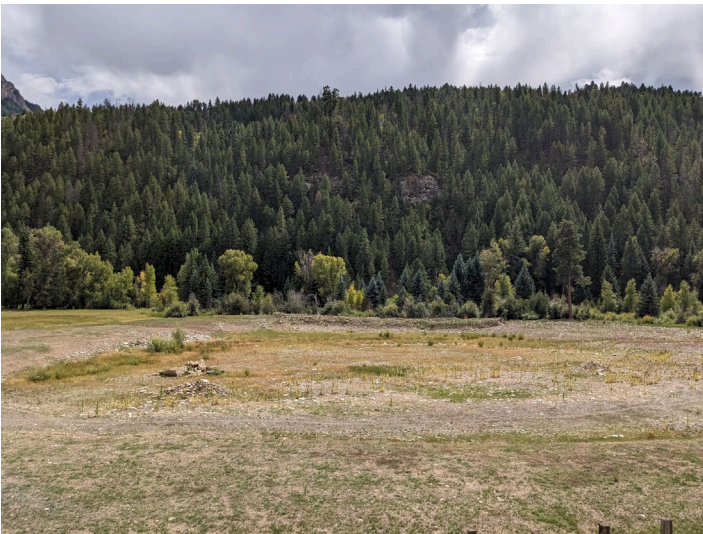
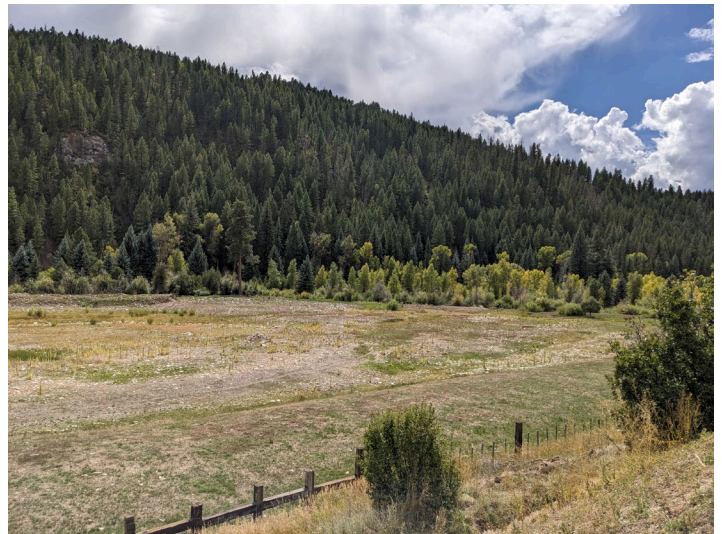
The current disturbance covers approximately three acres within the 9.9 acre permit area. Evidence of recent mining activity was not observed. The pit has been excavated to a depth of approximately three feet with side slopes 3H:1V or flatter. Topsoil has been pushed into a berm on the south side of the excavated pit. Mining equipment or fuels are not stored on site.
