Spring 2023 Subsidence and Geologic Field Observations

Southern Panels and Sunset Trail Mining Areas

Jonathan M. Kelly, P.E., Project Manager
Wright Water Engineers, Inc.

September 2023

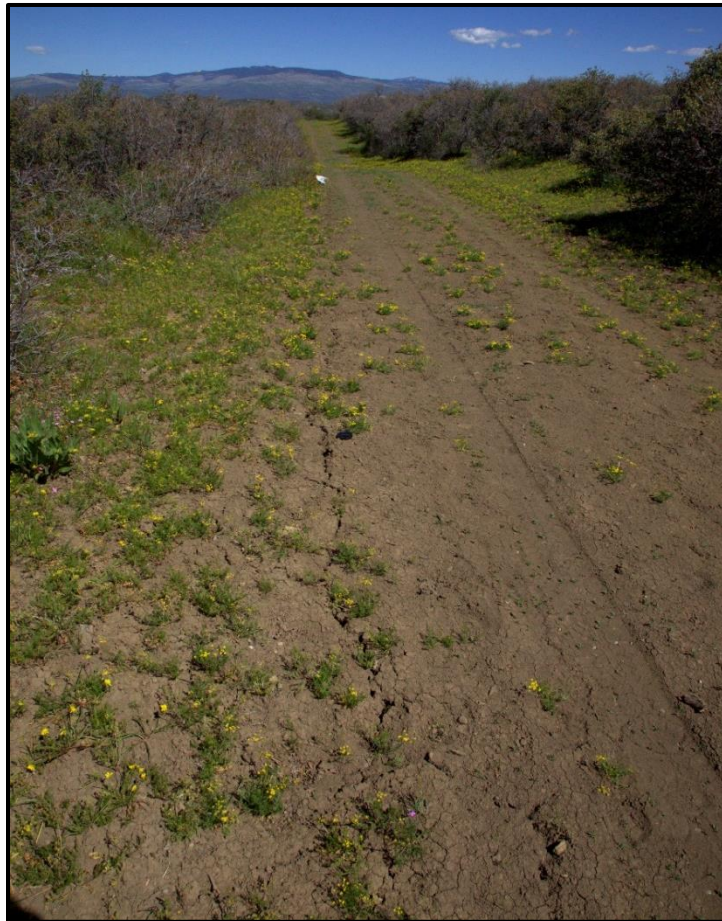
Cracks were observed along the existing road over the E14 Headgate between Crosscuts 23 and 22 during our spring 2022 site visit (Figure 1). No cracks had been observed along this traverse prior to mining in Longwall Panel E14. Therefore, the cracks were deemed to be subsidence-related features. The E-seam overburden thickness at this location is approximately 650 to 700 feet.

Figure 1: Southeast view of subsidence crack parallel to road on Traverse C-C' located over the E14 Headgate, between crosscuts 23 and 22 during spring 2022 visit.

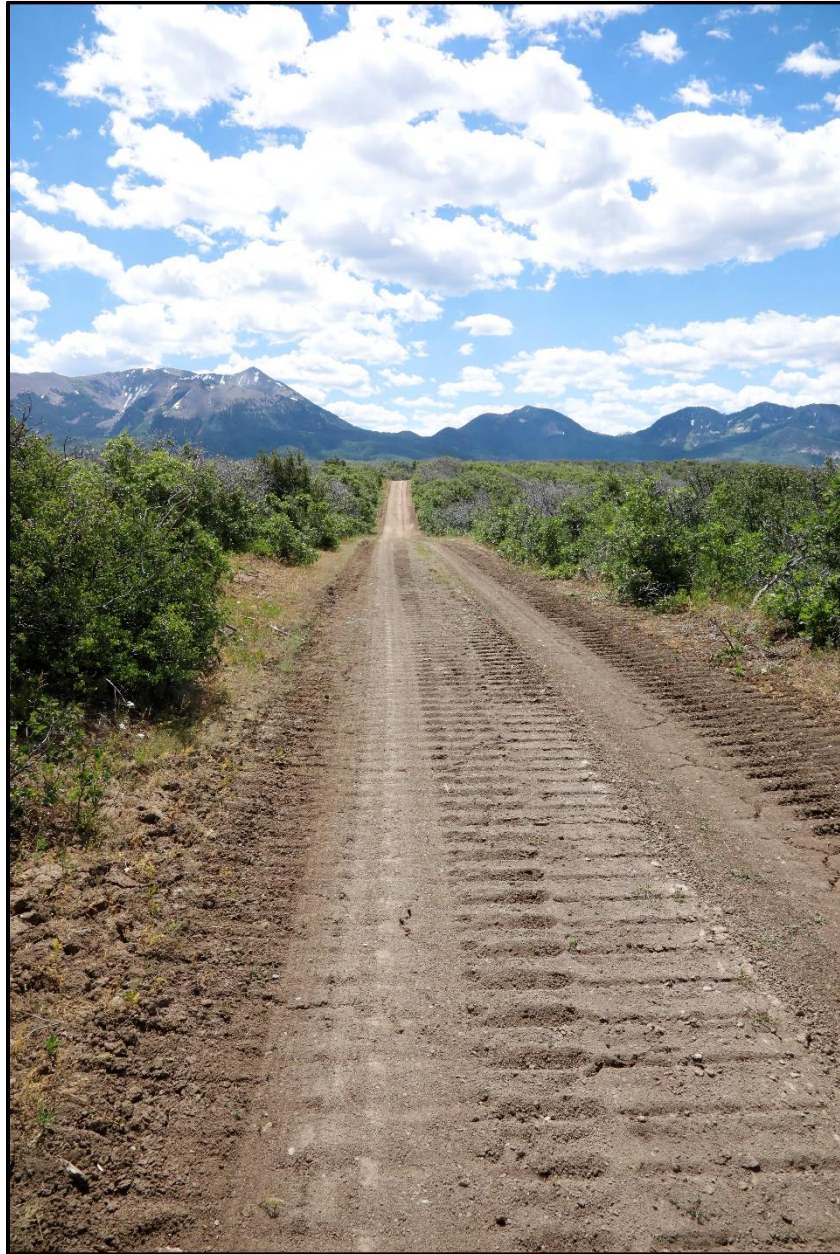
During the fall 2022 site visit, about 100 feet to the southeast along the road, small residual cracking was observed near Location 1 with similar orientation to those previously observed nearby. Prior to the spring 2023 site visit, significant road work and heavy truck traffic had occurred on the stretch of road containing Location 1 (Figure 2). As a result, no cracks were observed at this location.

Figure 2: Access road along Longwall Panel E14 Headgate follow roadwork.

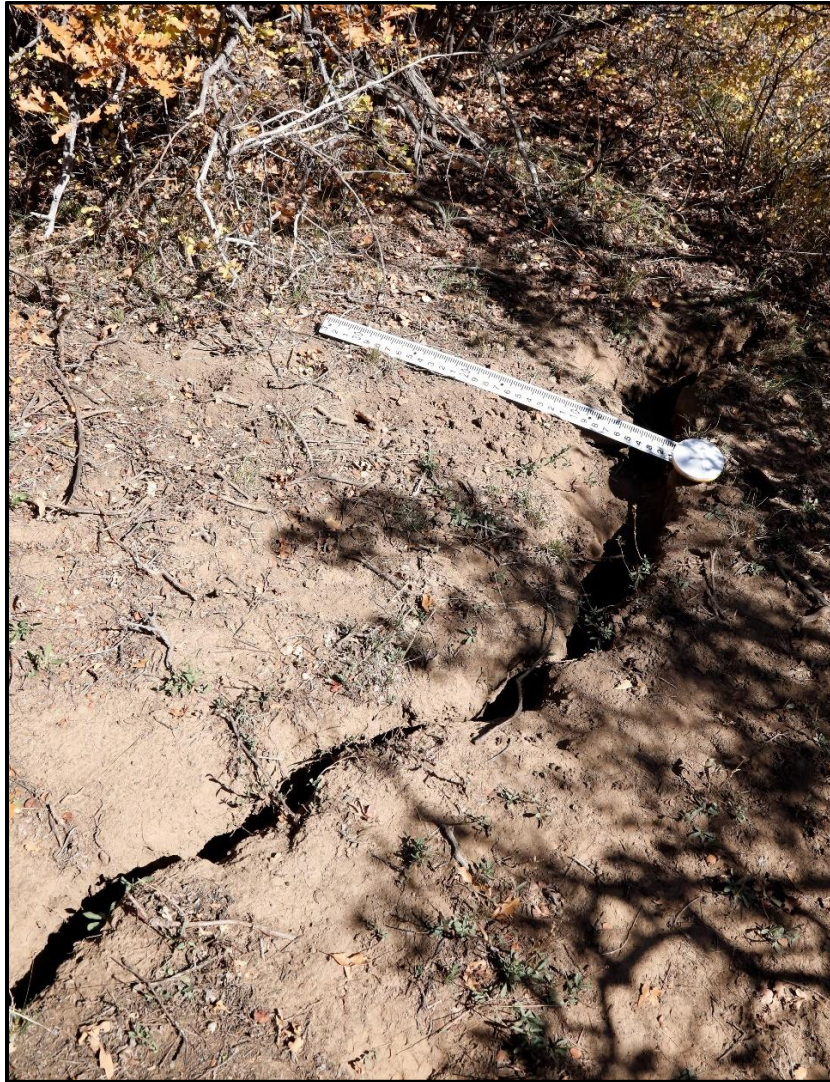
New cracks were observed south of the access road overlying the north end of E-seam Longwall Panel E14 during the fall 2022 site visit. As shown on Map 1, the cracks were observed at Location 2 adjacent to cross cut 17 of the E14 Headgate. A series of parallel cracks were observed roughly parallel to the E14 Headgate with an orientation of South 40° East. The largest of the observed cracks followed the topographic contour for approximately 100 feet (Figure 3).

Figure 3: The largest of the cracks observed at Location 2, south of the across road on Traverse C-C'.

The location of these cracks is consistent with locations where the tilt and horizontal displacement are largest near the edge of the panel as shown in Figure 3 of Exhibit 60E (WWE 2018). The existence of the series of parallel cracks was likely a combination of these horizontal strains in combination with the natural sloped hillside. In total, there were 5 cracks observed with the dimensions of the cracks generally decreasing in the downhill direction towards the center of the longwall panel.

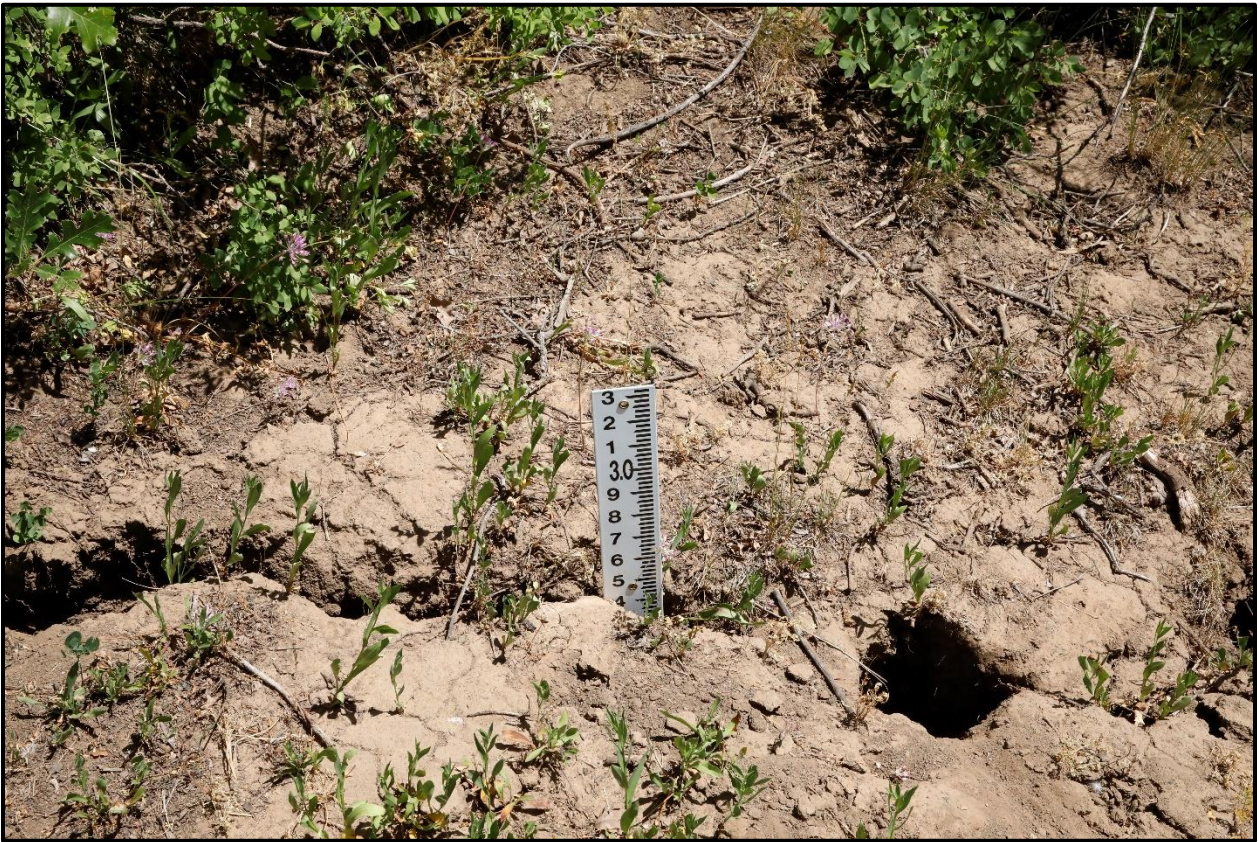
During the spring 2023 site visit, these cracks were still evident but were much less prominent. The smaller cracks had largely healed/sealed, especially where cattle or large game trails occurred. The largest crack was still open and roughly 2.5 feet in maximum depth (Figure 4).

Figure 4: The largest of the cracks at Location 2, south of the across road on Traverse C-C' during spring 2023 visit.

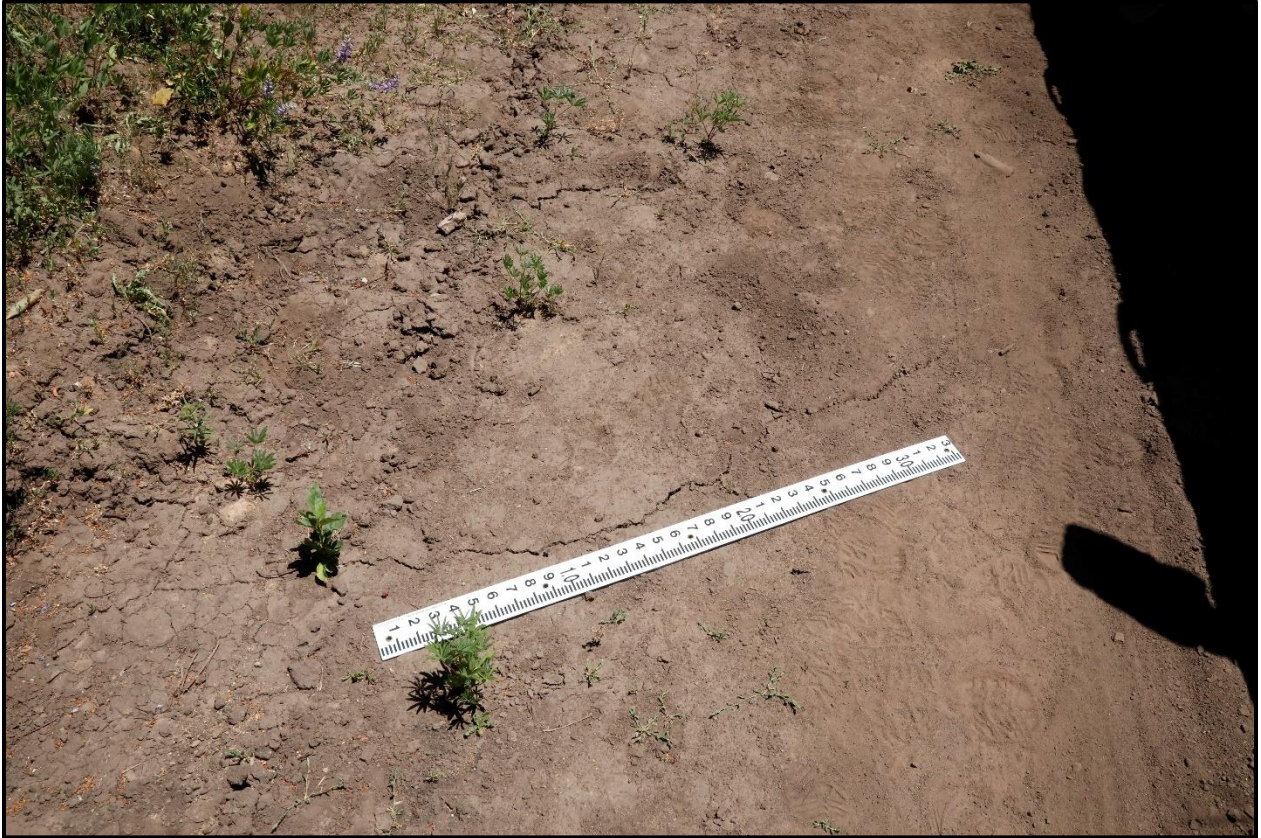
New cracks were observed along the north side of the access road overlying the north end of E-seam Longwall Panel SS3 during the spring 2023 site visit. As shown on Map 1, the cracks were observed between Location 3 and 4. A series of parallel cracks were observed roughly parallel each other with an orientation of South 37° East. The cracks had no discernable depth or width and were not perpendicular to the road (Figure 5). It is unclear whether these observed cracks were related to mining subsidence; however, their consistent orientation was noteworthy and merited documentation. Longwall mining occurred under Locations 3 to 4 during the months of December 2022 and January 2023.

Figure 5: Example of a newly observed crack along
the north side of E-seam Longwall Panel SS3

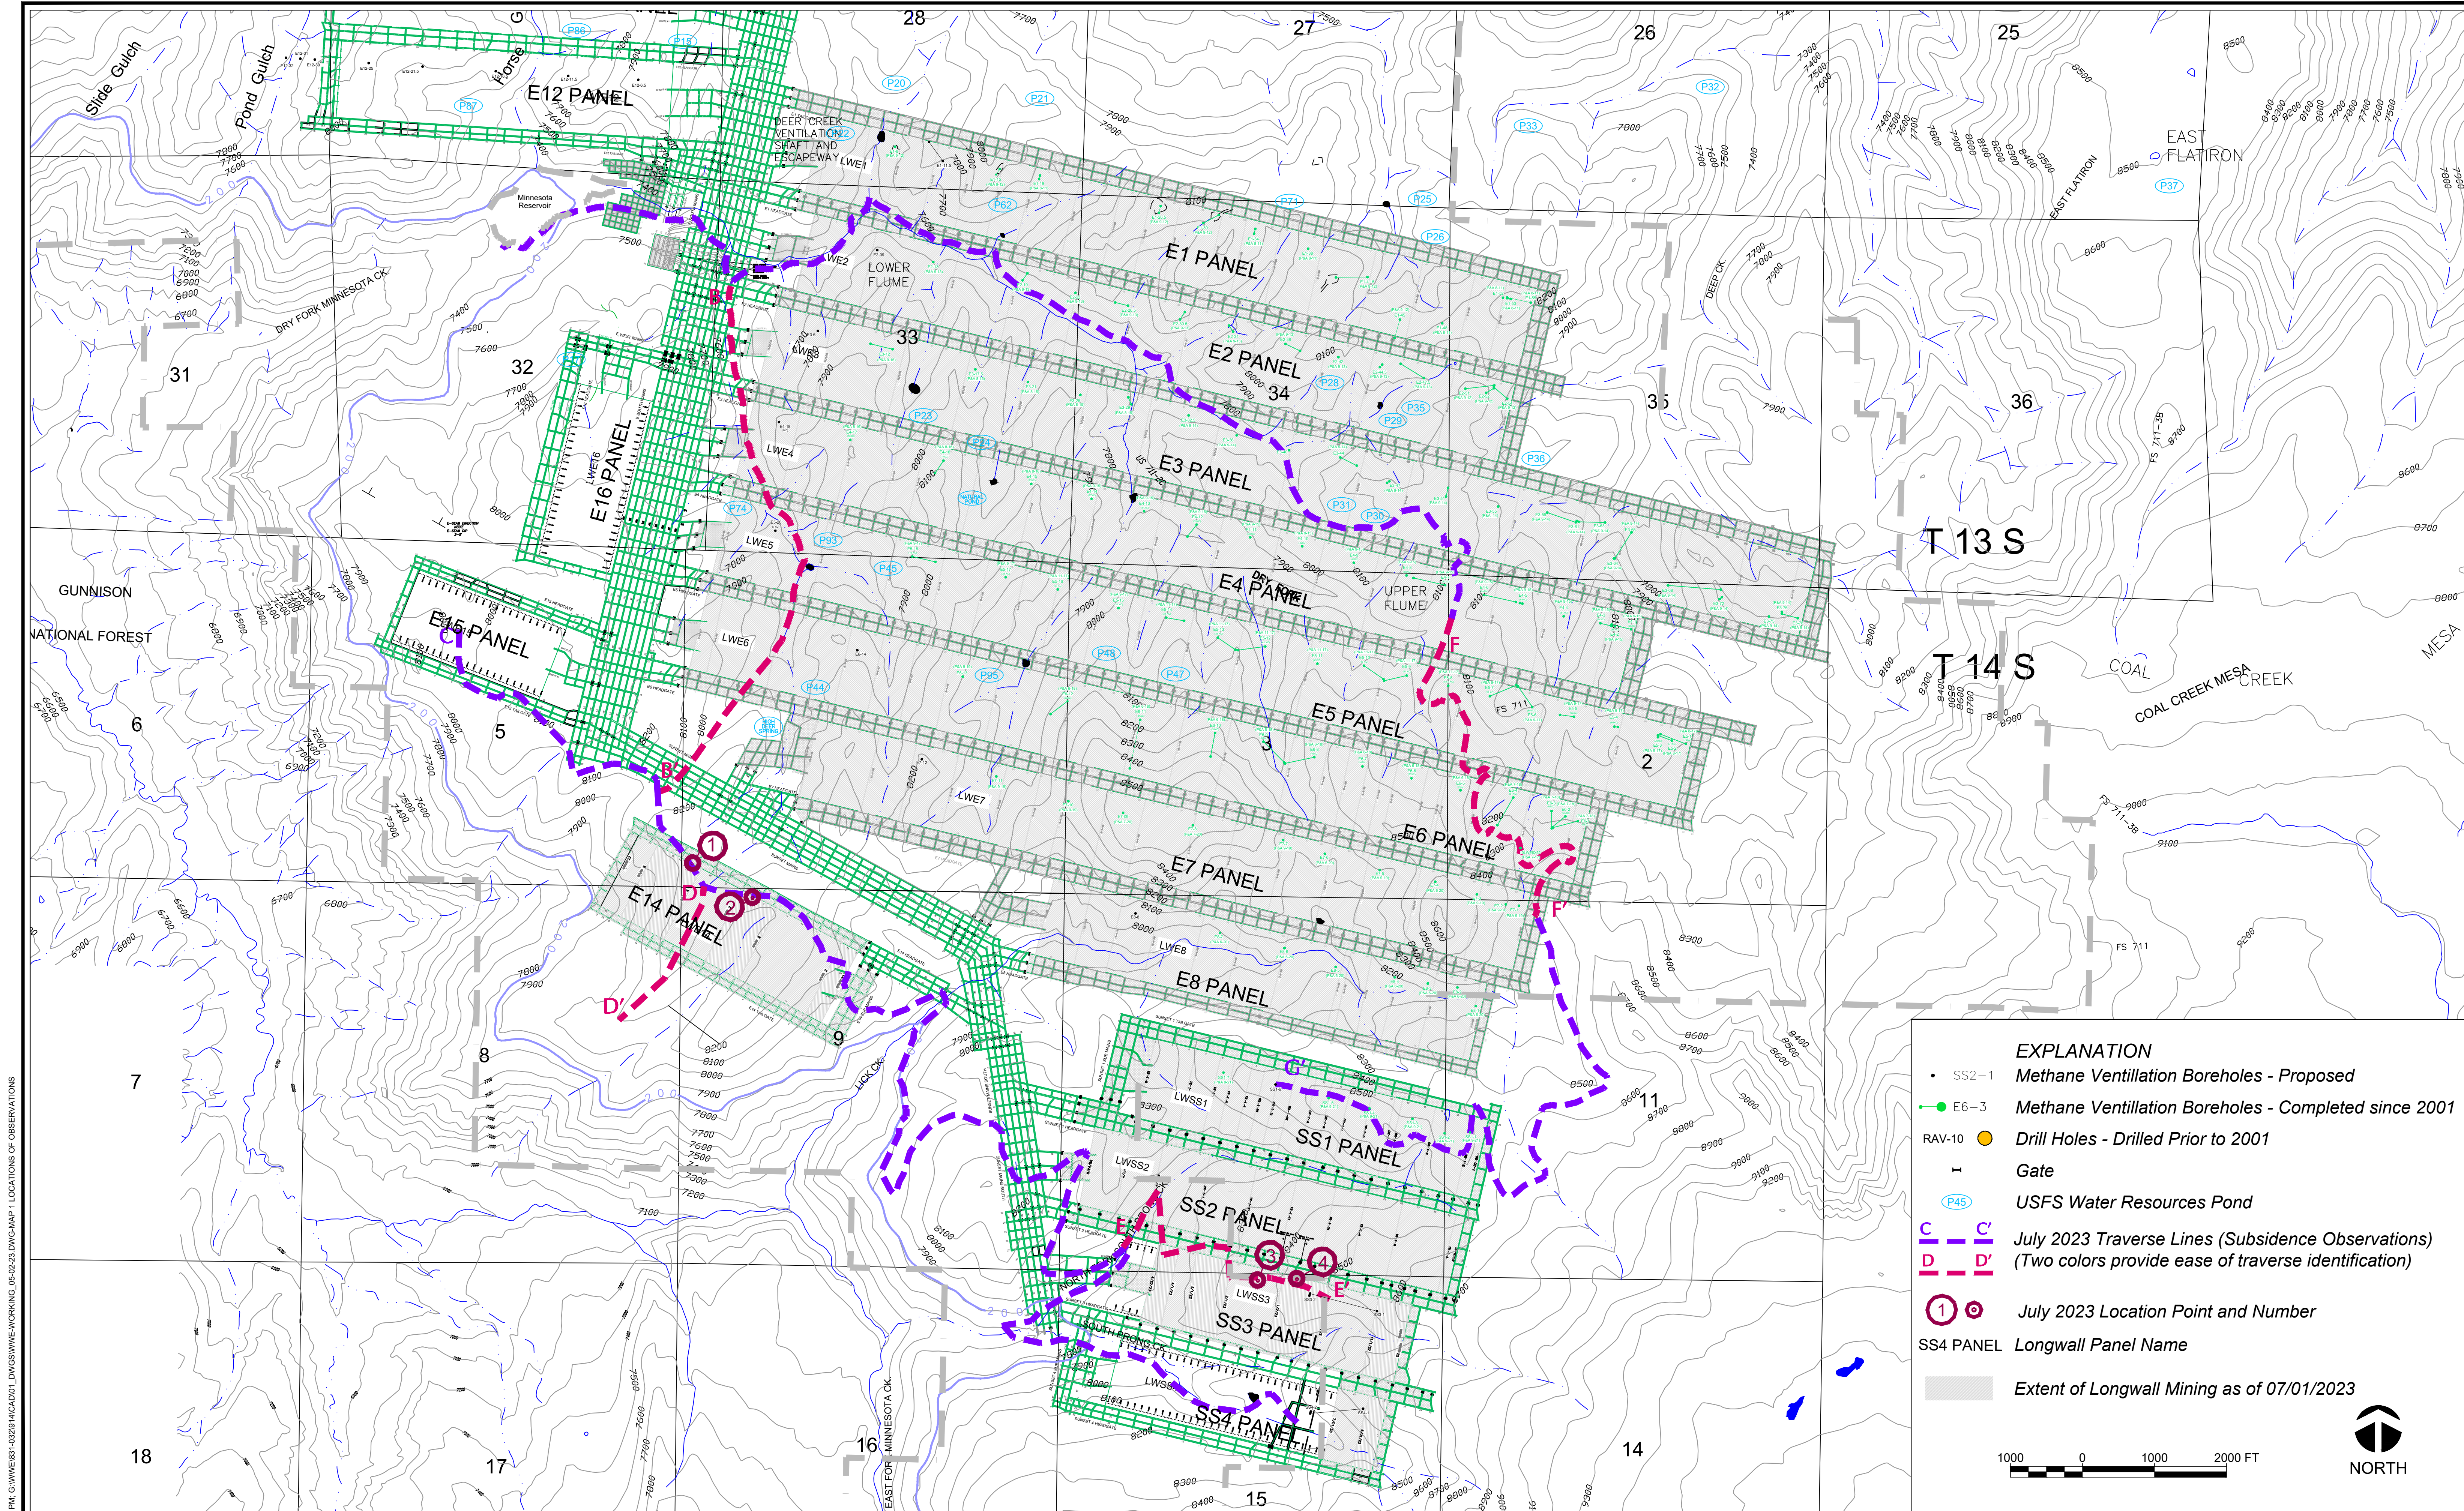
MAP
1

Cracks were observed along the access road to MBV SS3-2 overlying E-seam Longwall Panel SS3 in between Locations 3 and 4 as shown in Map 1 during the spring 2023 field visit.
