**MINERALS PROGRAM INSPECTION REPORT**  
**PHONE: (303) 866-3567**

<b>MINE NAME:</b> NCCI Pit #1	<b>MINE/PROSPECTING ID#:</b> M-2001-107	<b>MINERAL:</b> Sand and gravel	<b>COUNTY:</b> Weld
<b>INSPECTION TYPE:</b> Monitoring	<b>WEATHER:</b> Clear	<b>INSP. DATE:</b> September 14, 2023	<b>INSP. TIME:</b> 12:00
<b>OPERATOR:</b> Northern Colorado Constructors, Inc. Aggregate Div	<b>OPERATOR REPRESENTATIVE:</b> Chris Zadel and JC York	<b>TYPE OF OPERATION:</b> 112c - Construction Regular Operation	
<b>REASON FOR INSPECTION:</b> Citizen Complaint	<b>BOND CALCULATION TYPE:</b> None	<b>BOND AMOUNT:</b> \$486,745.00	
<b>DATE OF COMPLAINT:</b> 8/26/23	<b>POST INSP. CONTACTS:</b> None	<b>JOINT INSP. AGENCY:</b> None	
<b>INSPECTOR(S):</b> Hunter Ridley Michael Cunningham	<b>INSPECTOR'S SIGNATURE:</b>

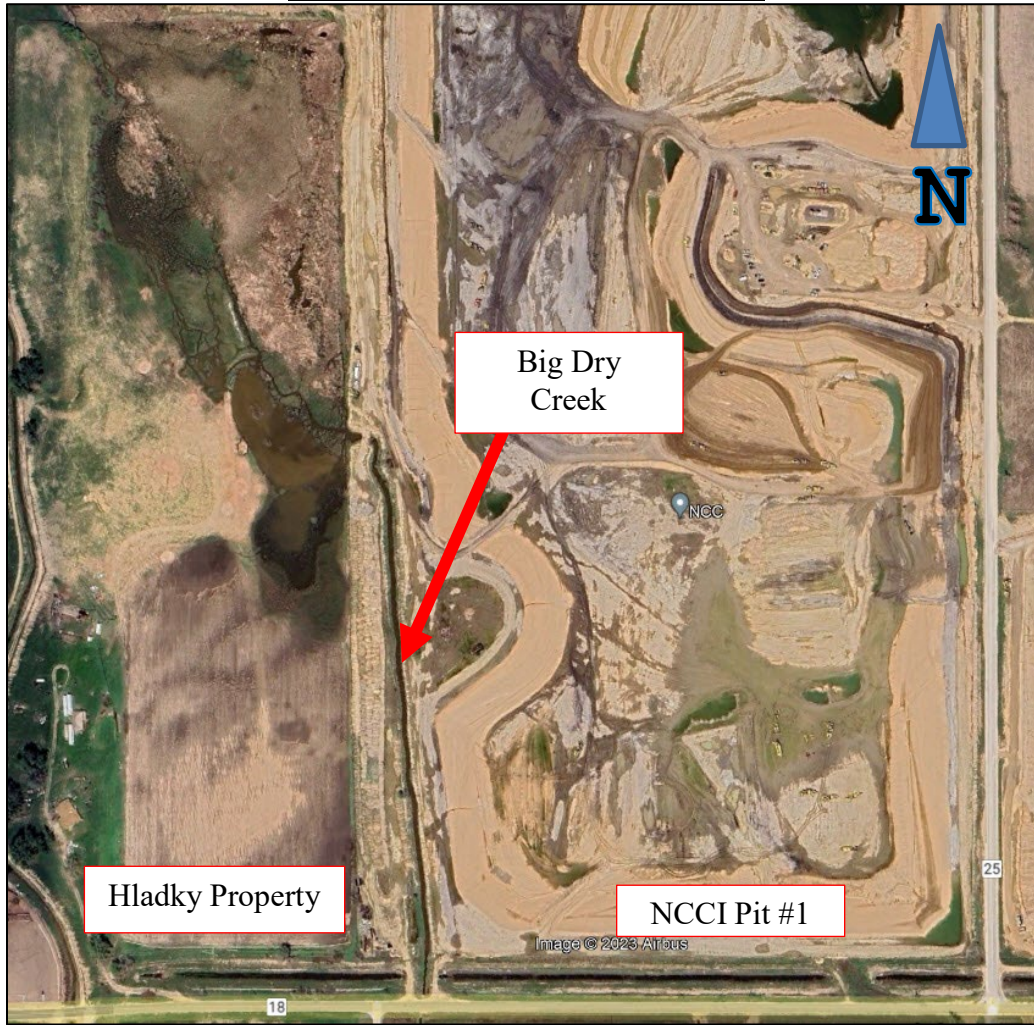
NCCI representatives showed the Division the western boundary line which separates the pit from Mr. Hladky's croplands (Figure 1). Little Dry Creek runs along this property line and through a culvert located on the NCCI pit's side (Photos 1 and 2). NCCI representatives stated that groundwater has likely been rebounding to pre-mine levels since the cessation of dewatering activities and completion of the clay liner at the NCCI pit, causing a relative rise in adjacent groundwater levels. Additionally, NCCI stated that Little Dry Creek used to be

**Figure 1: Google Earth Imagery (2023) which shows the southern portion of the NCCI Pit #1 and Mr. Hladky's cropland to the west.**

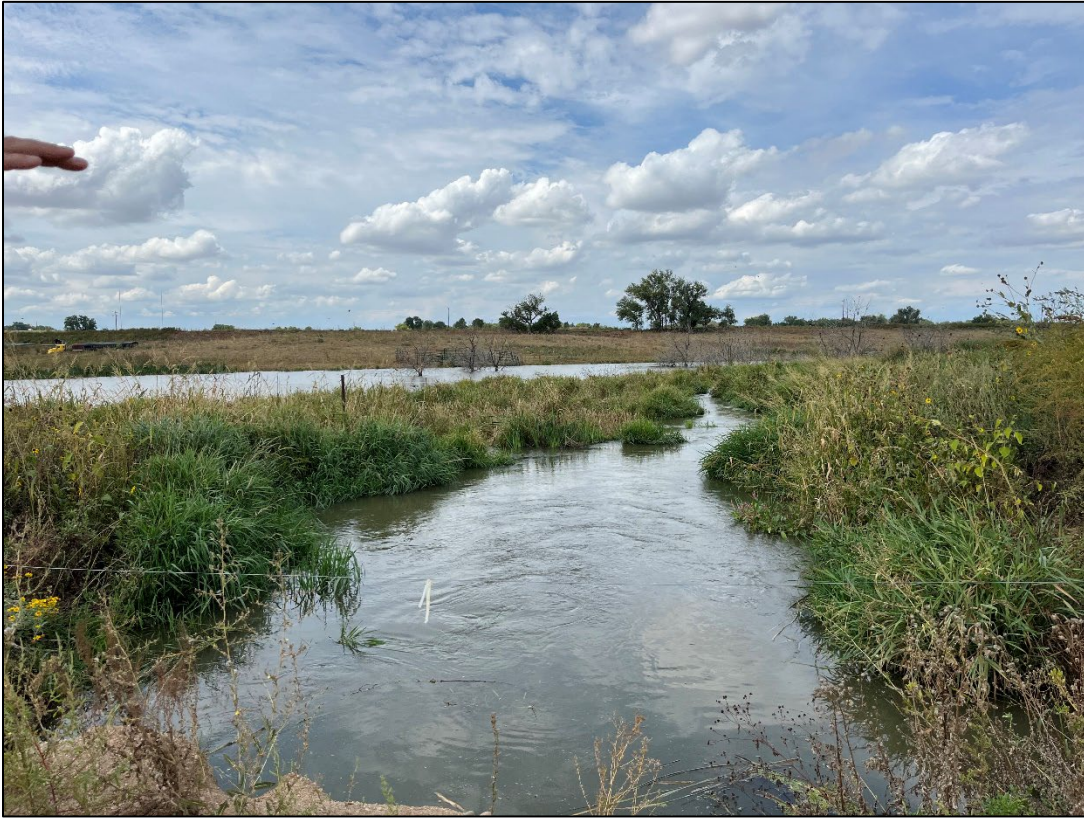
**Photo 1: View northwest, standing atop the culvert which directs Little Dry Creek through the NCCI site and to the west.**

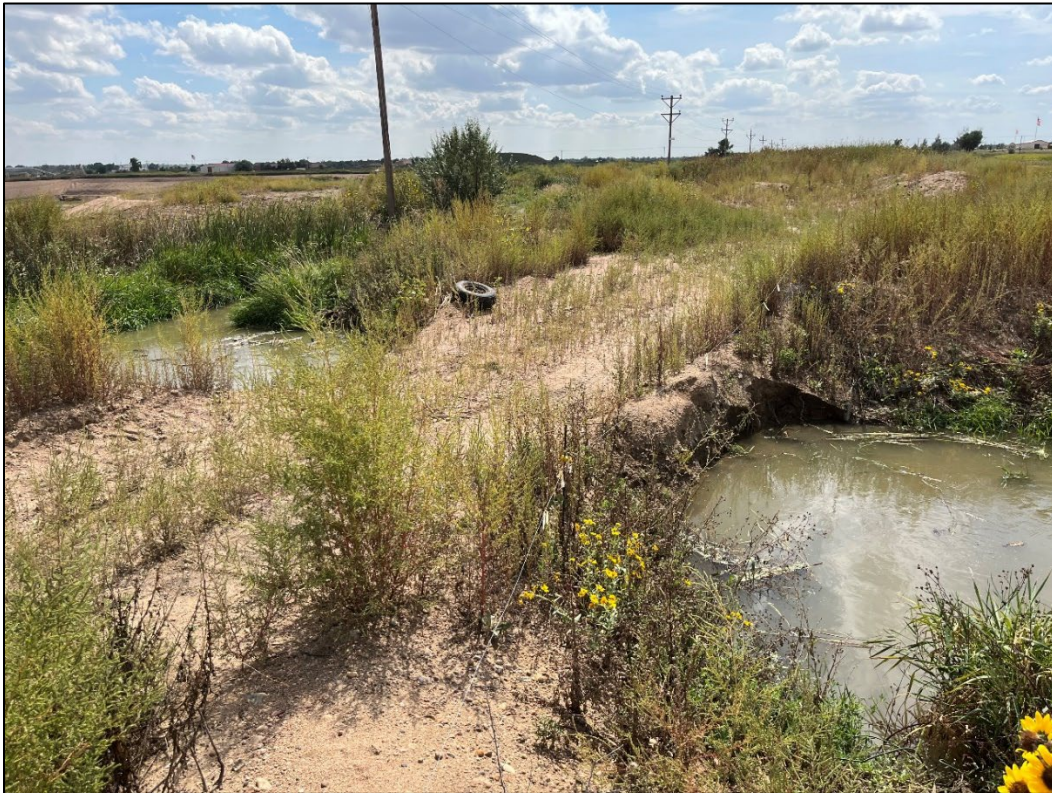
**Photo 2: An approximately 60" culvert allows Little Dry Creek to flow west across NCCI site property.**

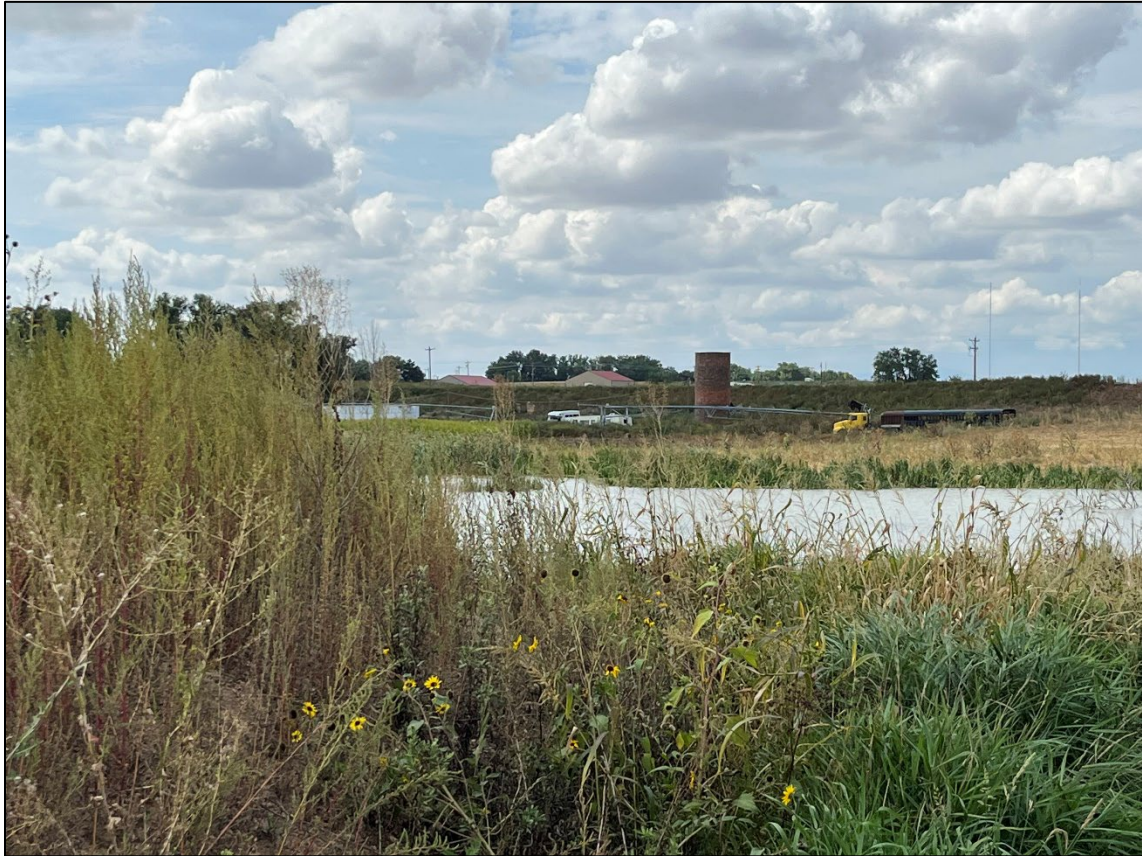
After inspection of the NCCI Pit #1, the Division met Mr. Hladkey to inspect his property which was the subject of the complaint. Mr. Hladkey and the Division walked along the field's access road and out to see where a semi, which could not be driven out due to muddy conditions, was located (Photos 8 and 9). The water table in this area was visibly elevated and muddy conditions persisted across the site, intensifying to the northwest. Mr. Hladky believes that the cessation of dewatering at NCCI Pit #1 and installation of a clay liner, combined with the lack of ditch cleanout, has caused his crops and agricultural land to become flooded to an extent that harvest and access to stock is not viable.

**Photo 3: View southwest onto Mr. Hladkey's cropland. The semi in this photo is the above referenced machinery which is stuck in mud on the property.**

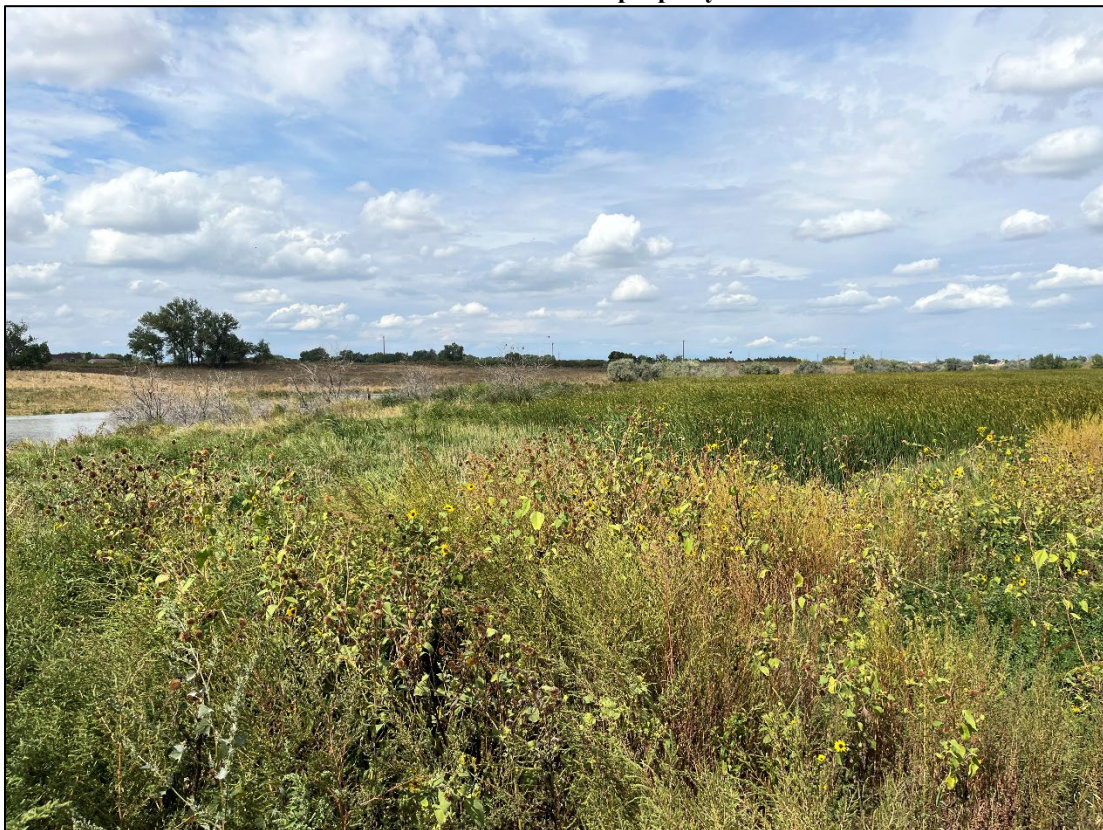
maintained and cleaned out on a regular basis by a previous landowner. When regular cleanouts ended, the creek began to overgrow with cattails and other aquatic vegetation. The Division did note an abundance of aquatic vegetation present adjacent to the site's western boundary (Photo 4). Over the years, the regular flow path of Little Dry Creek to the north has backed up and rerouted to the west as a result of this phreatophyte growth (Photos 5 and 6). Google imagery shows a steady increase in aquatic vegetation growth in Little Dry Creek since approximately 2010. NCCI asserts that three factors have caused Mr. Hladky's property to become flooded: a natural rebounding of water, lack of ditch cleanout, and a year of unusually high rainfall events.

**Photo 4: View northwest of cattails and vegetative overgrowth.**

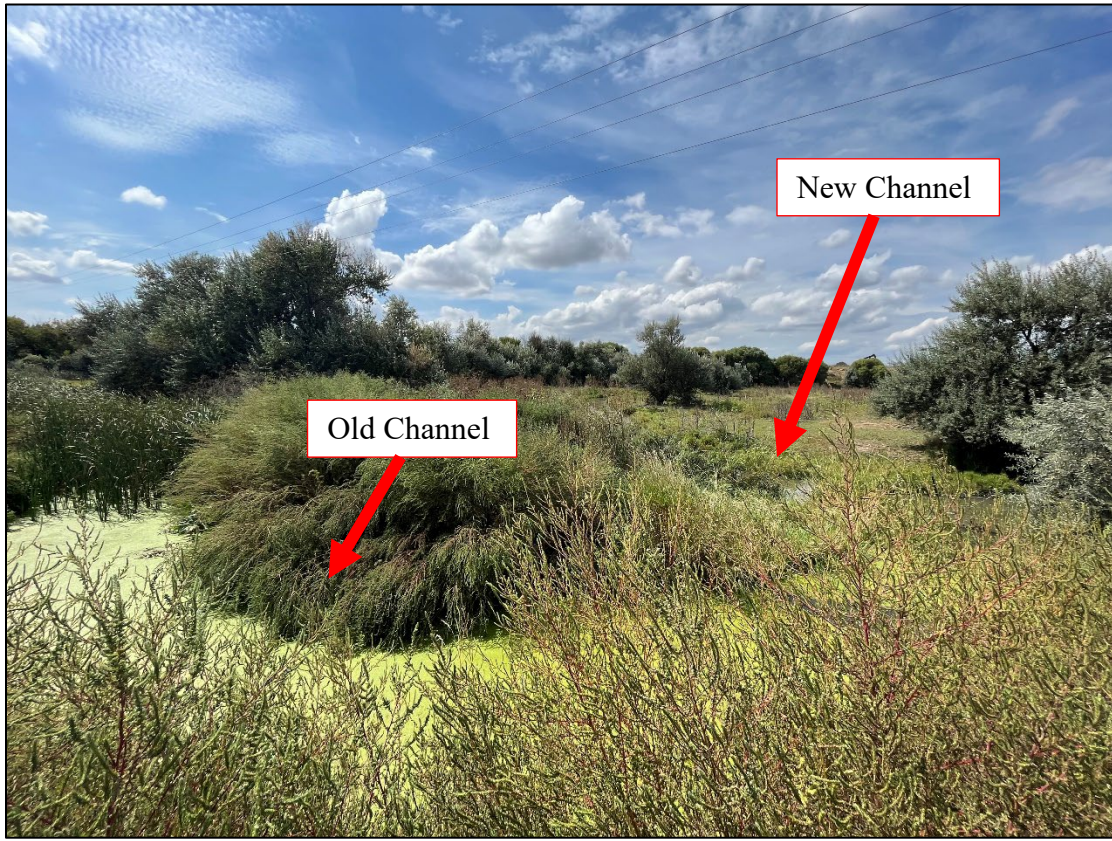
The Division then headed to the northern portion of the NCCI Pit #1 site to view Little Dry Creek in its natural drainage, upstream of the majority of aquatic vegetation overgrowth. NCCI stated that the algae filled channel in Photo 6 used to be the natural channel for Little Dry Creek. Vegetative overgrowth has caused the creek to reroute to the west and wind back towards the natural channel in order to bypass the overgrowth.

**Photo 5: View northwest of Little Dry Creek's old and new channels.**

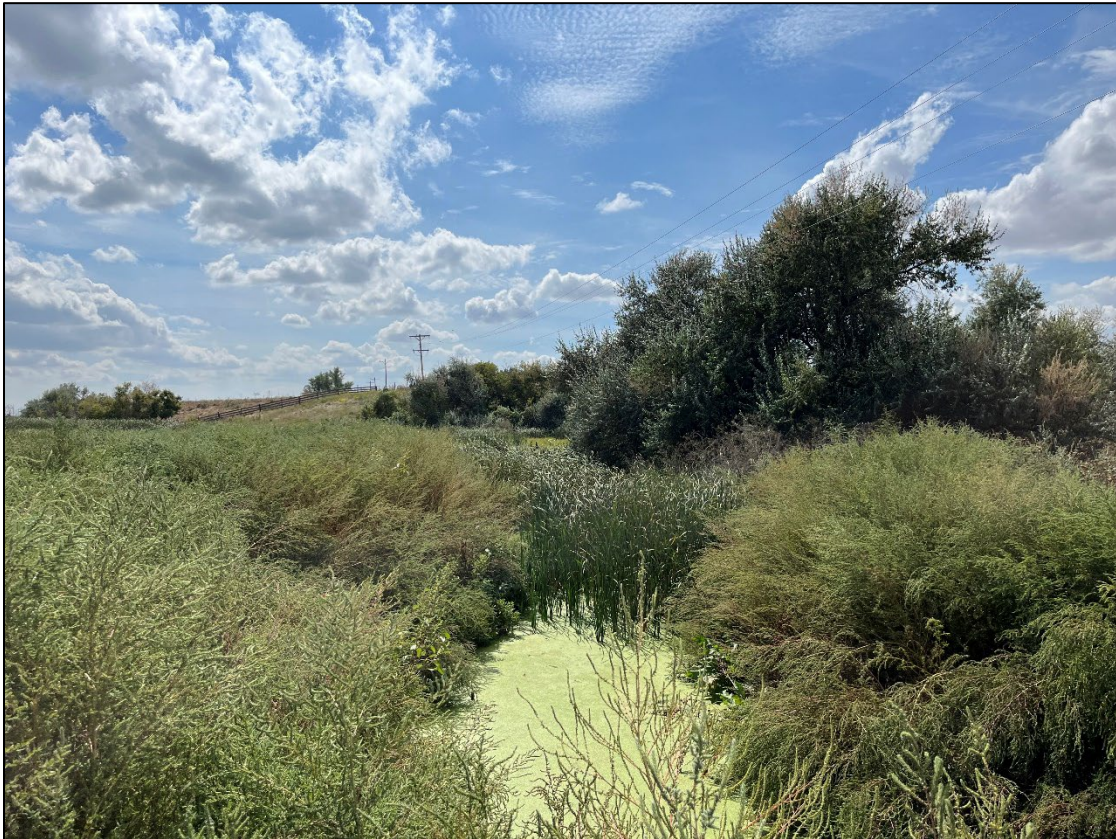
**Photo 6: View southwest of the old Little Dry Creek channel.**

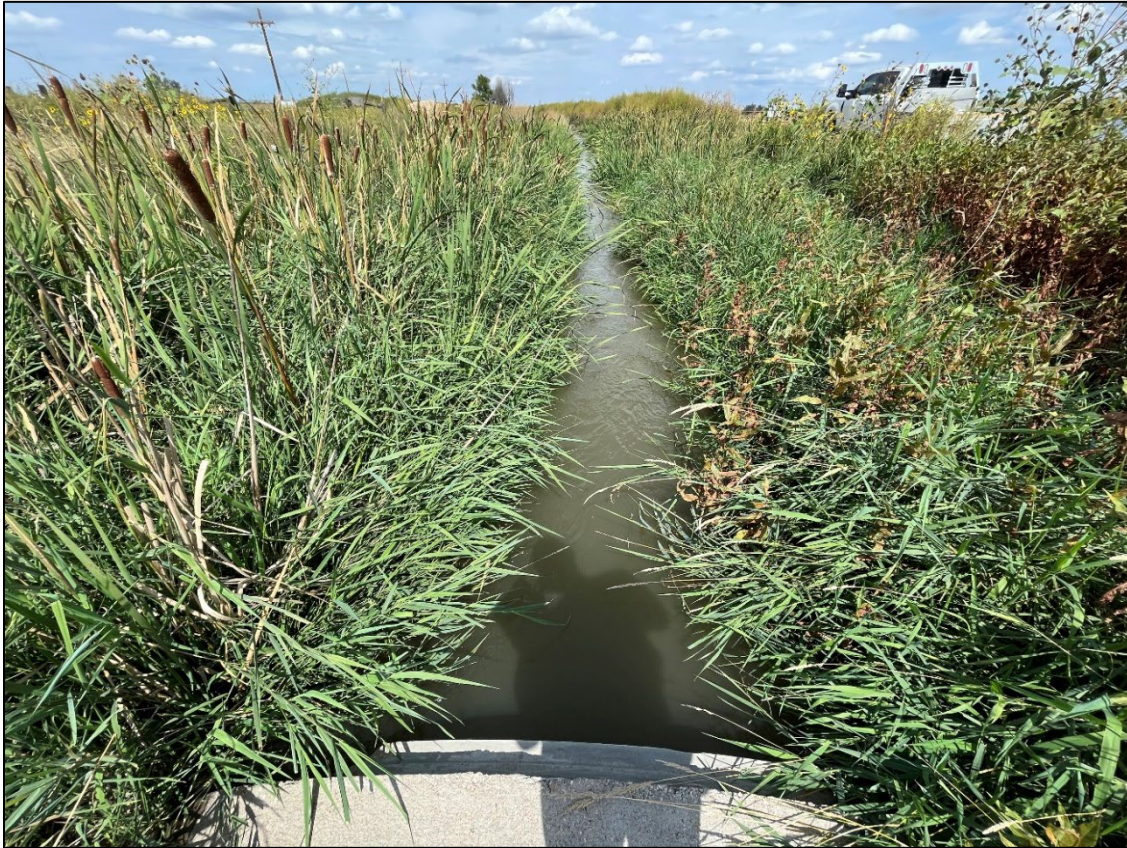
Finally, the Division inspected a culvert at the southern edge of the NCCI permit boundary which Little Dry Creek flows through (Photo 7). The culvert pictured is a horizontal 60" culvert equivalent. Little Dry Creek was flowing and the culvert was at full capacity at the time of inspection. Minor flows were noted in the Sandhill Reservoir discharge overflow which runs perpendicular to Little Dry Creek on the southern end of the NCCI Pit.

**Photo 7: View north of the Little Dry Creek culvert at the southern end of the permit boundary.**

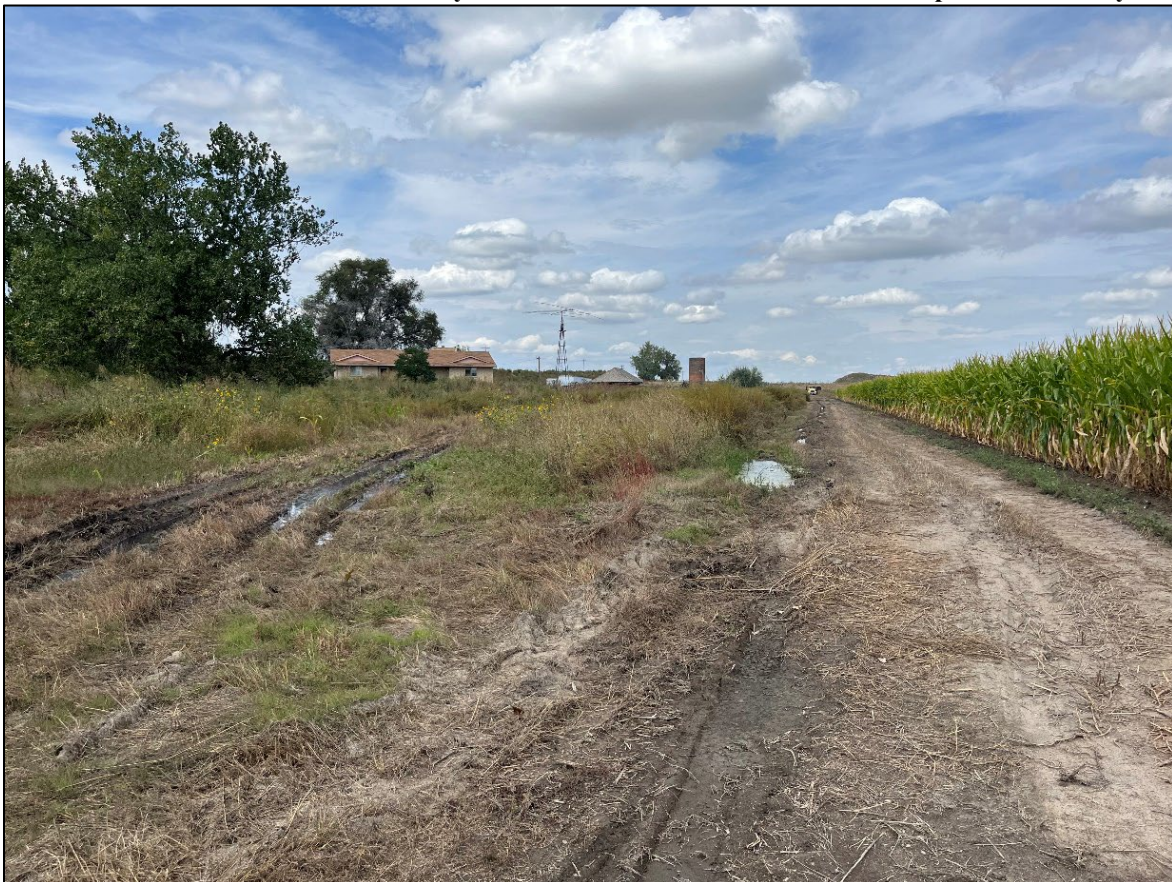
**Photo 8: View north of Mr. Hladky's access road and corn crop.**

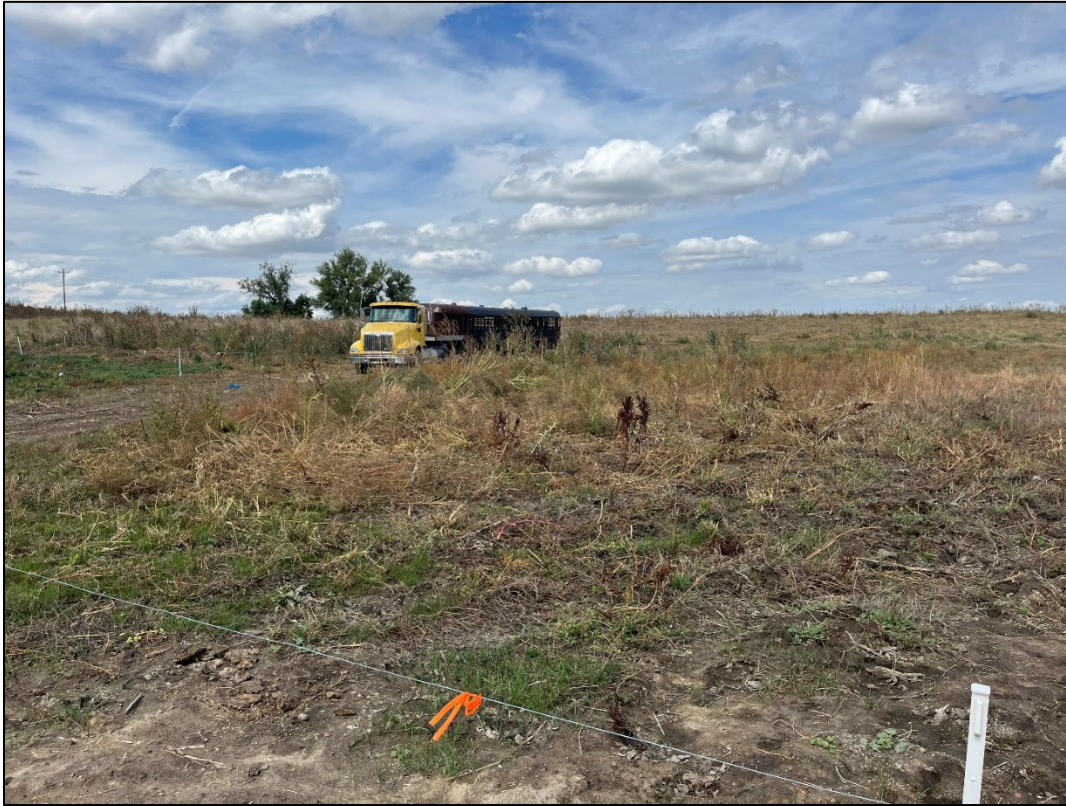
Figure 9: View northwest of the stranded semi. Cows are also roaming this fenced in area.
