**McClane Canyon Mine, C-1980-004, September Complete Inspection Report**

**PERMIT INFORMATION**

**INSPECTION INFORMATION**

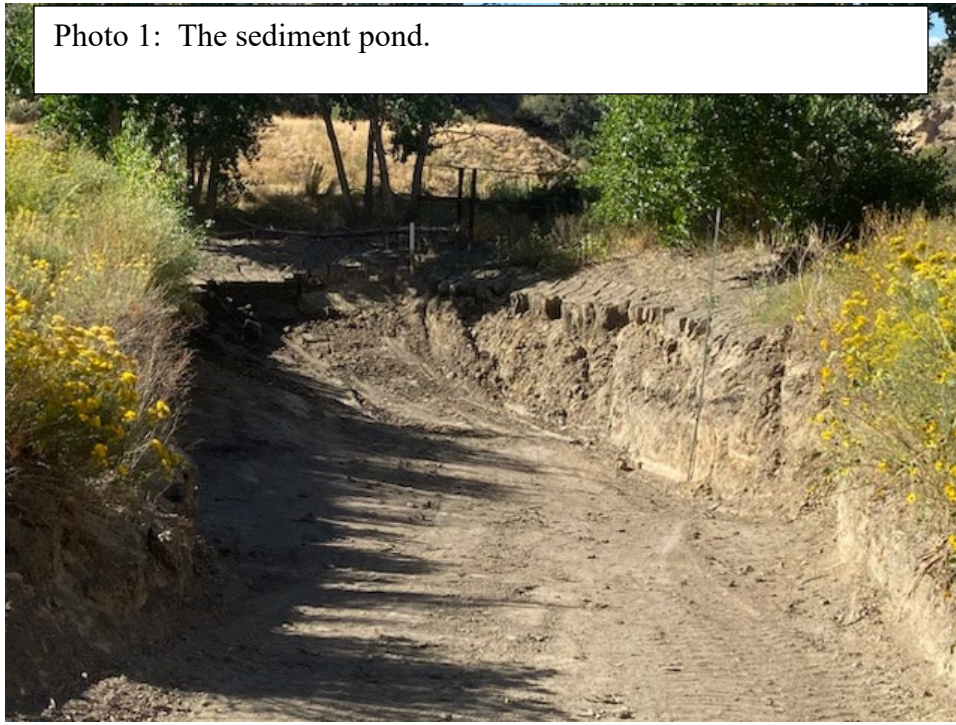
During the inspection the sediment pond was dry. The pond had been mostly cleaned out, restoring the pond's capacity to near original design (Photo 1). The sediment level marker was replaced in the pond (Photo 2). A silver marker on the post indicates the elevation at which the pond will require cleaning. The pond's embankment was stable with vegetative cover. There were no erosional issues identified. The outlet for the pond was clear of debris. The Inlet from the D-6 ditch into the sediment pond was stable. There were no erosional issues.

Photo 1: The sediment pond.

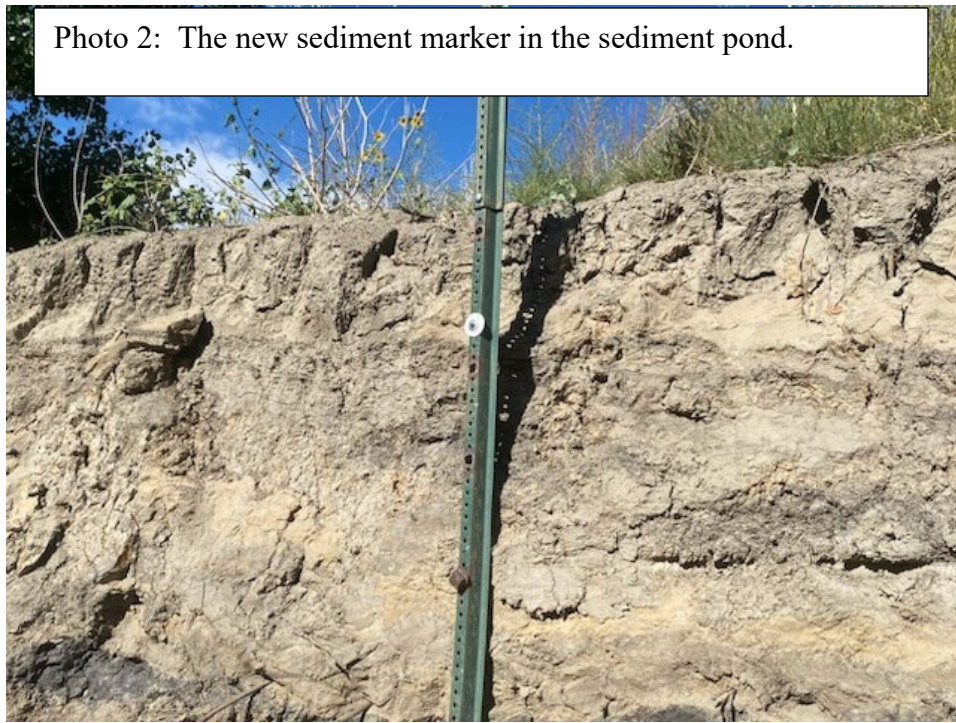
Photo 2: The new sediment marker in the sediment pond.

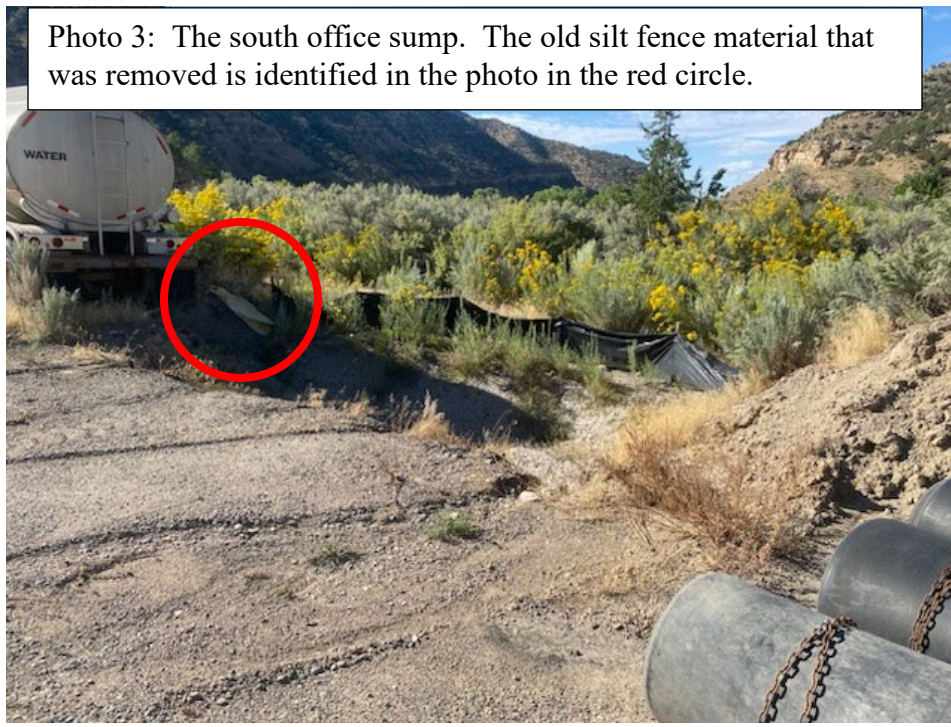
The north and south office pad sumps were dry (Photo 3). The silt fences placed at the sumps' outlets were in good condition. There were no indications of instability or erosion noted.

Photo 3: The south office sump. The old silt fence material that was removed is identified in the photo in the red circle.

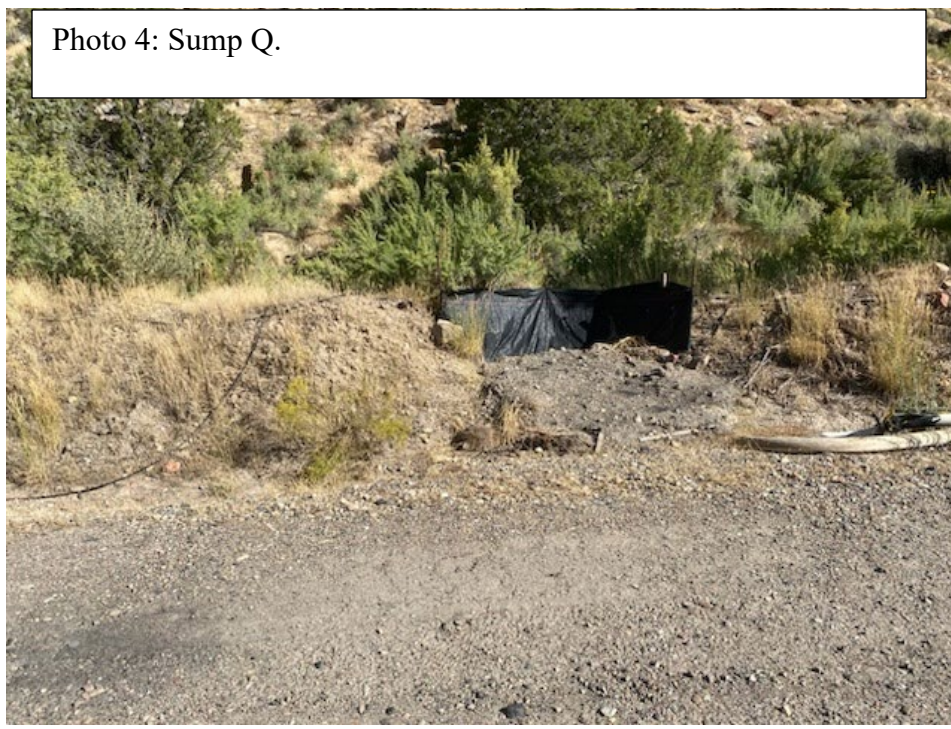
Sump P is located on the north side of the Haul Road in-between the office pad and the sediment pond. The sump was no holding water during the inspection (Photo 4). The silt fence placed at the outlet of the sump was in good repair. The sump was stable with no indications of erosional features.

Photo 4: Sump Q.

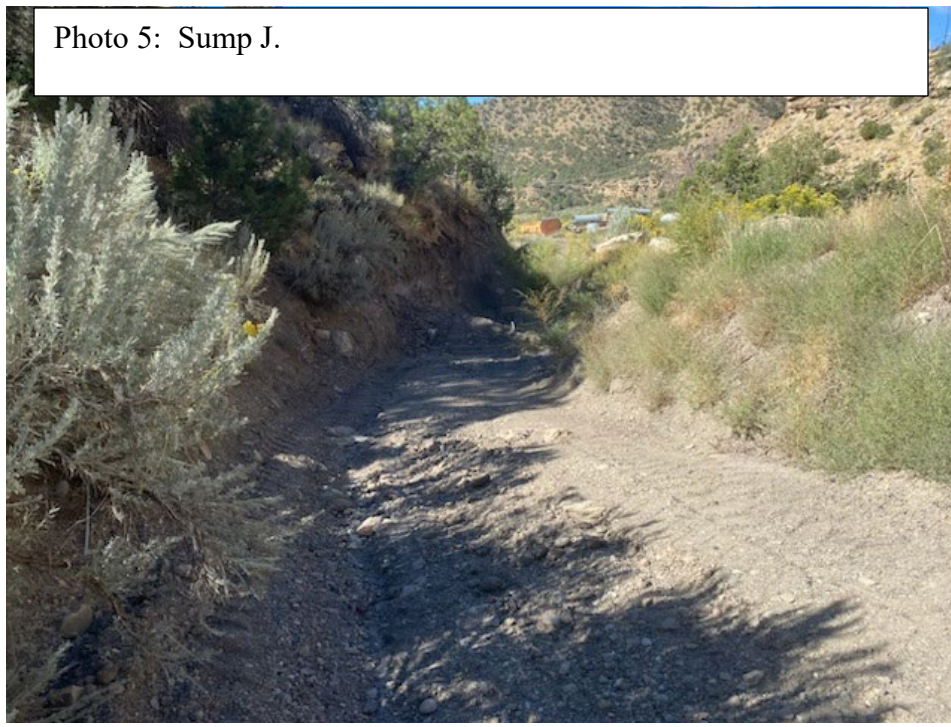
Sump J was also dry at the time of the inspection. The sump was stable with no erosional concerns (Photo 5). The outlet from the sump into the D-6 ditch was clear of debris.

Photo 5: Sump J.

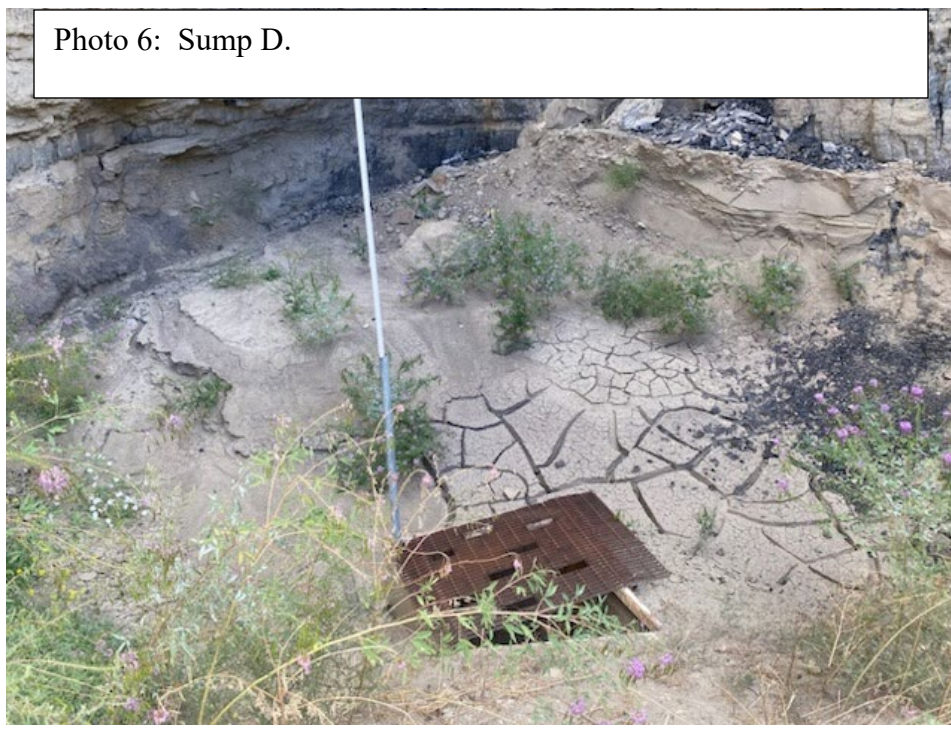
Sump D is located on the eastern end of the portals bench (Photo 6). The Sump serves the same purpose as Sump A and B. The Sump was dry. The trash rack covering the outlet was noted to be unobstructed.

Photo 6: Sump D.

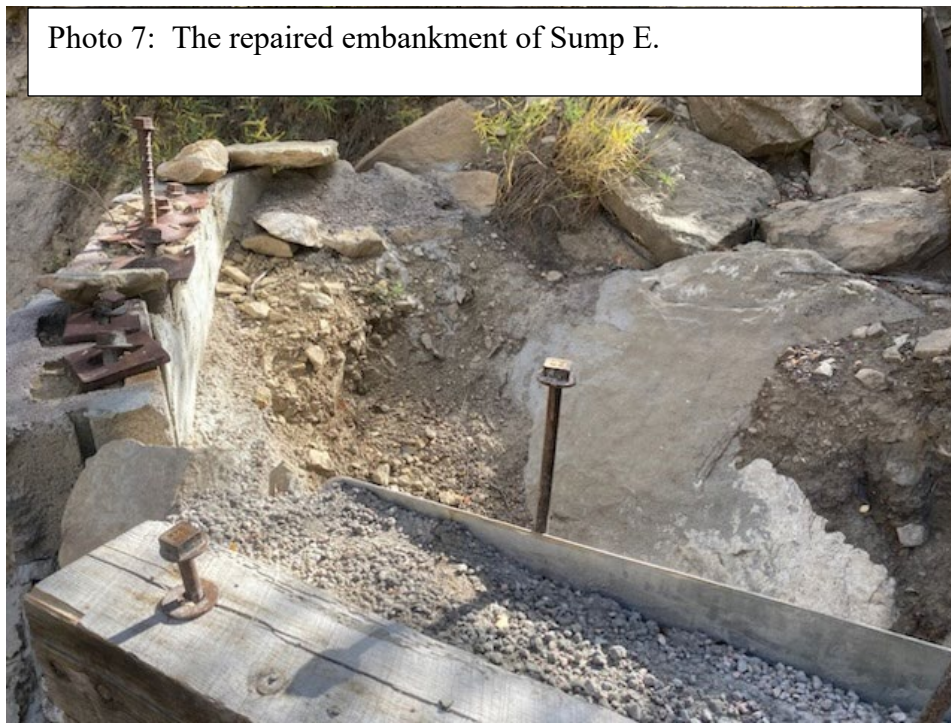
Sump E had been recently repaired. The embankment had been replaced (Photo 7) and the outlet had been cleared of all blockages. The sump was stable with no erosional concerns.

Photo 7: The repaired embankment of Sump E.

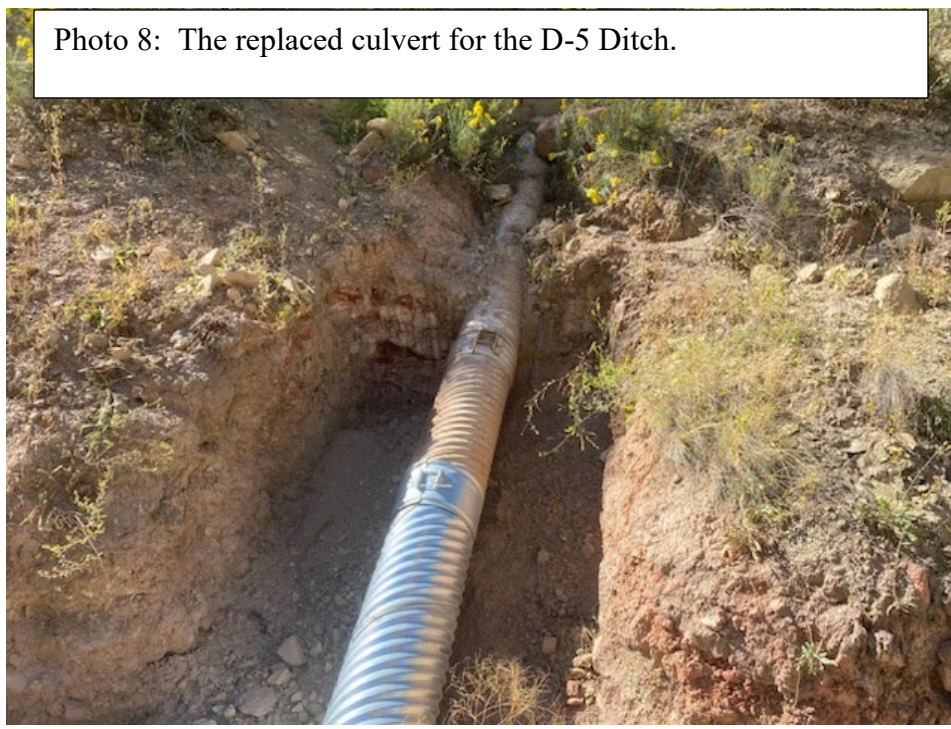
The culvert for the D-5 ditch had been repaired (Photo 8). The culvert transports upstream Clearwater beneath the portals bench. The culvert was stable with no blockages.

Photo 8: The replaced culvert for the D-5 Ditch.

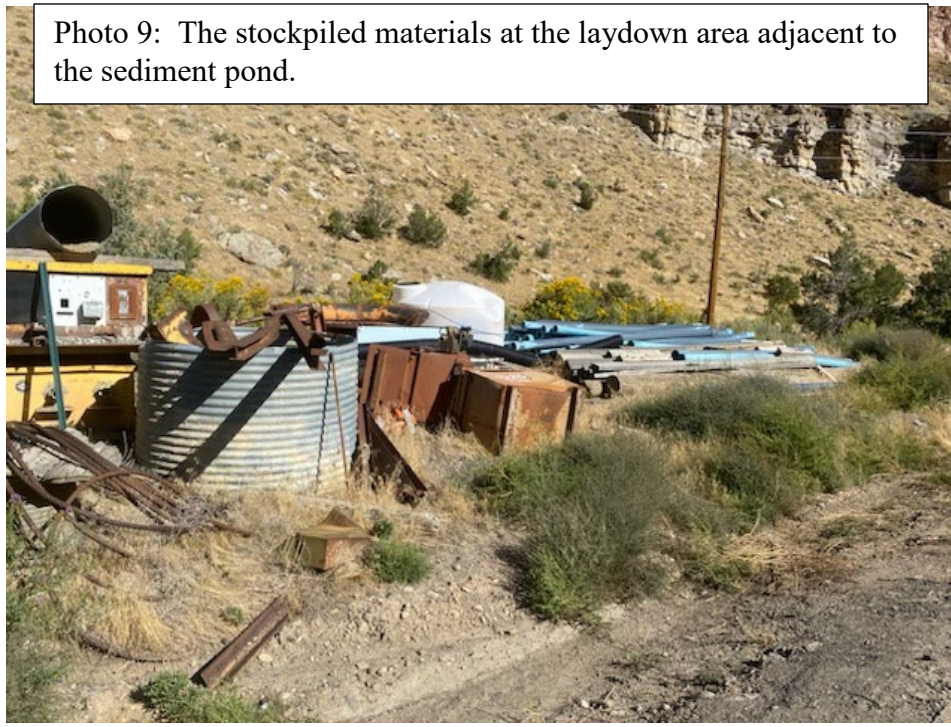
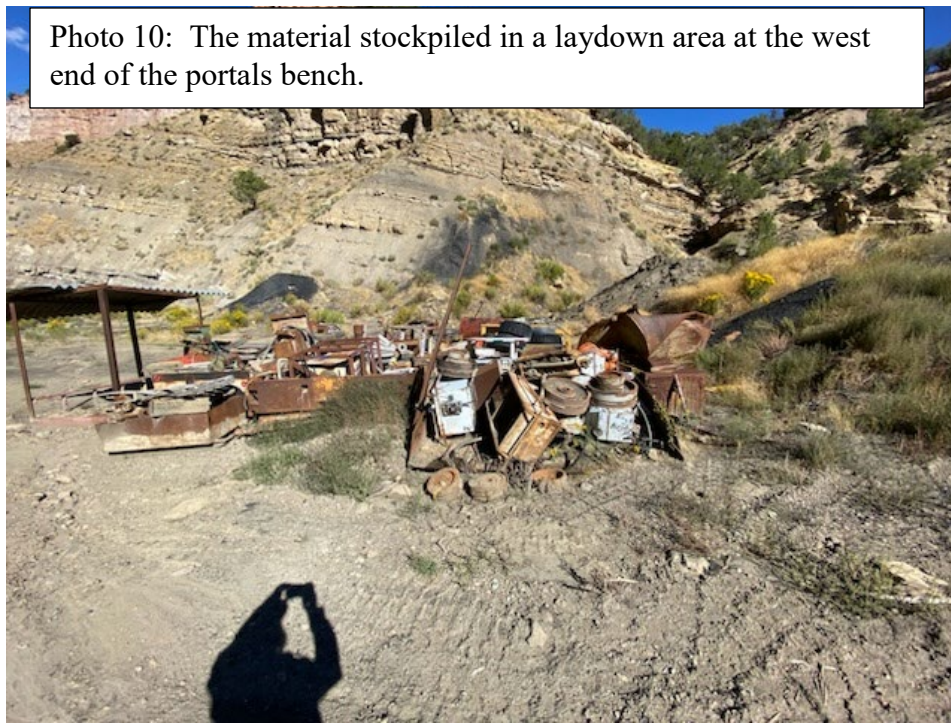
During the inspection, the Division verified that all Secondary Maintenance items outlined in the April 19, 2023 Inspection Report had been completed (Photo 9 and 10). These maintenance items had a

Photo 9: The stockpiled materials at the laydown area adjacent to the sediment pond.

Photo 10: The material stockpiled in a laydown area at the west end of the portals bench.

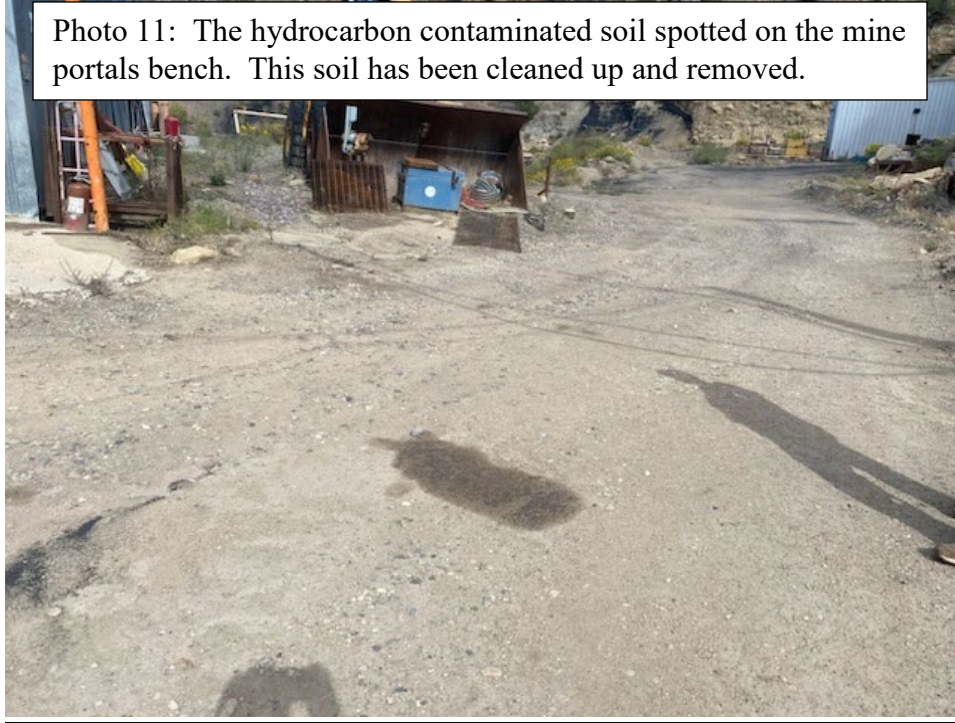
During the Division's inspection, a couple of maintenance items were identified. A small patch of soil had been contaminated by hydrocarbons on the access road in-between the shop and the filter storage shed (Photo 11). The Division gave the operator a due date of September 30, 2023 to clean up and remove the contaminated soil. On September 26, 2023 the Division received notification from the operator that the contaminated soil had been cleaned up and removed. The second item was removing a piece of the old silt fence material that was partially lodged in the dirt next to the south office pad sump (Photo 2). The Division received notification from the operator on September 29, 2023.

Photo 11: The hydrocarbon contaminated soil spotted on the mine portals bench. This soil has been cleaned up and removed.

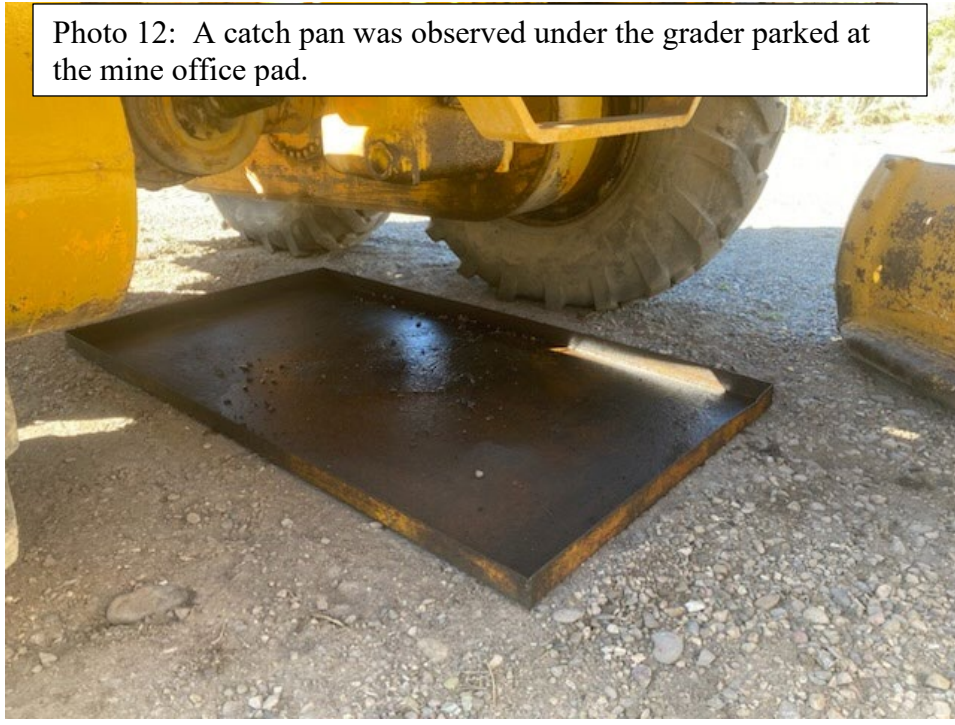
During the inspection the Division observed catch pans placed underneath the operator's grader (Photo 12). There was no evidence of contaminated soils from any leaked hydrocarbons.

Photo 12: A catch pan was observed under the grader parked at the mine office pad.

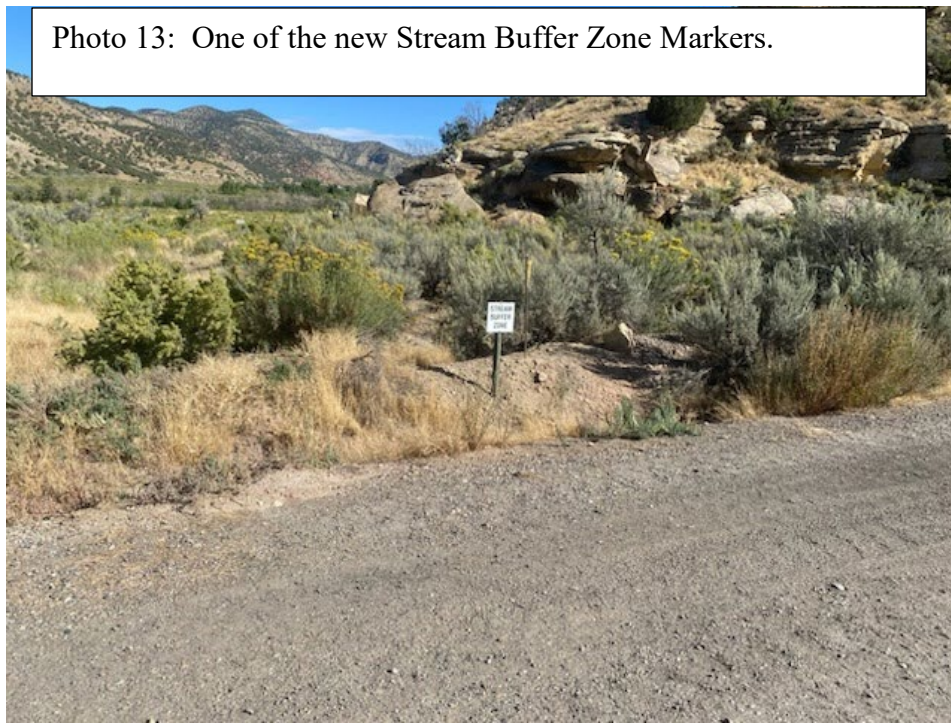
Stream buffer zone markers were placed in-between the north side of the haul road and the equipment laydown area, and Upper McClane Creek (Photo 13).

Photo 13: One of the new Stream Buffer Zone Markers.
