Deserado Mine, C-1981-018, September Complete Inspection Report

PERMIT INFORMATION

Permit Number: C-1981-018 Mine Name: Deserado Mine Operator: Blue Mountain Energy, Inc. Operator Address: Mr. Kurtis Blunt 3607 County Road 65 Rangely, CO, 81648	County: Moffat, Rio Blanco Operation Type: Underground Permit Status: Active Ownership: Private
	Operator Representative Present: Kurtis Blunt
Operator Representative Signature: (Field Issuance Only)

INSPECTION INFORMATION

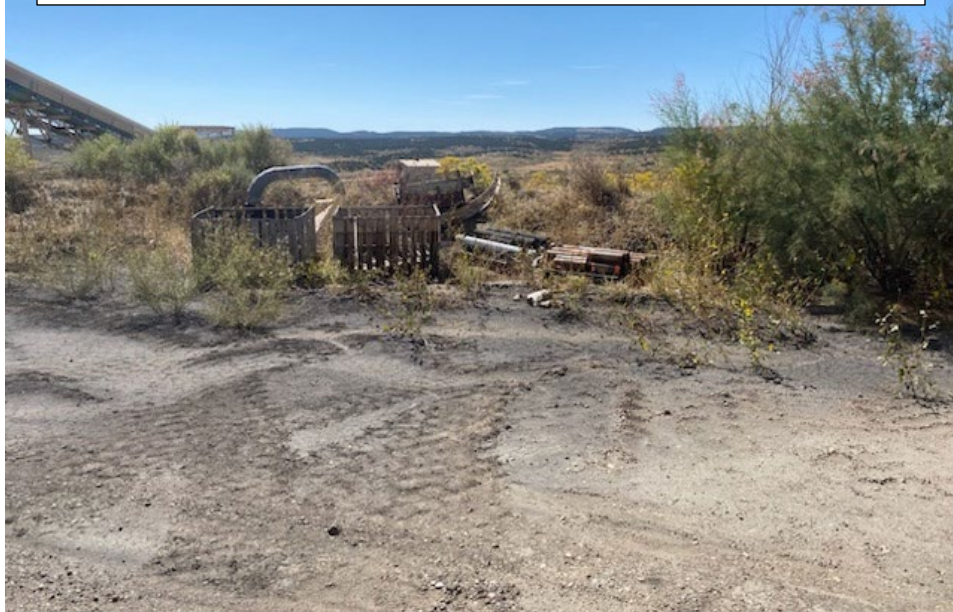
1. Waste debris was spotted outside the excavated pits at the Halandras Landfill. **Please clean up all waste debris and return it to the landfill.**
2. A small pile of material was found stockpiled against the southwestern berm at the Slot Storage. **Please clean up the materials and remove them to an appropriate laydown area (Photo 1).**

Photo 1: The materials stockpiled against the berm at the Slot Storage.

Support Facilities inspected included; Main Facilities/B Portals, Haul Road Blisters, RDH-2, Halandras Landfill, Slot Storage Facility, RDH-4, Conveyor Corridor, 2023 Drilling Program Pads LWC 16/17, B Vent Shaft No. 1 (Photo 11), and the Explosives Storage (Photo 12). Pads for the support facilities were found to be stable with no erosional concerns. Pads with berms were stable with vegetative cover. No off-site impacts were observed. A small pile of material was found stockpiled against the southwestern berm at the Slot Storage. **Please clean up the materials and remove them to an appropriate laydown area.**

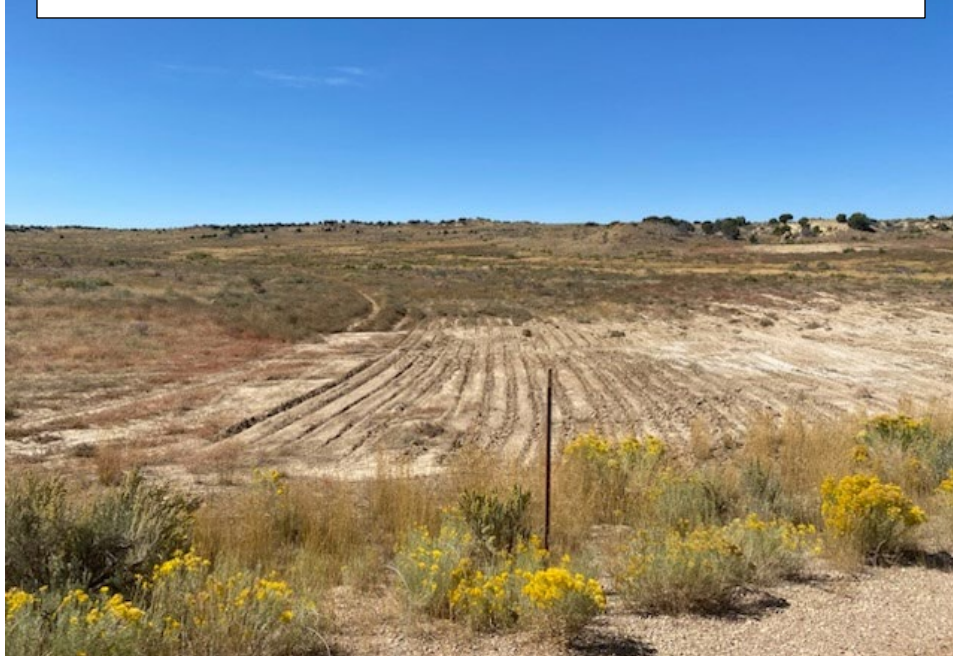
The Division inspected the recently reclaimed LWC-16 (Photo 2) and LWC-17 drill pads. The pads had been backfilled with topsoil replaced. The pads were returned to approximate original contour and were ripped to roughen the soil surface. The pads, along with other 2023 drill pads, are scheduled to be seeded this fall. The reclaimed pads were observed to be stable with no erosional features.

Photo 2: The reclaimed LWC-16 drill pad.

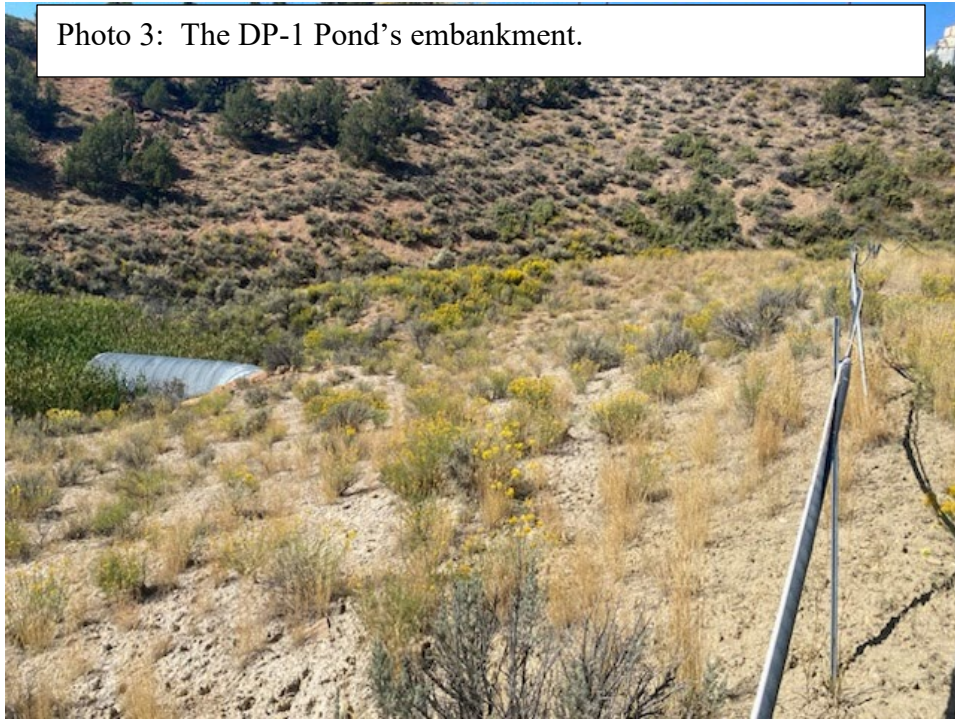
Three sediment ponds are located within the main facilities area. The DP-1 pond is located at the southern end of the lower facilities pad. The pond received and treats all runoff from the main facilities area. The pond was impounding water. The trash rack covering the discharge outlet was clear of debris and functioning as designed. The pond was observed to be discharging to Scullion Gulch. The pond's embankment was stable with vegetative cover (Photo 3). There were no indications of erosion. The PP-1 Pond is located on the prep plant bench. The pond was holding water during the inspection (Photo 4). No discharge was observed. The discharge outlet was unobstructed. The pond was stable and there were no erosional concerns identified. The PP-2 Pond is located on the upper facilities bench. PP-2 was also holding water with no discharge occurring. The pond's embankment was vegetated and stable. No erosional concerns were observed. The operator stated during the inspection that the facilities ponds were scheduled to be cleaned in the near future.

Photo 3: The DP-1 Pond's embankment.

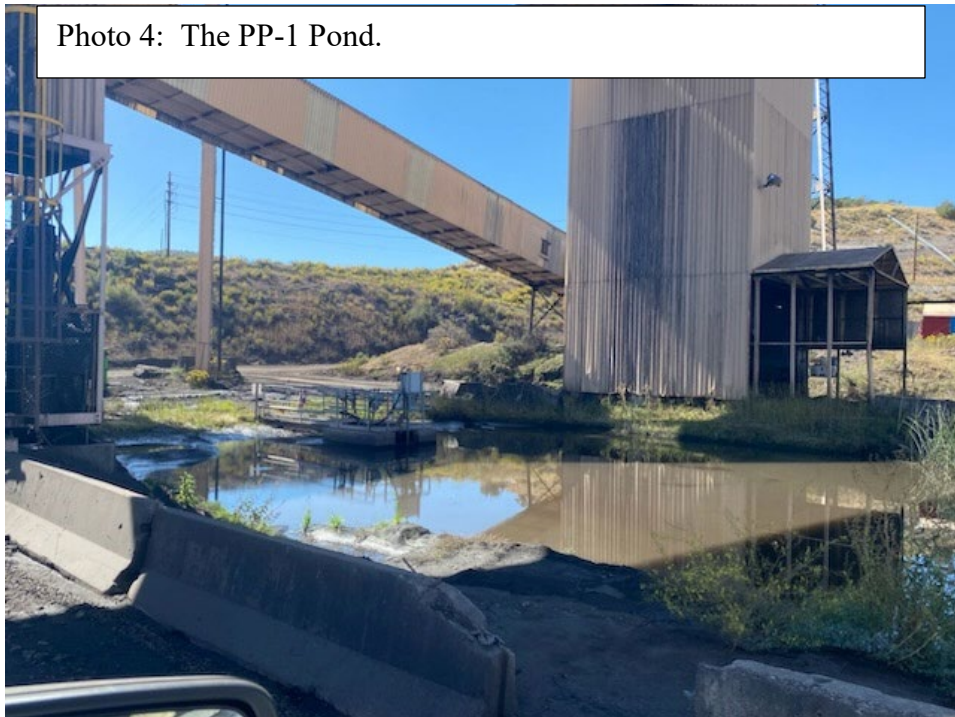
Photo 4: The PP-1 Pond.

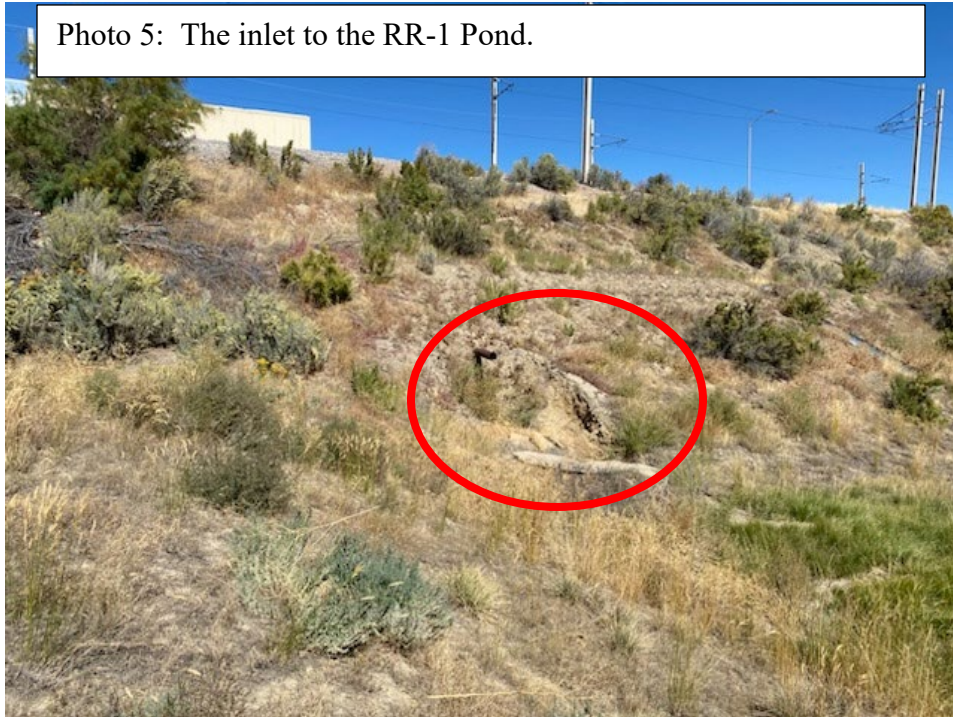
A sump, RS-1, and a pond, RR-1, are located below the south embankment of the rail loadout. The RS-1 sump was dry at the time of the inspection. The sump's embankments were stable with no erosion. The outlet for the sump was observed to be clear. The RR-1 pond was also dry. The pond's embankment was covered with vegetation and stable. The inlet to the pond has been previously documented to have minor erosion (Photo 5). The erosion has down-cut the inlet into the south embankment of the rail loadout. This erosional feature has been documented in previous DRMS inspections and is not thought to cause any structural instability. The pond's outlet was clear. There is a ditch running along the face of the rail loadout south embankment that transports runoff to RS-1 and RR-1. The ditch was dry and stable. During the inspection vegetation was noted to have grown in the bottom of the ditch. Evidence of flow through the ditch demonstrated that there has been no blockages or channel escapement. **The Division recommends the ditch be cleaned out during the normal spring maintenance in 2024.**

Photo 5: The inlet to the RR-1 Pond.

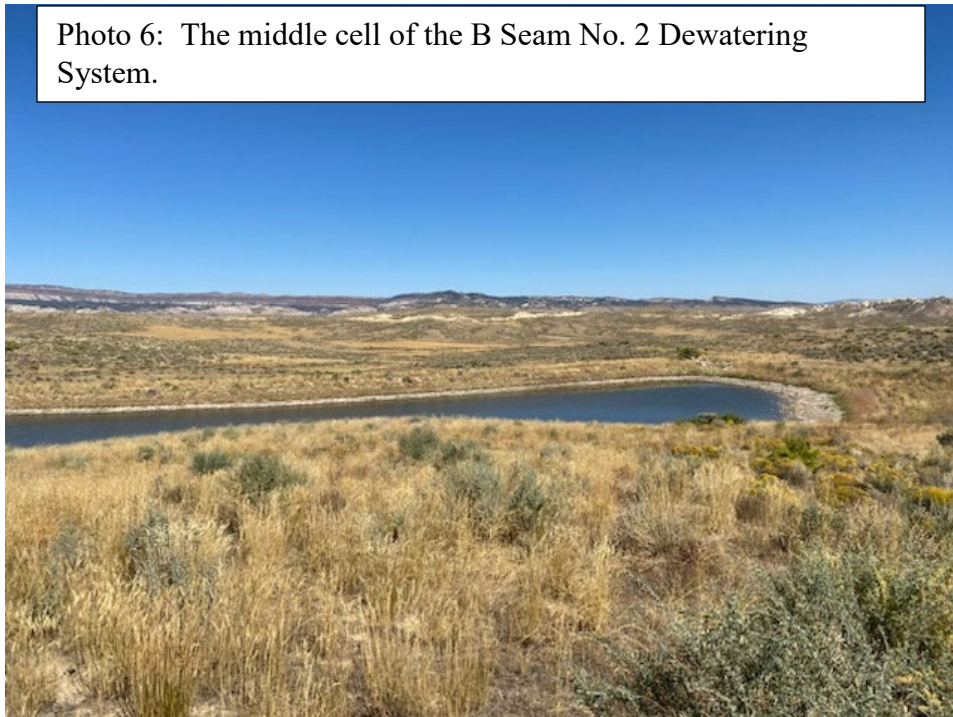
dewatering system. The middle cell was holding water below the level of the primary spillway, no discharge was occurring (Photo 6). The upper cell was dry. The east embankment of the upper cell had been recently repaired. (Photo 7) Embankments for the system were stable with vegetative cover. There were no indications of erosional features.

Photo 6: The middle cell of the B Seam No. 2 Dewatering System.

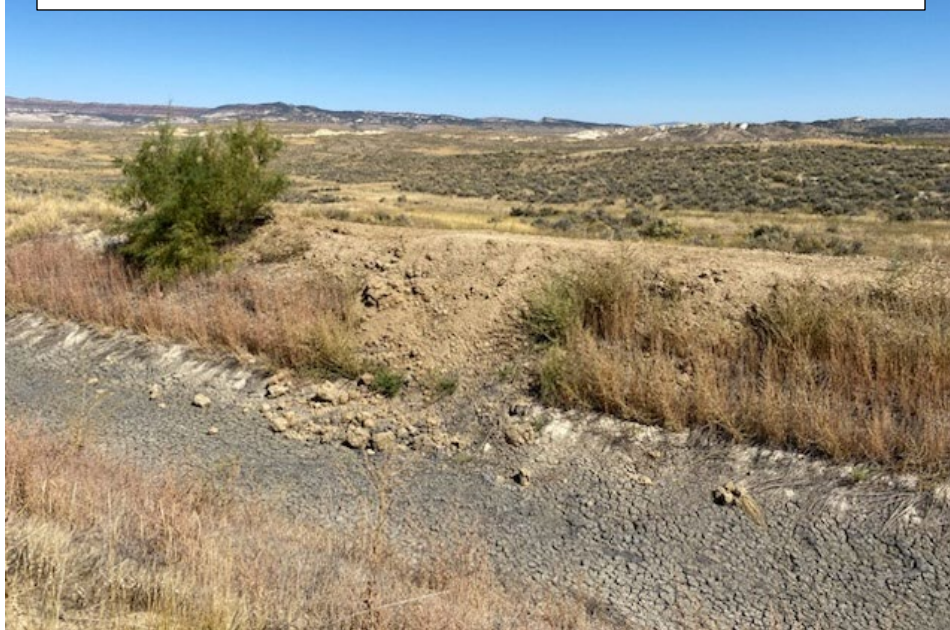
Photo 7: The repaired section of the B Seam No. 2 Dewatering System's upper cell.

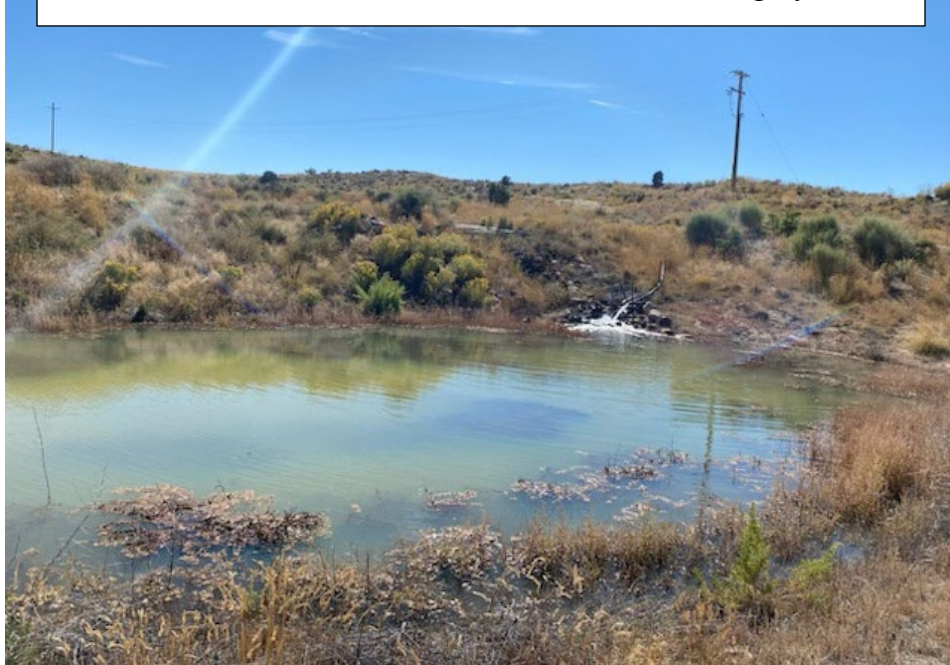
The SDH-3/5 D Seam Dewatering System is located in the southeastern portion of the permit area, on the east side of Red Wash. The dewatering system was active during the inspection (Photo 8). Only the lower cell is utilized to impound and treat water pumped from the D Seam workings. The pond was discharging through an unobstructed spillway. The embankment was vegetated and stable. There were no erosional features.

Photo 8: The Inlet to the SDH-3/5 D Seam Dewatering System.

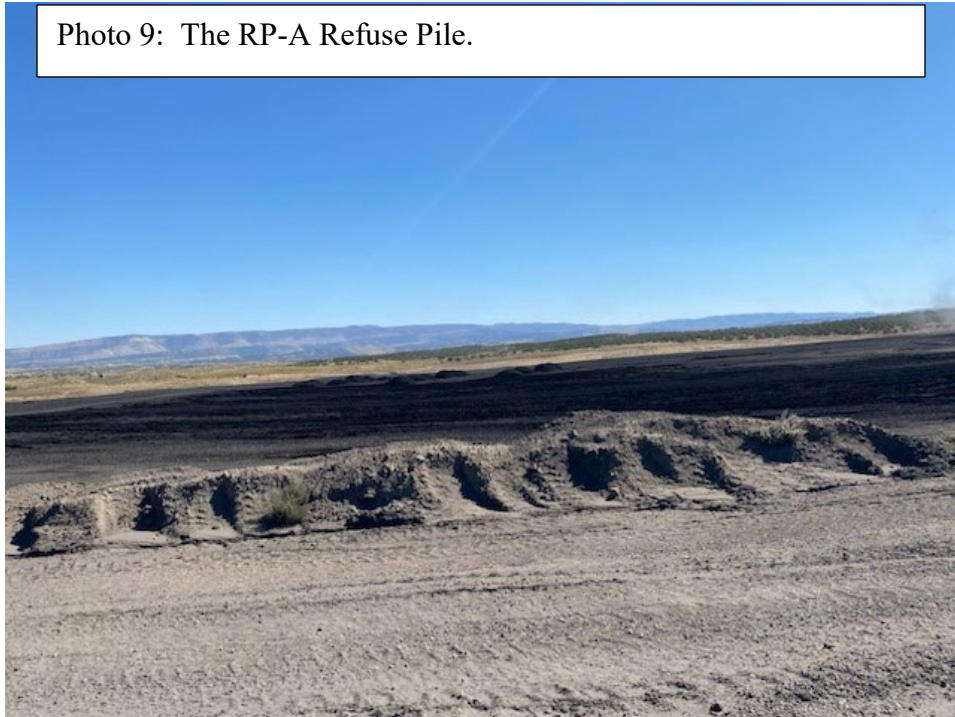
Refuse Material was actively being placed on the RP-A Refuse Pile. Material was being stockpiled in windrows to allow the material to dry before it will be spread and compacted (Photo 9). The RP-A refuse pile was stable with no erosional concerns. The ditches associated with the refuse pile were clear and dry.

Photo 9: The RP-A Refuse Pile.

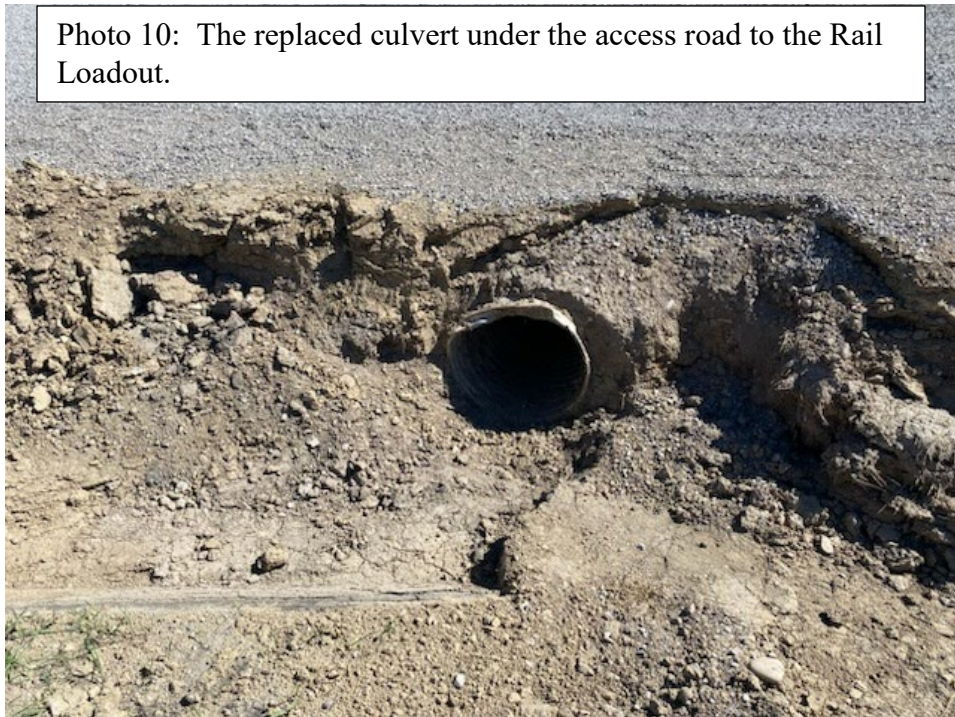
The Haul Road extends from the Main Facilities Area to the Refuse Disposal Piles. The haul road was stable and in good condition. There were no indications of erosion. The portion of the access road extending from the haul road at the intersection of the conveyor belt, to the Rail Loadout was well maintained. There were no sections with instability or erosion. A culvert located just east of the Nitrogen Plant No. 2 had been replaced (Photo 10). The culvert had become plugged and had deteriorated to the point where the operator deemed it necessary to replace the culvert over clearing it. Various access roads throughout the mine site were traversed during the inspection. Access roads were observed to be well maintained and stable. No erosional concerns were identified.

Photo 10: The replaced culvert under the access road to the Rail Loadout.

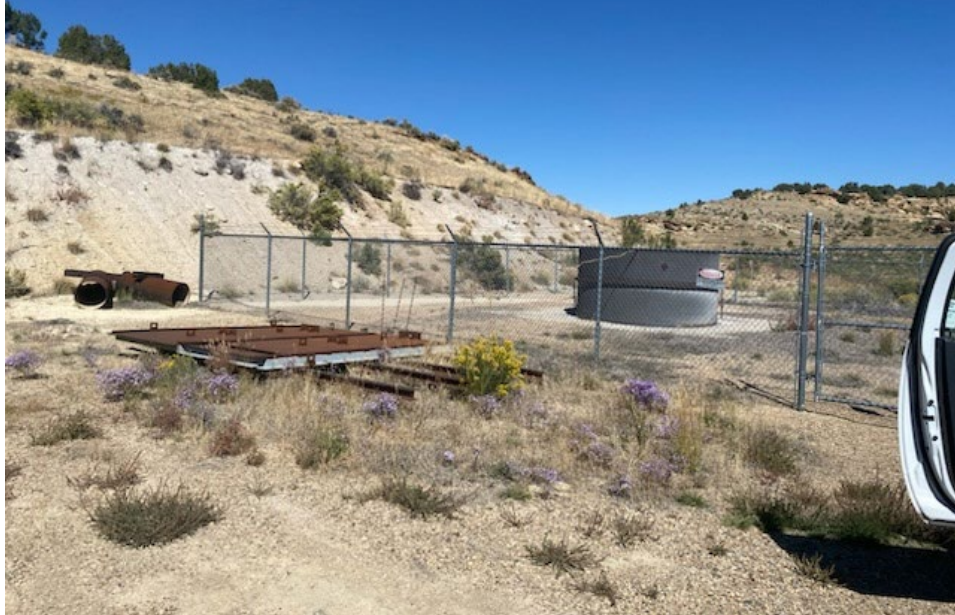
Photo 11: The B Vent Shaft No. 1 and pad.

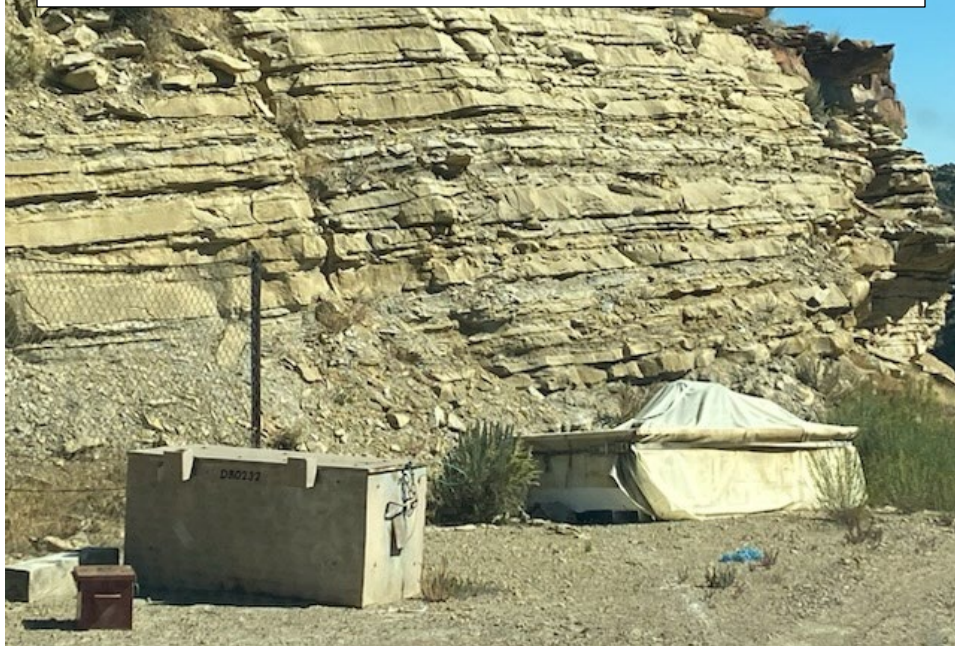
Photo 12: The Explosives Storage Area.
