C1980007, West Elk Mine, September Inspection Report

PERMIT INFORMATION

INSPECTION INFORMATION

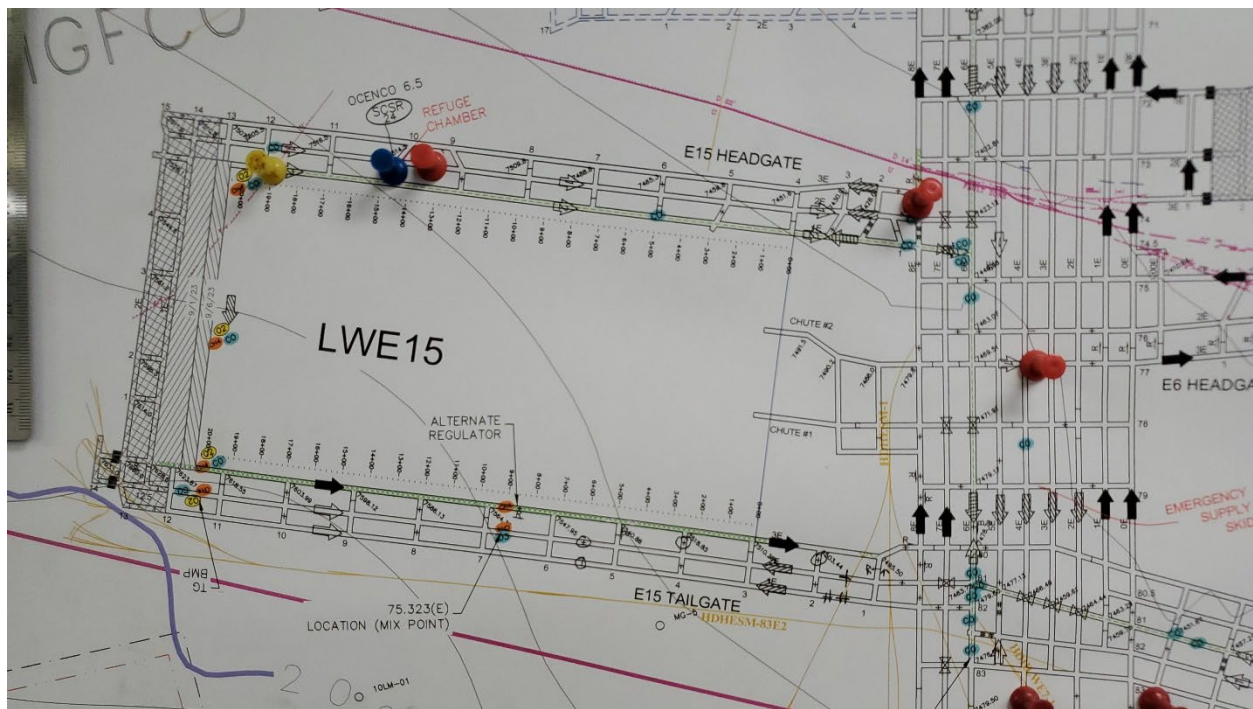
Longwall mining of the LWE15 panel was in progress, between crosscuts 13 and 12 on the headgate. Development of the LWE12 tailgate and start line was complete - the panel had been shortened from what had originally been planned - and development of the headgate was in progress, with crews advancing towards each other from around crosscuts 9 and 17.

Figure 1: Mine map showing longwall progress in LWE15

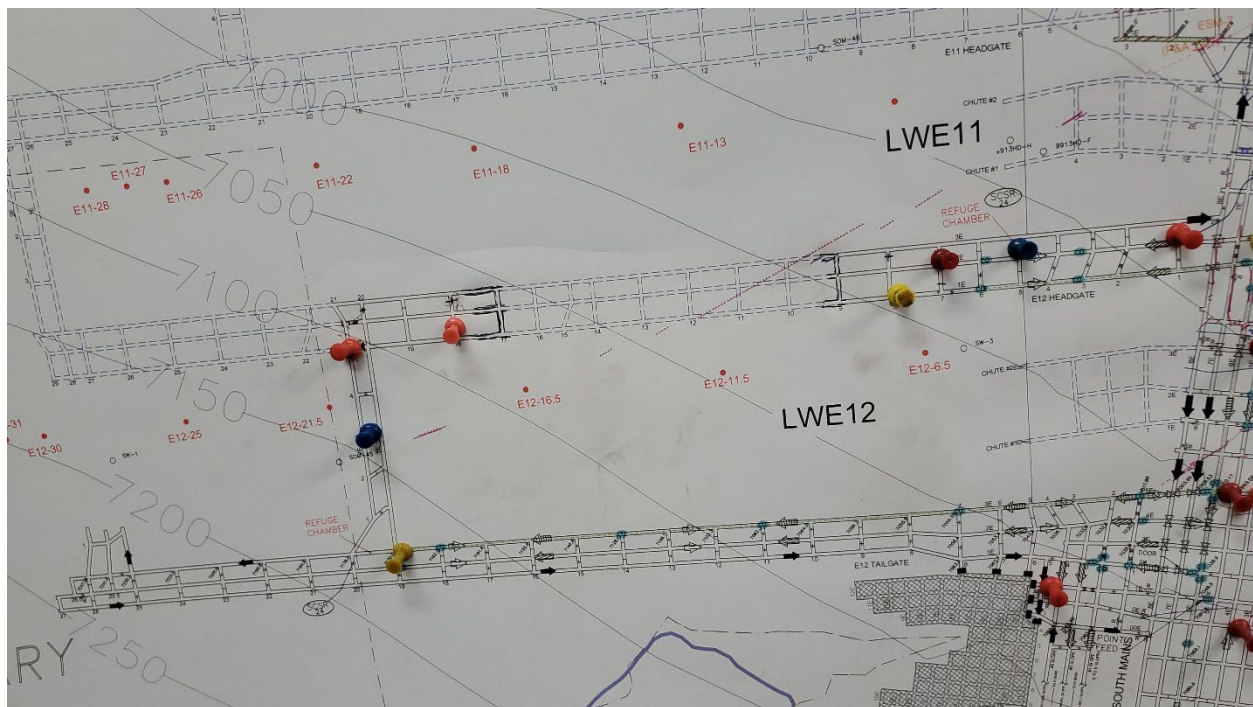
Figure 2: Mine map showing progress on development of LWE12

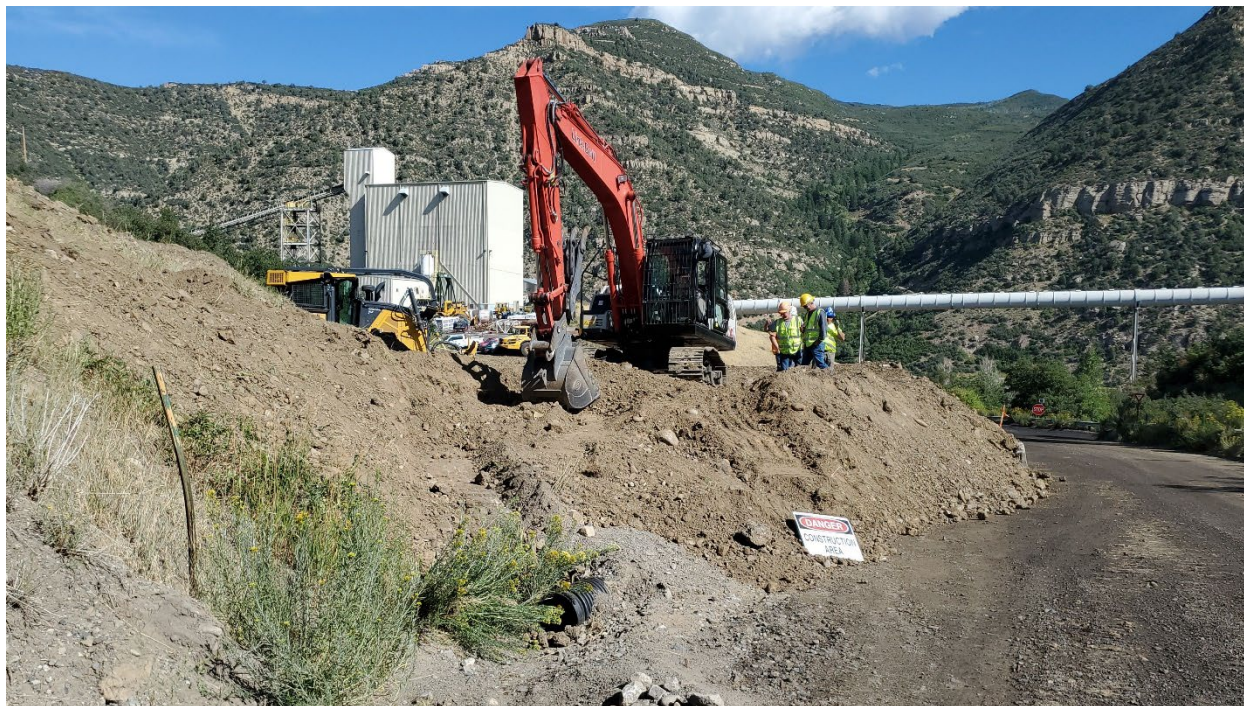
Contractors with D&S Underground were working to construct a pad for the recently permitted Box Canyon Well (MR-474). The pad footprint had temporarily spread into the Sylvester Gulch Haul/Access Road, covering the roadside ditch which had been diverted through a culvert. After the well has been constructed the pad will be reduced in size and the ditch restored.

Figure 3: Work in progress to construct temporary pad for Box Canyon Well construction; temporary culvert visible in foreground.

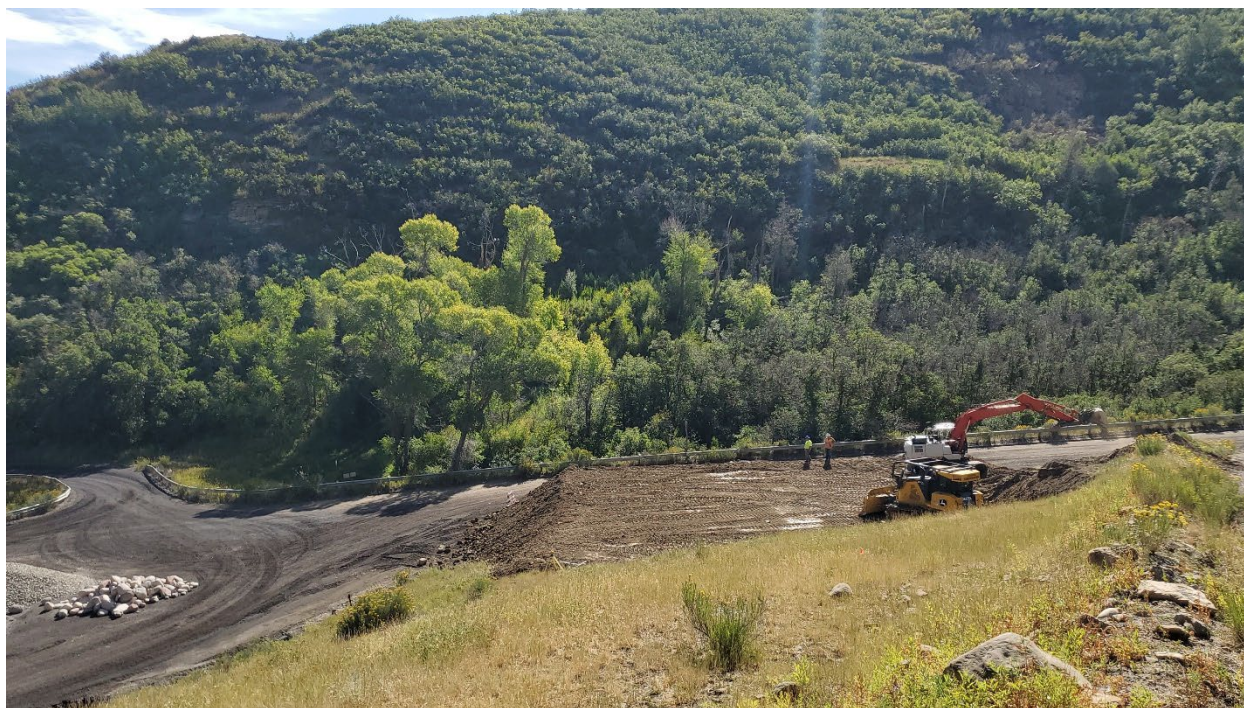
Figure 4: Box Canyon Well pad from above

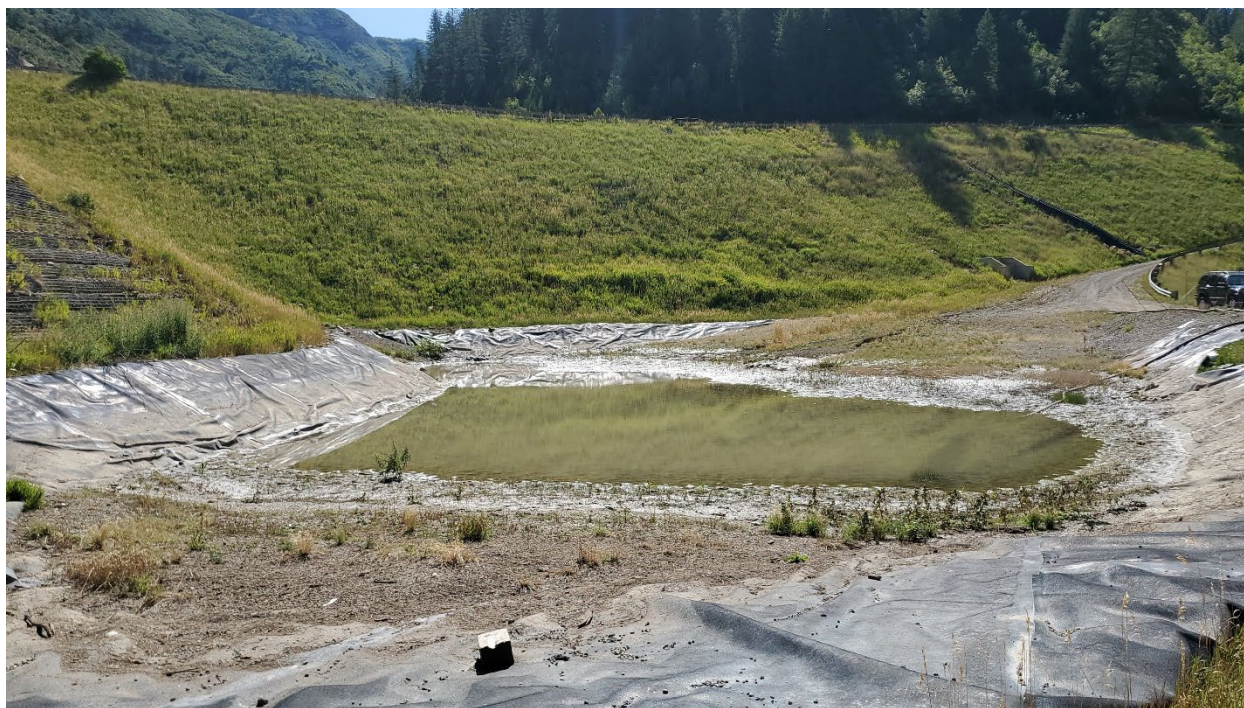
Based on a review of the quarterly reports, the SG-1 and MB-4 ponds were last cleaned in 2021 Q2. No other ponds have been cleaned since then, but a note on the 2023 Q1 and Q2 reports says that the RPE-East pond needs to be cleaned, (the 2023 Q3 report has not yet been submitted). The sediment level in the SG-1 pond was last reported as 5%. Page 2.05-31 of the Permit Application Packet (PAP) states that:

Figure 6: SG-1 pond

The quarterly reports since 2020 Q4 don't refer to any sediment surveys. **Please provide details of the most recent sediment level survey.**

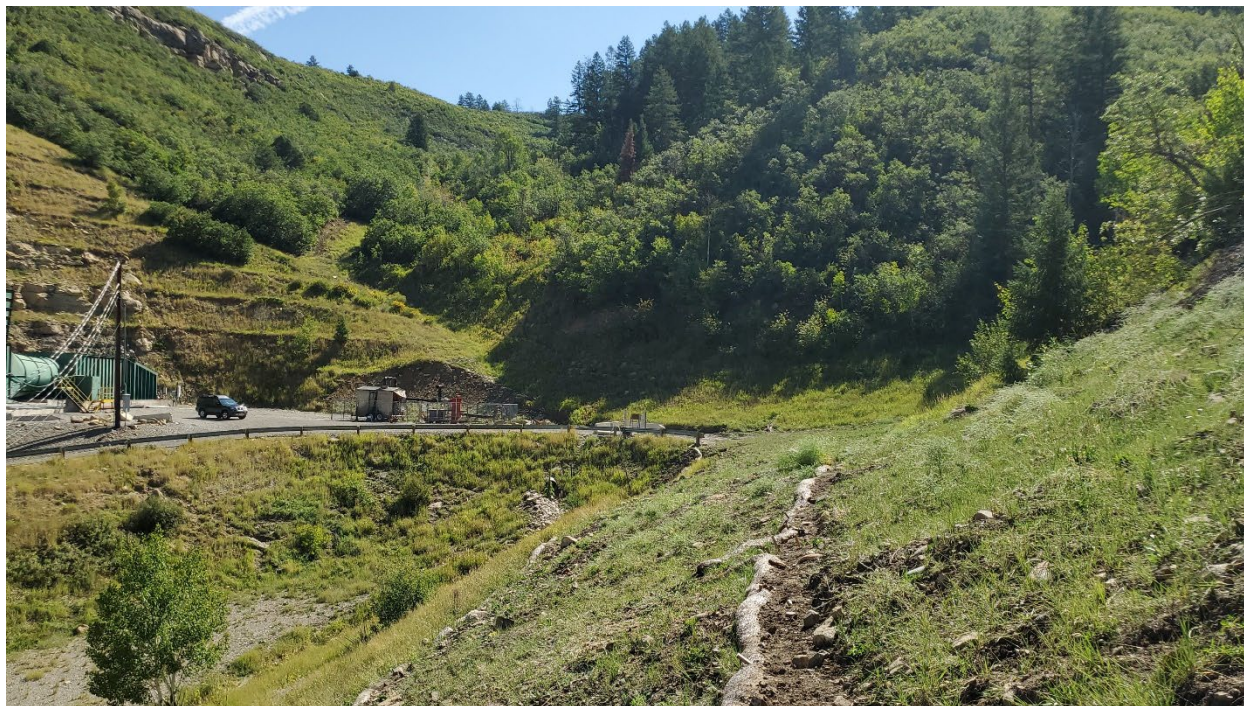
Straw wattles had been effective in controlling runoff on the reclaimed slope west of Shaft #3, however the wattles were in need of repair in places.

Figure 9: Reclaimed slope west of Shaft #3 pad

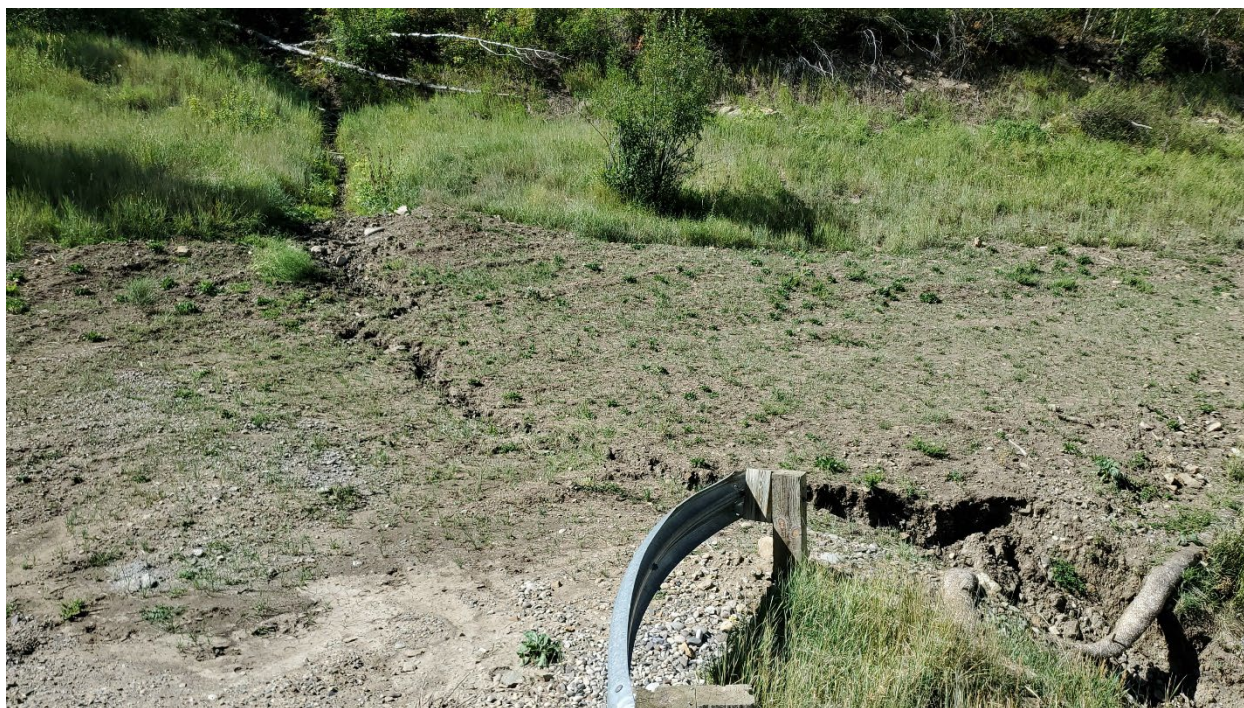
Surface water drainage across the eastern edge of the slope had caused erosion, particularly at outfall 034 (see figures 10 and 11). The slope should be repaired when conditions allow.

Figure 10: Surface water drainage across reclaimed slope west of Shaft #3 pad

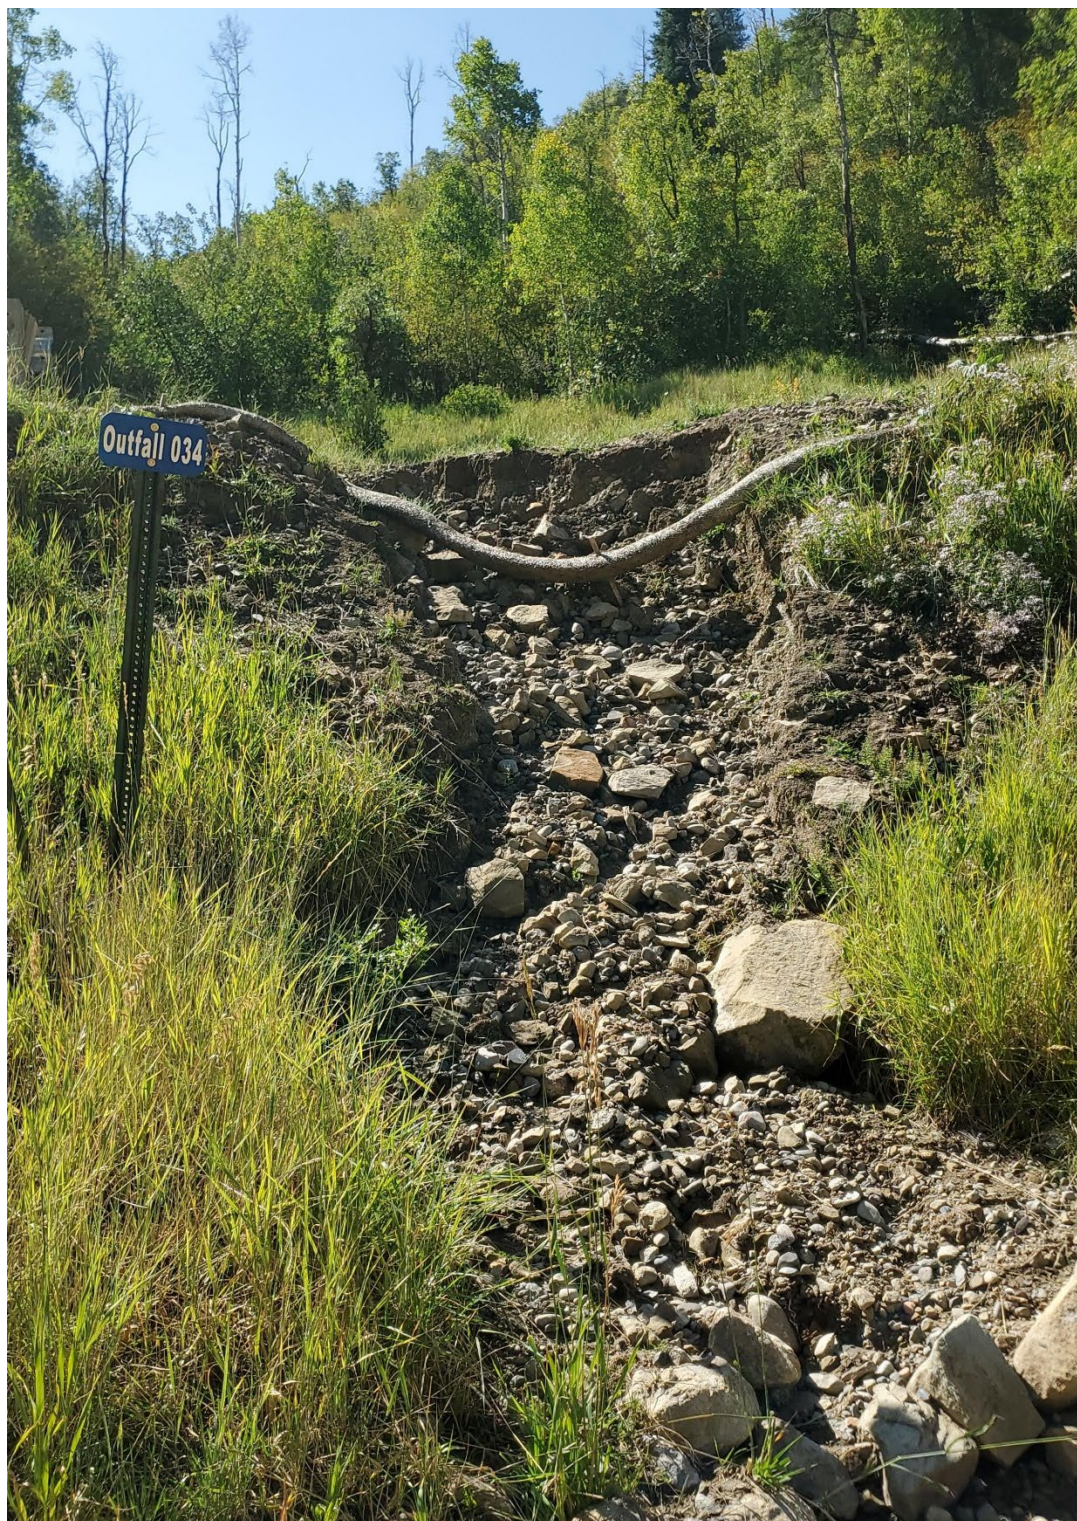
Figure 11: Slope at Outfall 34, needs maintenance

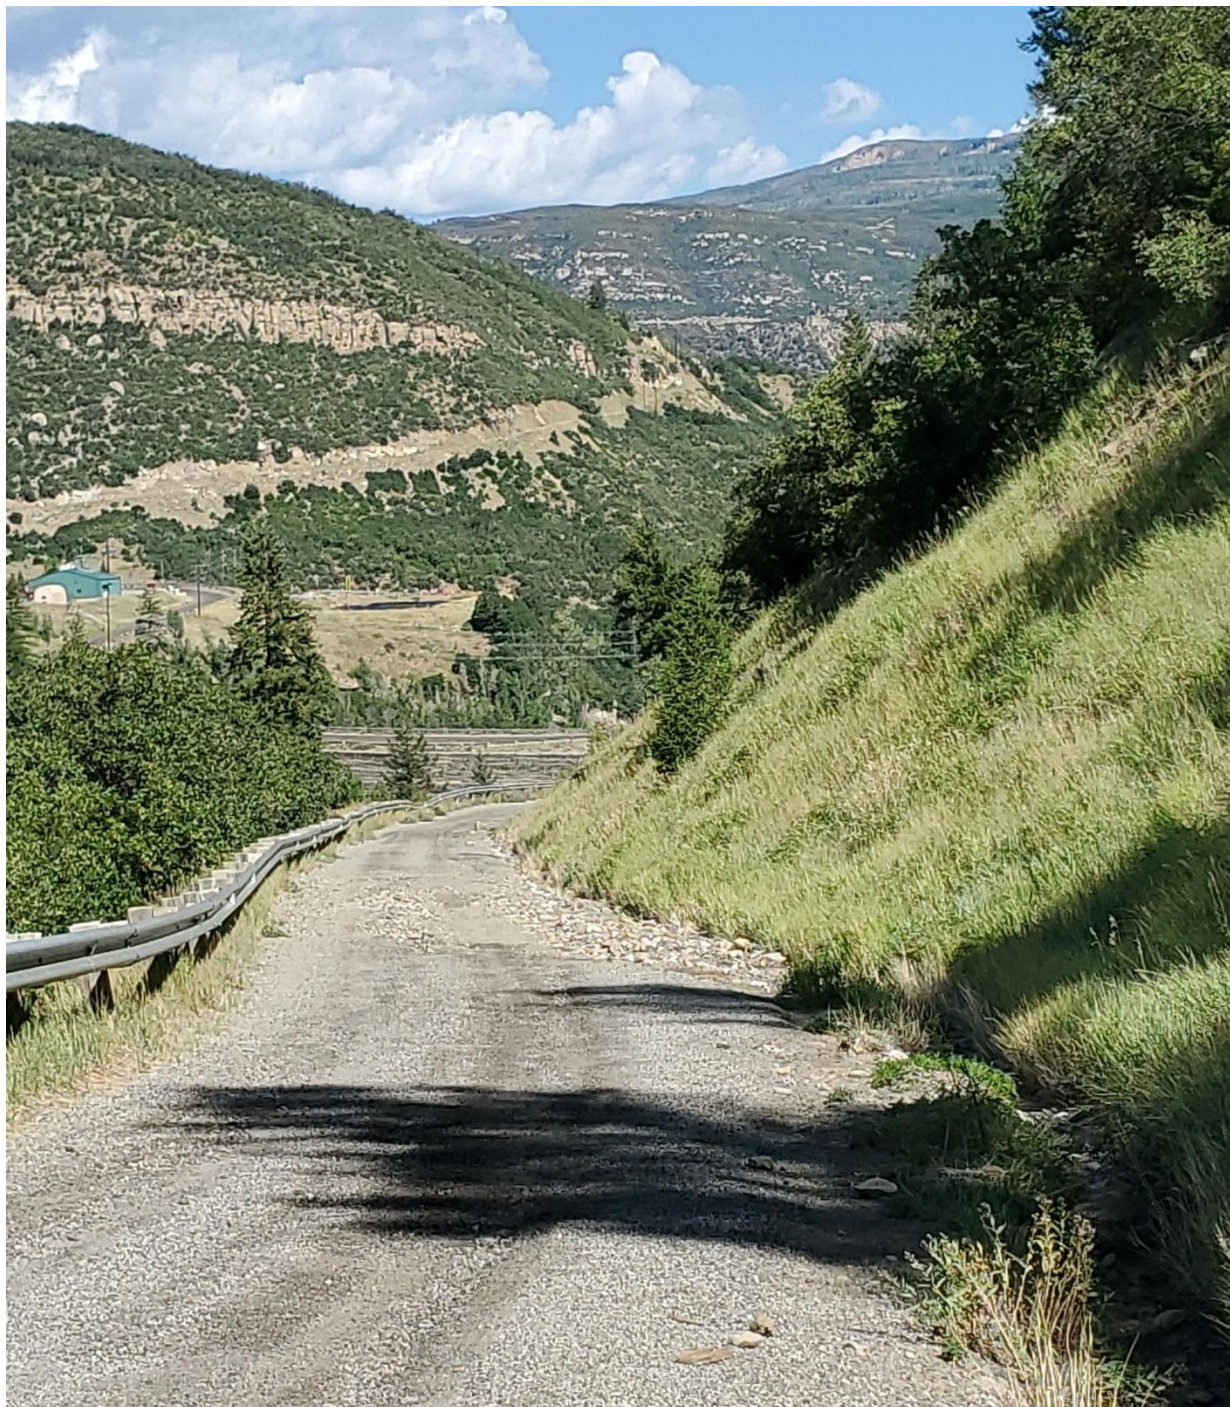
The ditch beside the road leading to Shaft #3 (DSLY-14) had breached and debris had spread across the road. Maintenance of the ditch and road is necessary (see figure 13)

Figure 13: Road to Shaft #3. Road and ditch need maintenance

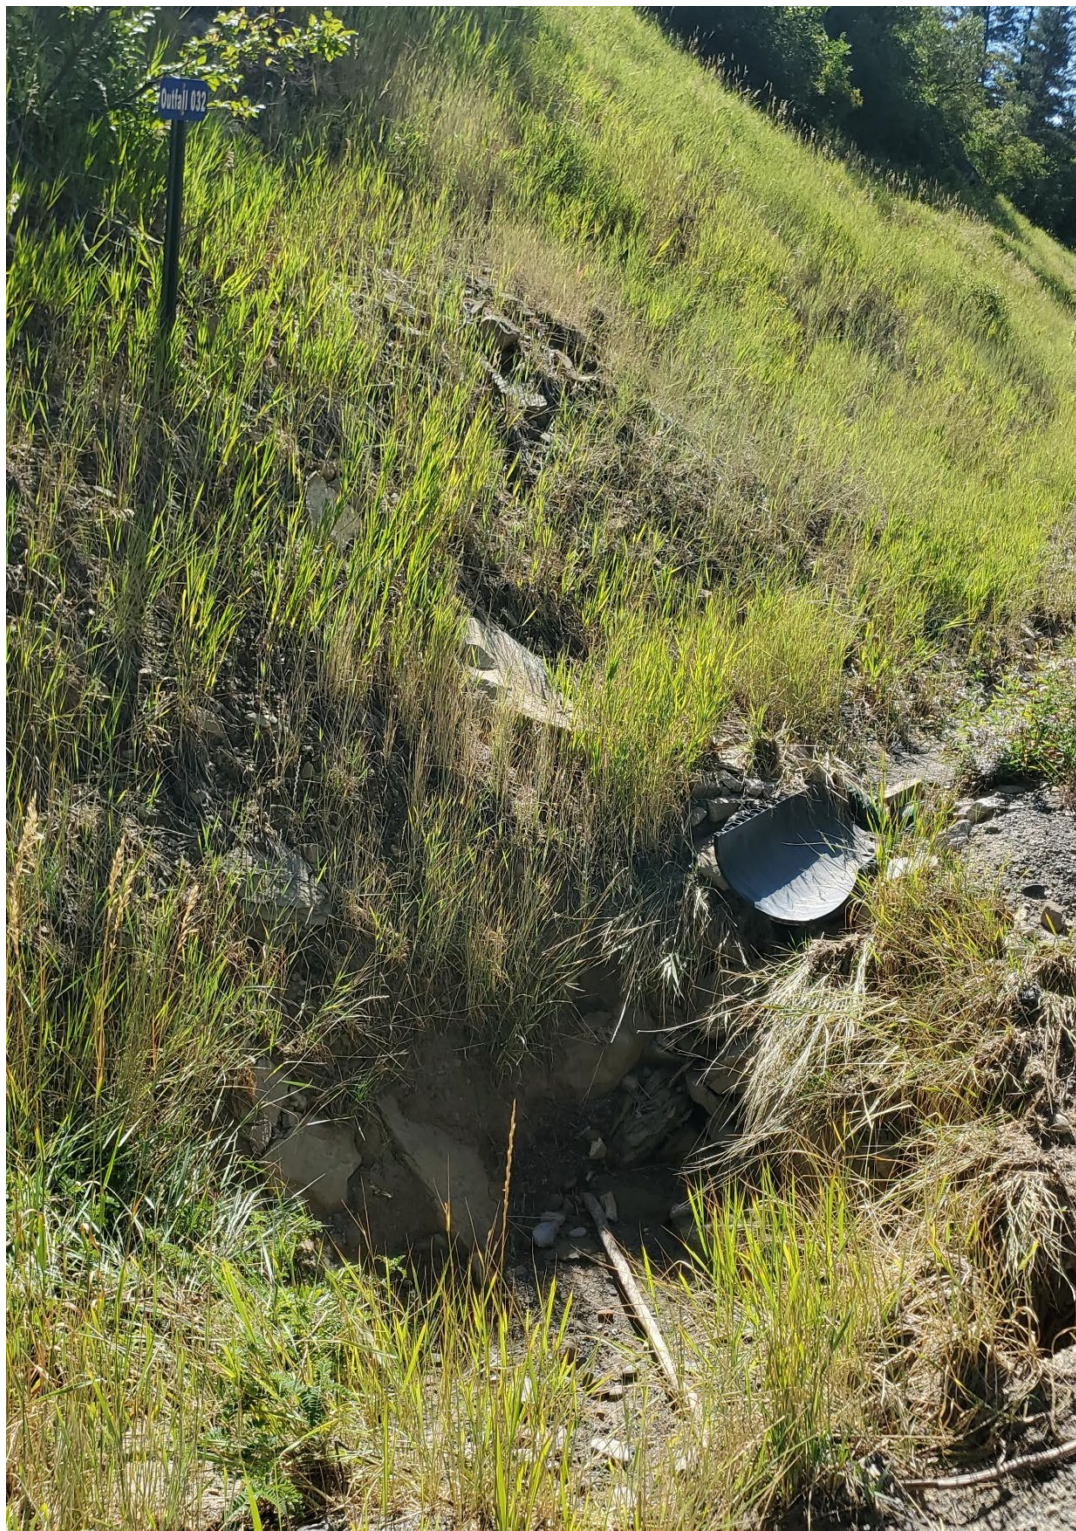
The sediment trap at Outfall 032 was in need of maintenance, (see figure 14).

Figure 14: Sediment trap below Outfall 32 needs maintenance

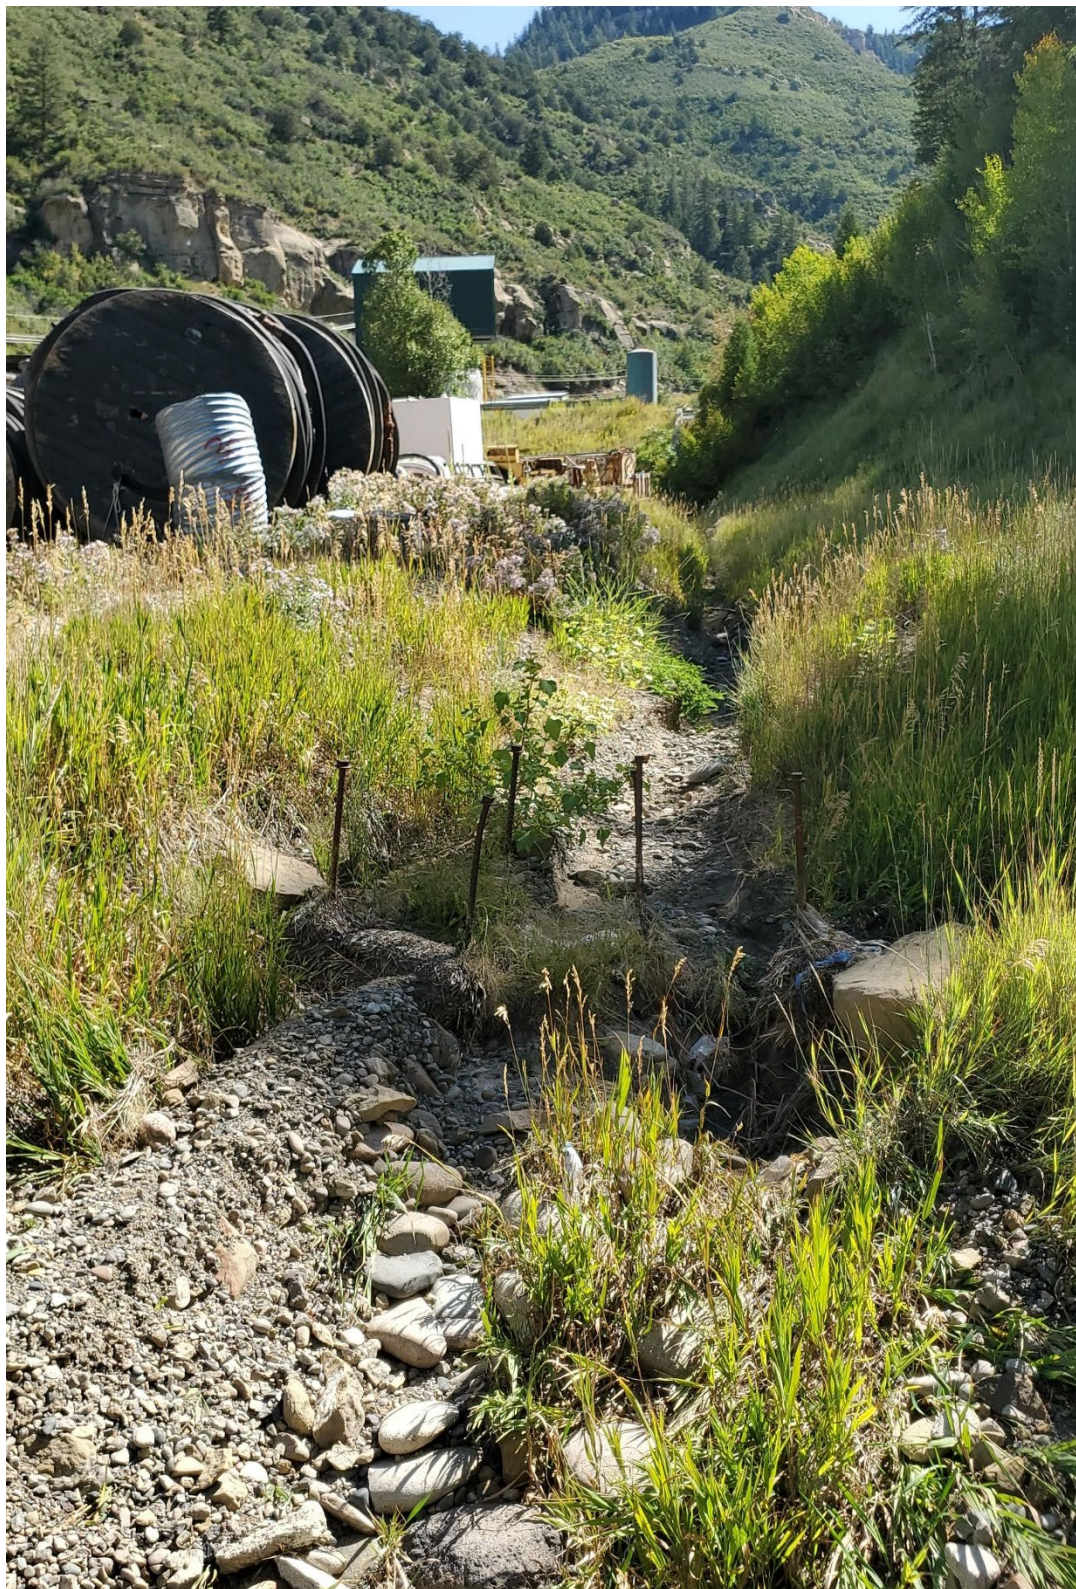
The ditch on the south side of the main Sylvester Gulch facilities area (DSG-1) and the sediment trap at the western end of the ditch were both in need of maintenance, (see figures 15 and 16).

Figure 15: Ditch beside Sylvester Gulch materials storage area needs maintenance

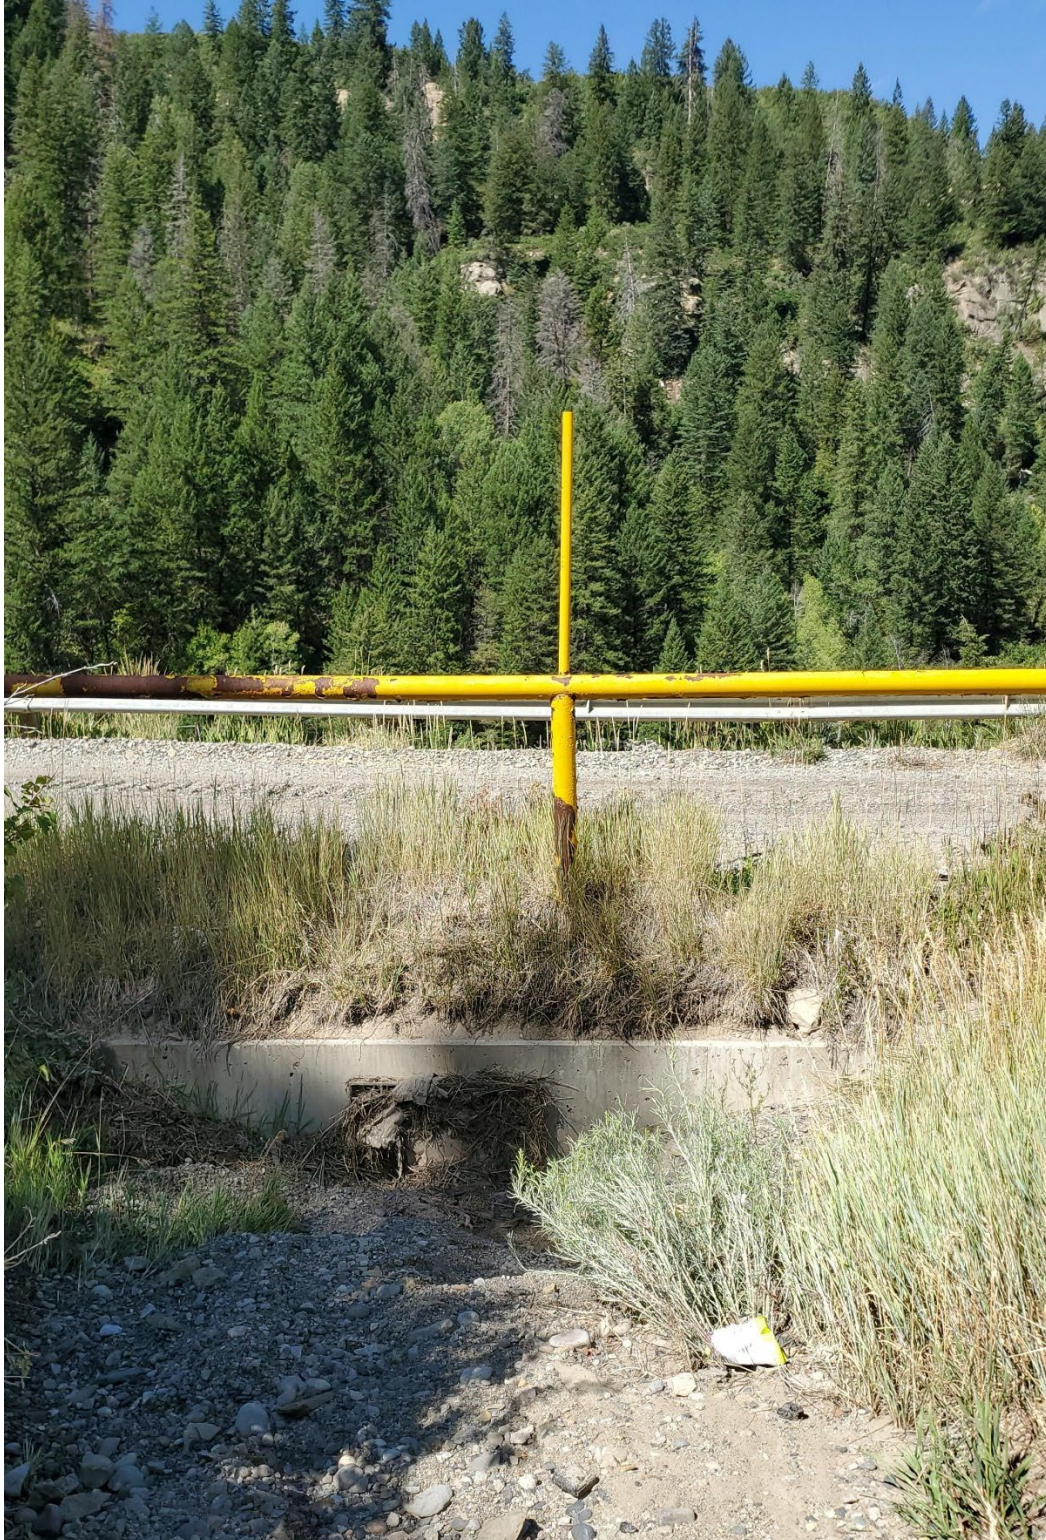
Figure 16: Sediment trap beside Sylvester Gulch materials storage area needs maintenance

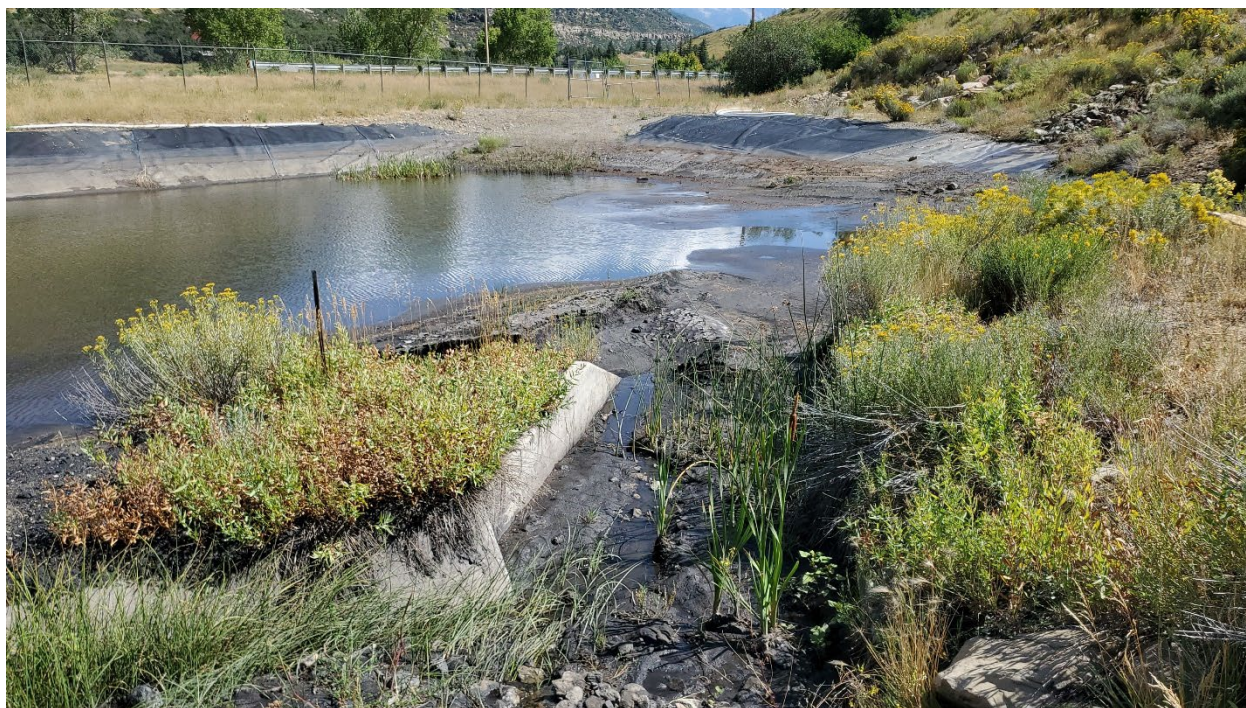
The ditch leading to the RPE ponds, beside the access road (DRPE-2) was in need of maintenance (see figures 18, 19 and 20).

Figure 18: RPE pond (east)

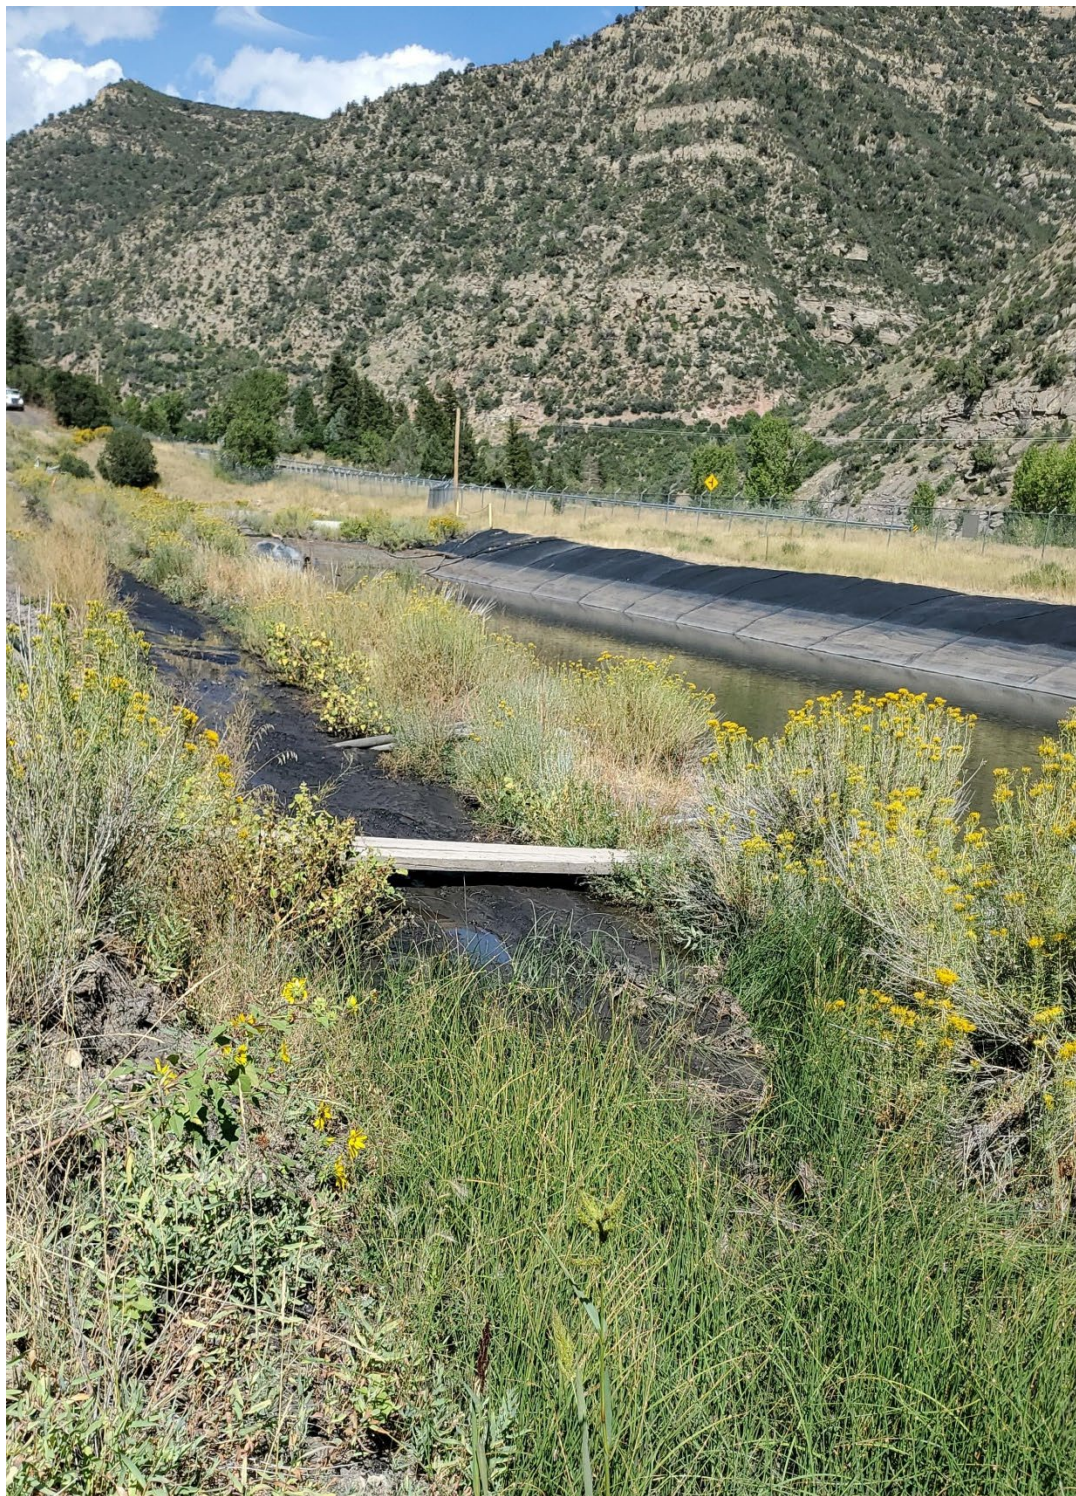
Figure 19: RPE pond (west)

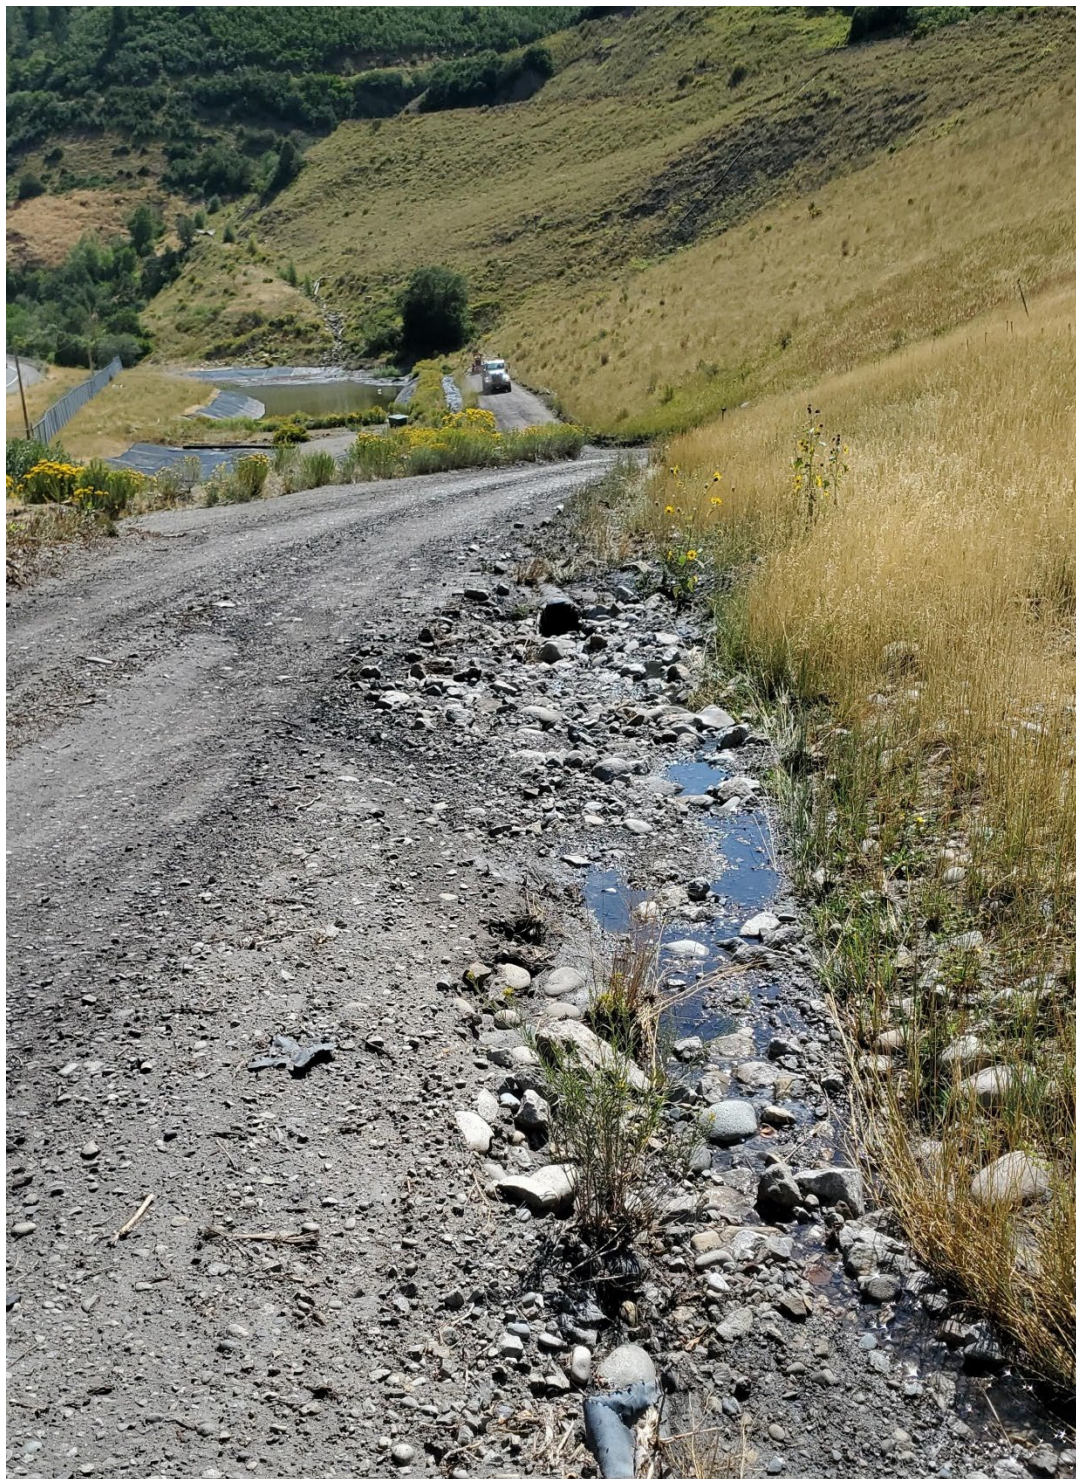
Figure 20: RPE ponds

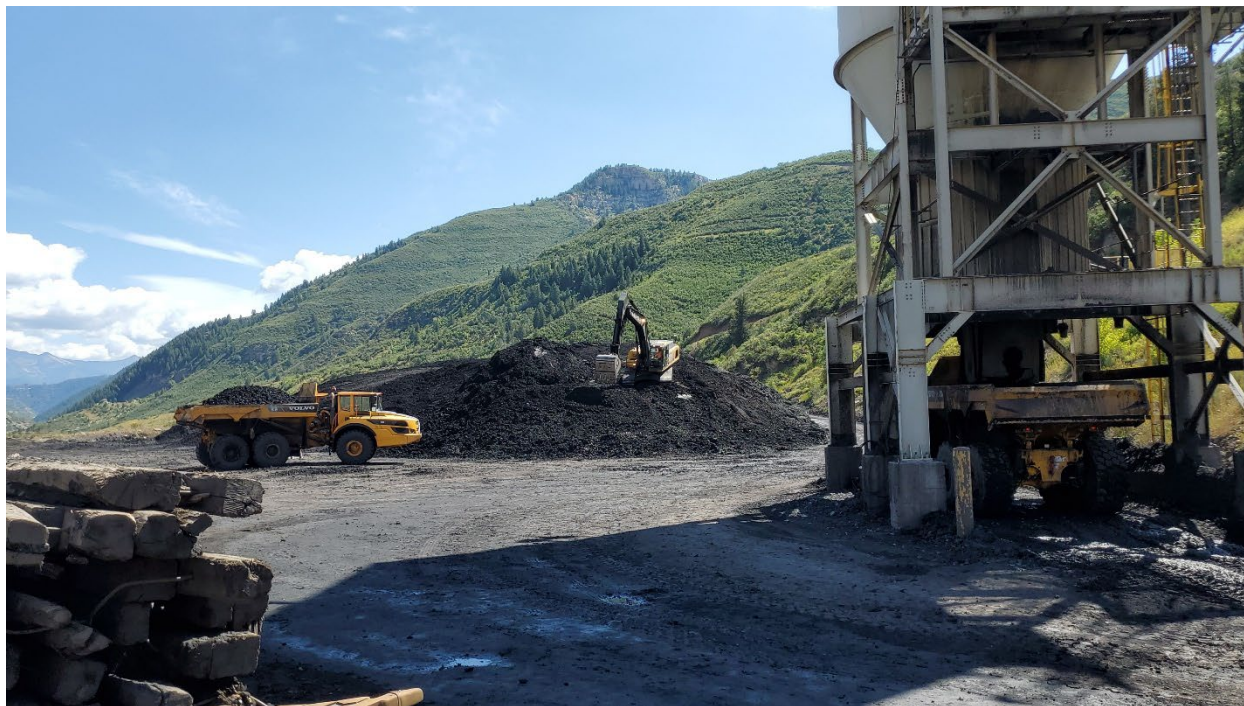
At the time of the inspection haul trucks were transporting fines as described above; waste from the temporary stockpile on the RPE to the RPEE; and new waste from the chute coming from the wash plant to the RPEE.

Figure 21: Temporary waste pile on RPE

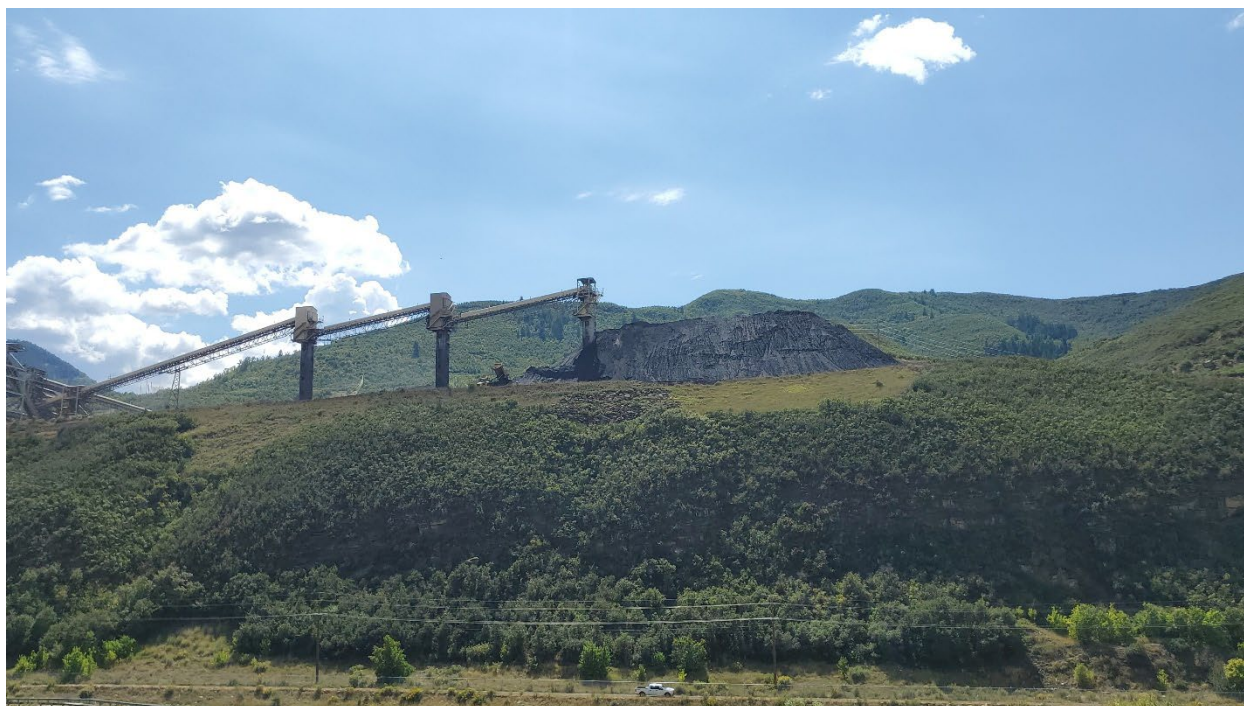
As has been the case for several months, coal fines from the wash plant were continuing to accumulate at Stack Tube 5 on the Clean Coal Stockpile pad. Some fines were being blended into the mix to load the trains from this location, but the rate at which fines were being produced continued to exceed the rate at which they could be blended into the coal being loaded onto trains. Excess fines were being transported by truck to the west end of the run-of-mine coal stockpile pad, west of Stack Tube 3, (see figure 22).

Figure 22: Fines stored on Run-of-Mine coal stockpile

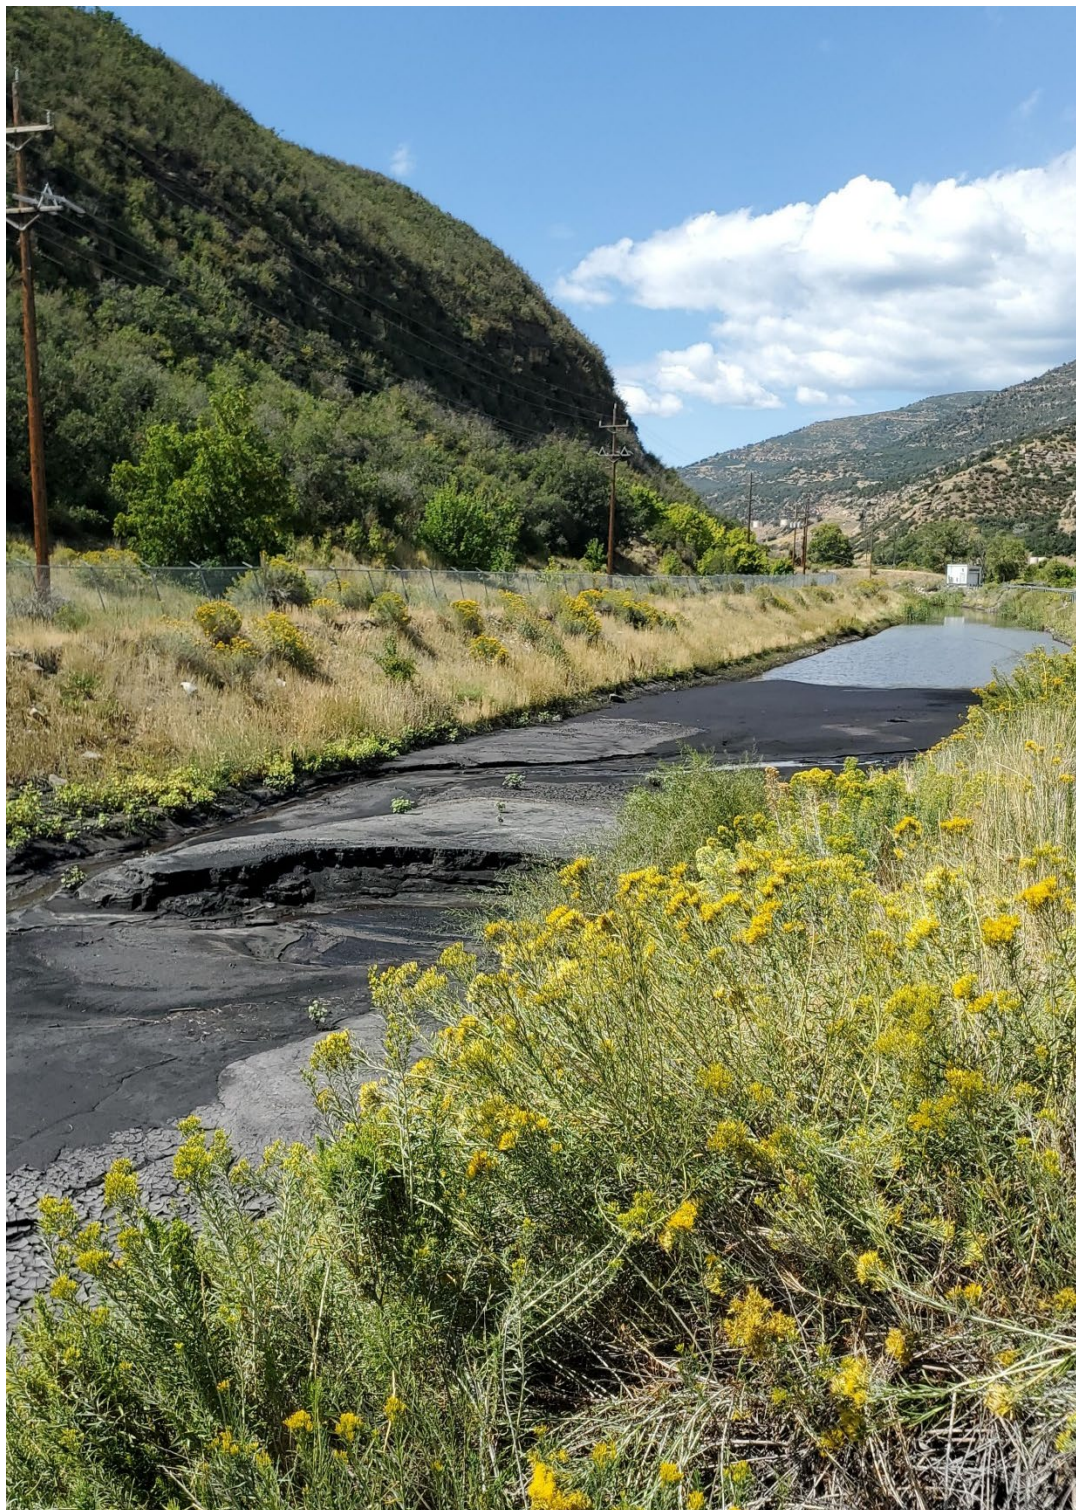
A substantial amount of sediment had accumulated in the south cell of the MB-5E pond, but it was hard to estimate by eye with precision. Based on the sediment level survey, it may be that this cell needs to be cleaned (see figure 23).

Figure 23: MB-5E pond (south)
