New Horizon Mine, C-1981-008, September Inspection Report

PERMIT INFORMATION

Permit Number: C-1981-008 Mine Name: New Horizon Mine Operator: Elk Ridge Mining and Reclamation, LLC Operator Address: Mr. Tony Tennyson P.O. Box 628 27646 West 5th Avenue Nucla, CO 81424	County: Montrose Operation Type: Surface Permit Status: Active Ownership: Private
	Operator Representative Present: Mindy Sickles
Operator Representative Signature: (Field Issuance Only)

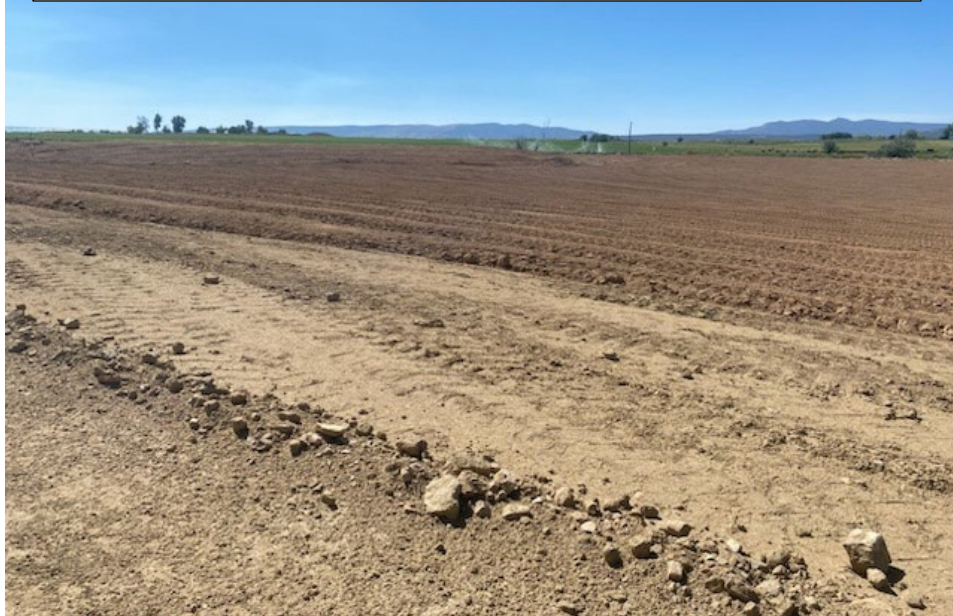
During the inspection the Division observed backfill and grading activity associated with reclaiming the southeast portion of section 36. The operator had completed spreading Bench 1 material and topsoil on the south side of the Johnson Access road (Photo 1 and 2). The reclaimed area was stable with no indications of erosional features. The reclaimed topography was gently sloping to the northeast/east. Seeding is scheduled for all reclamation work in Section 36 this fall. Machinery was actively taking material to the northern portion of the disturbed area and stockpiling soil to be spread and contoured (Photo 3 and 4). Areas north and east of the Johnson Access Road were stable with no erosional concerns identified.

Photo 1: The reclamation southwest of the Johnson Access Road.

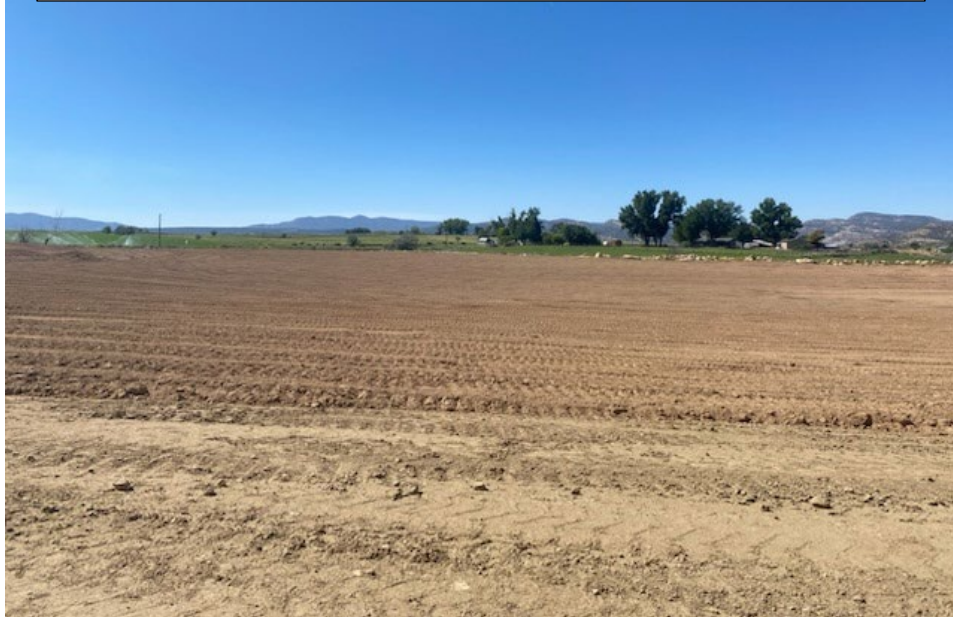
Photo 2: The reclamation west of the Johnson Access Road.

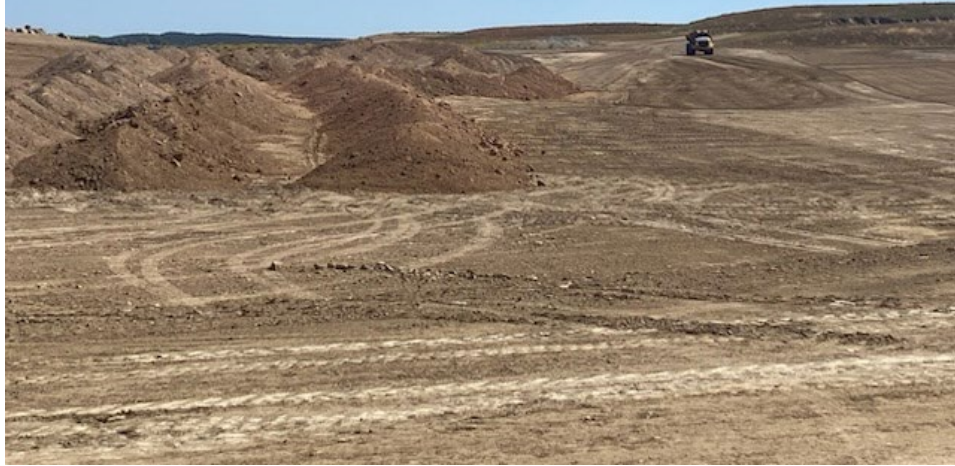
Photo 3: The reclamation northeast of the Johnson Access Road.

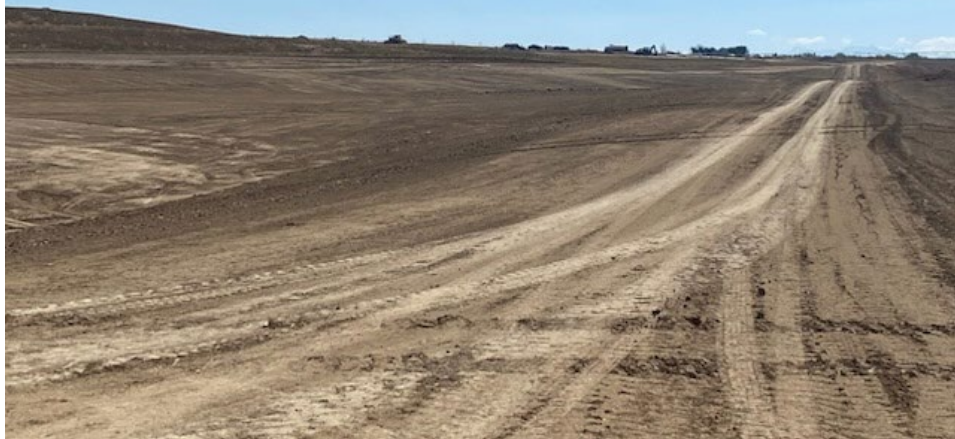
Photo 4: The reclamation work east of the Johnson Access Road.

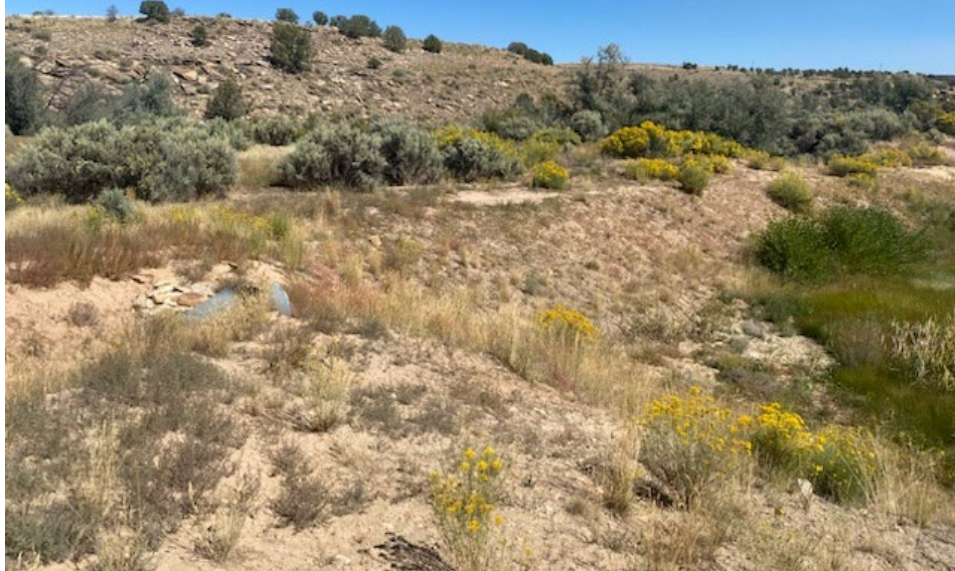
Pond 12 was dry during the inspection. The embankment was stable with vegetative cover (Photo 5). The outlet for the pond was clear of debris. There were no erosional issues observed. Pond 13 was impounding water from both culvert inlets. No water was flowing through the riprap lined inlet. The level of water in the pond was at the primary discharge outlet. Discharge was occurring. The pond's embankment was vegetated and stable with no erosion (Photo 6). Pond 15 was dry (Photo 7). The inlet and outlet for the pond were observed to be unobstructed. The embankments were stable with minor rills on them. These rills have been documented in previous Division inspection reports. The rills are not large enough to affect the embankments' stability. Some vegetative growth was observed on the embankments. Pond 16 was also dry during the inspection. The inlet and outlet for the pond were clear. The pond's embankment was stable with vegetation. There were no indications of erosion. The SP-2 stock pond was holding water at the time of the inspection (Photo 8). There was no discharge occurring. The outlet was observed to be clear of debris. SP-2's embankment was vegetated and stable. No concerns of erosion were noted. Pond 018 is located to the south of the mine office and shop. The pond was dry. The discharge outlet was unobstructed. Pond 018's embankment was stable with vegetative cover. There were no erosional features identified.

Photo 5: Pond 012.

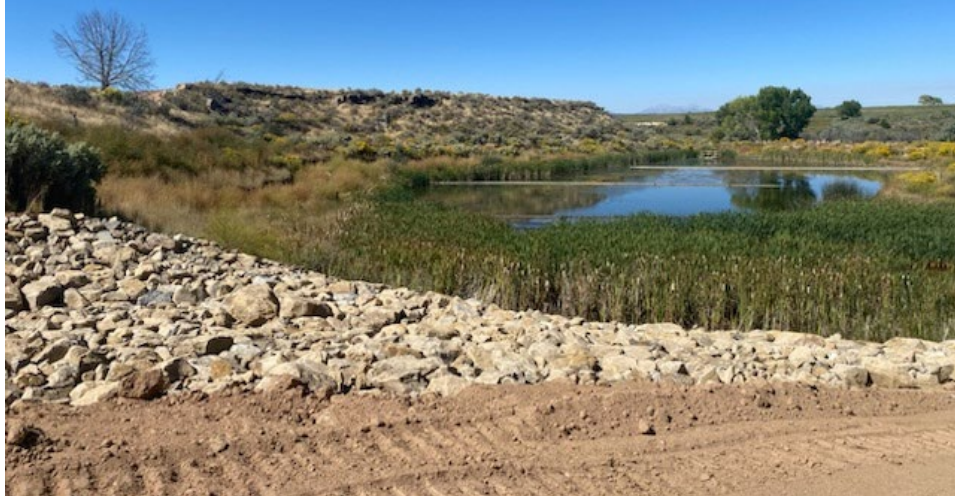
Photo 6: Pond 013.

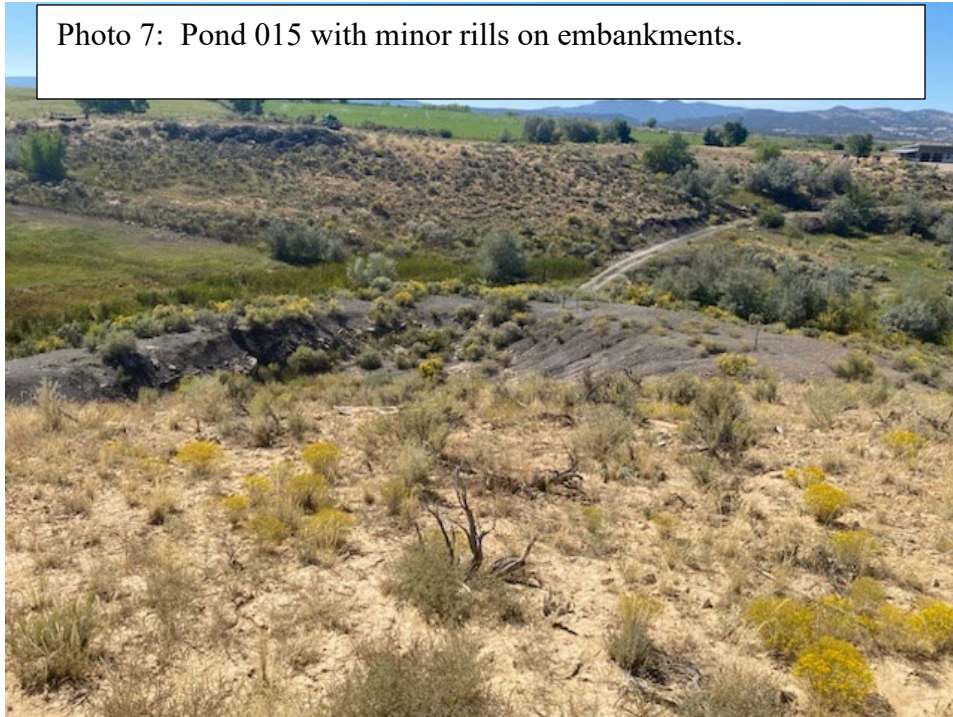
Photo 7: Pond 015 with minor rills on embankments.

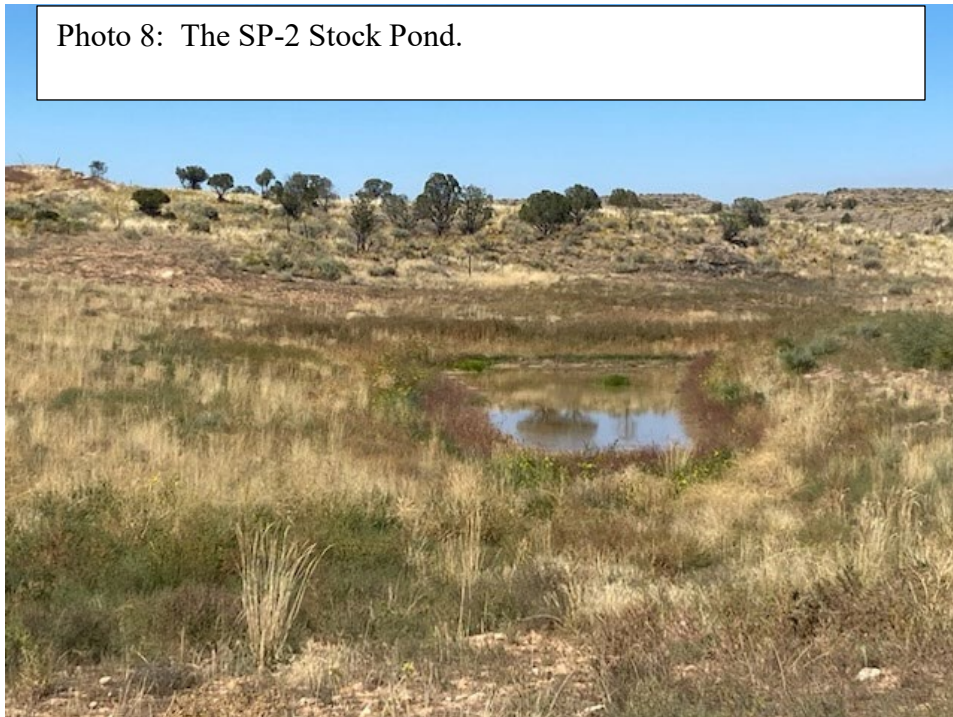
Photo 8: The SP-2 Stock Pond.

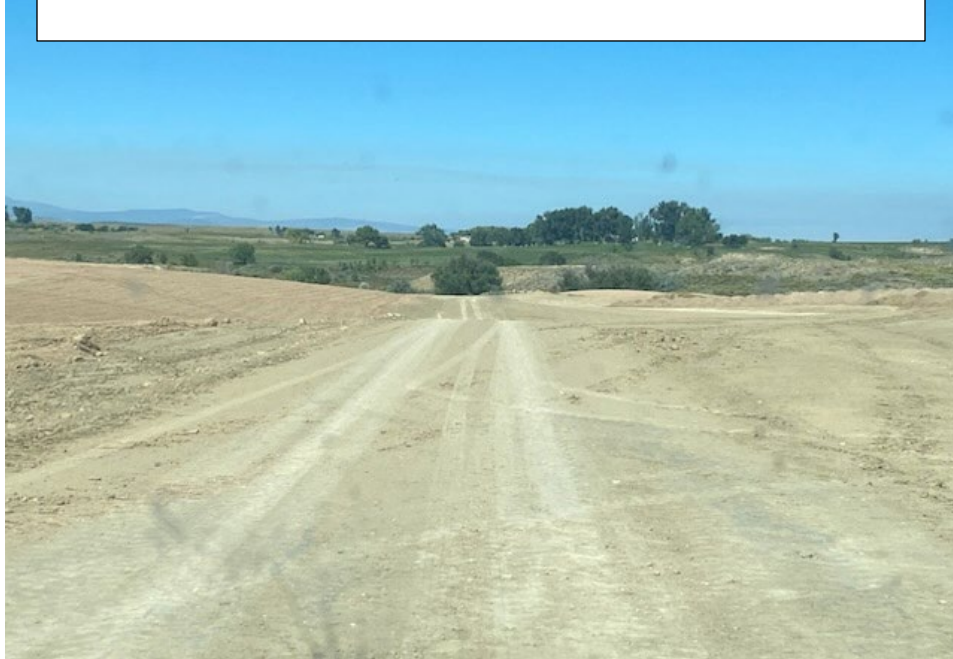
The Johnson Access road was approved in August 2023. The access road will remain as a permanent feature to allow access from BB Road to Pond 013. During the inspection the access road had been completed (Photo 9). The road was stable with no erosional features. The culverts for the road were clear of debris and dry. The access road to Pond 018 was stable with minor ruts. The ruts were created in the spring from large trucks. The ruts on the access road do not impede the ability to reach Pond 018.

Photo 9: The new Johnson Access Road.

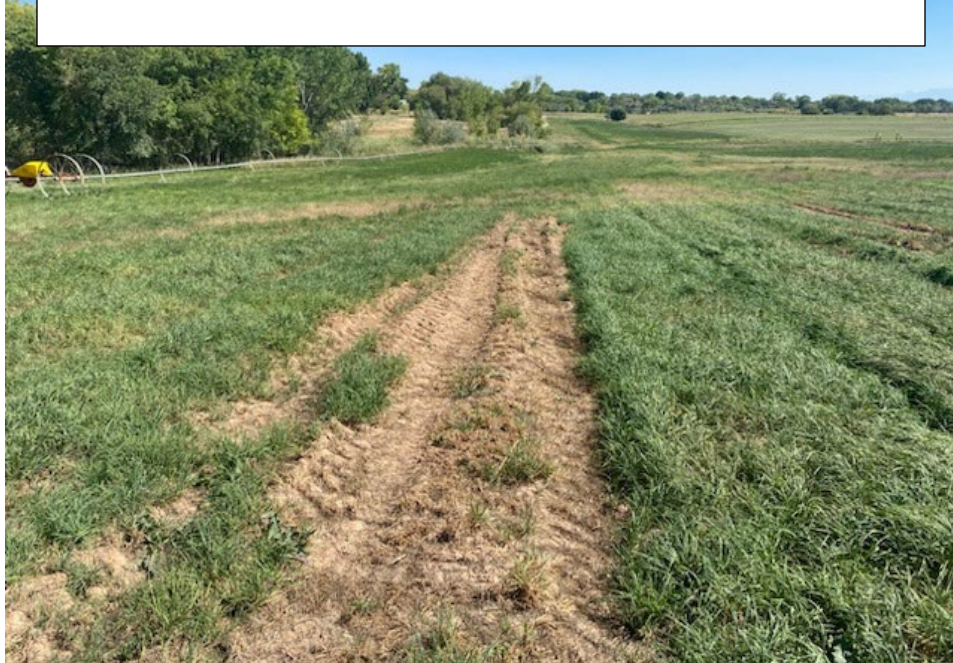
IP-10 is located in the northern portion of Section 6. The irrigated pasture was covered with vegetation and stable. There were no major erosional concerns identified. There was several sets of ruts created by the landowner's equipment (Photo 10). The ruts were observed to be near or just outside of the permit boundary for IP-10. The operator plans to survey this area in the near future to see if the ruts are within the permitted boundary. The Division recognizes that the operator did not create the ruts and will not consider the operator responsible for

Photo 10: The ruts identified near IP-10.

repairs of the ruts.

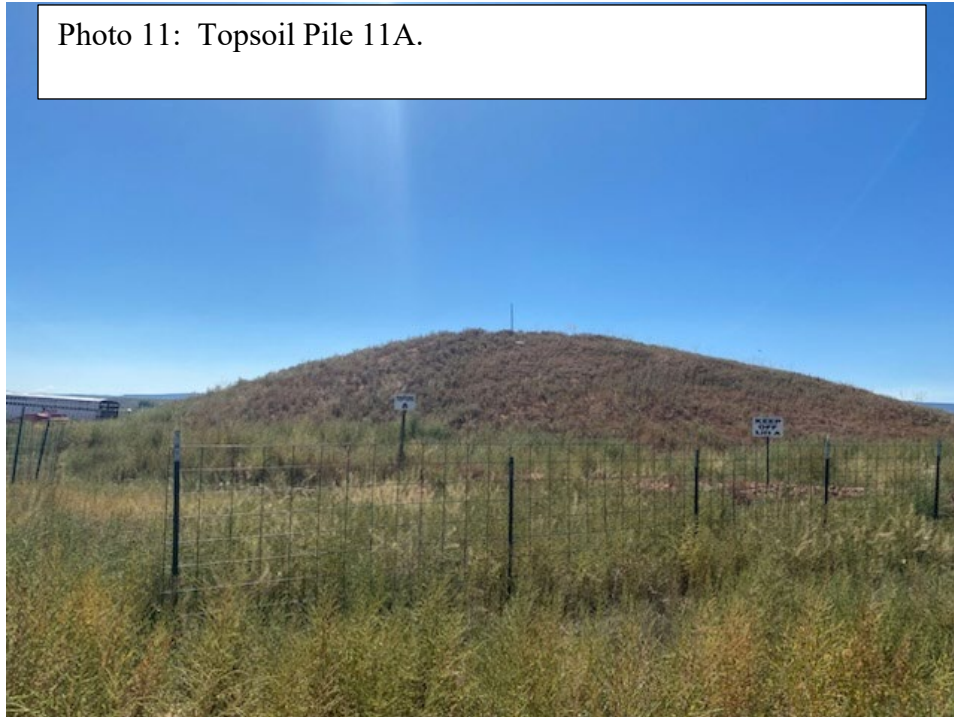
Topsoil piles 11A (Photo 11) and 11B are located on the south side of IC-1. The topsoil piles were stable with vegetative cover. There were no indications of erosional features. There was no loss of topsoil resource observed.

Photo 11: Topsoil Pile 11A.
