MINERALS PROGRAM INSPECTION REPORT
PHONE: (303) 866-3567

MINE NAME: Yetter Pit	MINE/PROSPECTING ID#: M-1996-050	MINERAL: Sand and gravel	COUNTY: Logan
INSPECTION TYPE: Surety Release Inspection	WEATHER: Clear	INSP. DATE: August 30, 2023	INSP. TIME: 12:30
OPERATOR: R & J Yetter Sand & Gravel LLC	OPERATOR REPRESENTATIVE: Jewelie Yetter	TYPE OF OPERATION: 110c - Construction Limited Impact	
REASON FOR INSPECTION: Surety Release Requested	BOND CALCULATION TYPE: None	BOND AMOUNT: \$17,500.00	
DATE OF COMPLAINT: NA	POST INSP. CONTACTS: None	JOINT INSP. AGENCY: None	
INSPECTOR(S): Nikie Gagnon	INSPECTOR'S SIGNATURE:

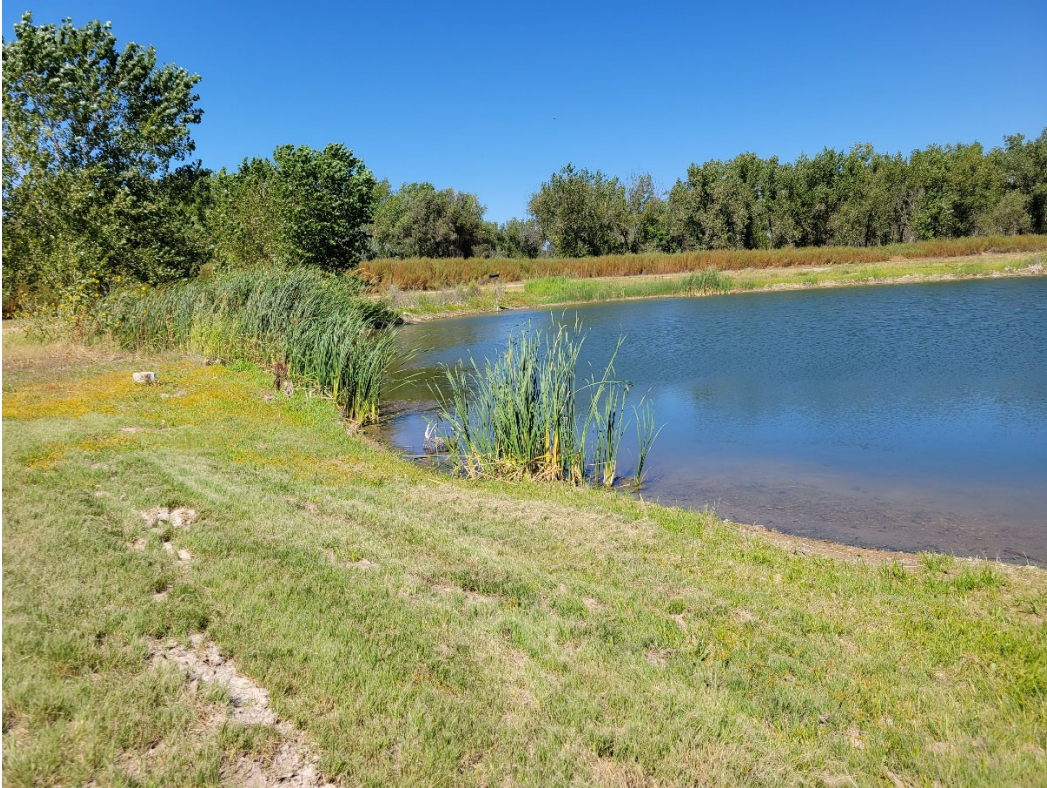
The South Platte borders the property. A permanent berm was constructed outside the permit boundary to mitigate flooding from the river. No evidence of flooding or runoff from the property was noted during this inspection. The shore of the unlined pond is graded to 3H:1V or shallower and the underwater portion is graded to no steeper than 2H:1V and appears to be mostly shallower close to shore. The shoreline is vegetated all around the pond. Birds were observed in the trees on the south side of the pond and in the cattails on the northern side.

Photo 1: Southwestern corner of the pond. Note the shoreline is less than 3H:1V and the underwater grade is less than 2H:1V.

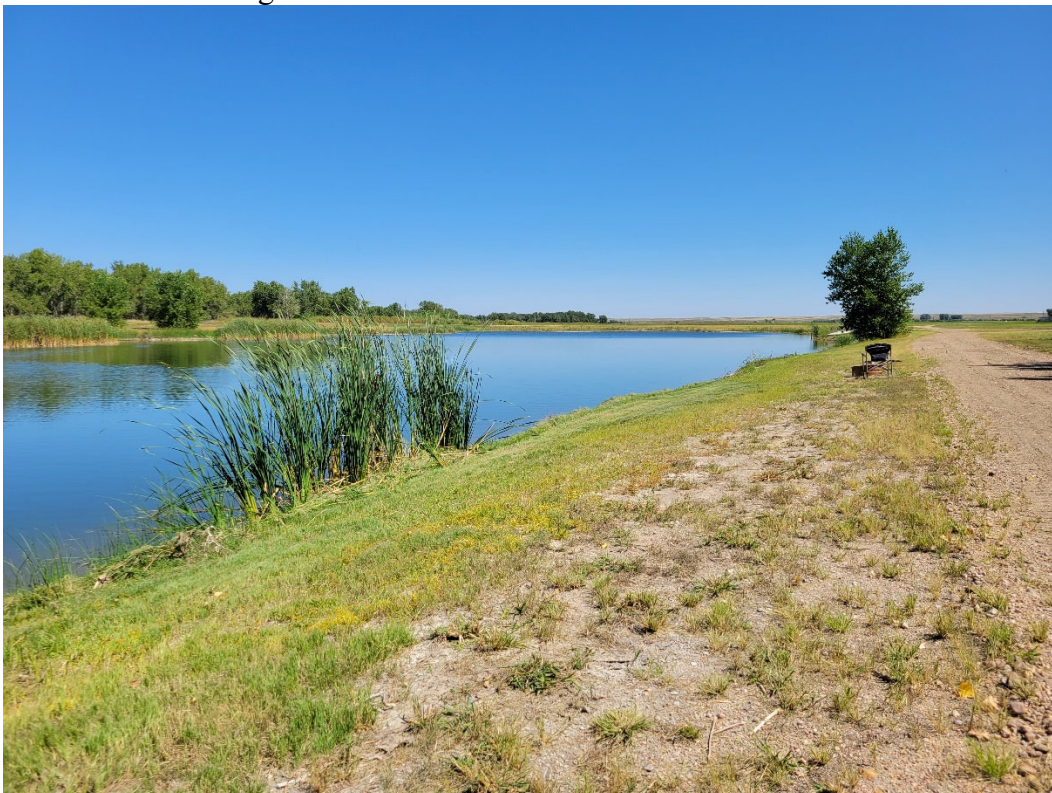
The desired vegetation is well established across most of the permit area. Native grasses, cattails, forbs, and some annual sunflowers were observed along the shorelines. Willows were observed along the northern bank and a couple of cottonwood trees have established on the north and south shoreline. Some small areas of compaction and sparse vegetation were noted, due to the landowner using the lake for recreation.

Photo 2: Looking east along the south shoreline. The area is near the entrance to the pond and used for recreation by the landowner.

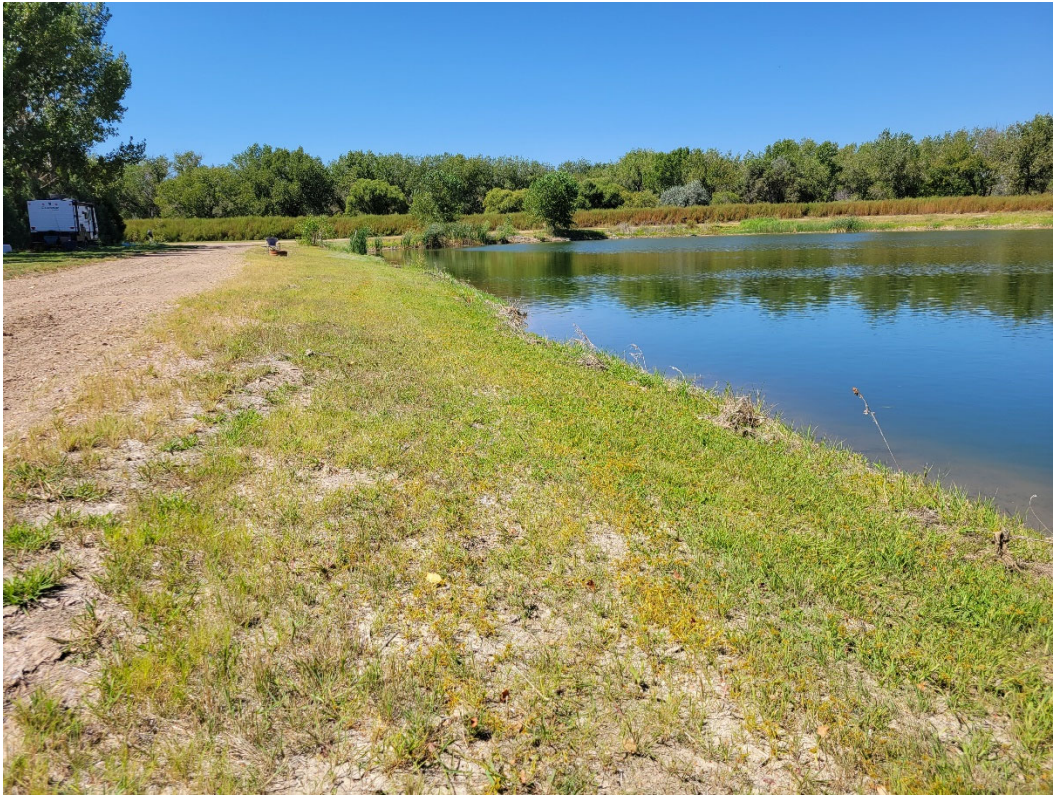
Photo 3: Looking west along the south shoreline. Slopes are 3H:1V or shallower.

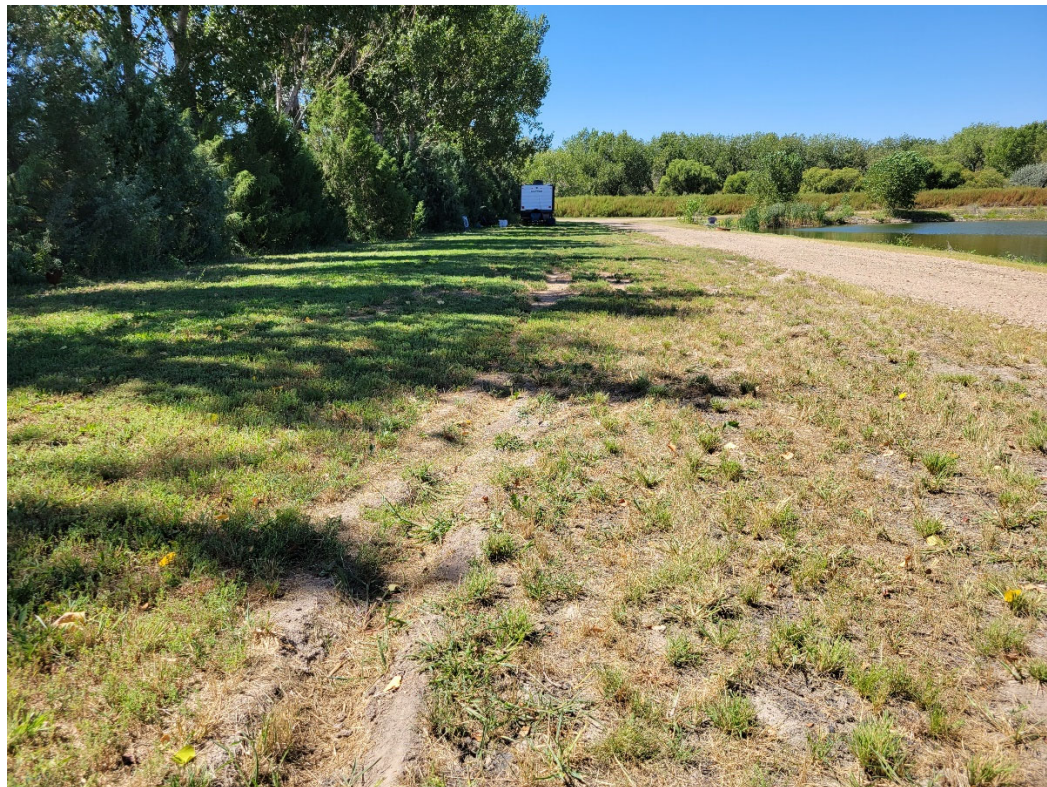
The small grassy area south of the access road, has patchy vegetation and is compacted. The landowner uses this area to park recreation vehicles, some bare ground is visible, but a combination of Kentucky bluegrass and native grasses were observed uniformly across the area, interspersed with a few annual weeds.

Photo 4: Looking west at RV parking area south of the access road.

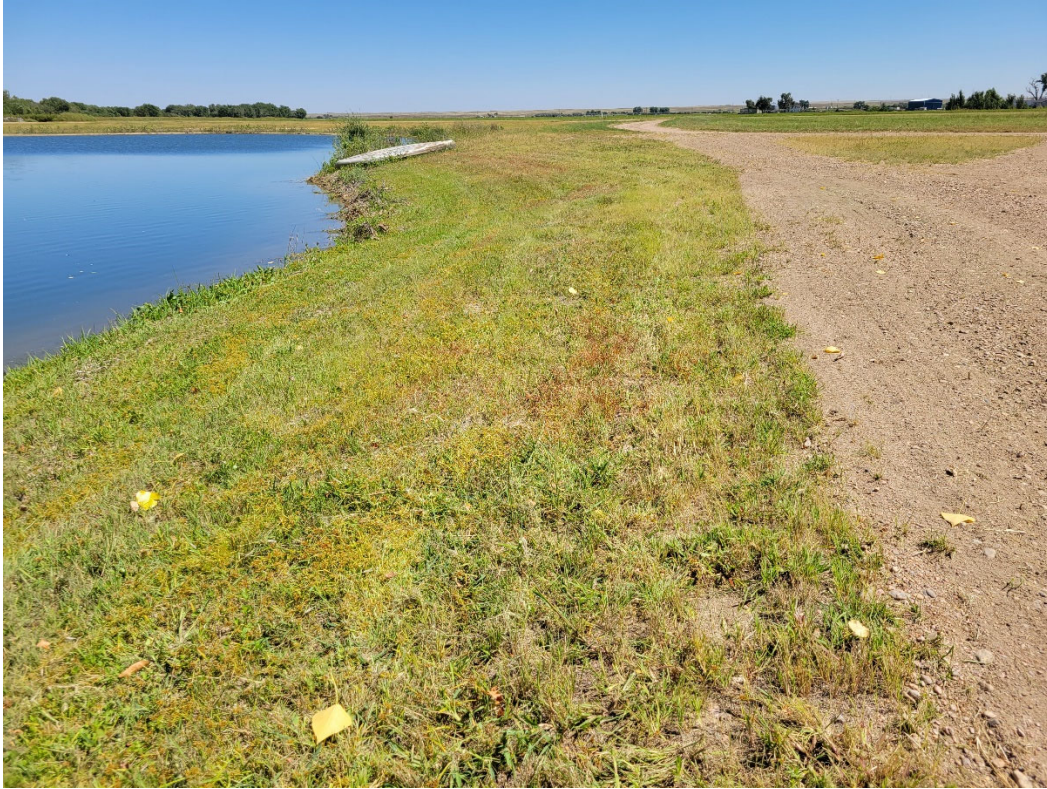
Photo 5: Looking east at the eastern end of the south shore.

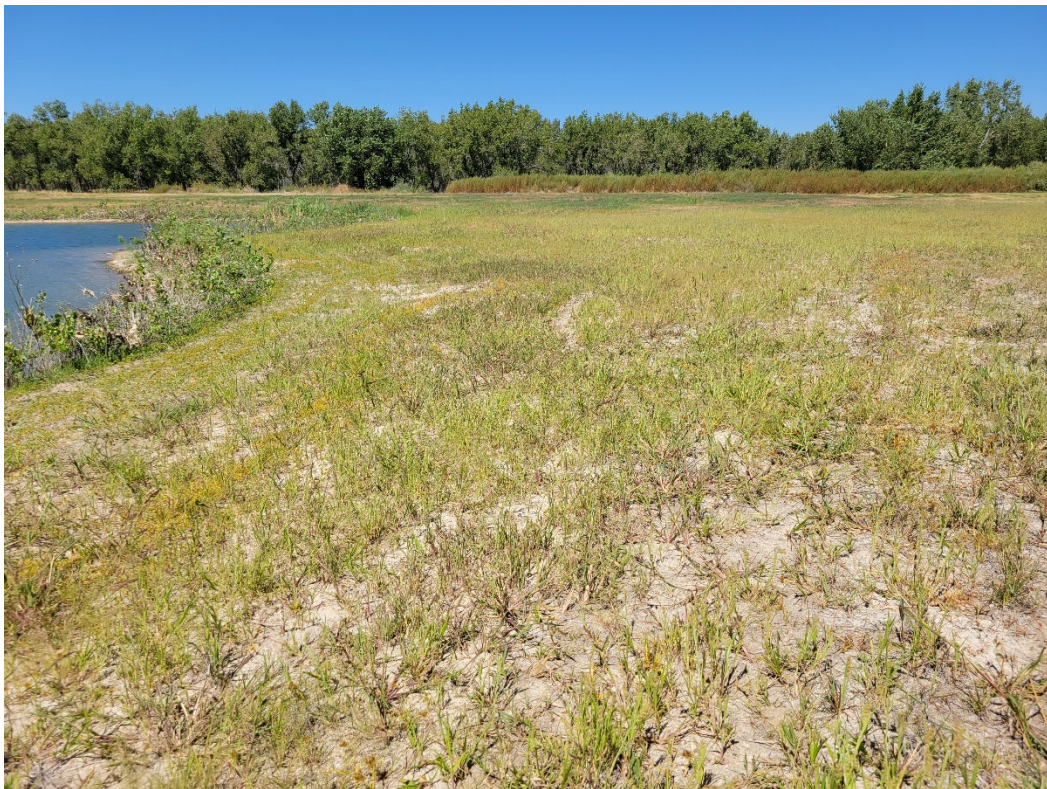
This past spring, the northeastern corner and eastern side of the pond were overseeded utilizing a drill seeding method. Over the spring and summer months, Logan County received higher precipitation than what is typical for the region helping the revegetation. Western wheatgrass and big bluestem plants were observed in this area, along with a few stands of prairie cordgrass and young cottonwoods along the banks. Vegetation uniformly covers the reseeded area and the grasses are interspersed with patches of annual weeds, primarily kochia and Russian thistle, which is expected at this stage of regrowth. This area had been mowed to help control weeds and the landowner stated he plans to continue mowing as a method of weed control. Overall vegetation has replaced the bare ground that was noted in this area during the May 2023 inspection and the Division is no longer concerned with erosion of bare areas or vegetation success.

Photo 6: Looking north across the eastern shoreline. Area overseeded in 2023. Western wheatgrass and big bluestem were observed in this area. Cottonwoods are growing along the shoreline.

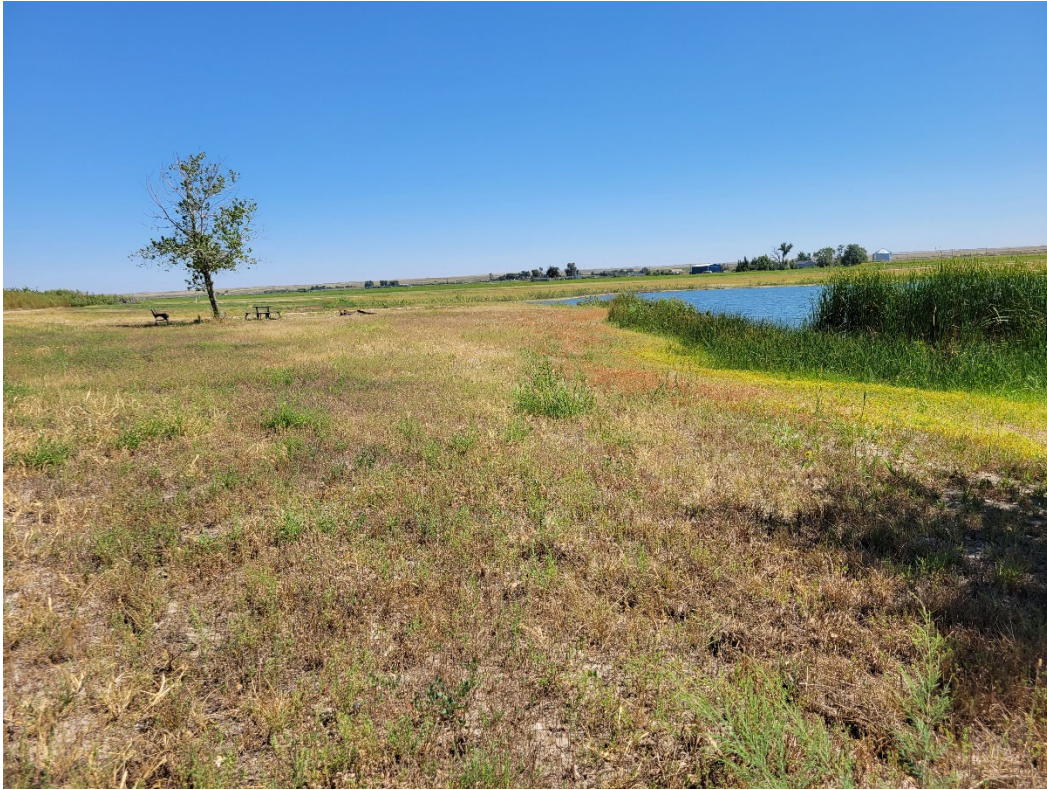
Photo 7: Looking east at reseeded area in the northwest corner. Boat launch in this area of the lake, soil is slightly compacted from recreation use.

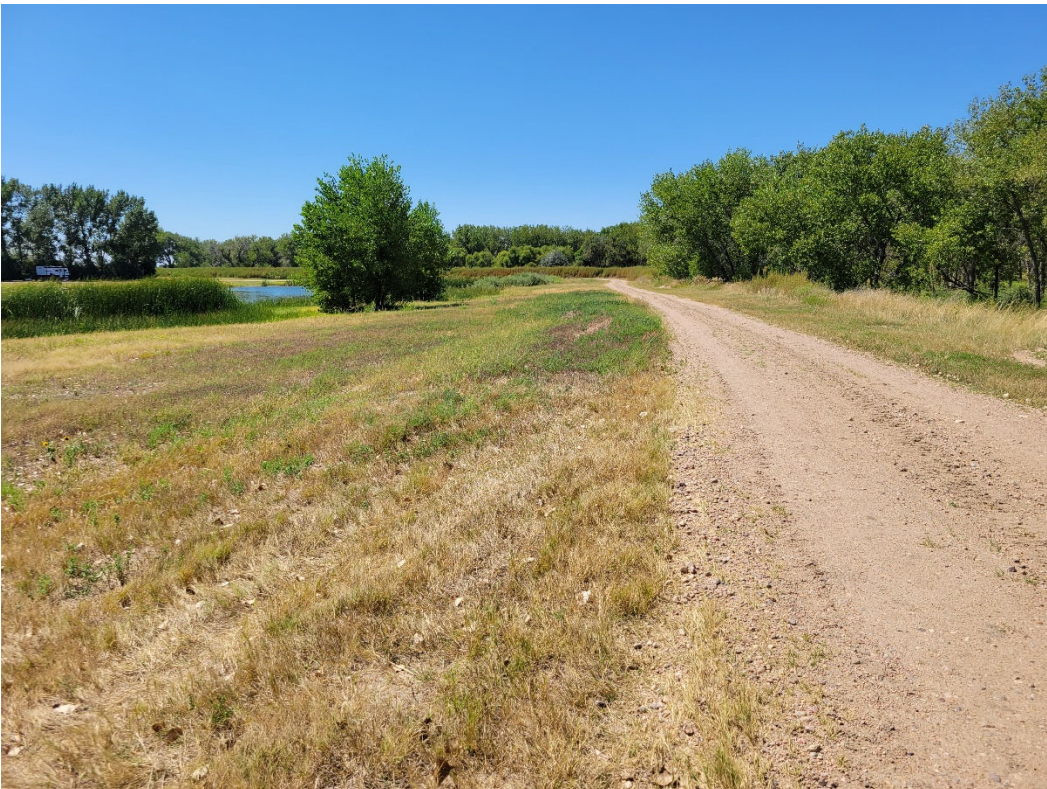
Photo 8: Looking west down the northern shoreline.

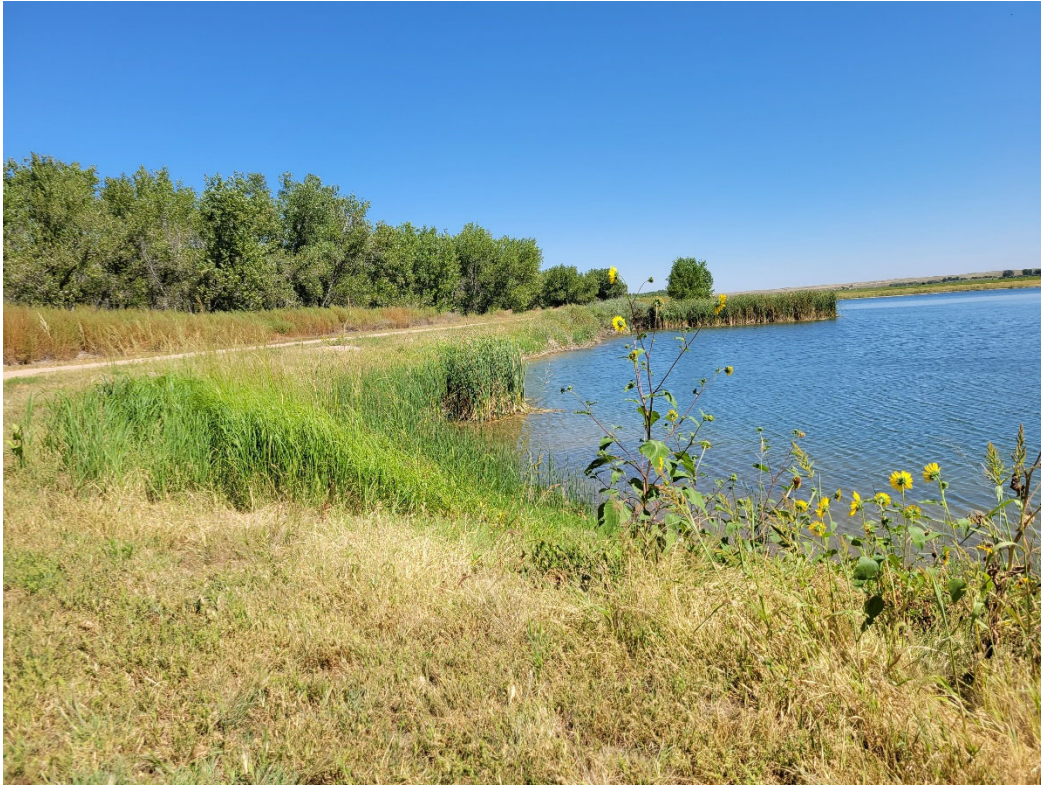
Photo 9: Looking east from the northwestern corner shoreline. This area was revegetated first after mining and appears dense and regenerating.
