Re: GCC Energy, LLC, King II Mine
CDRMS Permit # C-1981-035
Stoner Engineering: Quarterly Inspection: King I Water Quality Improvements
Inspection 3rd Quarter 2023

Date: October 4, 2023

Re: King Coal I – Quarterly Water Quality Improvements Inspection

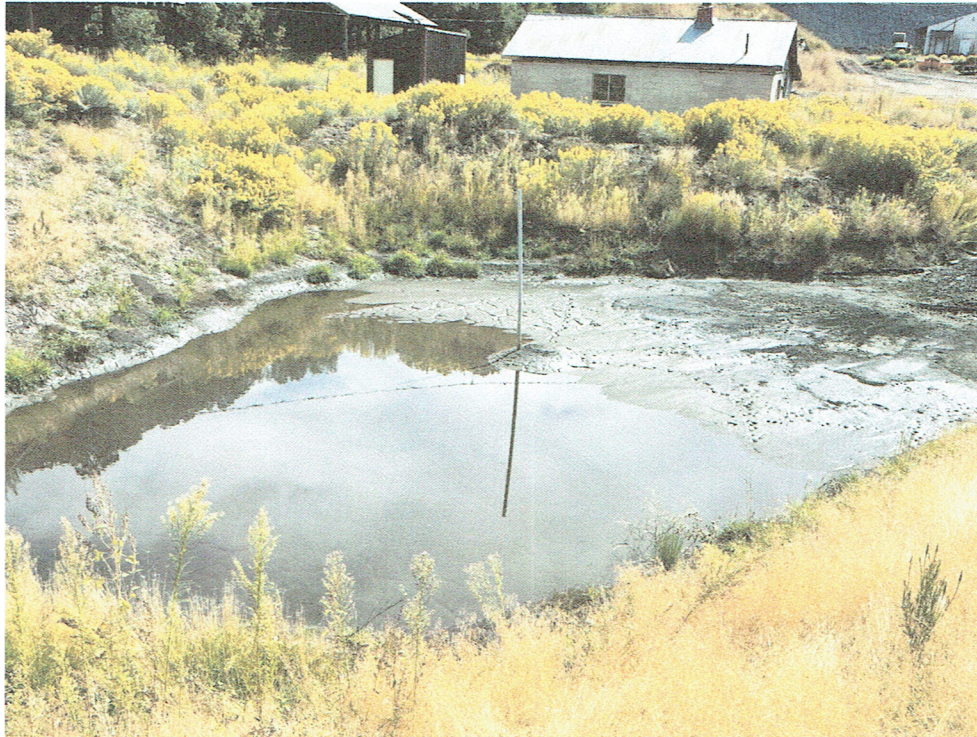
Both ponds held water at the time of the inspection due to recent storm events. The water level was roughly the same as the previous inspection (about 2-feet in depth) though the sediment level was noticeably higher (see Pic. 1). The west pond also had roughly 2-feet of water at the time of the inspection (see Pic. 2). All of the excess waste material placed in the pond had been removed as well as some of the accumulated sediment. Recent storm events have resulted in a pause of the sediment removal operations for the west pond. As conditions improve and the pond dries out, the excess material (sediment) should be removed. This excess material should be removed as soon as possible to ensure adequate pond capacity for runoff/storm events. The sedimentation traps at the entrance to the site are generally in good condition.

Pic. 1 –Water level, East pond.

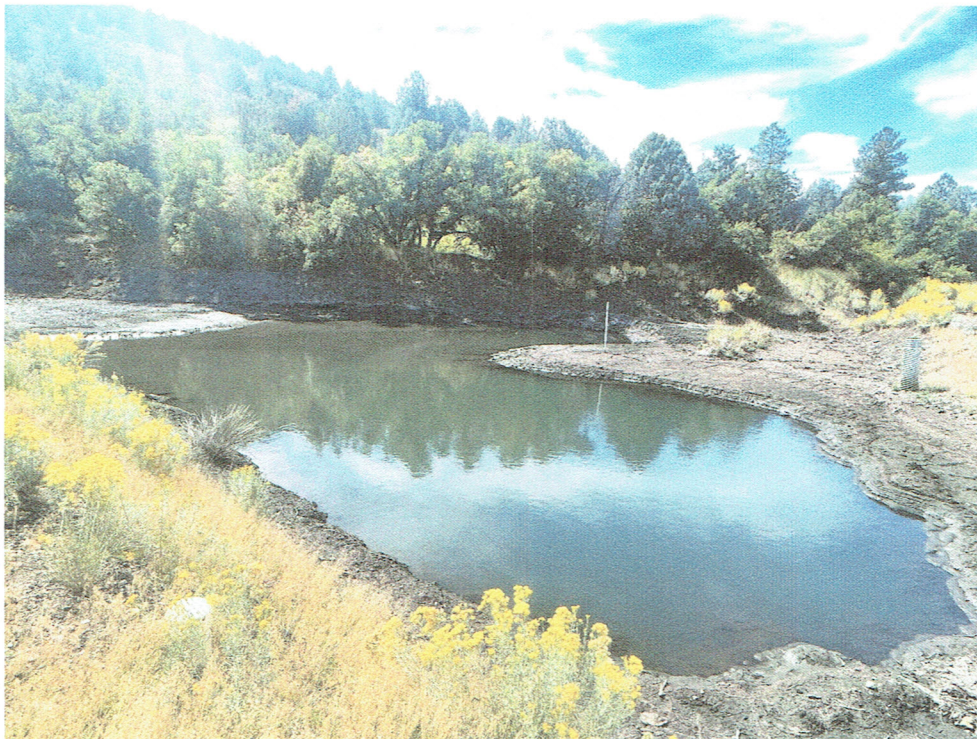
Pic. 2 – Water/waste material within boundary of West pond.

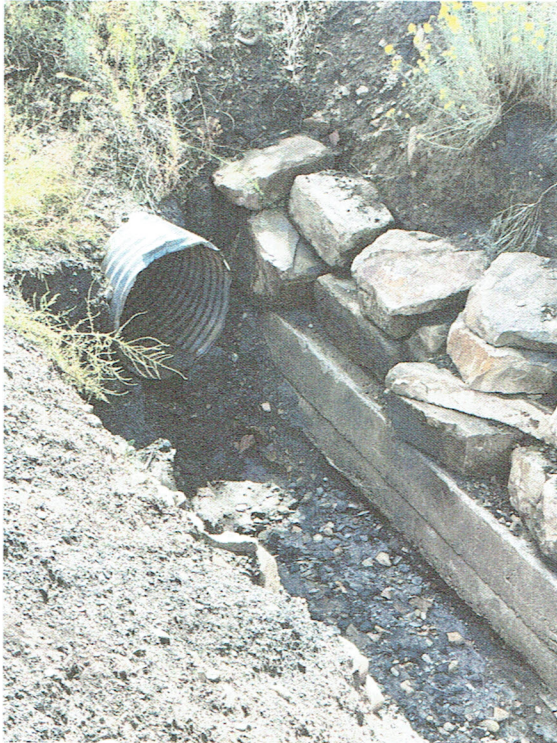
The existing ditches and culverts are generally in good condition. Most of the maintenance issues identified in the previous report have been corrected. The culvert located under the haul road (at the base of the lower waste pile) that flows into the west pond (Reach 8) has been cleaned (see Pic. 3). The corrugated (poly) culvert on the east side of the stilling basin, at the base of the haul road (East side, NW of bath house) has also been cleared of sediment (see Pic. 4). The culvert for the west clear water ditch (Reaches 3 & 6) which discharges into the north clear water ditch is still in need of cleaning. The culverts located on the switchbacks of the main waste embankment pile have also been cleared. The culvert located at the north switchback of the haul road has been replaced.

Pic. 3 – Outlet, culvert under haul road at base of lower pile (Reach 8).

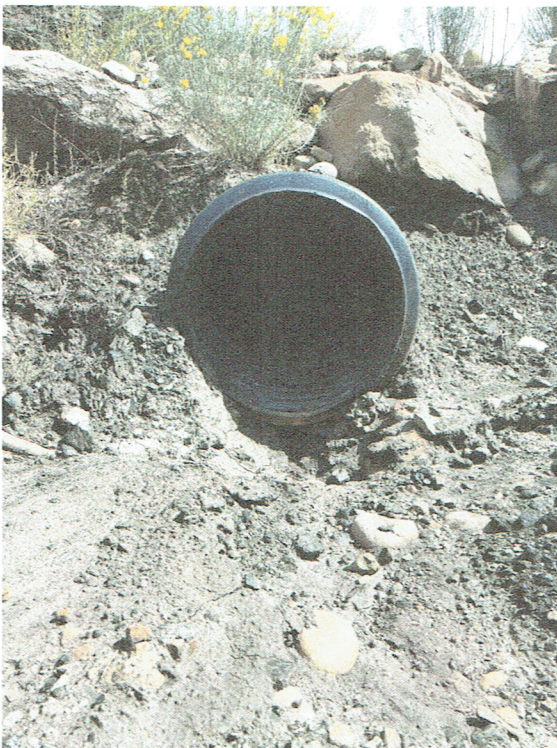
Pic. 4 – Corrugated Poly Culvert east side of the stilling basin.
