Roadside Mine, C-1981-041, September Complete Inspection Report

PERMIT INFORMATION

INSPECTION INFORMATION

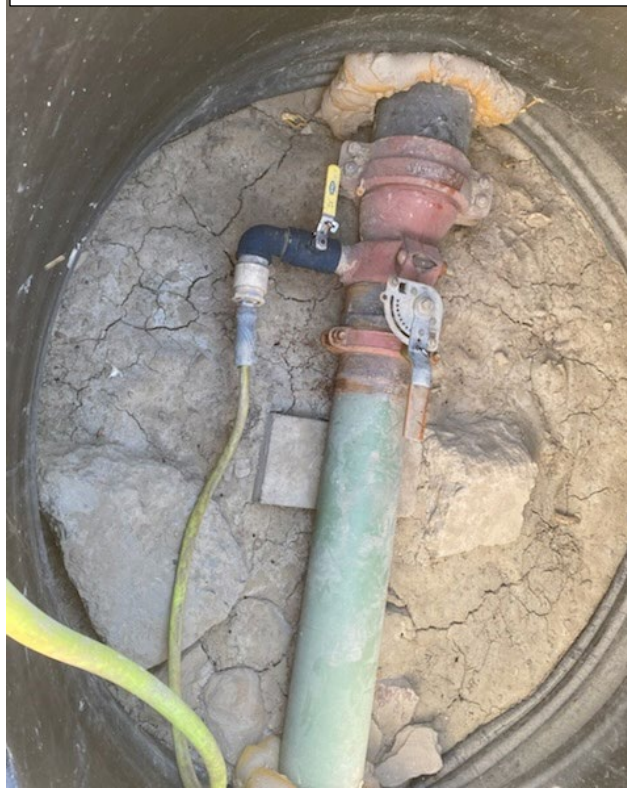
During the inspection the Discharge Point 016 was discharging. The meter on the discharge pipe was averaging 113 gpm. The discharge outlet was stable and there were no erosional issues identified (Photo 1).

Photo 1: The discharge structure for 016.

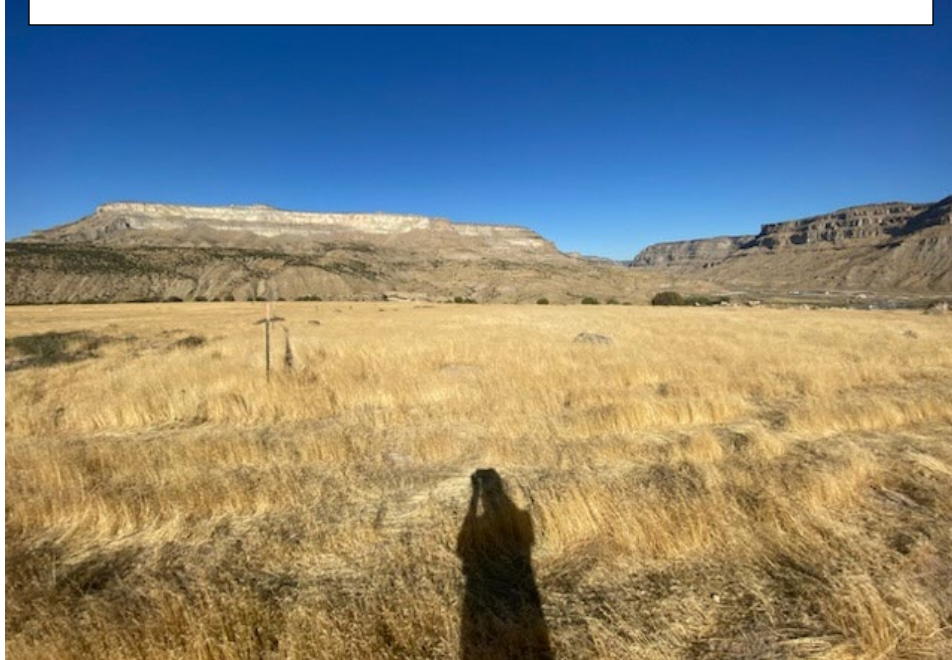
The remaining permitted disturbed area at the Roadside Mine is approximately 0.4 acres in size. This area is located in the northern portion of Tract 71 and is referred to as the TR-69 Repair Area. The reclamation work for the TR-69 Repair area was conducted in the fall of 2019. The disturbed boundary was marked with several T-posts. Each post was easily identified. The reclaimed area was stable with vegetative cover (Photo 2). There were no indications of erosional features. The northern most portion of the reclaimed area had been driven through by a

Photo 2: The TR-69 Repair Area. Photo 2 is looking to the west.

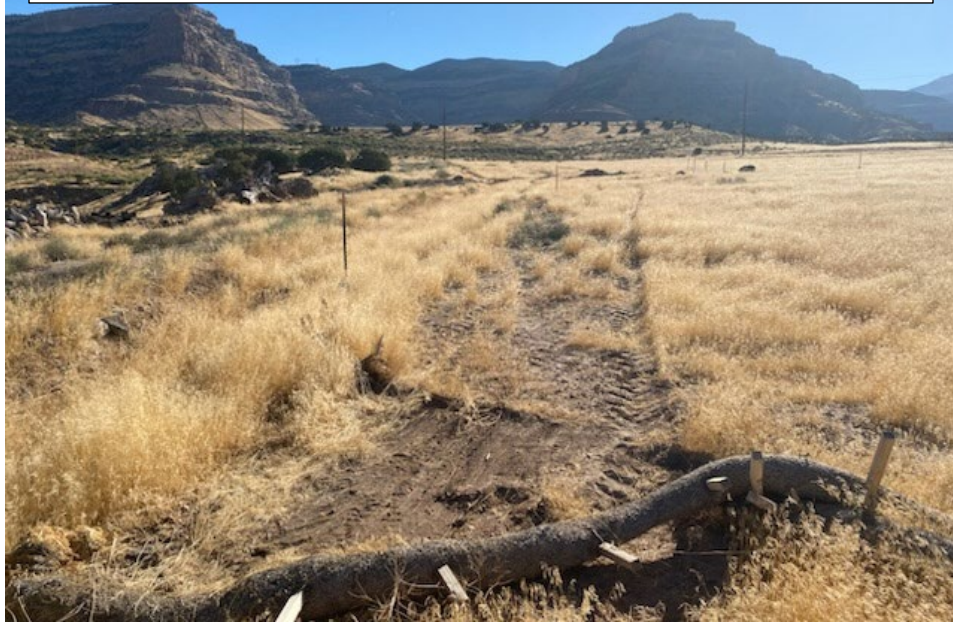
piece of equipment since the previous Division inspection (Photo 3). This was not an activity conducted by SCC. The tracts traversed from the northeastern disturbed boundary to the northwest disturbed boundary. The vehicle had severed the straw waddle located at the northwestern disturbed boundary (Photo 4). SCC's representative indicated that they would have the straw waddle repaired as soon as possible. No other disturbances to the TR-69 Repair Area were observed.

Photo 3: The Tracks identified in the northern portion of the TR-69 Repair Area. The photo was taken looking to the east.

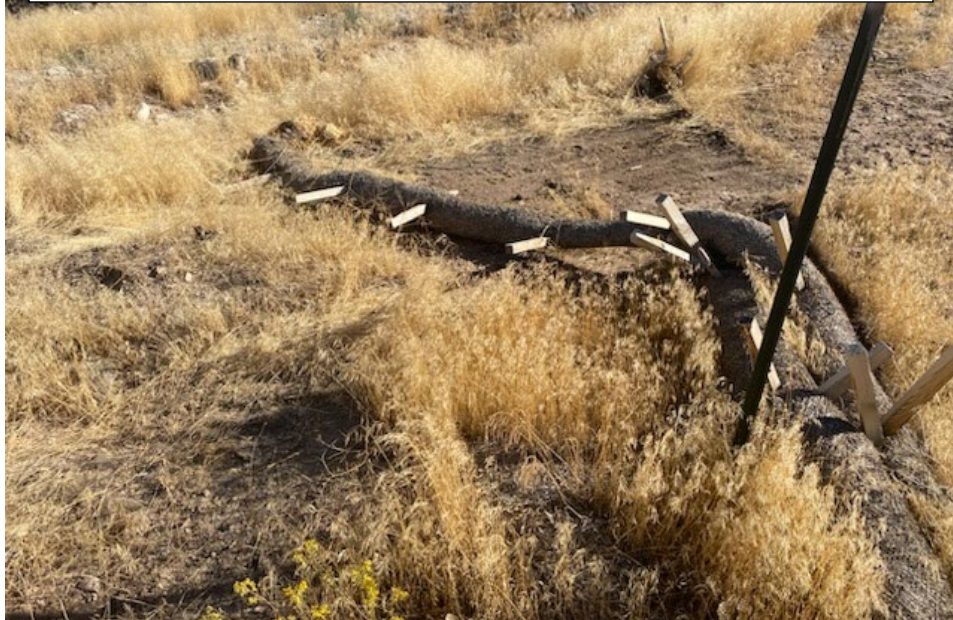
Photo 3: The severed straw waddle at the northwest boundary of the TR-69 Repair Area.

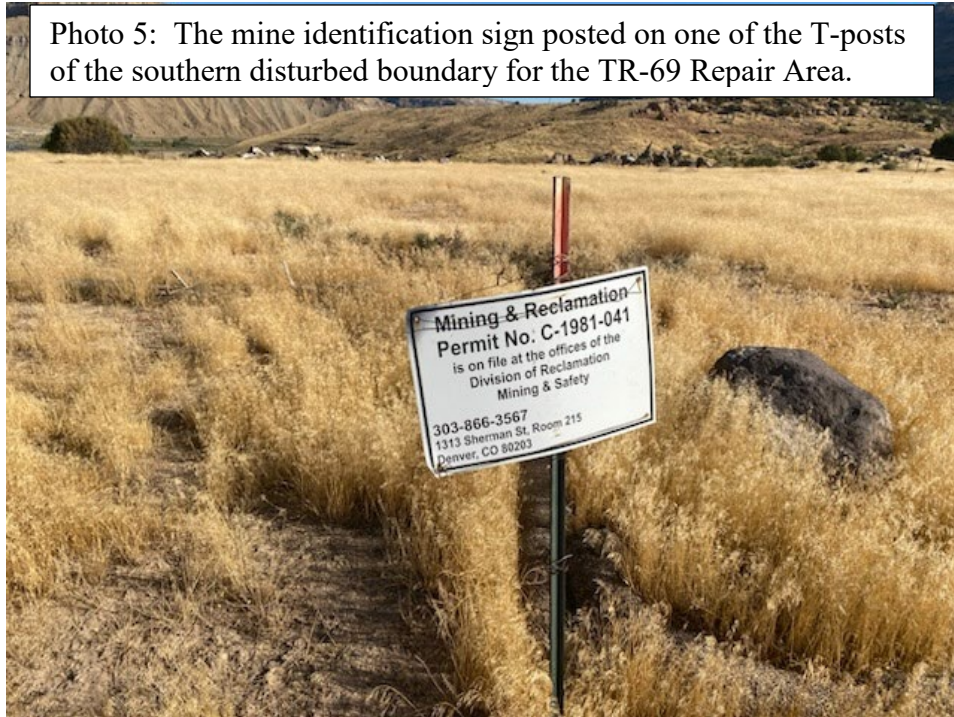
Mine identification signs are posted at the southern and northern entrances to the permit boundary. The signs were in good condition and located in a visible spot. The signs displayed the mine's permit number, contact information for the Division, and the location a copy of the permit is located (Photo 5). An additional mine identification sign is posted on one of the southern disturbed boundary markers for the TR-69 Repair Area. This sign displayed the same information as the others.

Photo 5: The mine identification sign posted on one of the T-posts of the southern disturbed boundary for the TR-69 Repair Area.
