Re: GCC Energy, LLC, King II Mine
CDRMS Permit # C-1981-035
Stoner Engineering: King II Water Quality Improvements Inspection Annual
Inspection 2023

Date: October 4, 2022

Re: King Coal II - Annual Water Quality Improvements Inspection

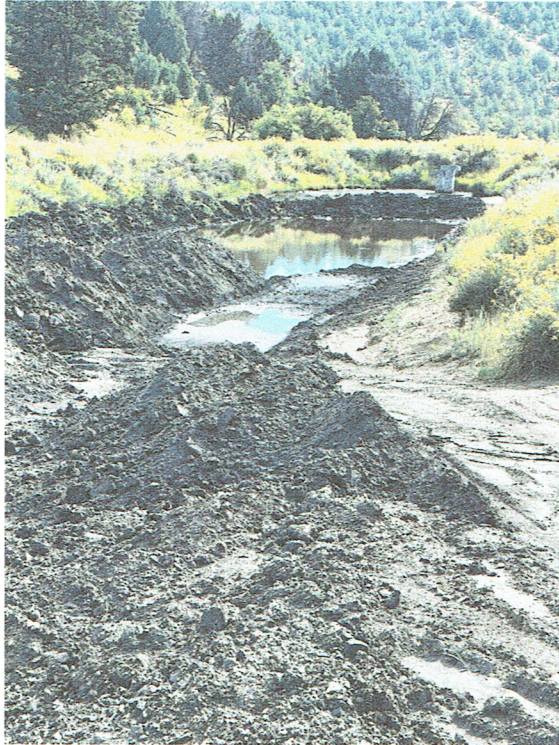
The water quality pond had some water at the time of the inspection. The elevation at the bottom of the pond could not be determined due to both the existing water level and the ongoing sediment removal operations within the pond at the time of the inspection (see Pic. 1). Removal of sediment from the pond was ongoing and placed on hold due to recent storm events. It is anticipated that the remainder of the excess sediment will be removed from the detention pond as soon as site conditions allow.

Pic. 1 – Detention Pond-sediment removal has begun.

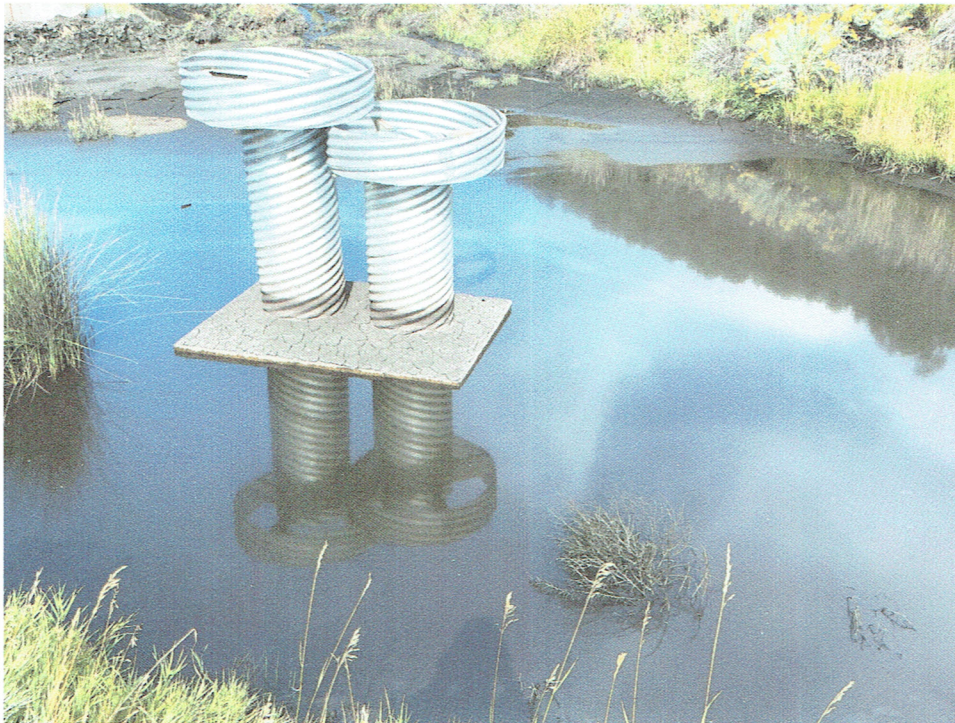
The vegetation both inside and out of the pond and embankments is well established to minimize the erosion impacts of storm runoff. The outlet structure shows no signs of damage and was functioning as designed at the time of the inspection (see Pic. 2). The outlet pipes were free from debris, sediment and excessive vegetation (see Pic. 3). The water quality pond appears to be in generally good condition. There were no signs of weakness or distress to either the outlet structure or the embankment material. The vegetative cover is thick in the areas not impacted by the sediment removal operations. The water quality pond has the storage capacity to function as designed.

Pic. 2 – Outlet structure appears to be in good condition.

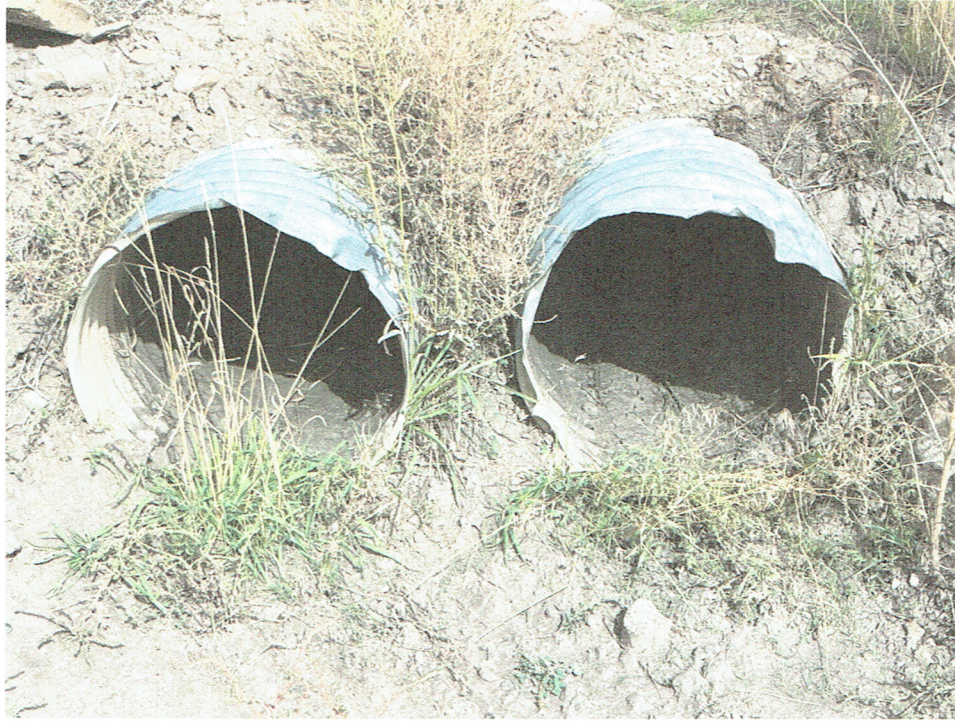
Pic. 3 Outlet structure culverts in good condition.

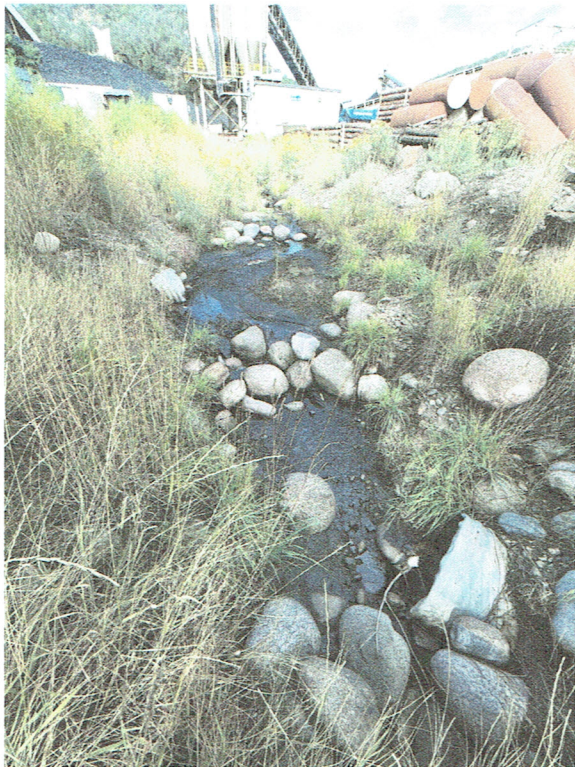
The erosion control structures for the treated water ditch located south of the scale house had been cleaned out to prevent clogging of the culvert leading to the detention pond (see Pic. 4). All ditches should be inspected and repaired as necessary, especially after storm events.

Pic. 4 –Treated water ditch south of scale house in good condition.
