**MINERALS PROGRAM INSPECTION REPORT**  
**PHONE: (303) 866-3567**

<b>MINE NAME:</b> East Rigden Pit	<b>MINE/PROSPECTING ID#:</b> M-1979-097	<b>MINERAL:</b> Sand and gravel	<b>COUNTY:</b> Larimer
<b>INSPECTION TYPE:</b> Surety Release Inspection	<b>WEATHER:</b> Clear	<b>INSP. DATE:</b> September 26, 2023	<b>INSP. TIME:</b> 10:00
<b>OPERATOR:</b> City of Fort Collins	<b>OPERATOR REPRESENTATIVE:</b> Matthew Parker	<b>TYPE OF OPERATION:</b> 112c - Construction Regular Operation	
<b>REASON FOR INSPECTION:</b> Surety Release Requested	<b>BOND CALCULATION TYPE:</b> None	<b>BOND AMOUNT:</b> \$0.00	
<b>DATE OF COMPLAINT:</b> NA	<b>POST INSP. CONTACTS:</b> None	<b>JOINT INSP. AGENCY:</b> None	
<b>INSPECTOR(S):</b> Nikie Gagnon	<b>INSPECTOR'S SIGNATURE:</b>

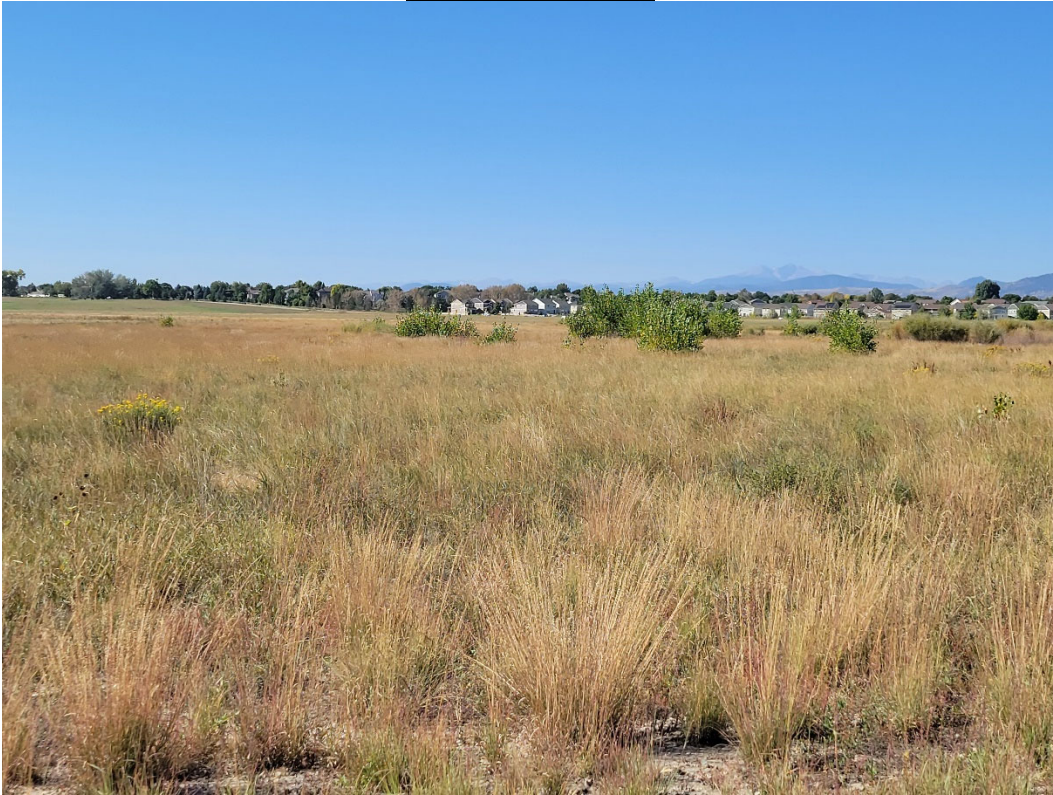
Photo 1: Looking west across the meadow northwest of the reservoir.

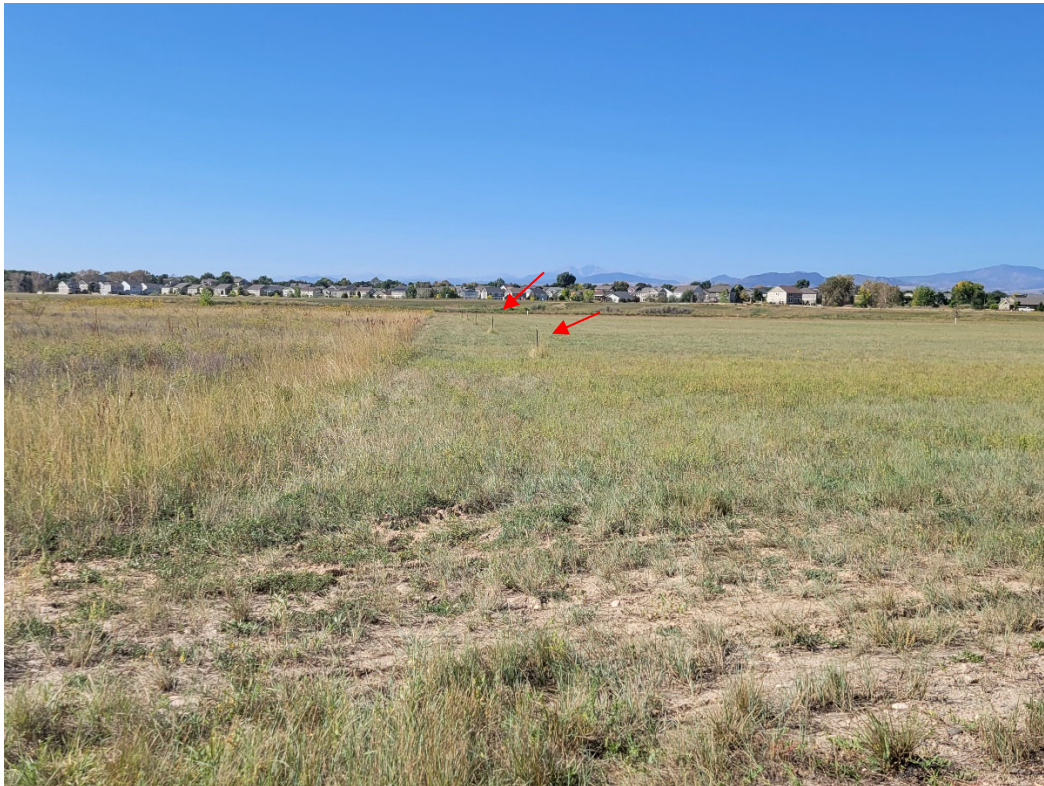
Photo 2: Looking west down the northern boundary of the release area. The area on the left is the City owned land in the release area and the land on the right is owned by Cottonwood Farms. Arrows point to boundary markers.

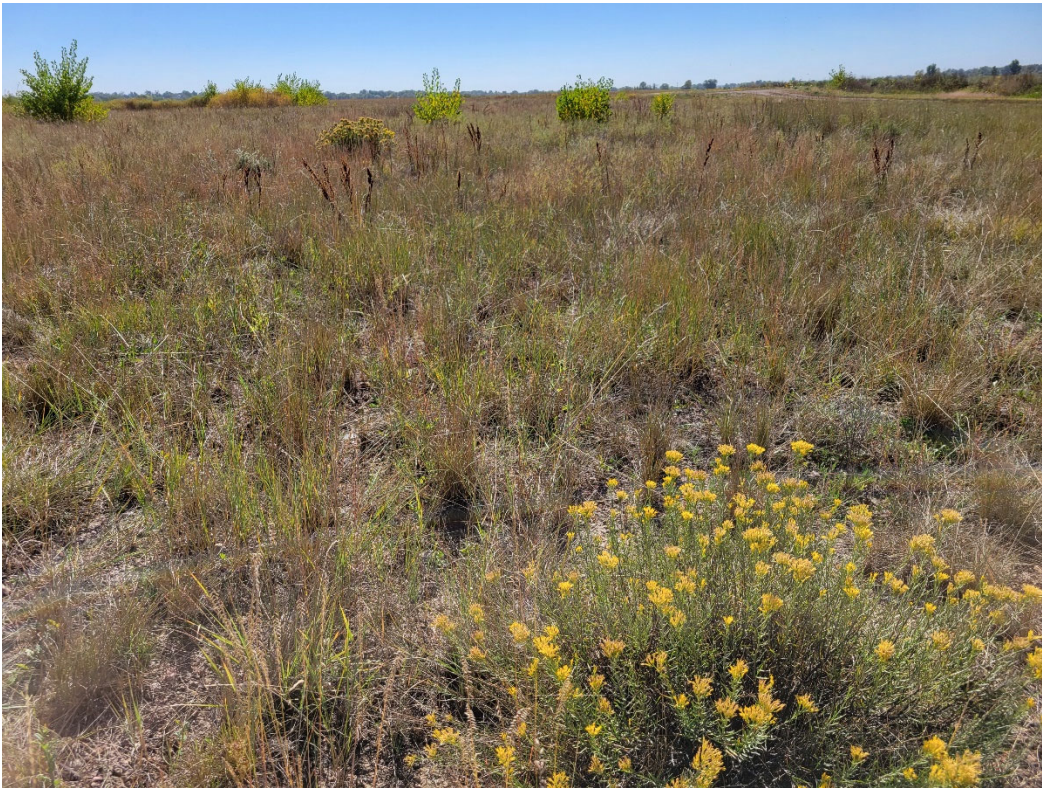
Reclamation work is complete in the proposed release area. The area northwest of the reservoir has been revegetated and contains a dense and diverse ecosystem of grasses, forbs, rabbitbrush and young cottonwoods. Weeds appeared to be well controlled in this area.

Photo 3: Dense vegetation in the meadow area northwest of the reservoir.

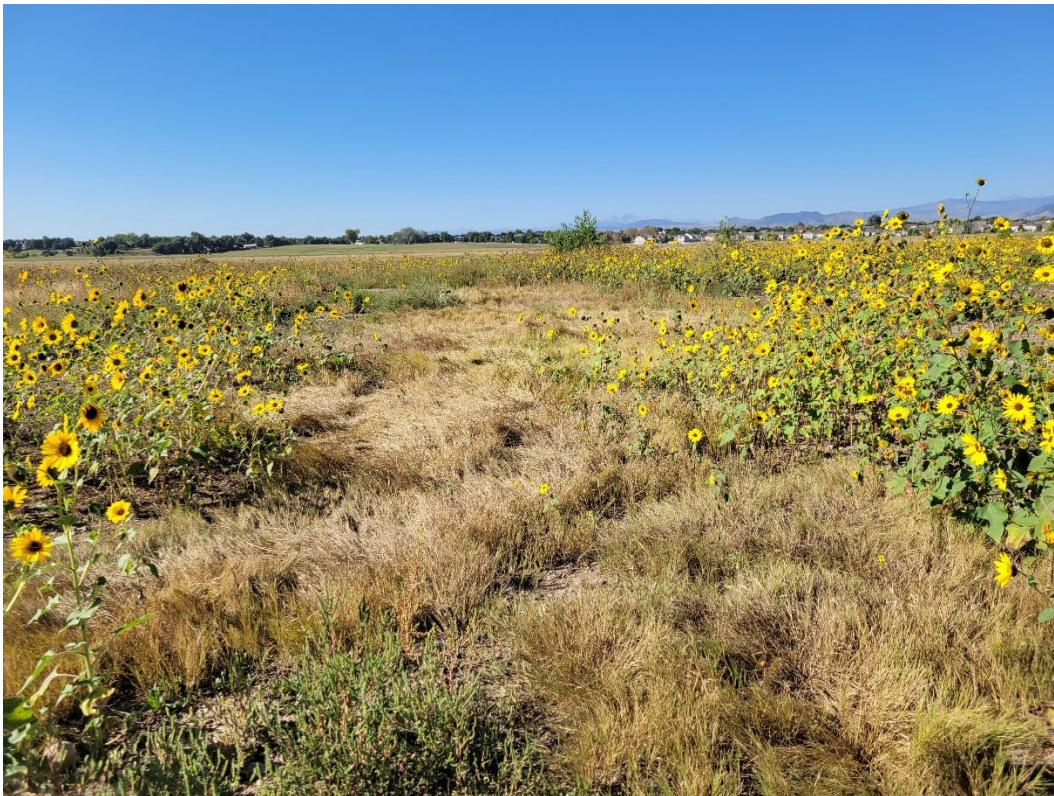
During a previous inspection in 2020, land in the northwest corner of the reservoir, near the northern access road, had sparse vegetative cover consisting primarily of weeds. The Division inspected this area during this visit and observed patches of dense grass, annual sunflowers, and a few rabbitbrush shrubs spreading across the area that was previously bare. Some annual weeds were noted here but that is to be expected at this stage of regeneration. Cracks in the soil indicate occasional standing water in this area, however the vegetative cover is expanding, controlling erosion and capable of self-regeneration.

Photo 4: Area in the northwest corner of the reservoir. Dense patches of grass and sunflowers are growing in a low/wet area outside the northwest corner of the reservoir.

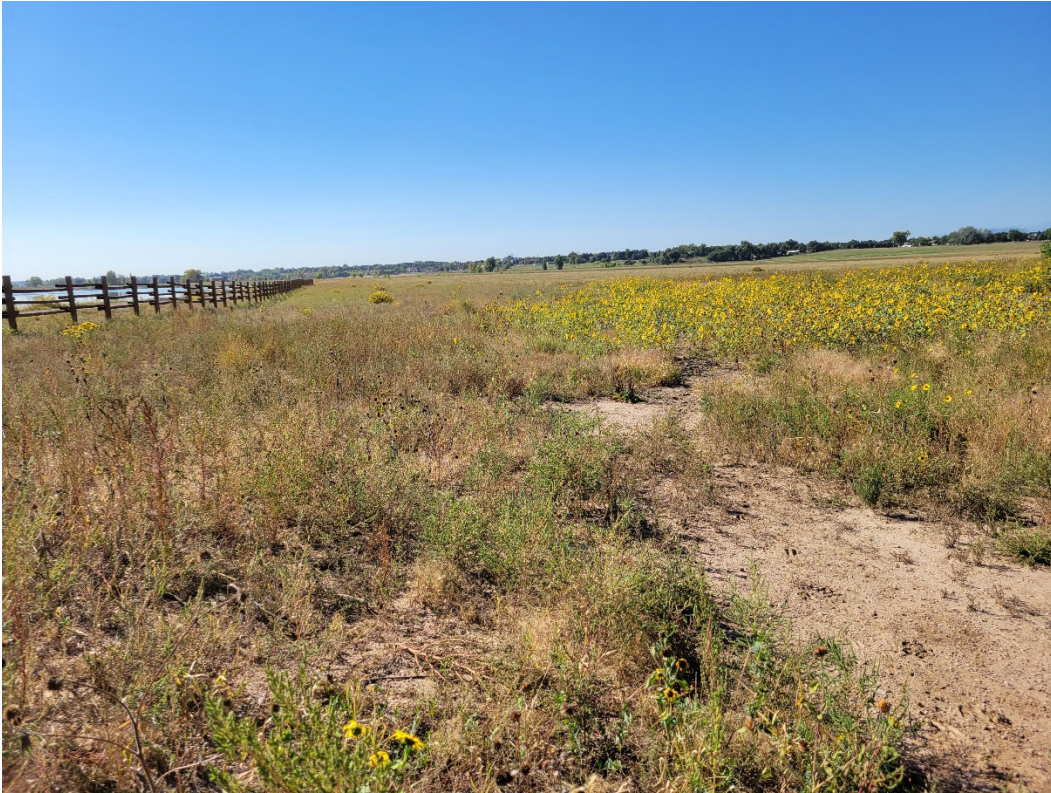
Photo 5: Area just outside the northwest corner of the reservoir. Some evidence of past standing water here. Vegetation surrounds patches of bare ground where water accumulates after storms.

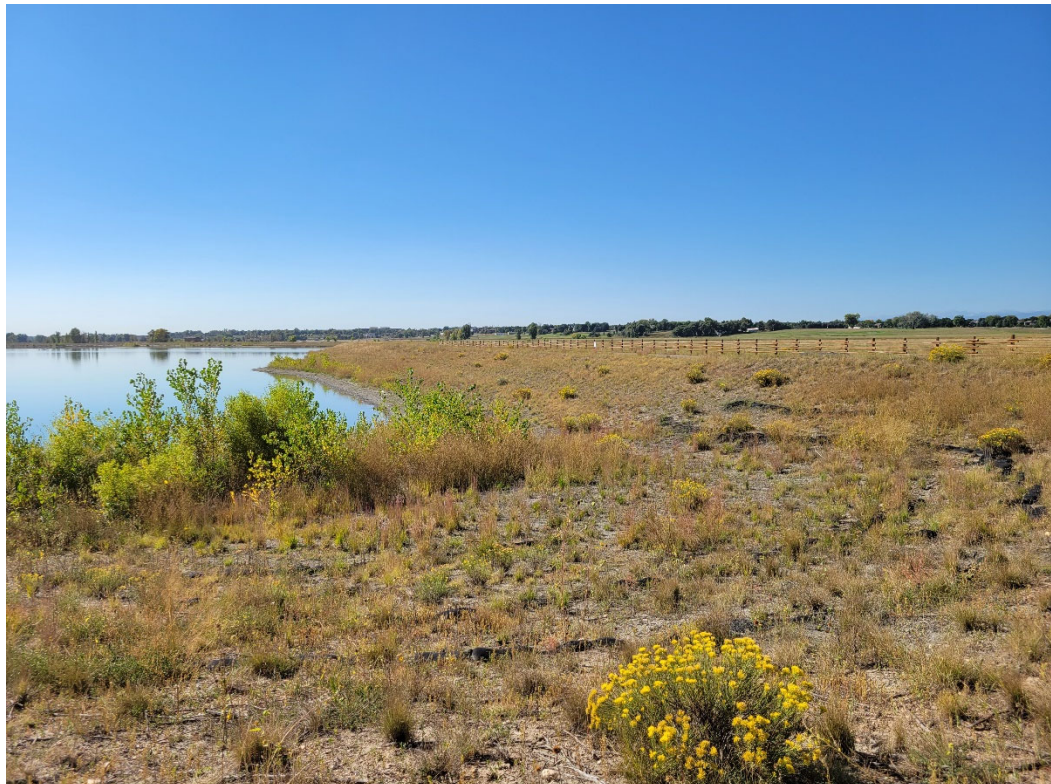
The shorelines of the pond are graded flatter than 3H:1V and are stable with established grasses, forbs, and a few volunteer cottonwood and willow trees. The land surrounding the pond is well vegetated with grasses. The northwest corner of the reservoir has been overseeded a few times to ensure uniform growth and the City installed shallow terracing and rock berms to slow water flowing down the slope.

Photo 6: Northwest corner of reservoir. City placed berms filled with crushed rock on the slope to control water erosion. Grasses are uniform across this area.

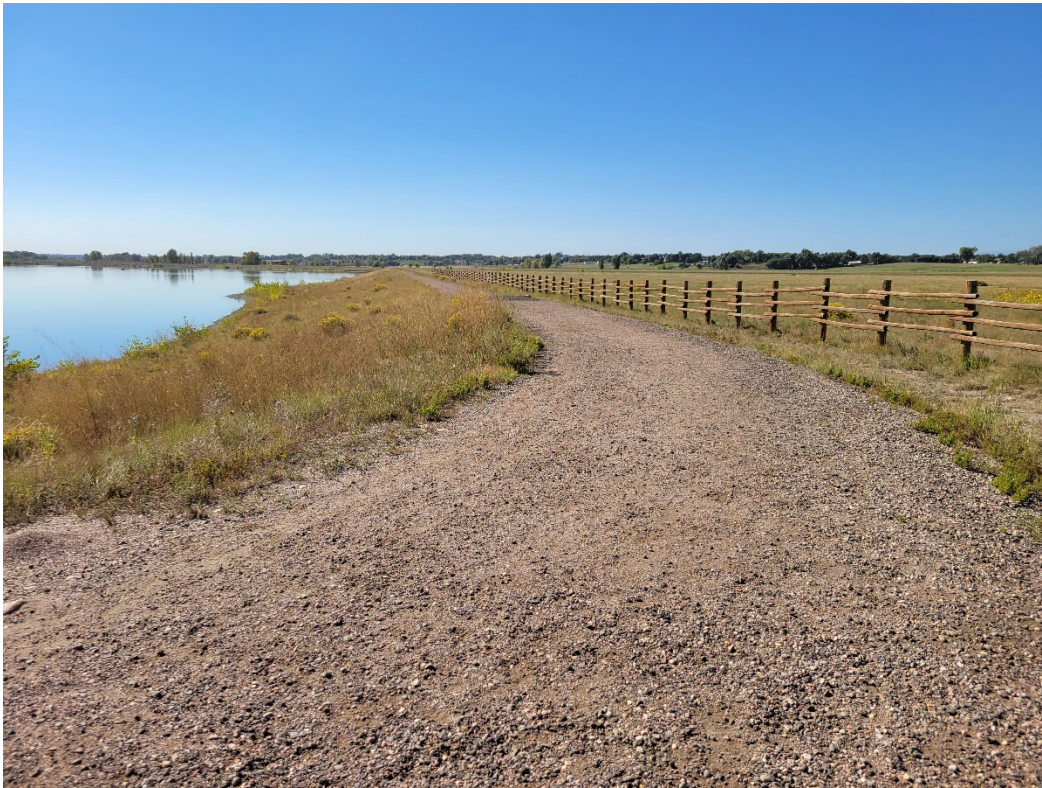
Photo 7: Looking south down trail around reservoir from northwest corner.

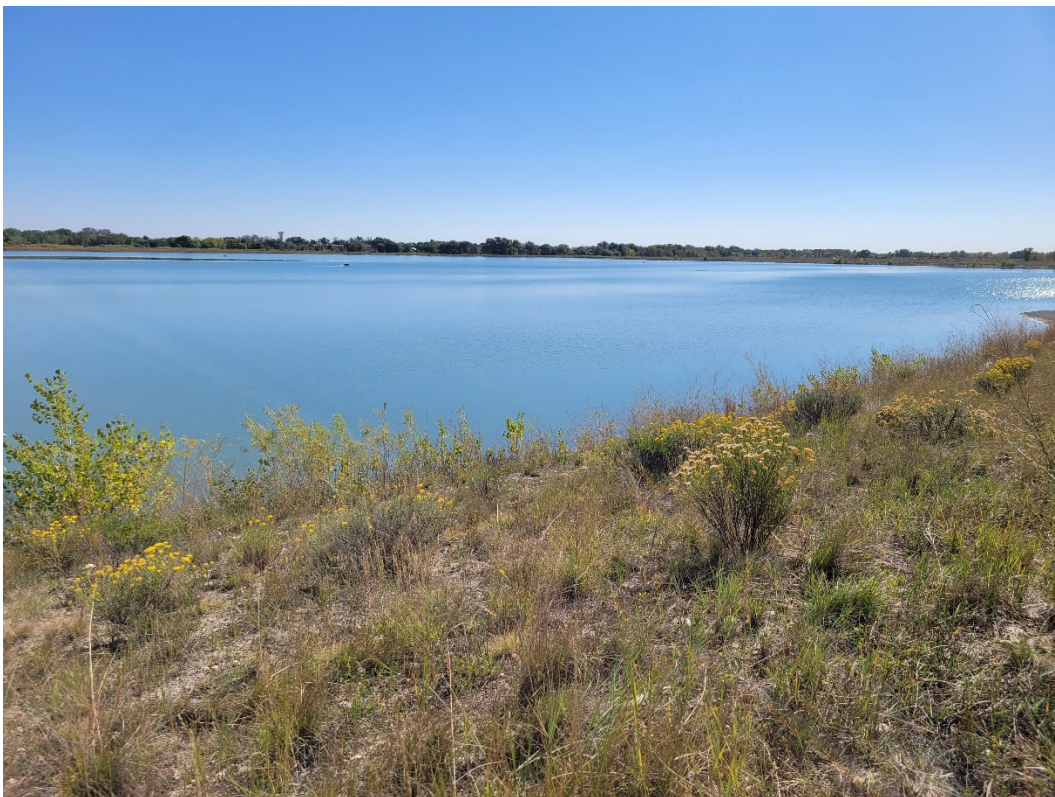
Photo 8: View across reservoir from the southeastern side.

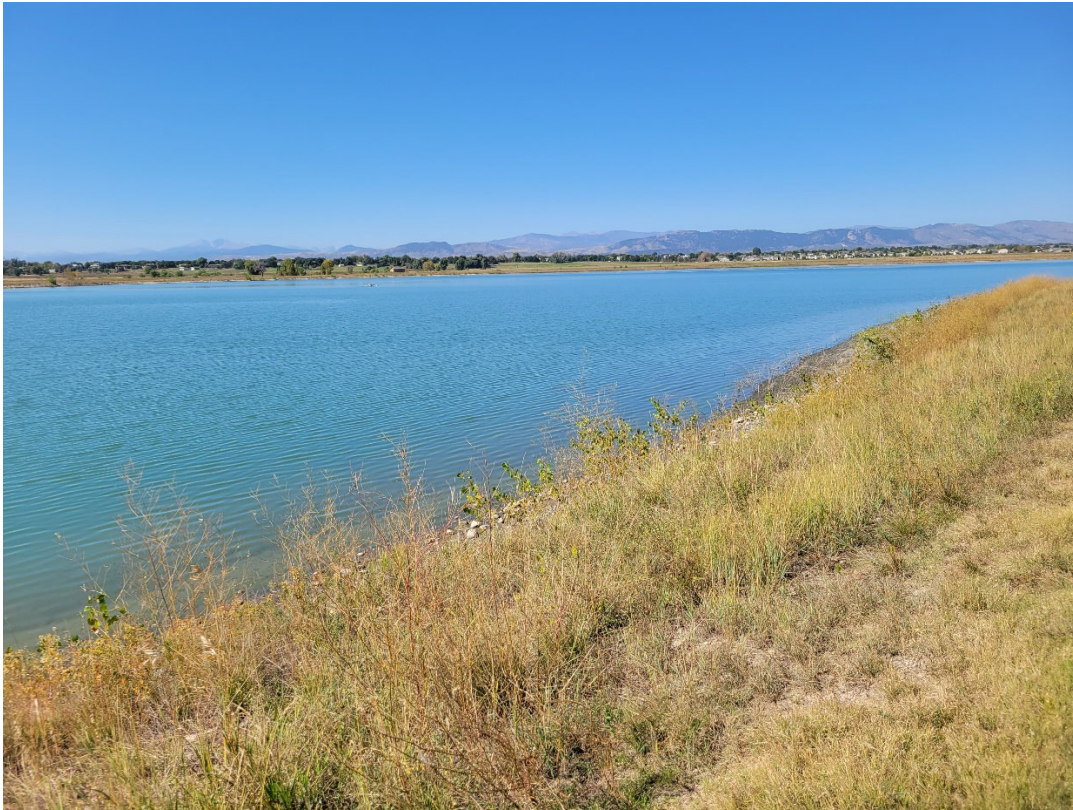
Photo 9: Looking west from the east side of the reservoir.

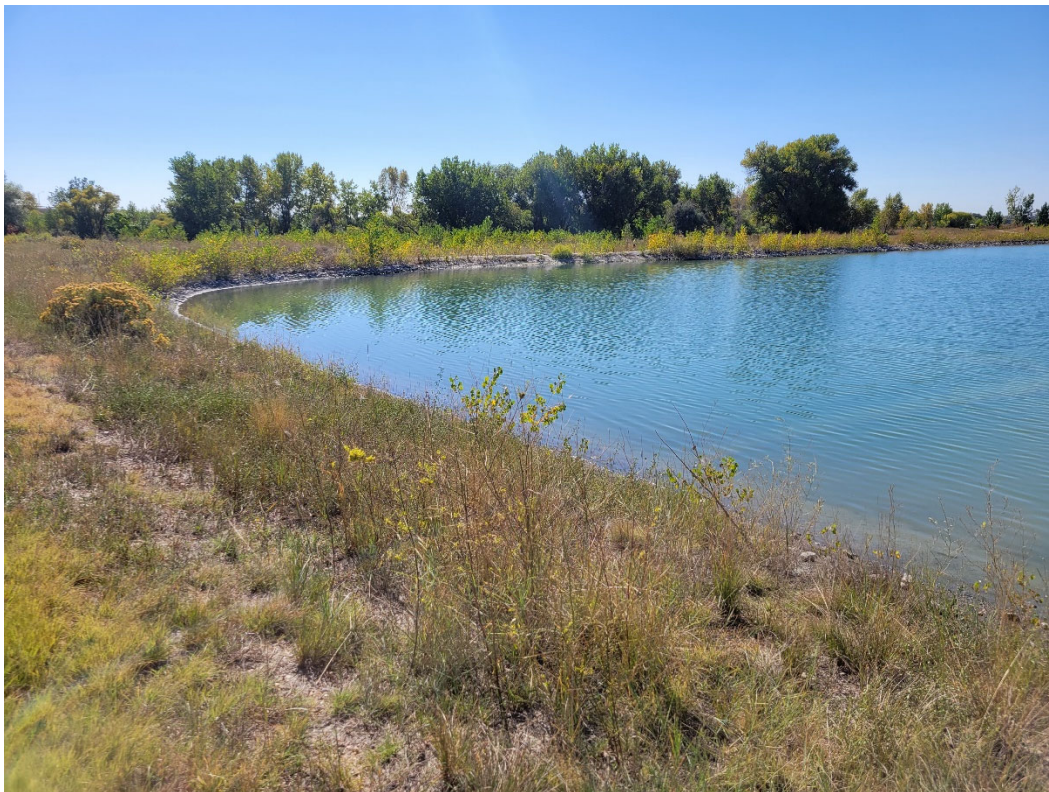
Photo 10: Looking at the southern corner of the reservoir. Slopes are 3H:1V or shallower above and below the water line.

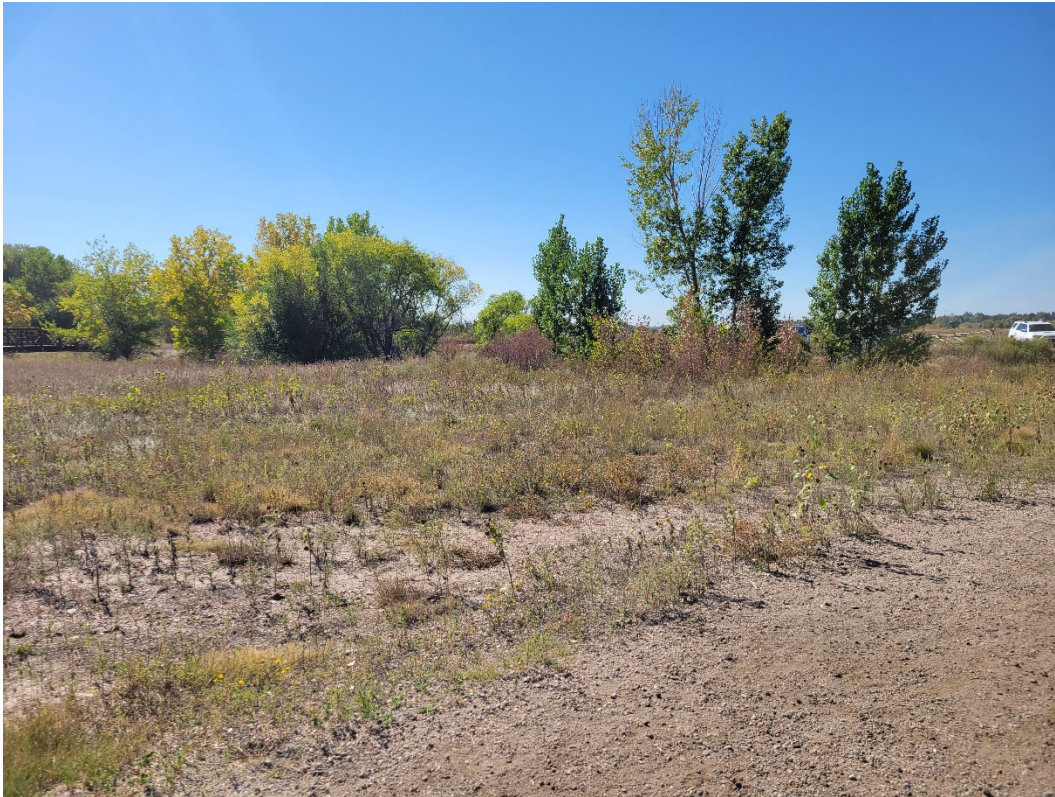
Photo 11: Revegetated area just outside the southern end of the reservoir.

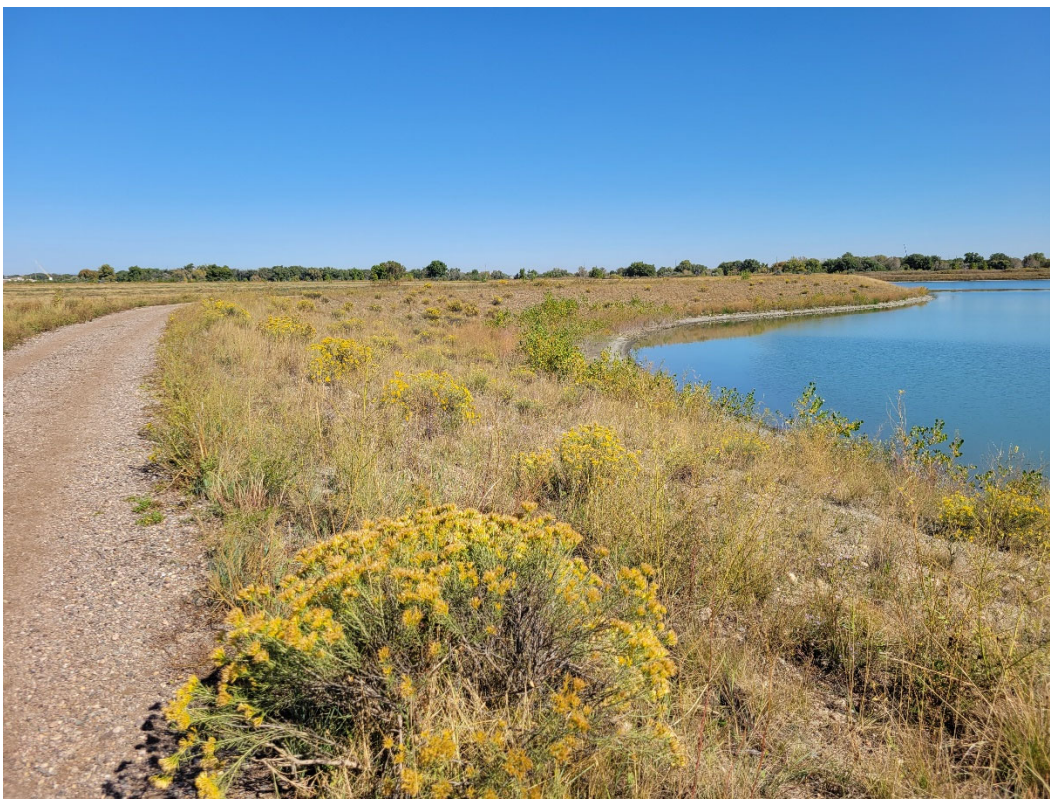
Photo 12: Looking at the slopes along the northwestern side of the reservoir.

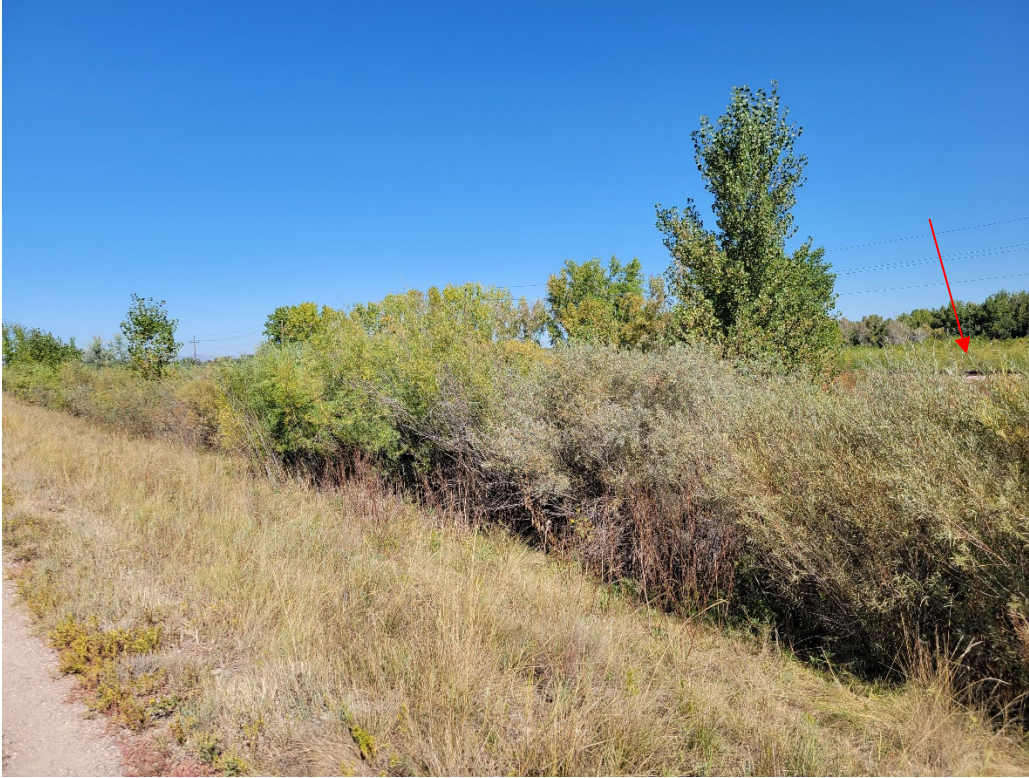
The Division noted a few Tamarisk trees growing along the railroad right-of-way between the eastern and western permit areas. The trees appear to be outside the release area and the City stated the trees are scheduled for removal in the following week.

Photo 13: Riparian buffer between the western and eastern mining areas. Arrow points to railway bed that runs through, parallel to the eastern side of the reservoir.
