Permit Number: C-1981-015 Mine Name: Fruita No 1 & 2 Operator: Dorchester Coal Company Operator Address: Greg Lewicki 9054 South Forrest Drive Highlands Ranch, CO 80126	County: Mesa Operation Type: Underground Permit Status: Revoked Ownership: Private
	Operator Representative Present: NA
Operator Representative Signature: (Field Issuance Only)

Inspection Start Date: September 27, 2023 Inspection Start Time: 11:15 Inspection End Date: September 27, 2023 Inspection End Time: 12:00		Inspection Type: Coal Complete Inspection Inspection Reason: Normal I&E Program Weather: Clear	
Joint Inspection Agency: None		Joint Inspection Contacts: None	
Post Inspection Agency: None		Post Inspection Contacts: None	
Inspector(s): Clayton Wein	Inspector's Signature: <i>Clayton Wein</i>		
		Signature Date: 10/10/2023

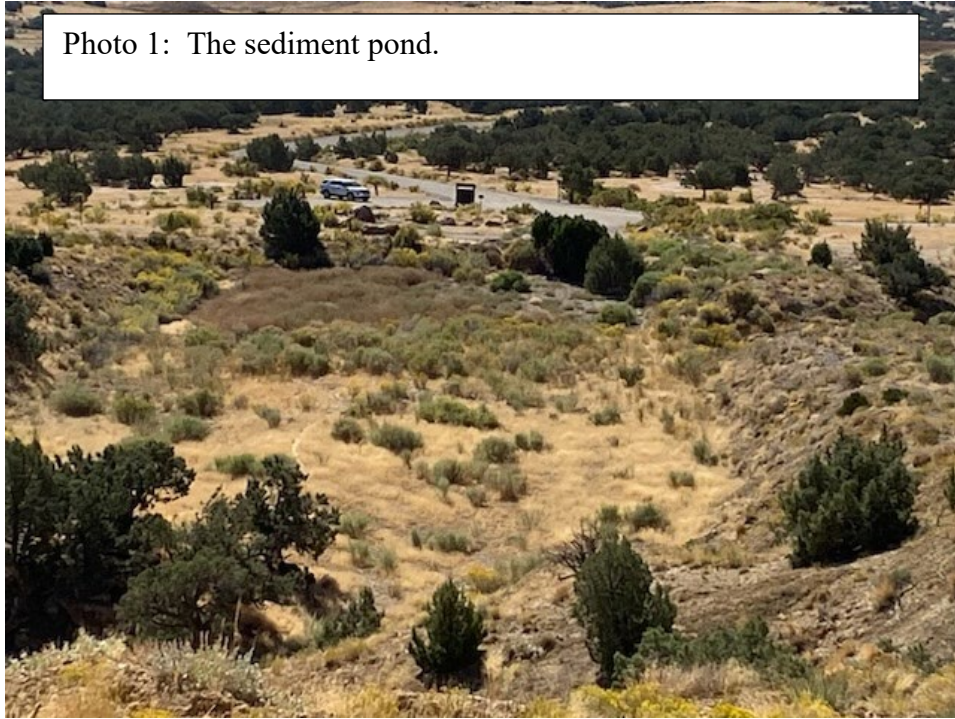
During the inspection, the sediment pond was dry (Photo 1). The sediment pond will remain at the site as a permanent feature. The embankment was stable with vegetative cover. There were no indications of erosional features. The outlet for the pond is located on the west side of the pond and is lined with riprap. The outlet was stable. Vegetation and shrubs have grown in the outlet. The outlet is not blocked and flow is capable of passing through as designed.

Photo 1: The sediment pond.

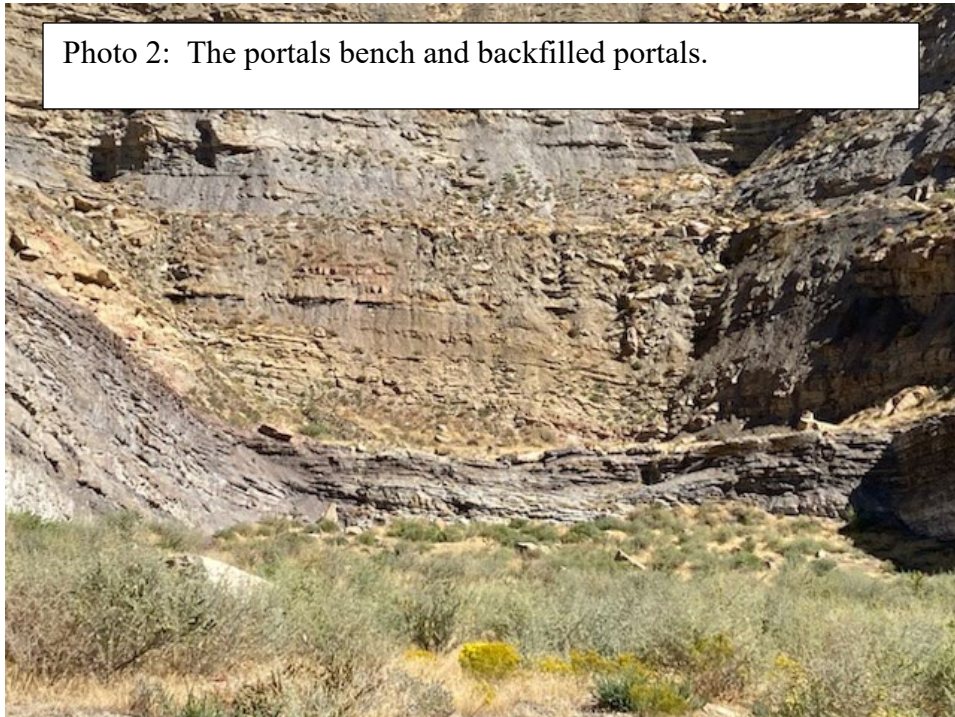
The reclaimed portals bench was covered with vegetation and stable (Photo 2). There were no indications of erosion observed. The backfilled portals were stable with no signs of sloughing or erosion. The southern slope off of the portals bench was stable with minimal vegetative cover on the upper half and more vegetation on the lower half. The steepness of the slope and the southern exposure has made it difficult for vegetation to grow in. This has been documented in previous Division inspection reports. The riprap lined channel connects the portals bench to the gulch below that eventually enters the

Photo 2: The portals bench and backfilled portals.

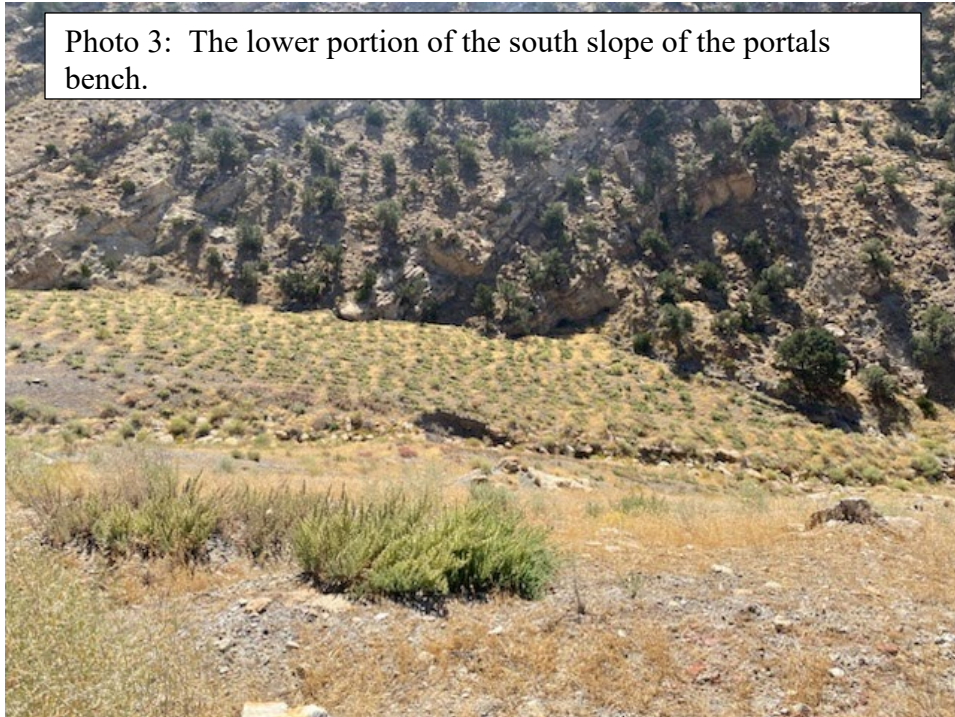
sediment pond. The channel was stable with no new erosional features identified. A large rill has been documented on the side of the channel near the bottom half. The rill did not appear to have enlarged (Photo 3).

Photo 3: The lower portion of the south slope of the portals bench.

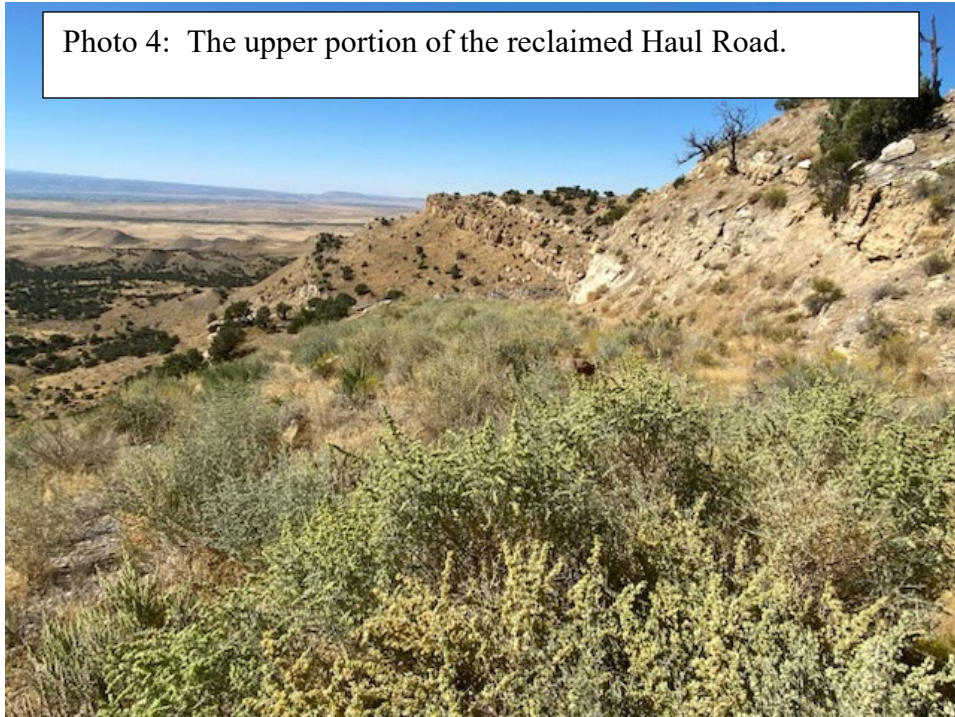
The upper, middle and lower portions of the reclaimed haul road were stable and covered with vegetation (Photo 4, 5 and 6). There were no erosional concerns. A rill on the middle portion of the reclaimed haul road has been documented in previous Division inspection reports. The rill has decreased in size and was observed to be normalizing. The rill has filled some with sediment and was no longer down-cutting.

Photo 4: The upper portion of the reclaimed Haul Road.

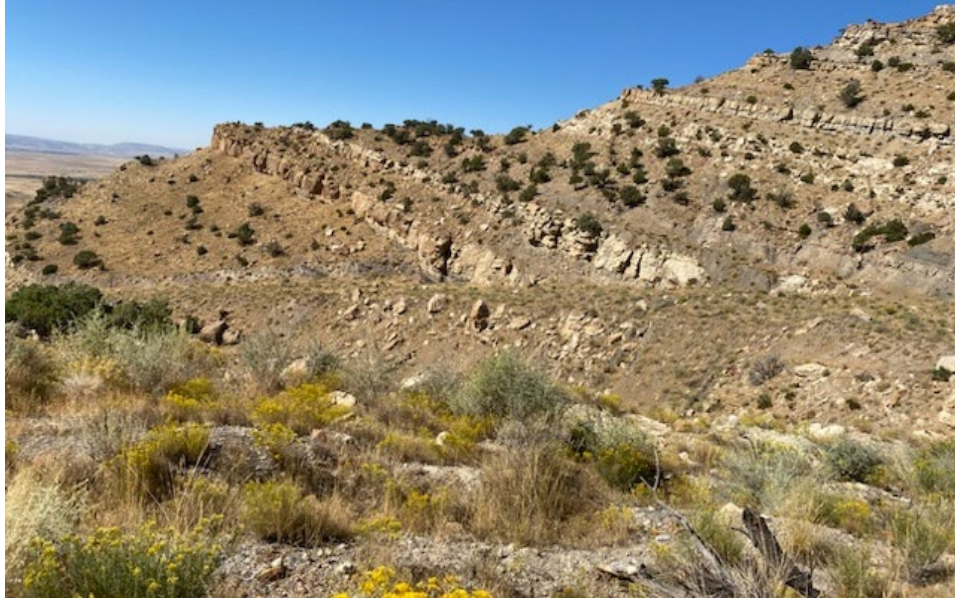
Photo 5: The middle portion of the reclaimed Haul Road.

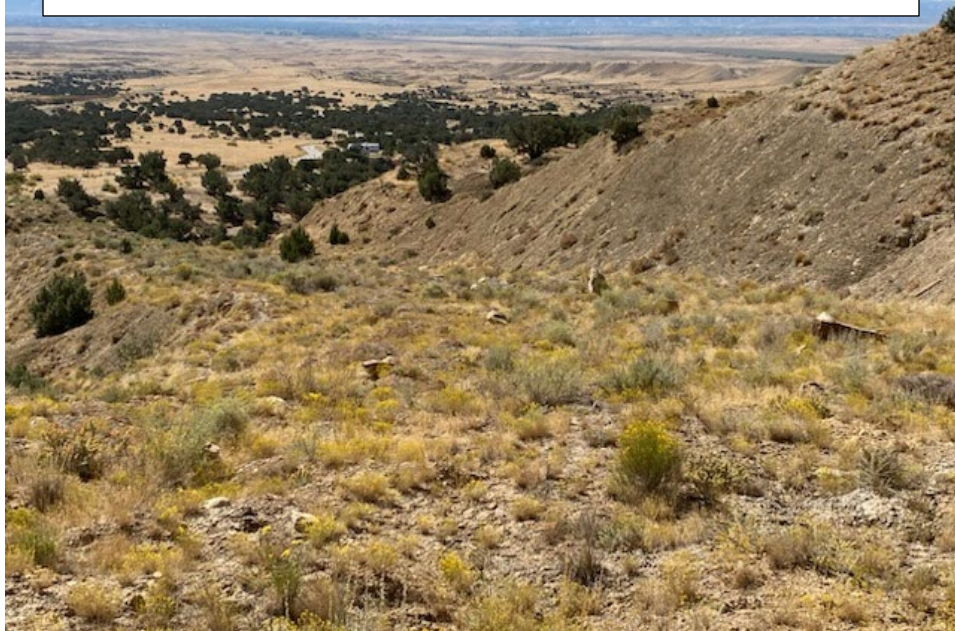
Photo 6: The lower portion of the reclaimed Haul Road.
