MINERALS PROGRAM INSPECTION REPORT
PHONE: (303) 866-3567

MINE NAME: Deterding Pit	MINE/PROSPECTING ID#: M-2011-006	MINERAL: Sand and gravel	COUNTY: Yuma
INSPECTION TYPE: Monitoring	WEATHER: Clear	INSP. DATE: August 31, 2023	INSP. TIME: 11:00
OPERATOR: Yuma County	OPERATOR REPRESENTATIVE: Tom Anderson	TYPE OF OPERATION: 112c - Construction Regular Operation	
REASON FOR INSPECTION: Normal I&E Program	BOND CALCULATION TYPE: None	BOND AMOUNT: N/A	
DATE OF COMPLAINT: NA	POST INSP. CONTACTS: None	JOINT INSP. AGENCY: None	
INSPECTOR(S): Nikie Gagnon	INSPECTOR'S SIGNATURE:

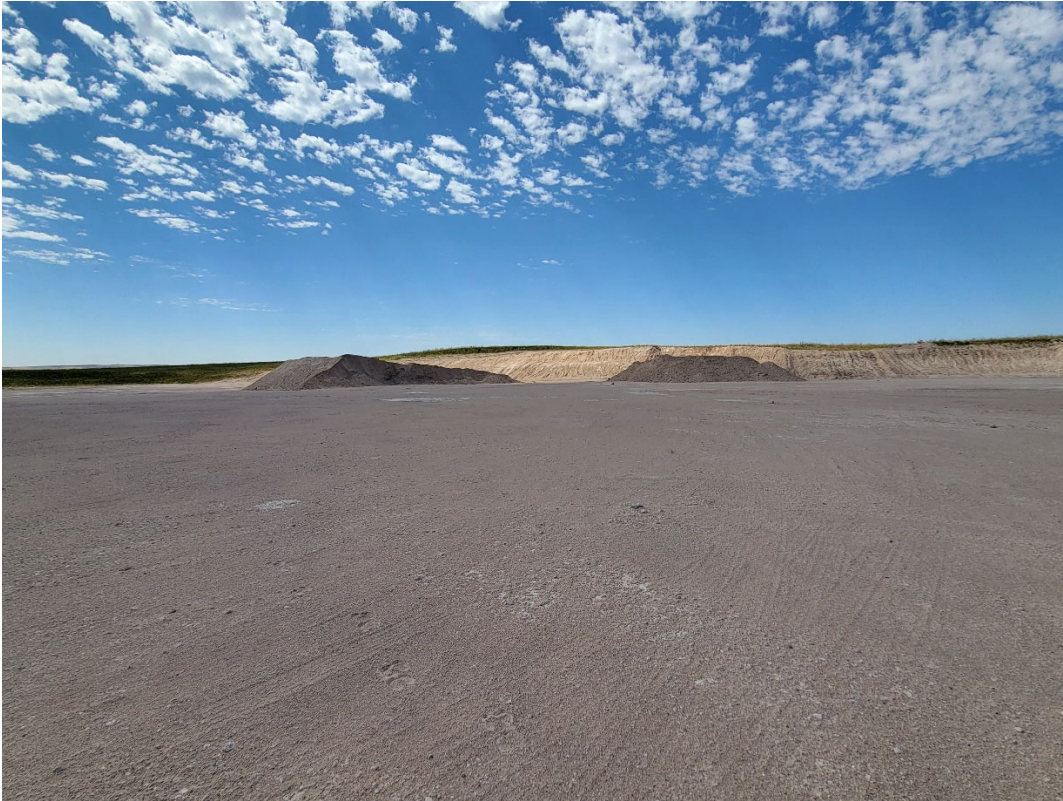
Photo 1: Looking south across the pit floor. Stockpiled material stored along the base of the highwall.

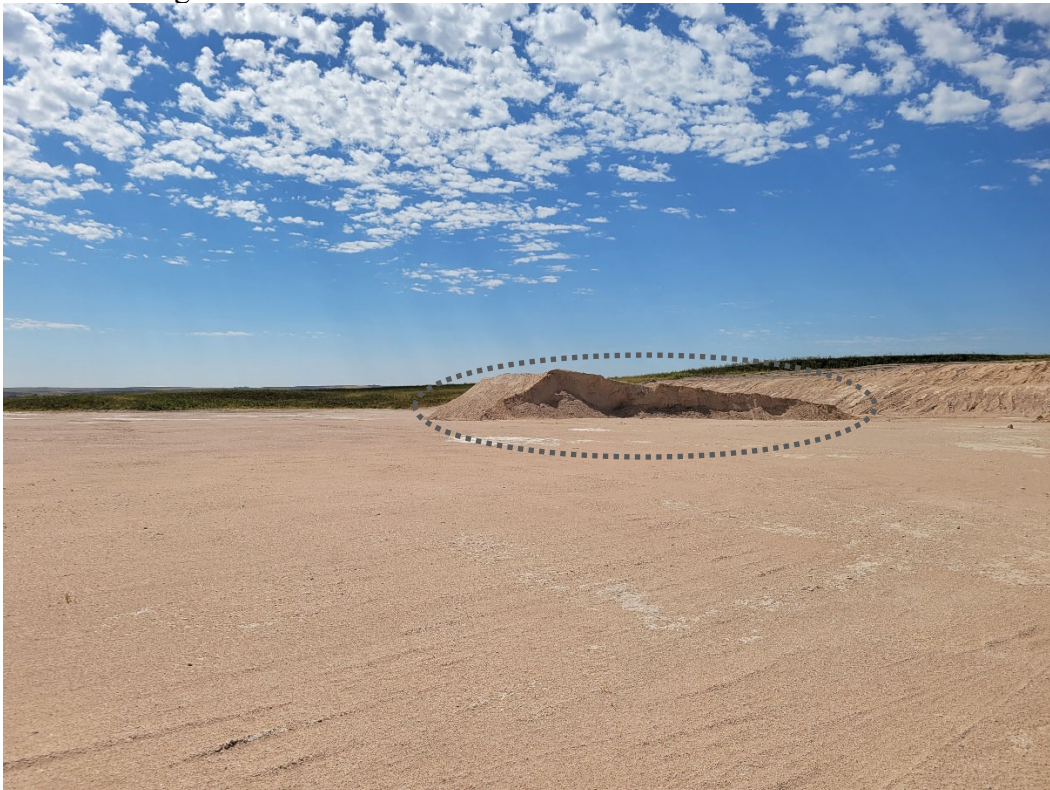
Photo 2: Looking southeast at stockpile of material stored in the pit.

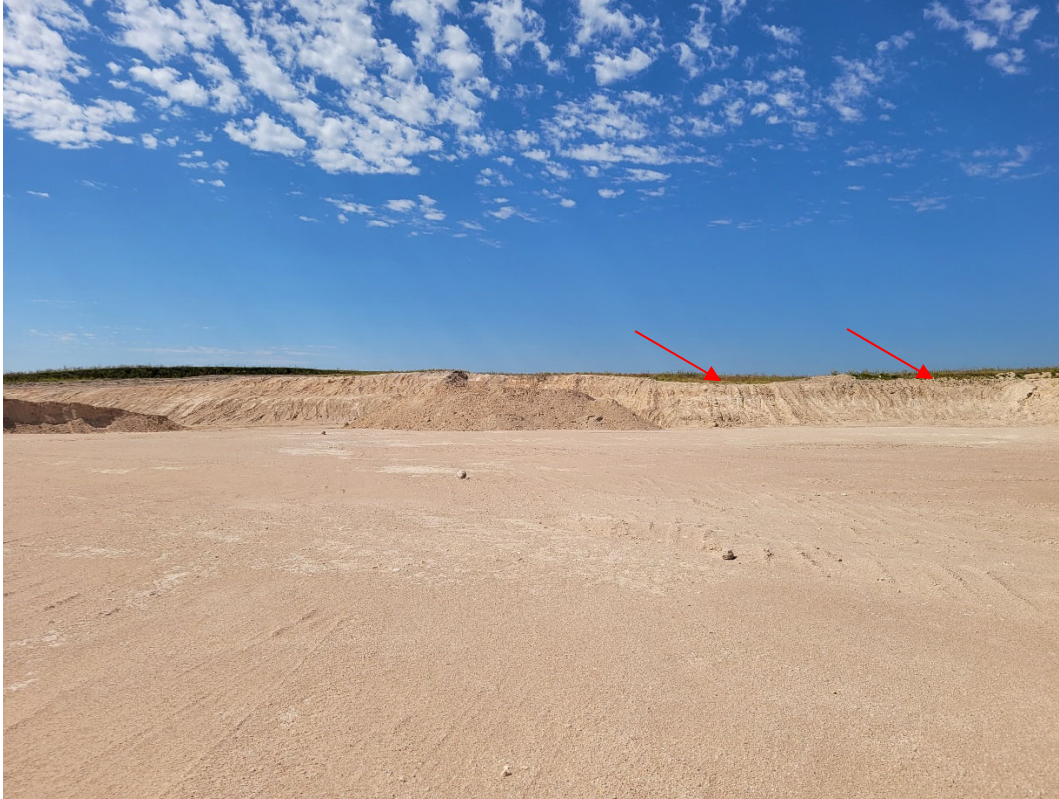
The original 111 mined area was in the northeast corner of the permit area, on the east side of an intermittent drainage channel that runs north to south across the site. The original excavation was graded, topsoiled and seeded prior to approval of the 112c conversion. Over the years, the area of active mining moved west. The current operation consists of a large u-shaped excavation on the west side of the drainage that daylights to the north. The pit area is flat. The side slopes of the pit were observed to be 3H:1V or shallower on three sides and the highwall along the southern limit of the pit is closer to 2H:1H in some areas. Two stockpiles of mined material was observed in the pit area.

Photo 3: Looking highwall along the southern limit of the pit. Arrows point to area where highwall is steeper than 3:1.

The approved mine plan states the intent is to work approximately 10 acres at a time in three mining phases over the life of the mine. According to the plan, after Area 1 is mined, the topsoil will be spread out evenly and a 3:1 slope will be maintained on the side walls.

The final reclamation plan includes grading all slopes to 3:1 or shallower, ripping the mined area across the slope to catch moisture and loosen soil, and spreading the stockpiled topsoil over the prepared area. The permit area will be seeded with the approved seed mix utilizing a drill seeding method, and weed free straw or banded fiber matrix will be applied at 3,000 pounds per acre. Once reclaimed, the area will be inspected for noxious weeds on a regular basis. The existing roadway will remain for use by the landowner and all internal haul roads will be reclaimed.

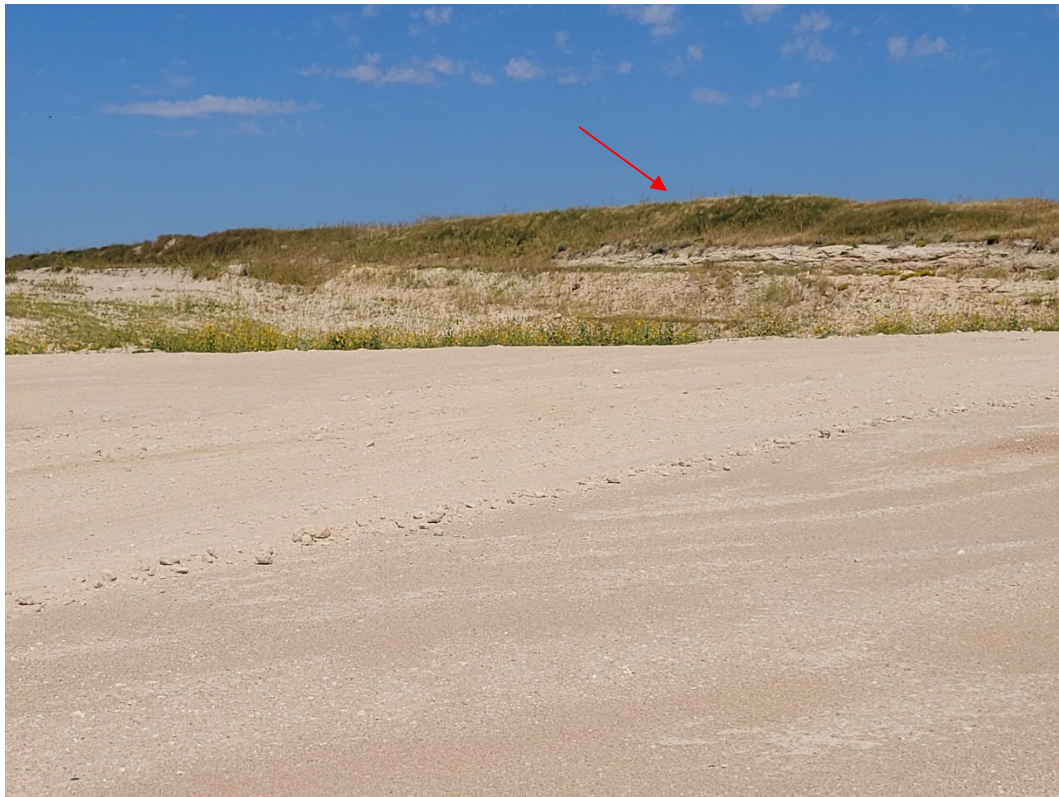
Topsoil is salvaged and stored in a berm above the highwalls on the southern and western sides of the pit. The berms are vegetated with grasses, some annual weeds were observed growing on bare patches on side slopes and on top of the berm, however no erosion gullies were observed, and the topsoil is stable. The approved mine plan states the topsoil berms will be seeded with crested wheat grass to minimize blowing and erosion. The Division recommends reseeding bare patches on the topsoil pile. According to the mine plan, there is no overburden to stockpile.

Photo 4: Looking west from the pit floor. Topsoil berm located on the western side of the pit.

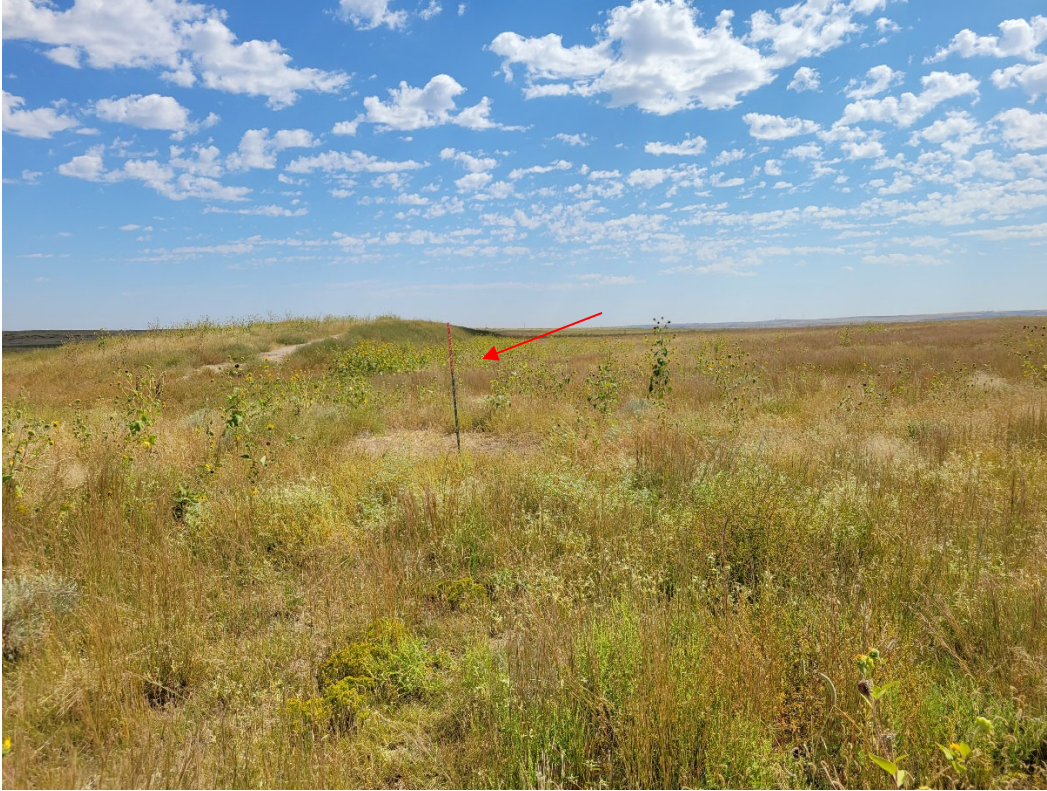
A mine sign was posted in accordance with Rule 3.1.12(1) at the entrance to the pit and the boundaries are marked in the corners with metal posts painted red at the top.

Photo 5: Looking north at boundary marker located on the eastern side of the permit area.

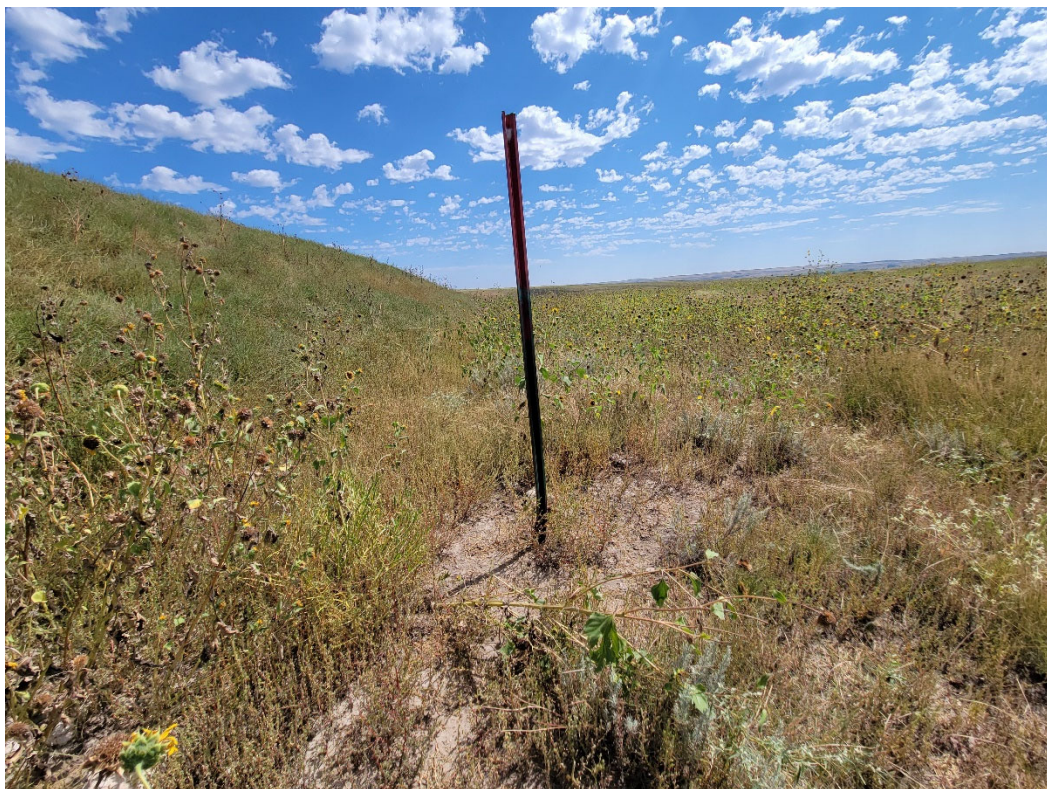
Photo 6: Looking east at boundary marker located outside a topsoil berm along the southern boundary.

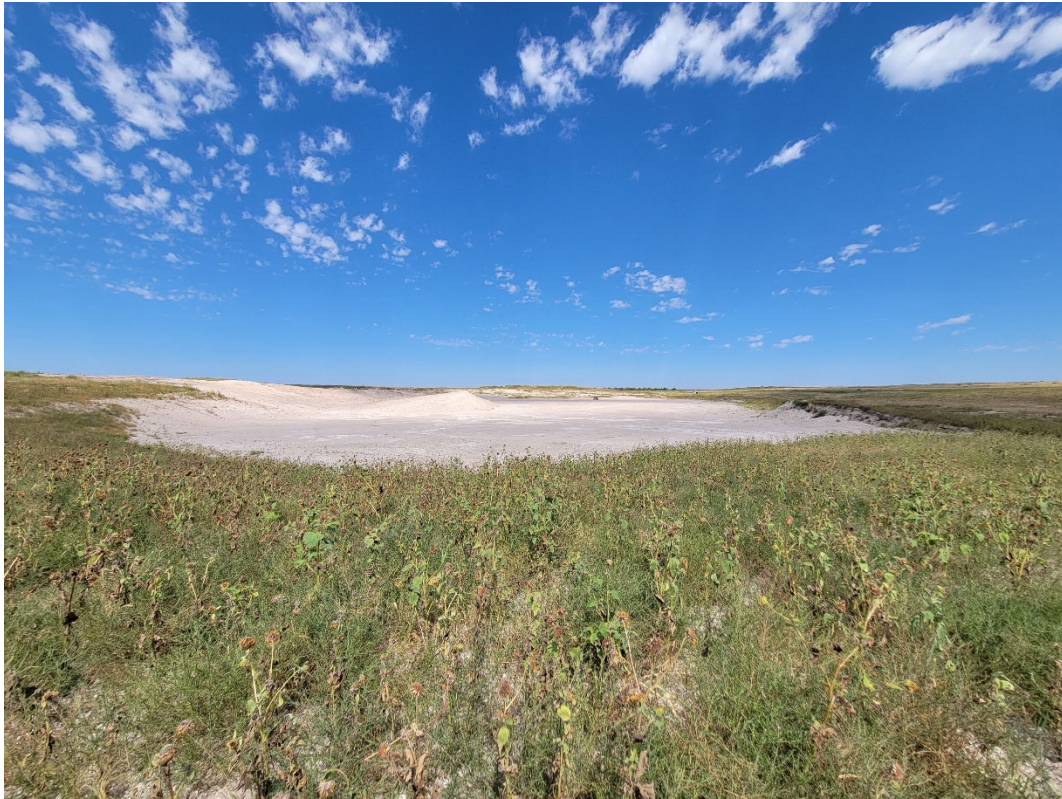
Photo 7: Looking west across the excavated mining area.

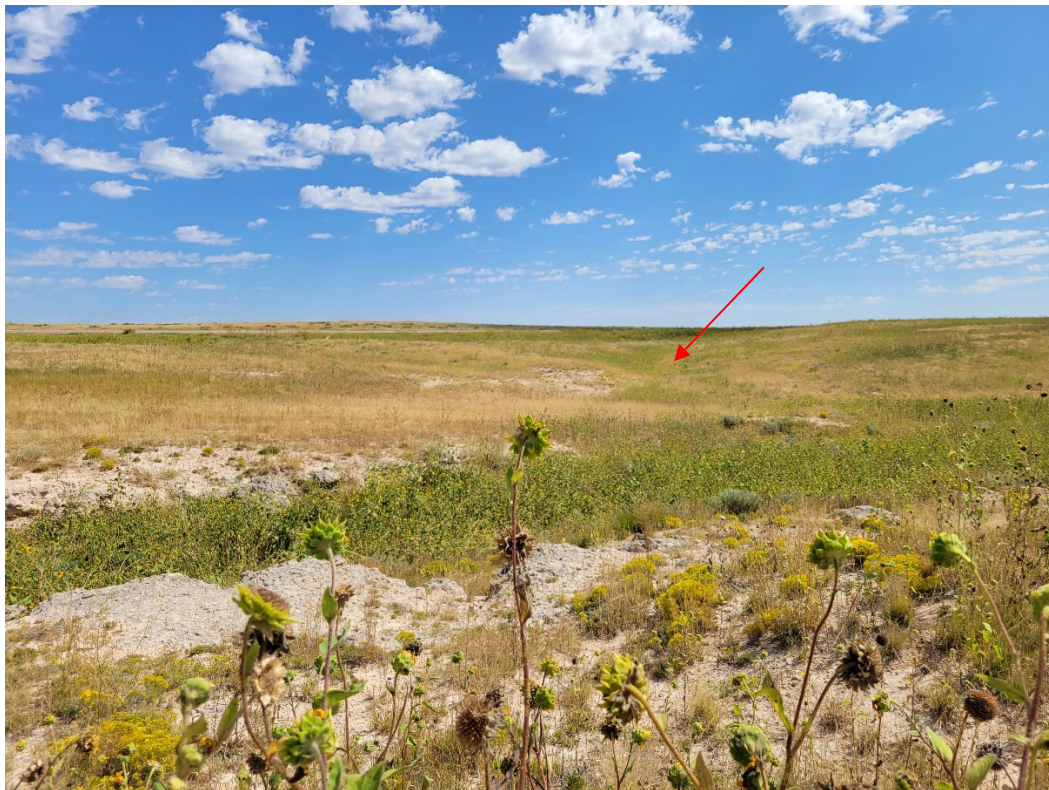
Photo 8: Looking northeast across older mining area. Red arrow points to intermitted drainage between the two mining areas that drains to the south.

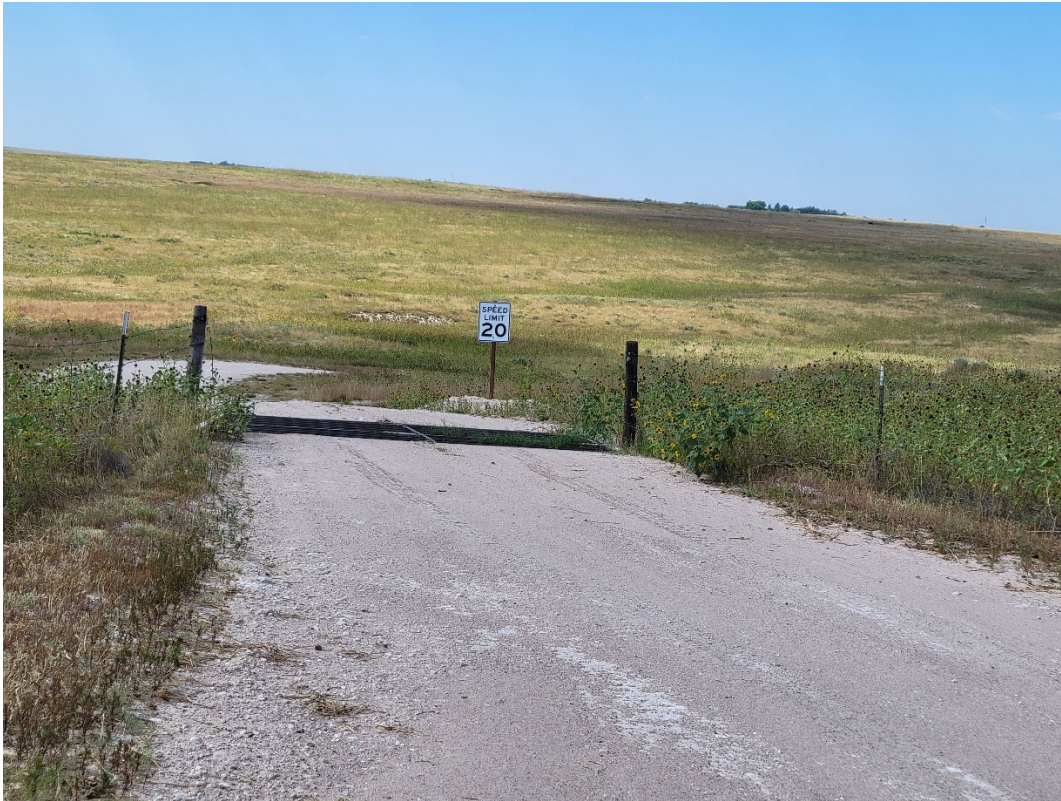
There are two access points off Highway 34 in the northeast and northwest corners of the permit area. A gravel road runs around 3 sides of the pit. The approved mine plan states the operation will maintain a 225' setback between the northern edge of the active pit and Highway 34 and a 25-foot setback around the perimeter of the active mining area to allow for inspections and maintenance. The Division observed these setbacks during this inspection.

Photo 9: Entry point and access road on the east side of the permit area.

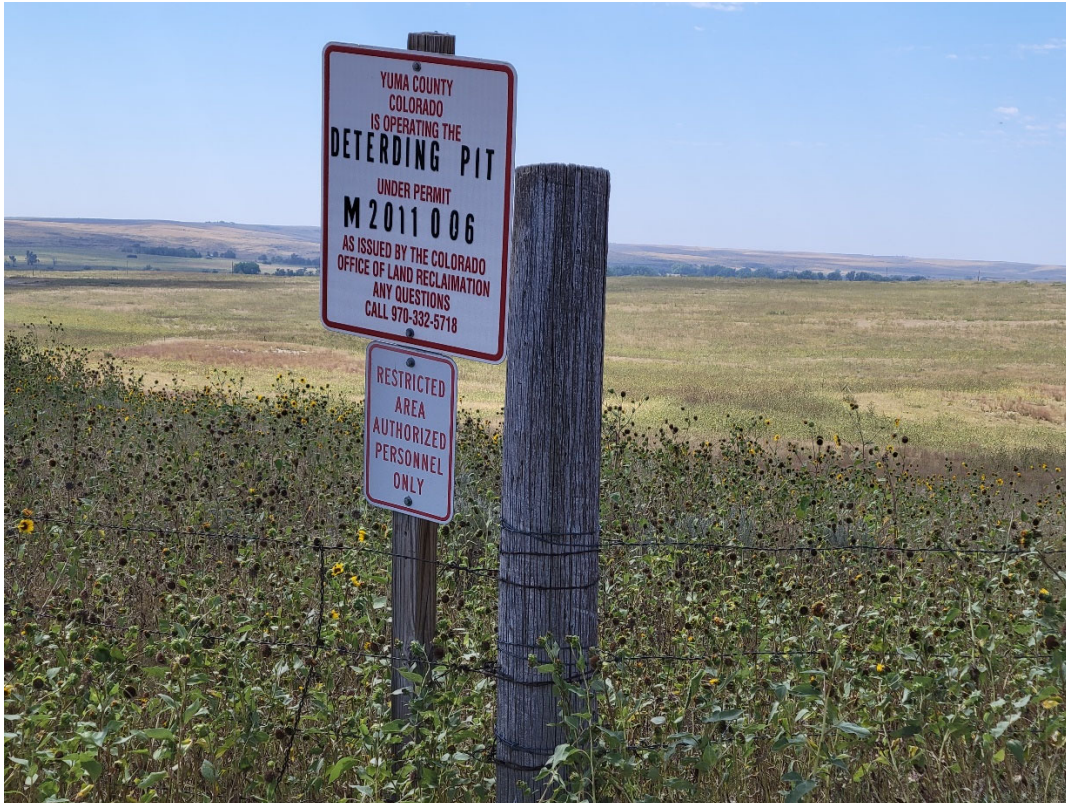
Photo 10: Mine sign posted at east entrance off Highway 34.

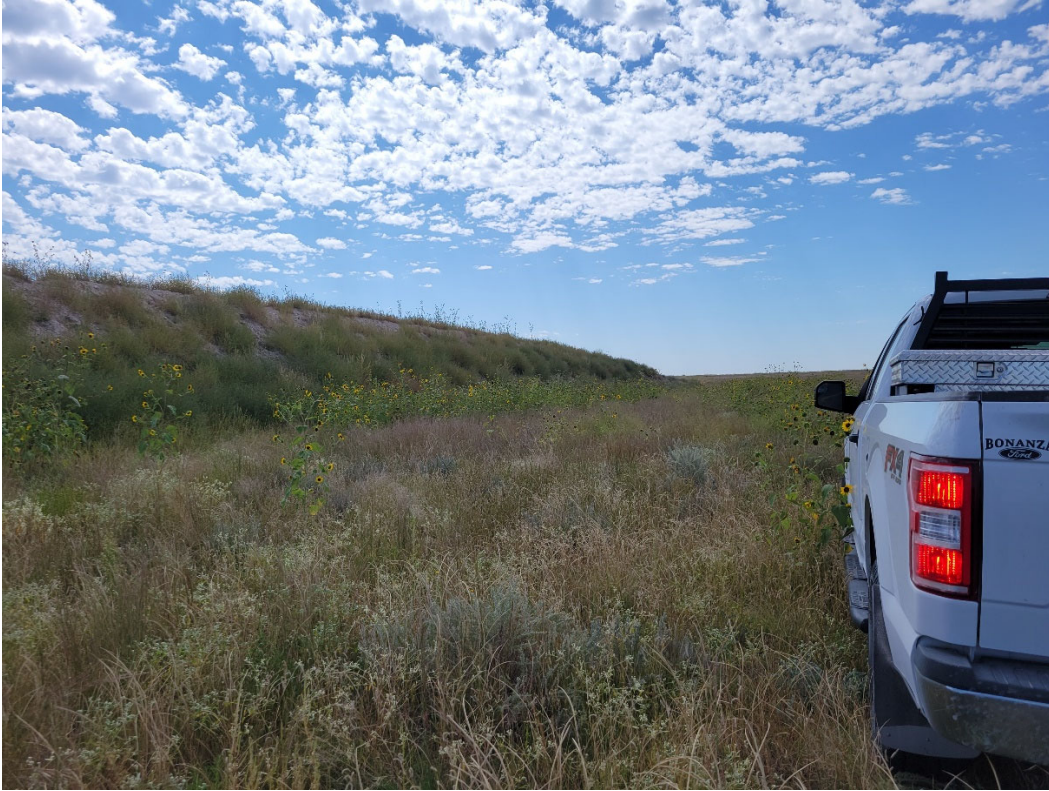
Photo 11: View of the backside of the topsoil berm. Some bare patches and annual weeds and sunflowers growing on the berm. Recommend overseeding with the approved seed mix.
