MINERALS PROGRAM INSPECTION REPORT
PHONE: (303) 866-3567

MINE NAME: Mekelburg Pit No 1	MINE/PROSPECTING ID#: M-1981-179	MINERAL: Sand and gravel	COUNTY: Yuma
INSPECTION TYPE: Monitoring	WEATHER: Clear	INSP. DATE: August 31, 2023	INSP. TIME: 13:50
OPERATOR: Yuma County	OPERATOR REPRESENTATIVE: Tom Anderson	TYPE OF OPERATION: 112c - Construction Regular Operation	
REASON FOR INSPECTION: Normal I&E Program	BOND CALCULATION TYPE: None	BOND AMOUNT: \$0.00	
DATE OF COMPLAINT: NA	POST INSP. CONTACTS: None	JOINT INSP. AGENCY: None	
INSPECTOR(S): Nikie Gagnon	INSPECTOR'S SIGNATURE:

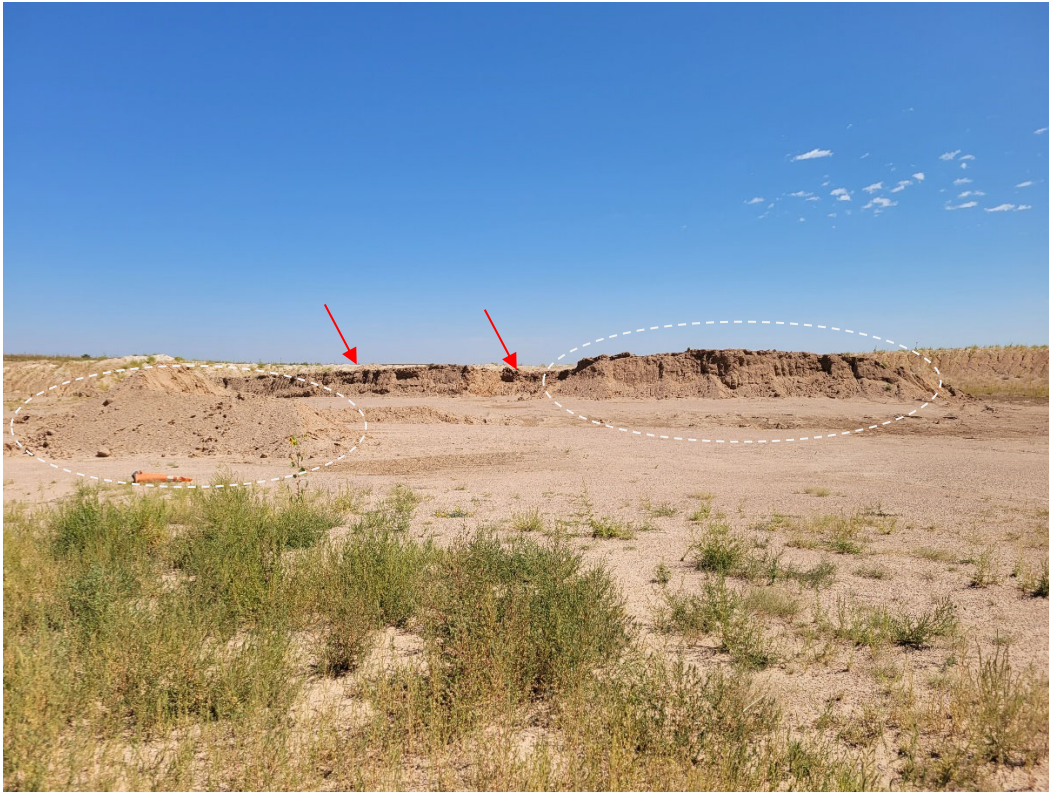
Pit Area 1 is on the south side of the permit area. This area was not currently being mined at the time of inspection, however there was evidence of recent mining activity. Mining is progressing to the east in a u-shaped excavation that daylights to the west. The active mining cut face is approximately 500 feet in length and approximately 20 feet high. The highwall along the east side of the pit is nearly vertical in the center and shallower on the sides. Slopes on the north and south sides of the pit, closer the entrance are graded to 3H:1V and vegetated. Stockpiles of mined material are stored in the bottom of the pit.

Photo 1: Looking east into Pit Area 1. Stockpiled material is stored on the pit floor (circled). Evidence of recent mining activity along the highwall (red arrow)

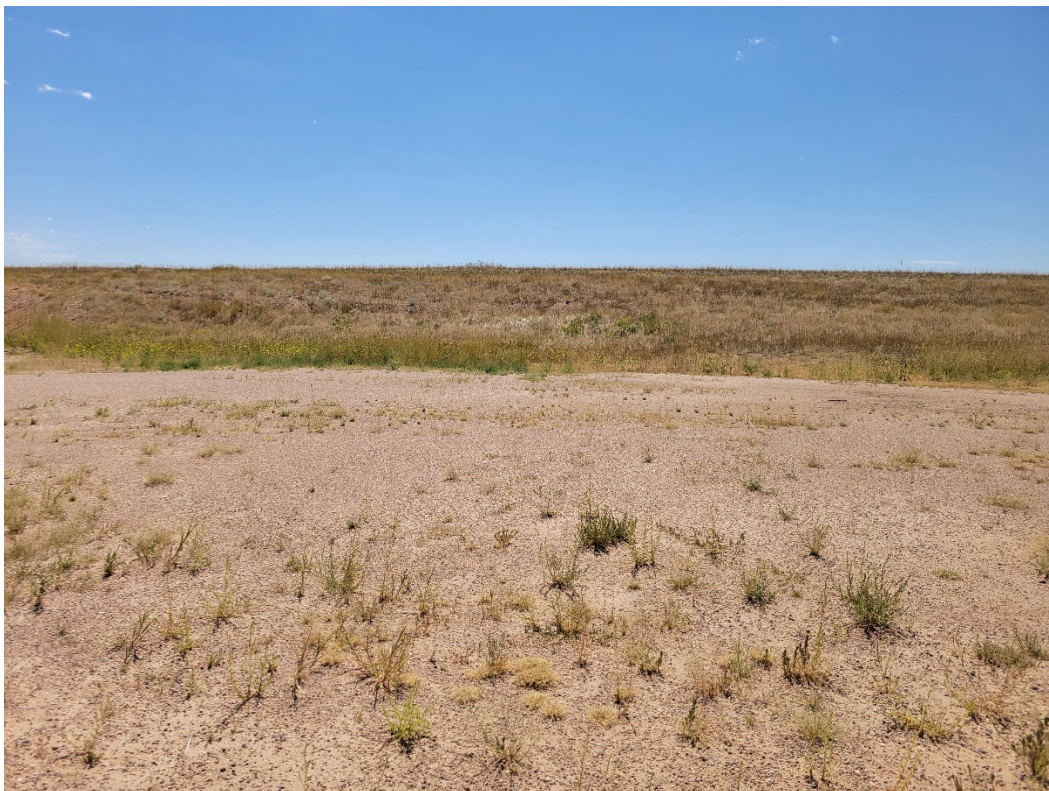
Photo 2: Looking at an older mined slope on the south side of the pit. The slope graded to 3H:1V and vegetated with grass.

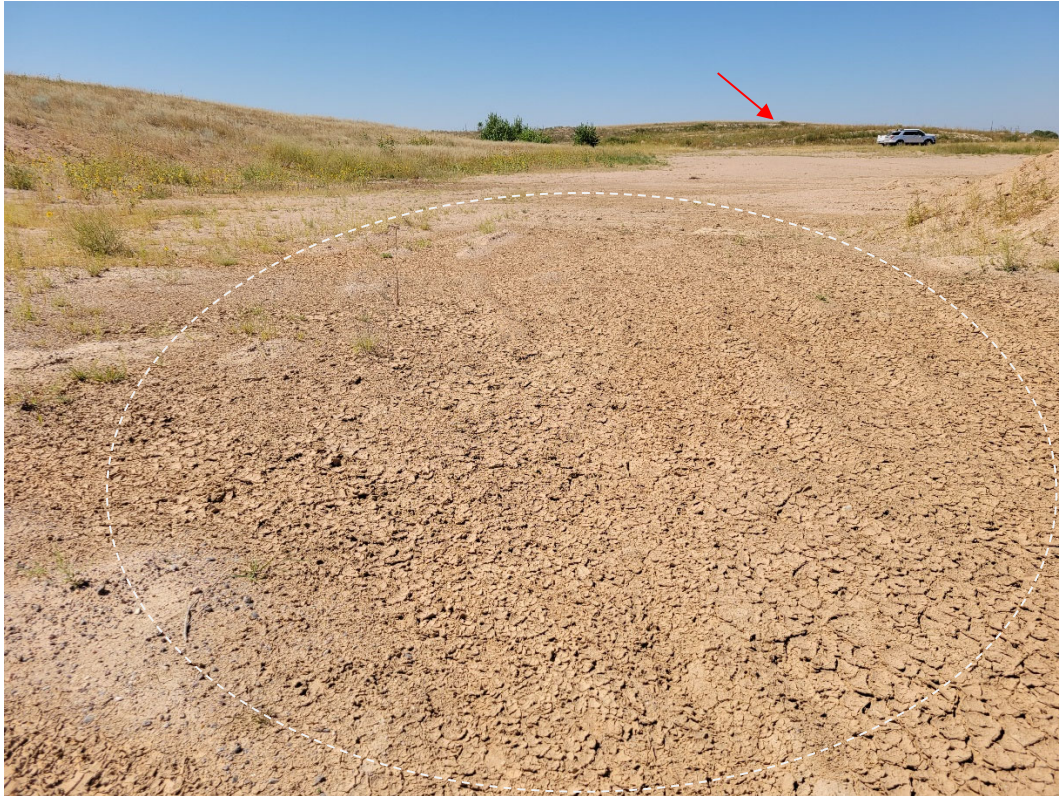
No standing water was observed in either pit area during this inspection. Soil cracking indicating standing water was noted in front of the highwall in Pit Area 1. Mr. Anderson stated stormwater had collected in a low spot in the pit but they grade the pit floor occasionally to eliminate depressions that trap water. Mining has not disturbed the ephemeral drainage between Pit Area 2 and 3.

Photo 3: Area of cracked soil in the foreground, indication of past standing water near the highwall in Pit Area 1. Vegetated topsoil berm in the background marked with a red arrow.

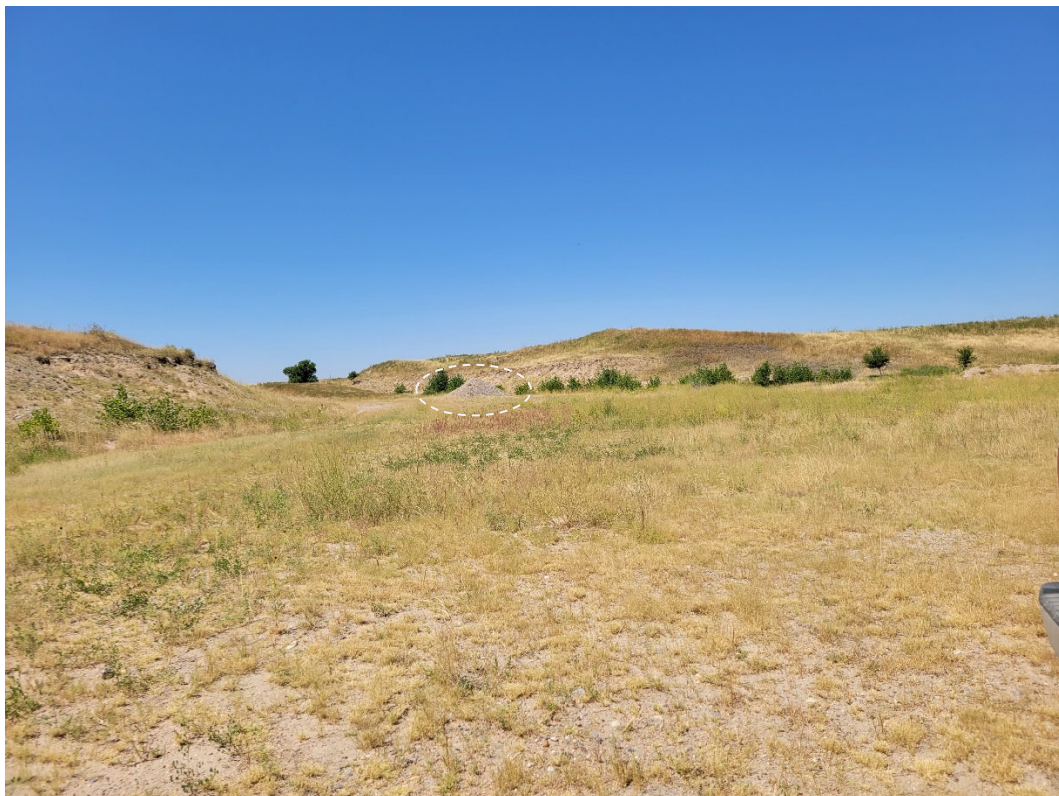
Photo 4: Looking northeast across Pit Area 2. Young cottonwoods are growing at the base of the highwalls around the pit, grasses, sunflowers, and annual weeds are growing on the pit floor. Small stockpile of gravel stored in the pit (circled).

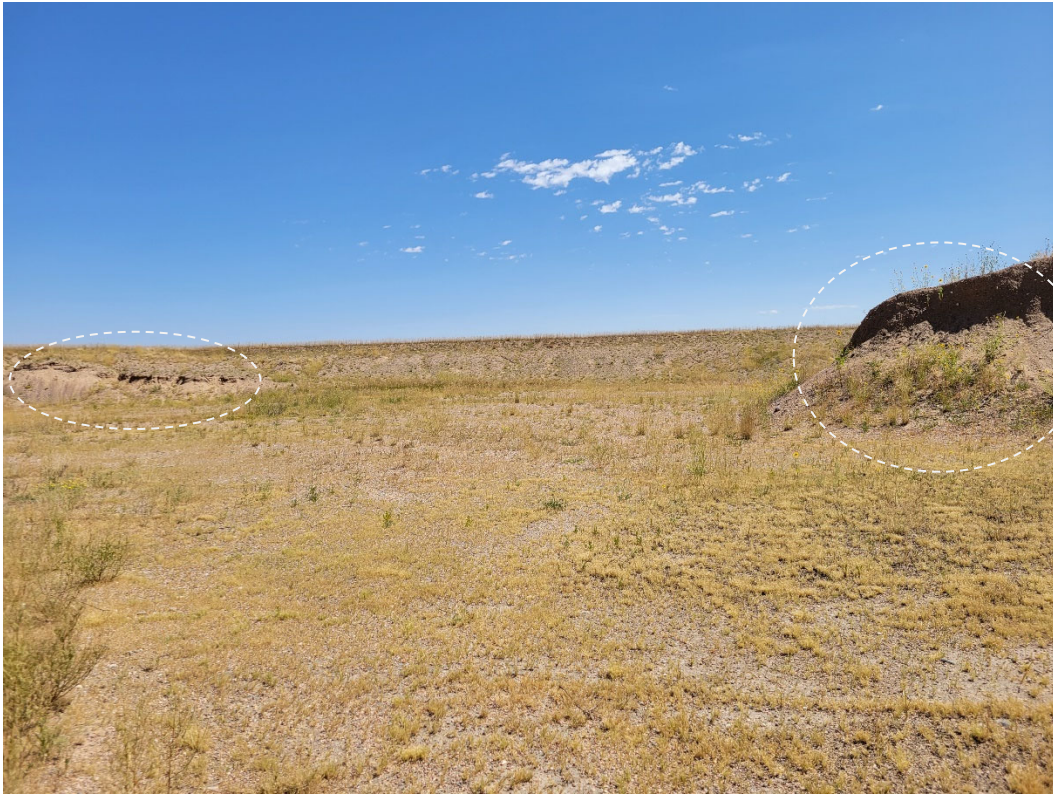
Photo 5: Looking east at Pit Area 2. No evidence of recent mining. Stockpiled material stored in the pit (circled).

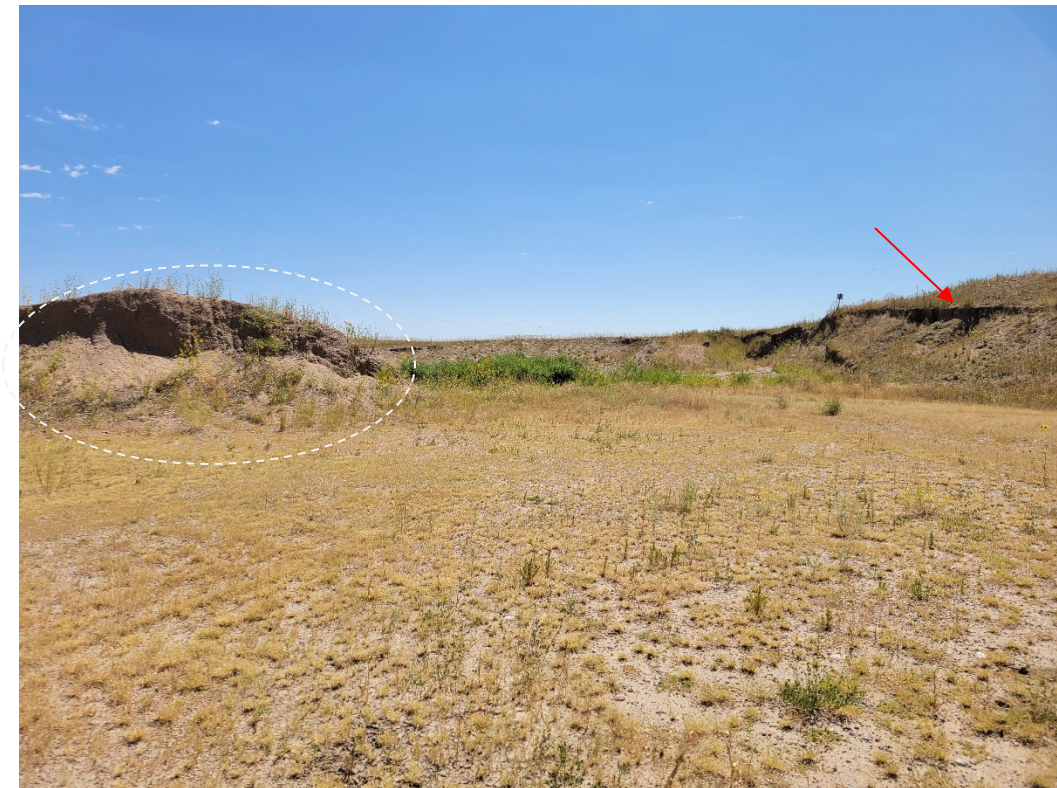
Photo 6: Looking southeast from the entrance to Pit Area 2. Stockpiled material in the pit (circled) and slopes on the south sides show signs of erosion below vegetation layer (red arrow).

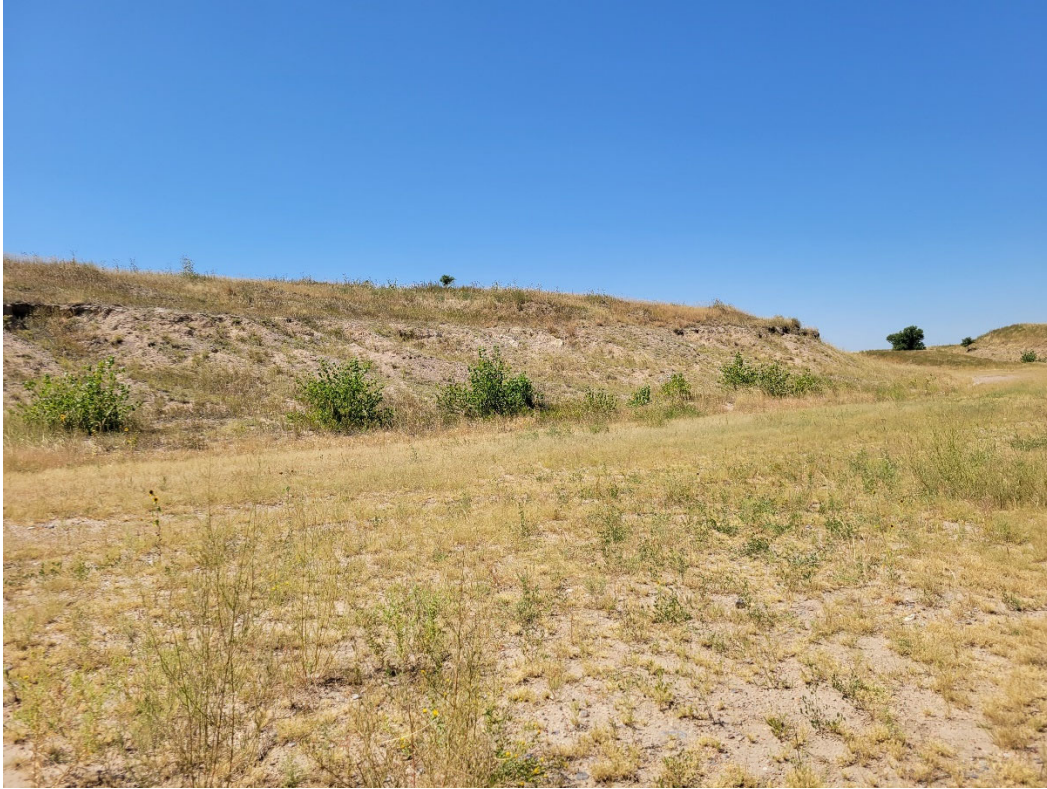
Photo 7: Slopes on the north side of Pit Area 2. Cottonwoods growing at the base of the slope.

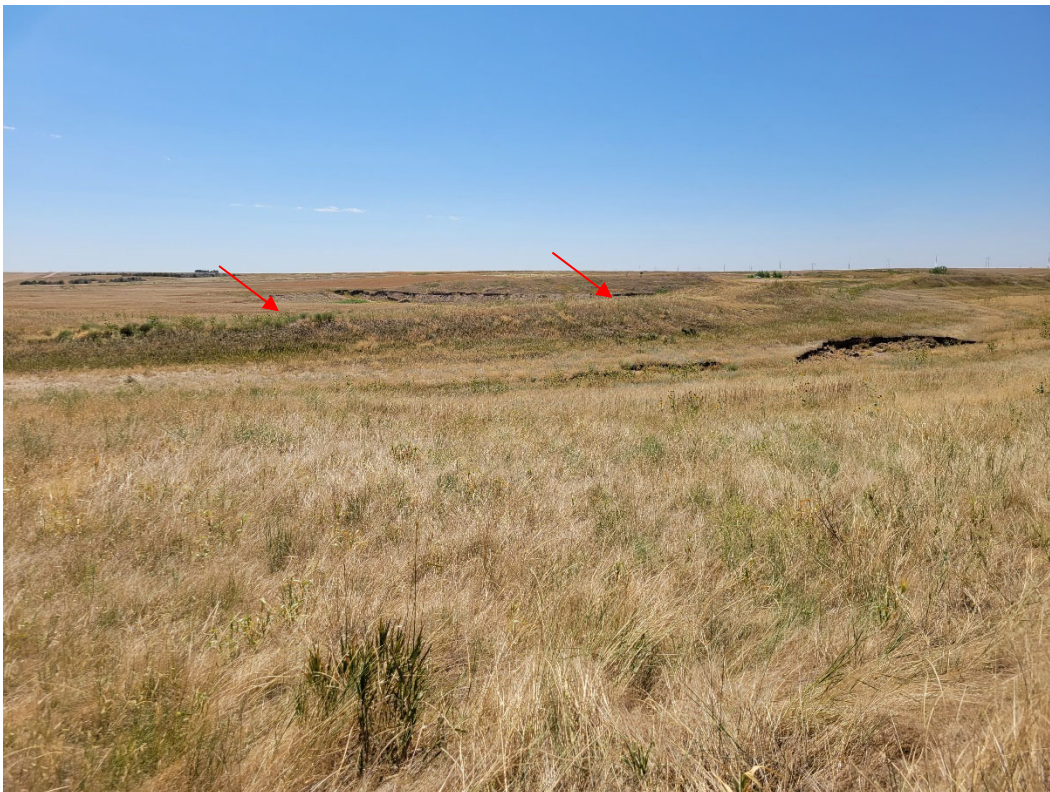
In Pit Area 1, the Division observed a vegetated topsoil berm along the west side of the permit area. The Division observed a vegetated u-shaped topsoil berm on the eastern boundary of Pit Area 2. The mine plan calls for seeding the topsoil with western wheatgrass to control erosion. All topsoil areas appeared stable with grasses during this inspection.

Photo 8: Topsoil berm on the eastern side of Pit Area 2.

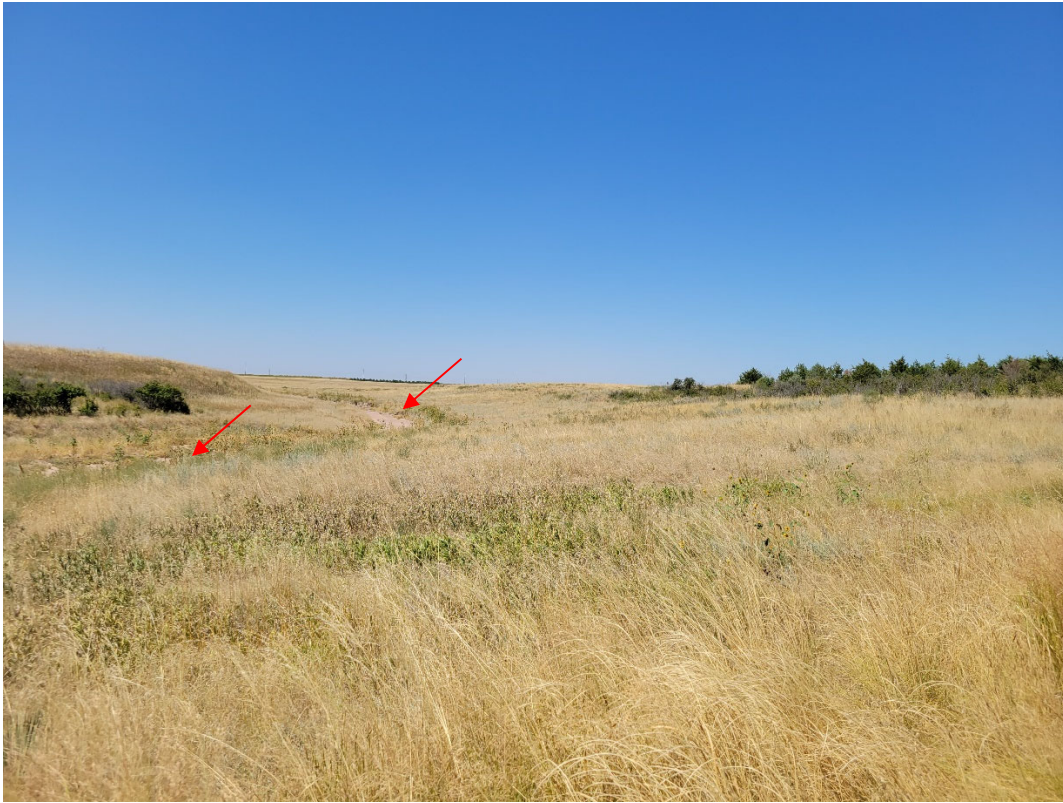
Photo 9: Ephemeral drainage that runs between Pit Area 2 and Pit Area 3.

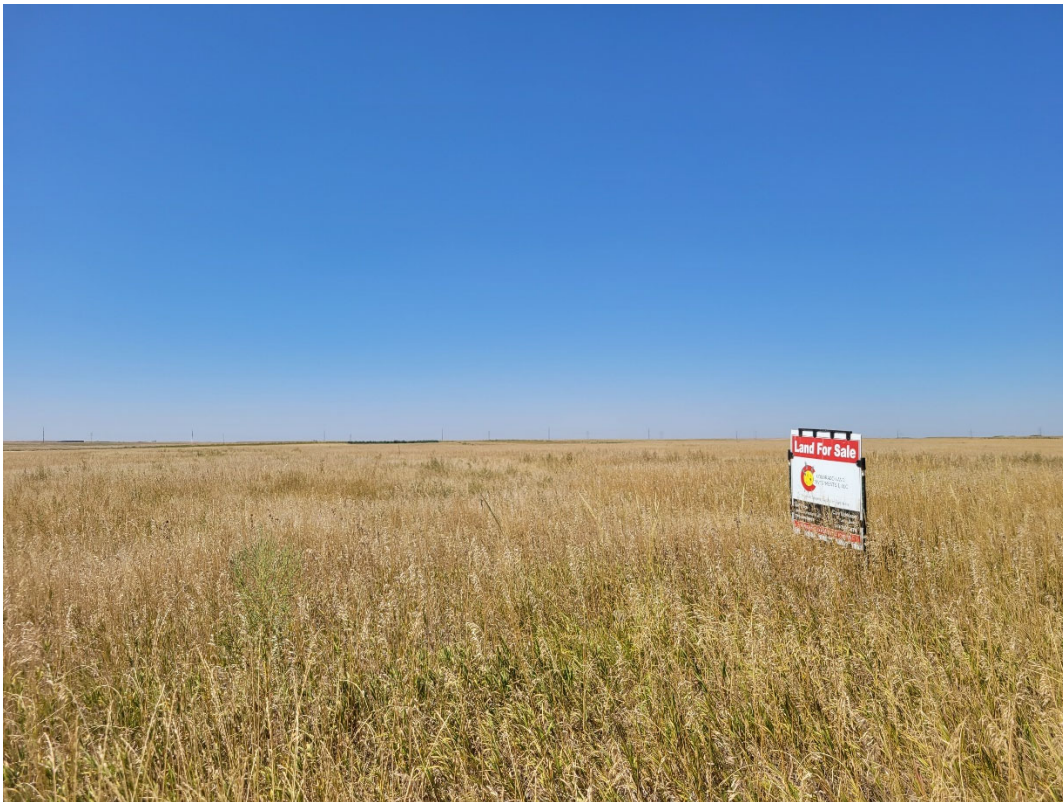
During this inspection, Mr. Anderson informed the Division that the land to the north, encompassing the 3rd mining area is being sold and the County plans to seek a release of this area from the permit once a sale is complete. The Division viewed this area and noted it remains undisturbed.

Photo 10: Pit Area 3 currently for sale. This area remains undisturbed by mining.

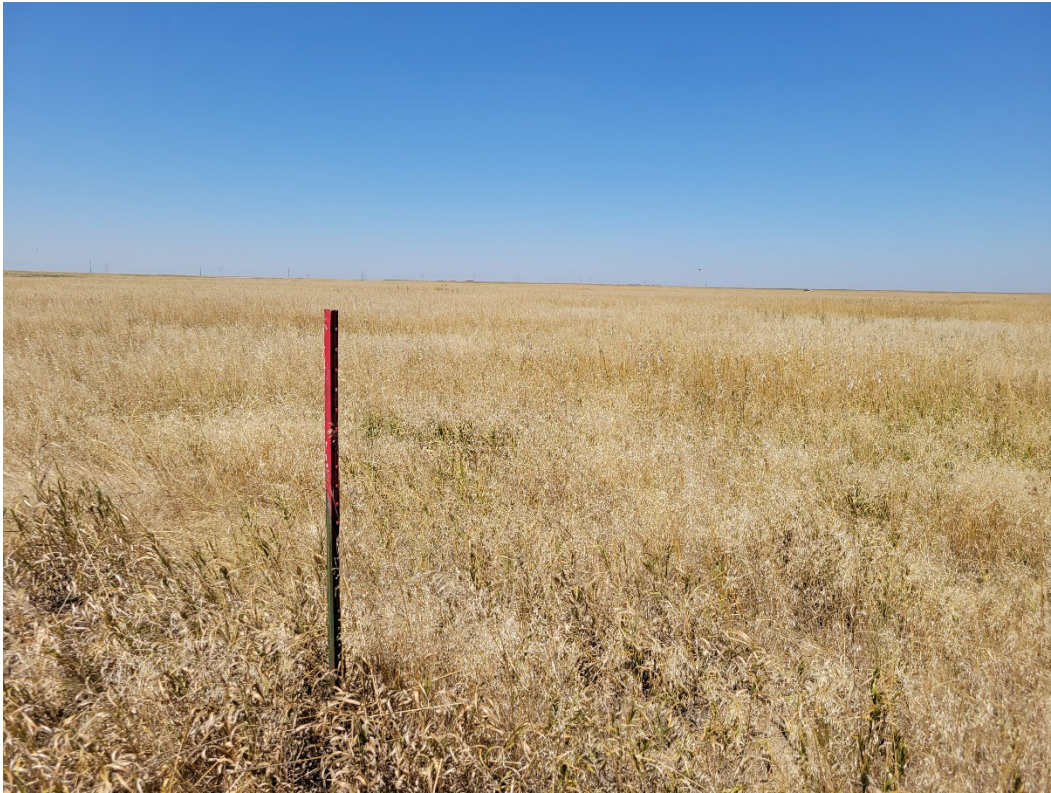
Photo 11: Looking west across Pit Area 3 from eastern boundary.
