## MINERALS PROGRAM INSPECTION REPORT

<b>MINE NAME:</b> Witherbee Pit	<b>MINE/PROSPECTING ID#:</b> M-2009-070	<b>MINERAL:</b> Gravel and borrow m construction	<b>COUNTY:</b> Yuma
<b>INSPECTION TYPE:</b> Monitoring	<b>WEATHER:</b> Clear	<b>INSP. DATE:</b> August 31, 2023	<b>INSP. TIME:</b> 08:00
<b>OPERATOR:</b> Yuma County	<b>OPERATOR REPRESENTATIVE:</b> N/A	<b>TYPE OF OPERATION:</b> 112c - Construction Regular Operation	
<b>REASON FOR INSPECTION:</b> Normal I&E Program	<b>BOND CALCULATION TYPE:</b> None	<b>BOND AMOUNT:</b> N/A	
<b>DATE OF COMPLAINT:</b> NA	<b>POST INSP. CONTACTS:</b> Tom Anderson	<b>JOINT INSP. AGENCY:</b> None	
<b>INSPECTOR(S):</b> Nikie Gagnon	<b>INSPECTOR'S SIGNATURE:</b>

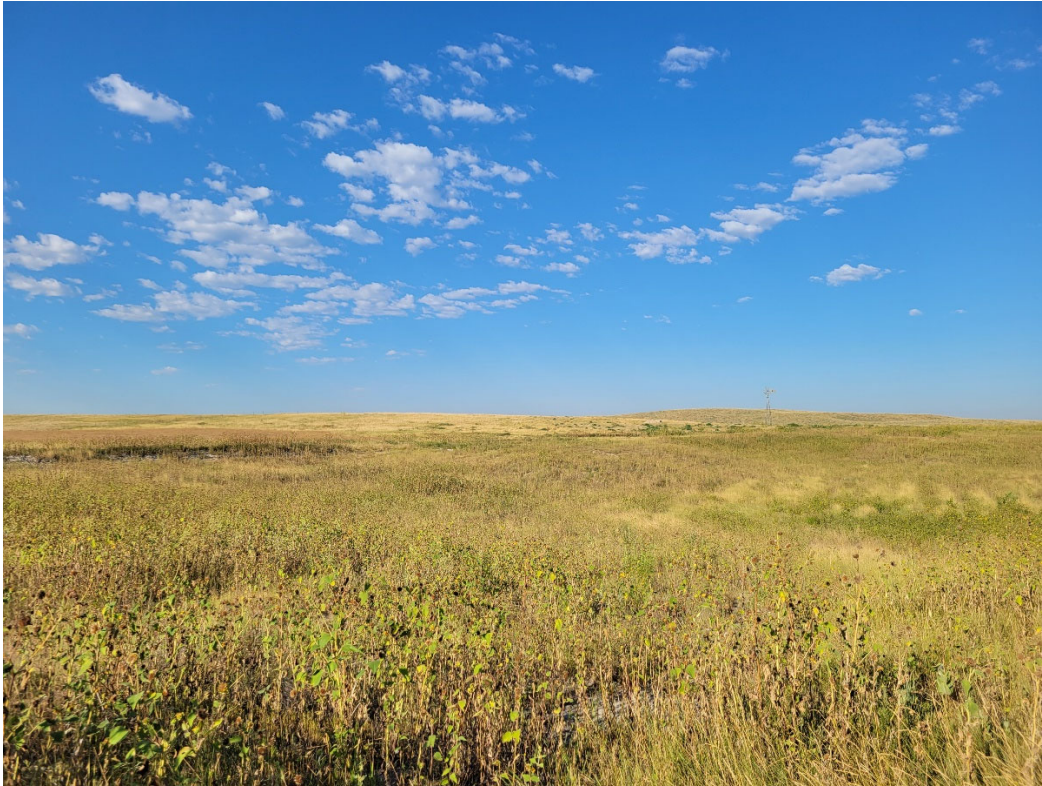
Photo 1: Looking west from the access road.

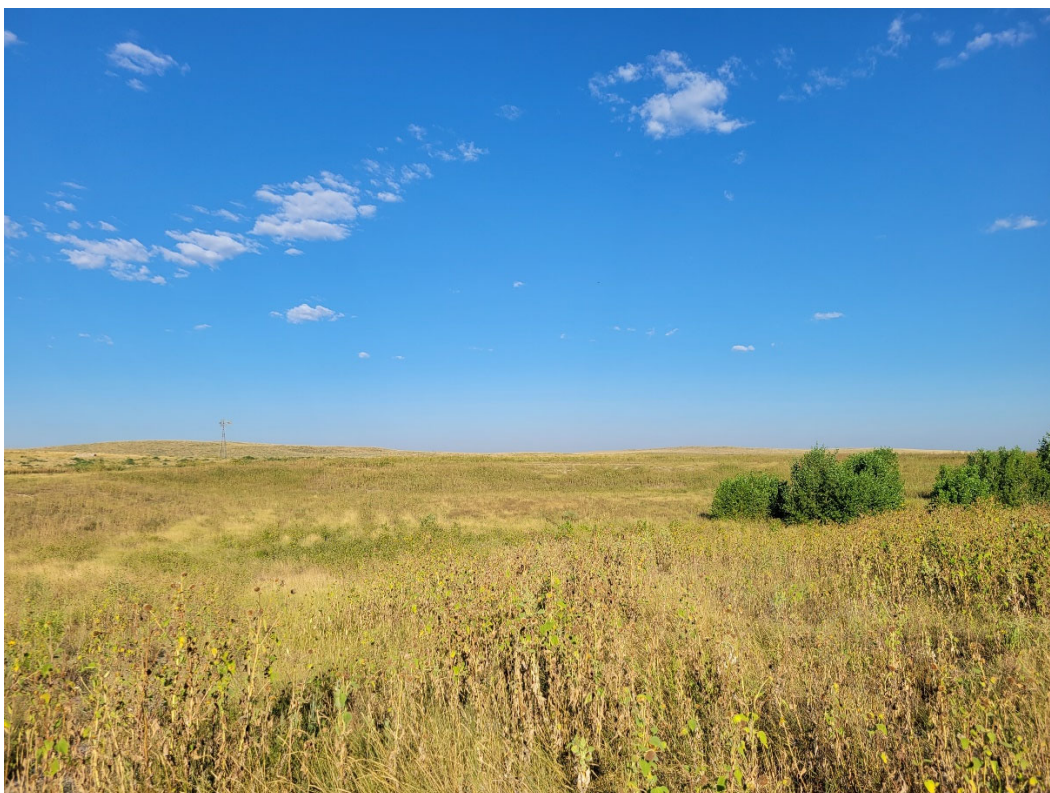
Photo 2: Looking north across the site. Grass is growing in the pit floor and Cottonwood trees are growing in the northeast corner.

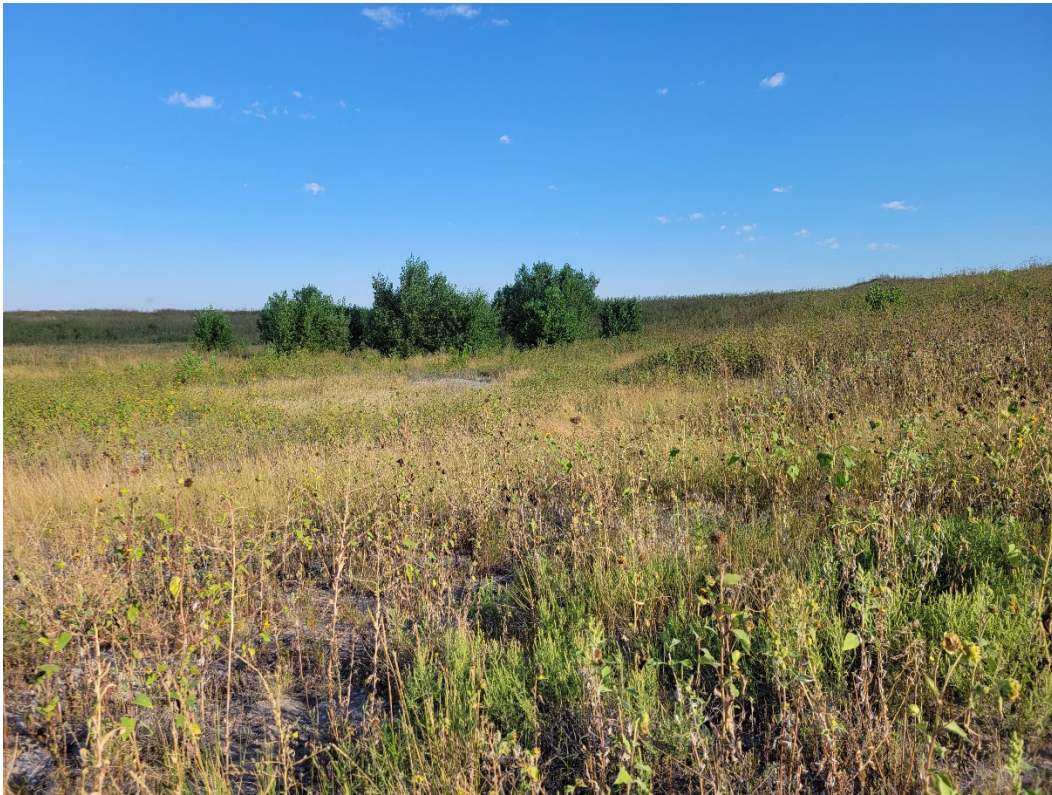
Photo 3: Looking northeast at vegetative cover at the base of the slope.

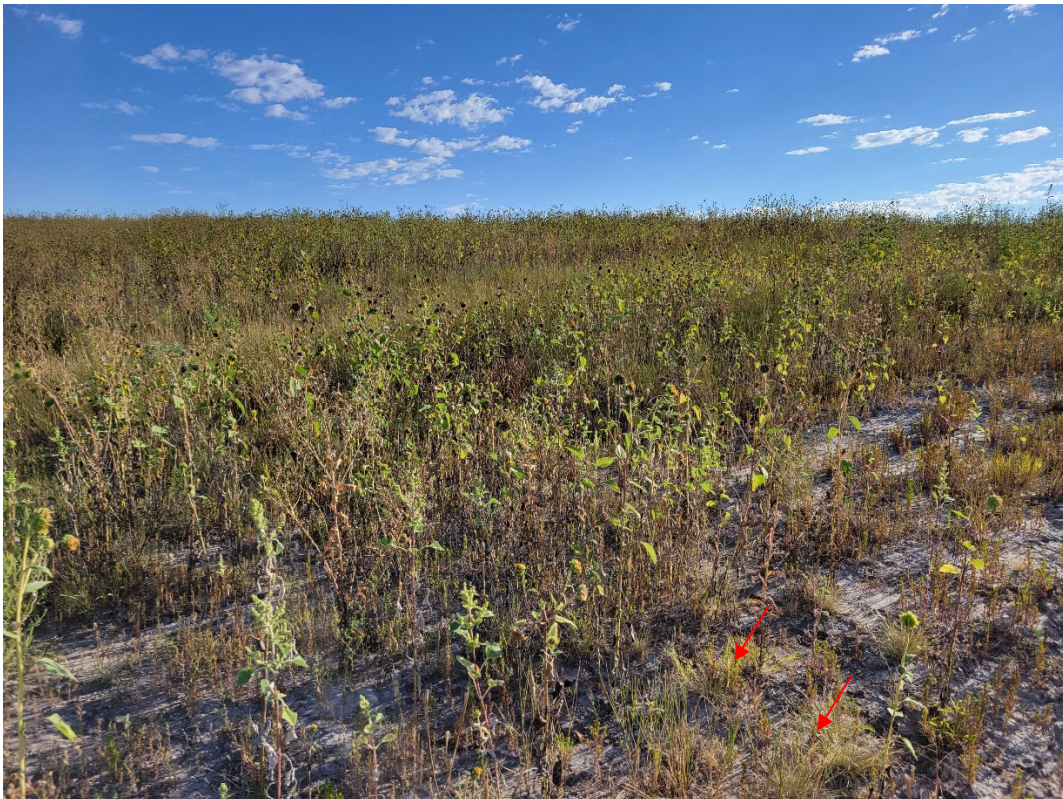
Photo 4: Slope of the eastern side of the pit. Grasses observed sprouting below weeds and sunflowers (red arrows).

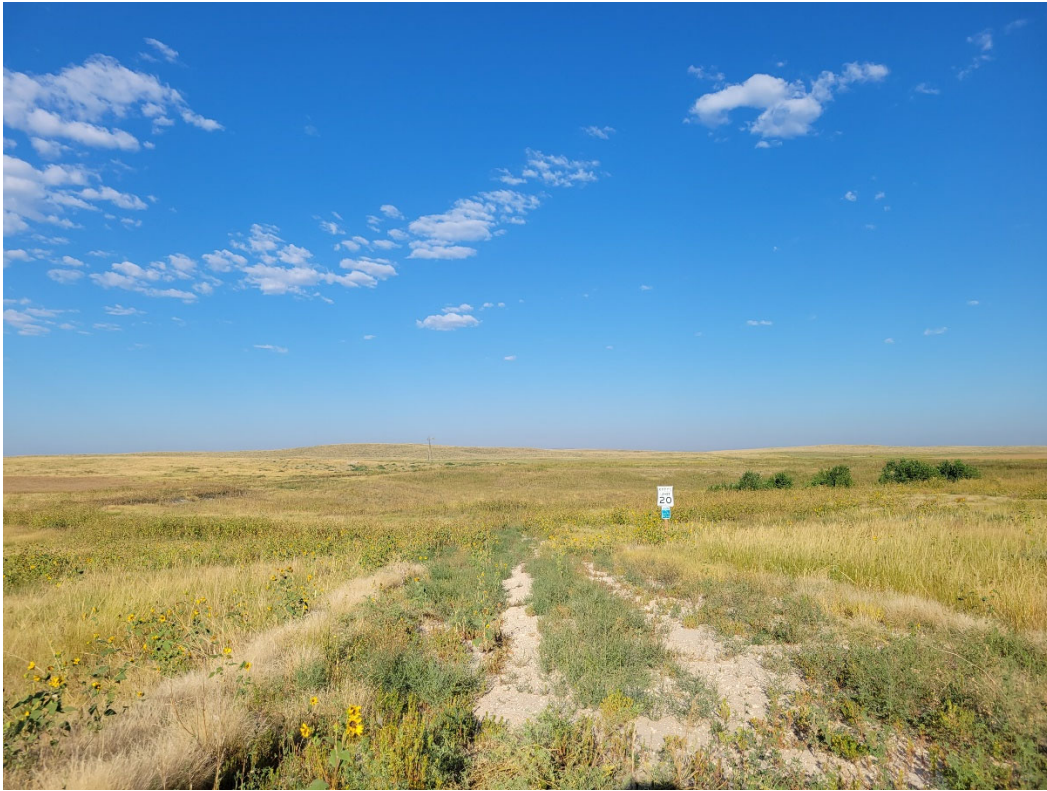
According to the approved reclamation plan, the access road will remain after release.

Photo 5: View of access road going down into the pit that will remain.

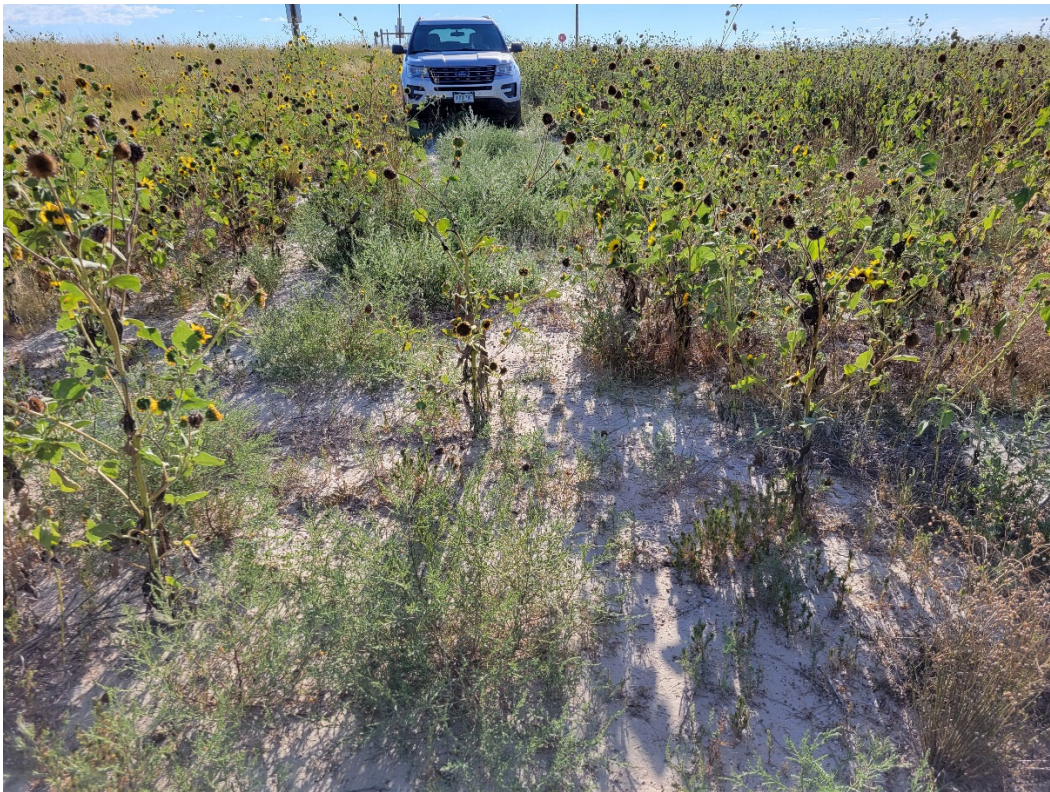
Photo 6: Sunflowers and annual weeds cover much of the eastern slope at the end of the access road.

Based on observations during this inspection, the permit area is not quite ready for release. The primary concerns are sparse grassy cover, annual weeds, dense sunflowers, and the bare erosion rills developing on the slopes of the pit. Next spring, if dense sunflowers return, the Division recommends contacting the local NRCS office to discuss treatment options. Overall, vegetation is more established this year and desirable species are spreading around the site which should eventually outcompete the annual weeds and sunflowers.

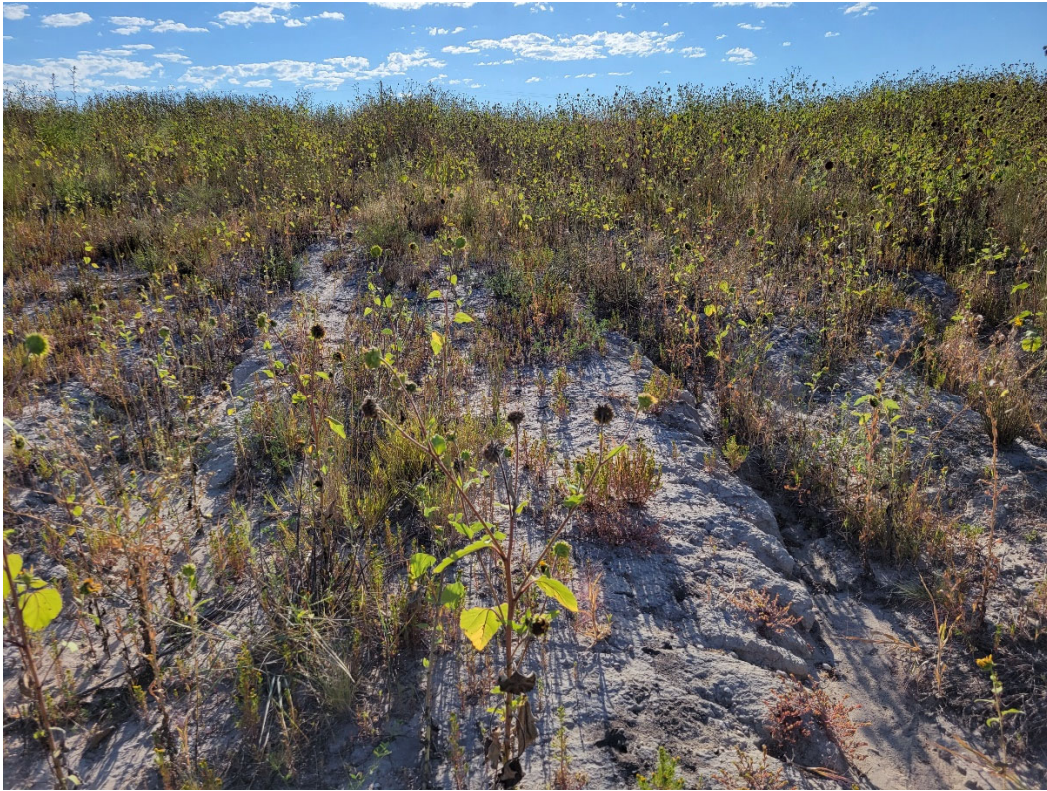
This site was last inspected by Brock Bowles on May 18, 2022 at the request of the Operator. At that time, the vegetation around the clay pit was sparse, especially in the southeast corner of the pit and erosion rills were noted on the slopes. During this inspection, the Division observed denser vegetation, grasses are sprouting beneath the sunflowers and annual weeds (primarily kochia) filling in some of the bare spots observed a year ago. A dense band of sunflowers was observed on the eastern side of the pit. The topsoil is harder and more capable of withstanding erosion. Cottonwoods and grasses are growing in the pit floor. The previous inspection noted rills on the side slopes. These rills were observed during this inspection, the surrounding soil is still bare around the rills indicating water is flowing too quickly down the slope to allow vegetation to take hold. At this stage, it may do more harm than good to repair these areas and the Division recommends monitoring for another year to see how the vegetative cover fills in since this is only the third year after topsoil placement and seeding.

Photo 7: Erosion rills and bare spots observed on the side slopes. Vegetation observed here primarily annual weeds and sunflowers.

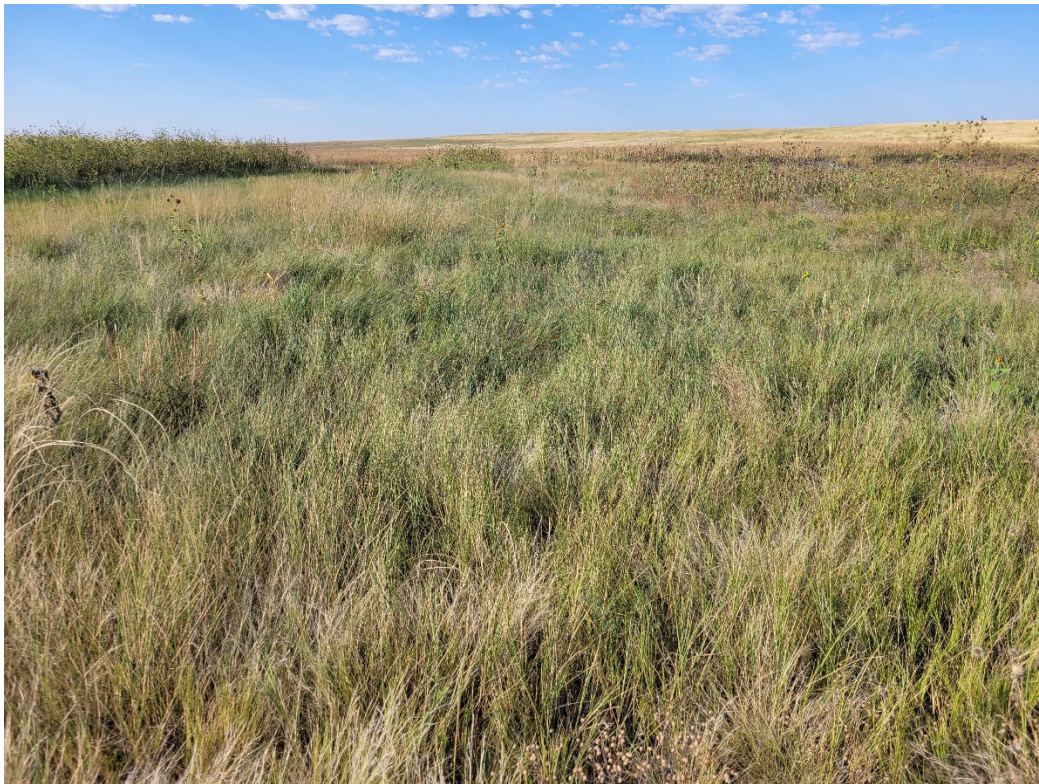
Outside of the mining disturbance area, within the permit boundary, dense grasses were observed. This grassy area represents the anticipated long-term vegetation coverage across the site.

Photo 8: Undisturbed area of grassland species growing on the north and south sides of the access road.

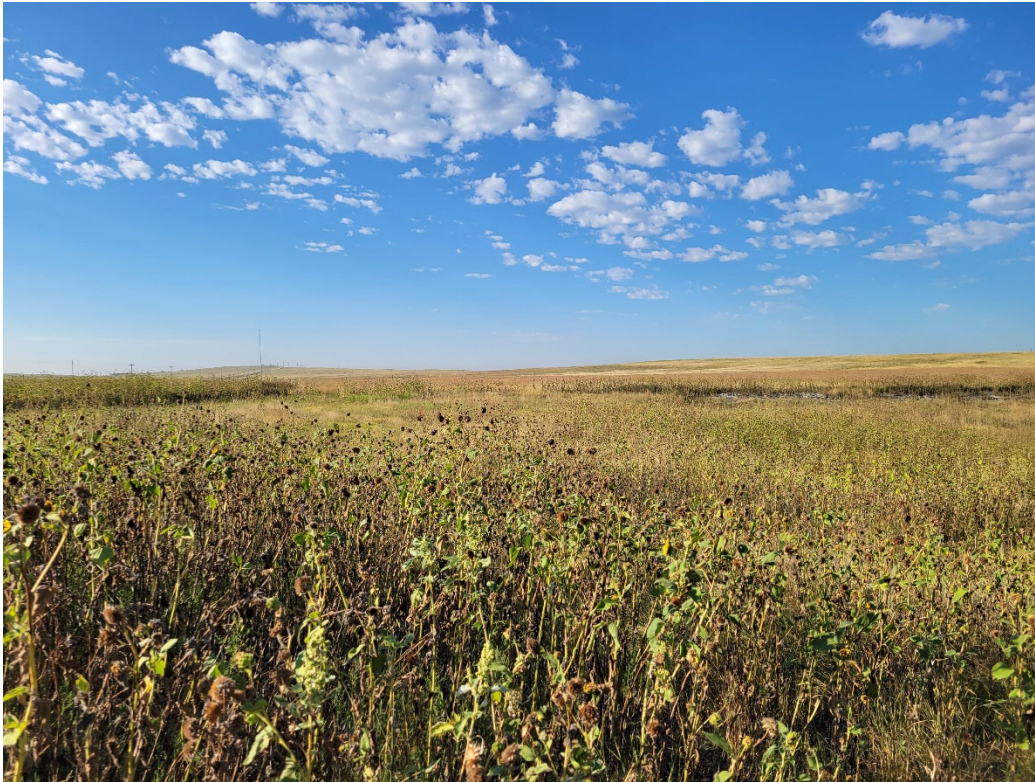
Photo 9: Thick band of sunflowers growing around the slopes of the pit.
