MINERALS PROGRAM INSPECTION REPORT
PHONE: (303) 866-3567

MINE NAME: GIR Surface Exploration Drilling	MINE/PROSPECTING ID#: P-2021-013	MINERAL: Gold and silver	COUNTY: Boulder
INSPECTION TYPE: Monitoring	WEATHER: Clear	INSP. DATE: September 28, 2023	INSP. TIME: 09:00
OPERATOR: Grand Island Resources LLC	OPERATOR REPRESENTATIVE: Richard Mittasch	TYPE OF OPERATION: MP - Mineral Prospecting	
REASON FOR INSPECTION: Normal I&E Program	BOND CALCULATION TYPE: Partial Bond	BOND AMOUNT: \$25,179.00	
DATE OF COMPLAINT: NA	POST INSP. CONTACTS: None	JOINT INSP. AGENCY: None	
INSPECTOR(S): Patrick Lennberg	INSPECTOR'S SIGNATURE:

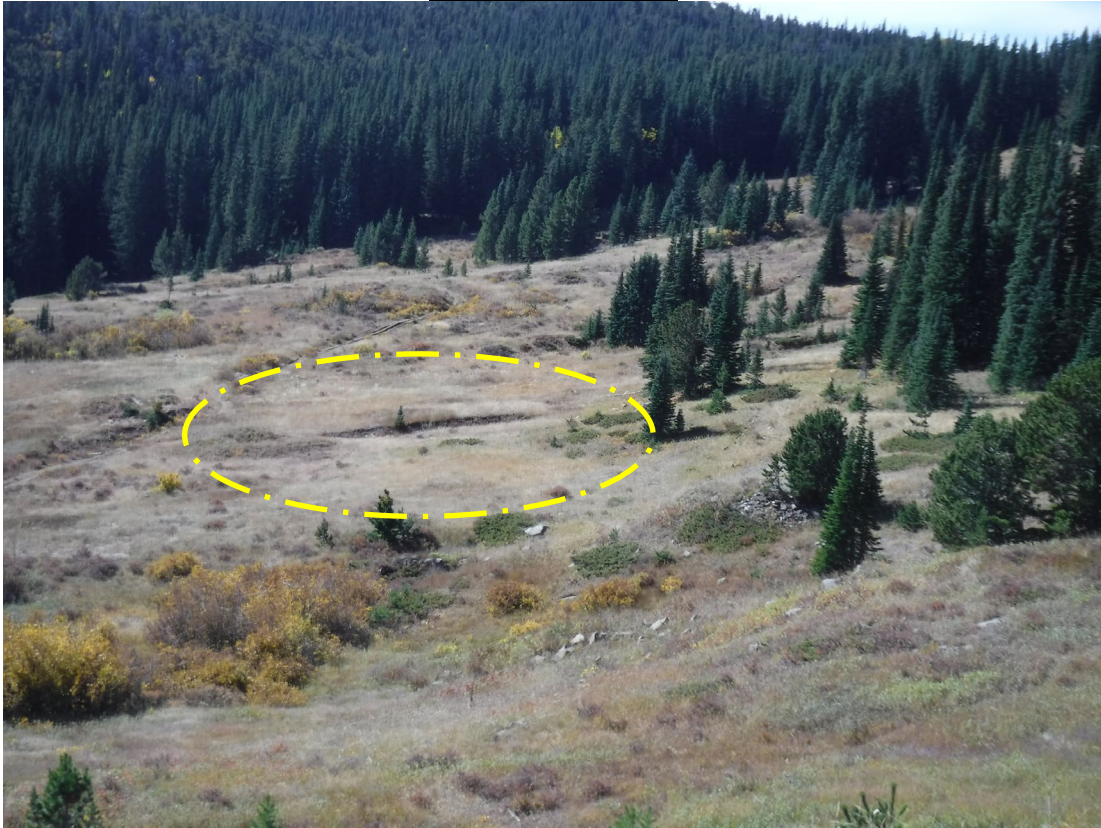
The Eastern Extension has had no activity occur on it.

Photo 1: Looking south from Caribou Road to where the Eastern Extension would be located (yellow outline)

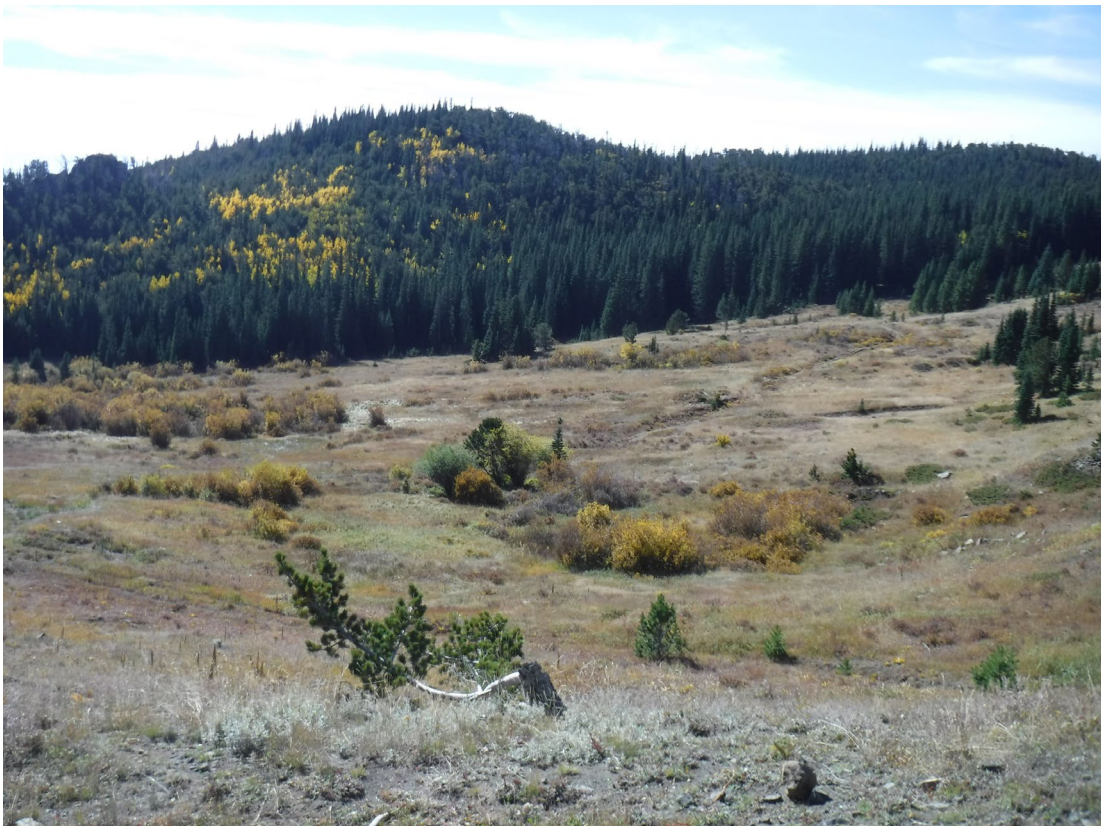
Photo 2: Looking south from Caribou Road to where the Eastern Extension would be located, no support roads

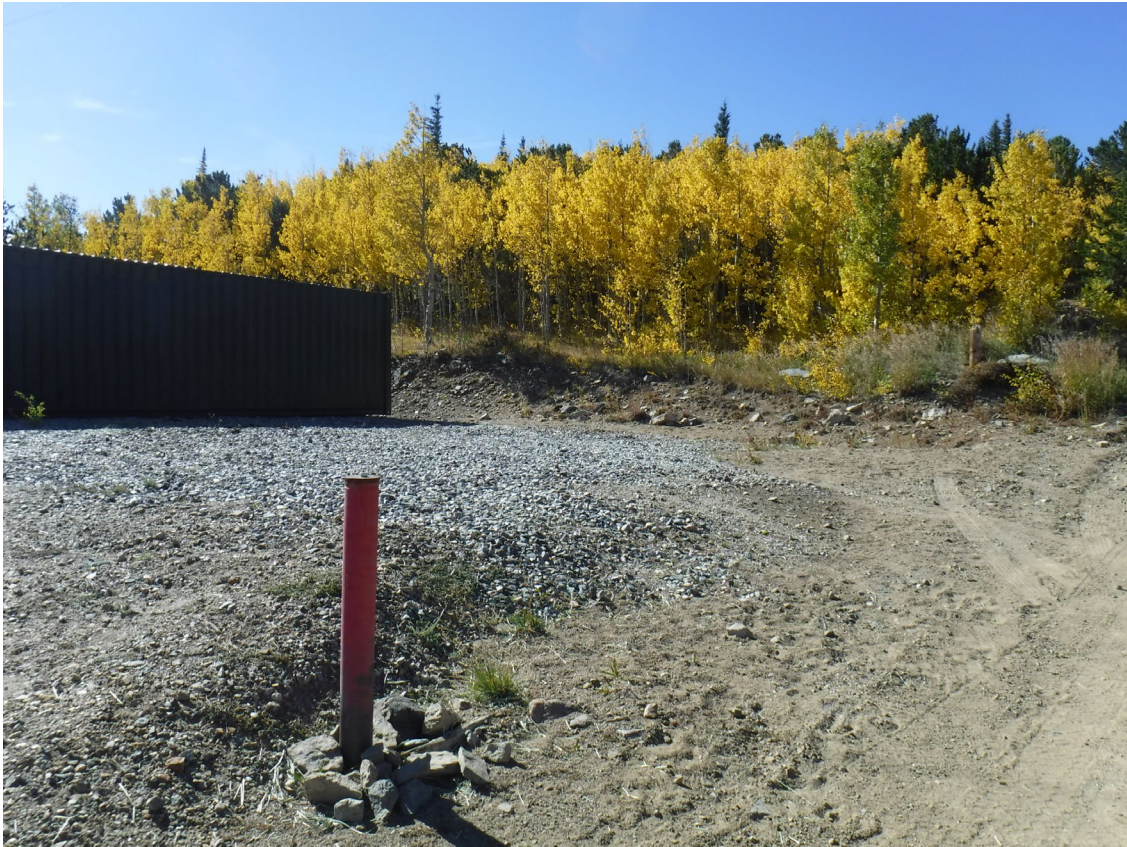
During the 2022 inspection the Prospector inquired whether the drill pad for the Western Extension, where six boreholes were advanced, could be reclaimed as a storage and equipment laydown area. The Division informed the Prospector through that inspection report the 80 feet x 80 feet could be reclaimed in that manner. Additionally, during the 2022 inspection the Prospector provided completed borehole abandonment forms for the boreholes drilled. At the time of this inspection the area had been graded flat with gravel apron and a CONEX storage container was on the pad. The container will be used to house core samples from the Comstock Mill building that will be rehabilitated in time.

Photo 3: Looking at the Western Extension reclaimed drill pad area, survey marker post in foreground

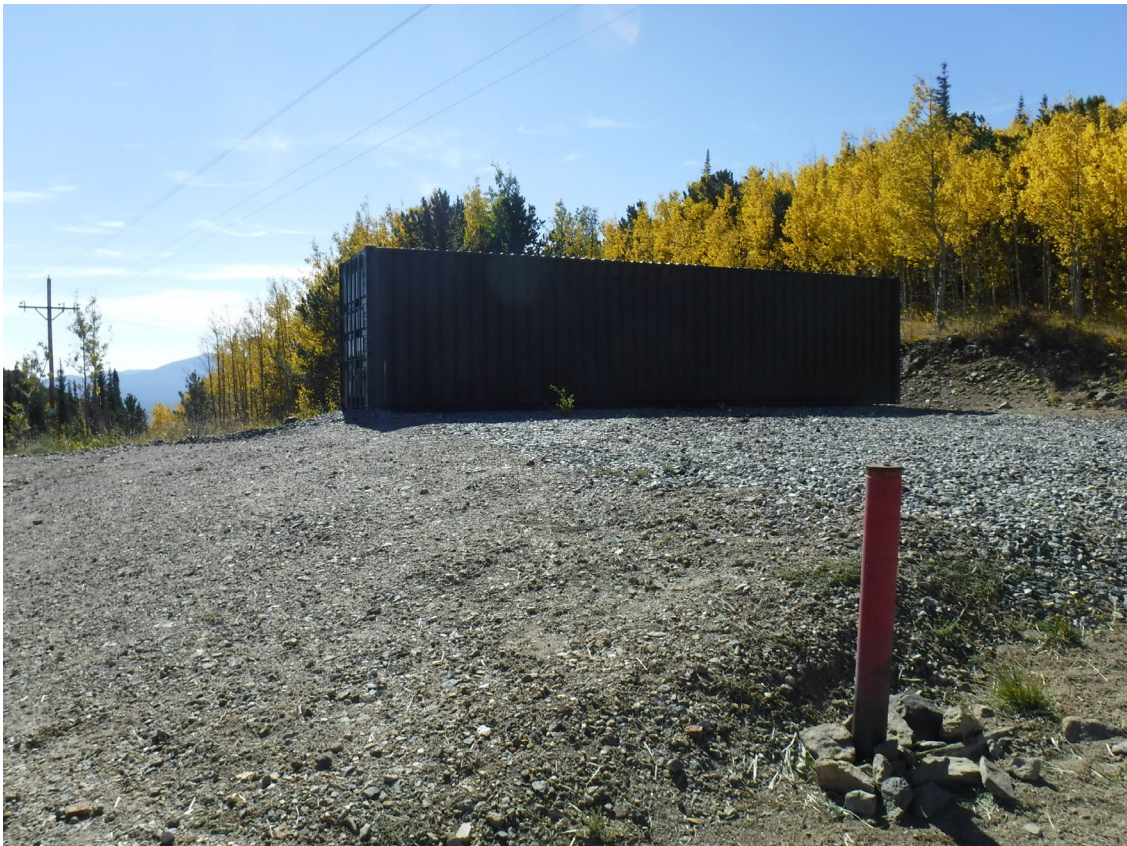
Photo 4: Looking at the Western Extension reclaimed drill pad area, survey marker post in foreground

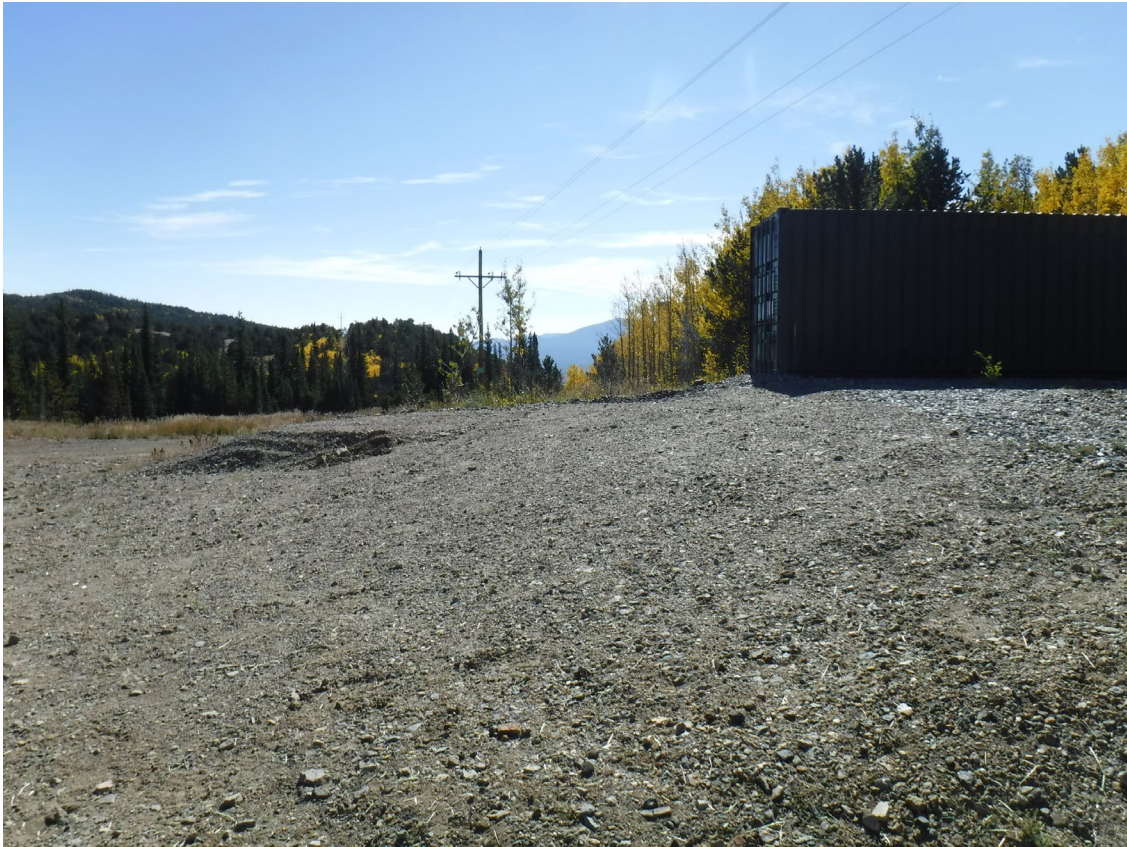
Photo 5: Looking at the Western Extension reclaimed drill pad area
