MINERALS PROGRAM INSPECTION REPORT PHONE: (303) 866-3567

MINE NAME:	MINE/PROSPECTING ID#:	MINERAL:	COUNTY:
Wasterock Exploration Core Drilling	P-2021-016	Gold and silver	Boulder
INSPECTION TYPE:	WEATHER: Clear	INSP. DATE:	INSP. TIME:
Monitoring		September 28, 2023	09:00
OPERATOR:	OPERATOR REPRESENTATIVE:	TYPE OF OPERATION:	
Grand Island Resources LLC	Richard Mittasch	MP - Mineral Prospecting	
REASON FOR INSPECTION:	BOND CALCULATION TYPE:	BOND AMOUNT:	
Normal I&E Program	Partial Bond	\$40,300.00	
DATE OF COMPLAINT:	POST INSP. CONTACTS:	JOINT INSP. AGE	NCY:
NA	None	None	
INSPECTOR(S):	INSPECTOR'S SIGNATURE:	SIGNATURE DAT	E:
Patrick Lennberg		October 14, 2023	
	Patrick St

PERMIT #: P-2021-016 INSPECTOR'S INITIALS: JPL INSPECTION DATE: September 28, 2023

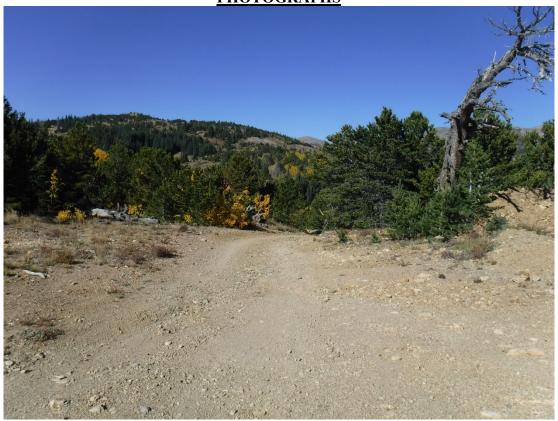
Photo 1: Looking west from the drill pad to where the spur road reaches the drill location

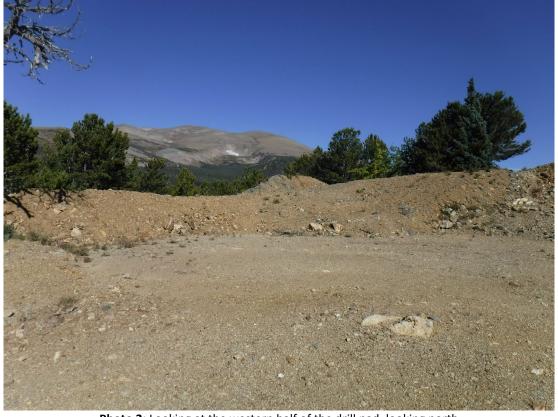
Photo 2: Looking at the western half of the drill pad, looking north

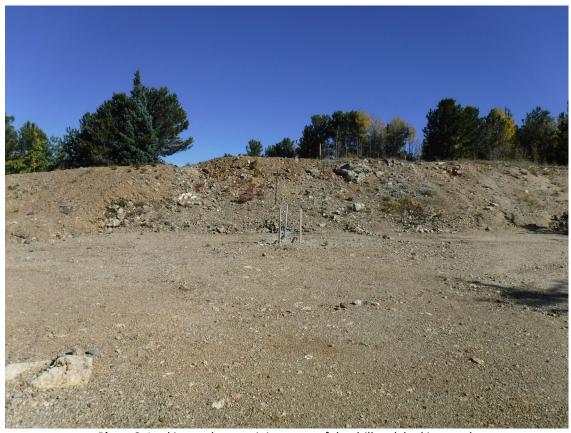
Photo 3: Looking at the remaining areas of the drill pad, looking north

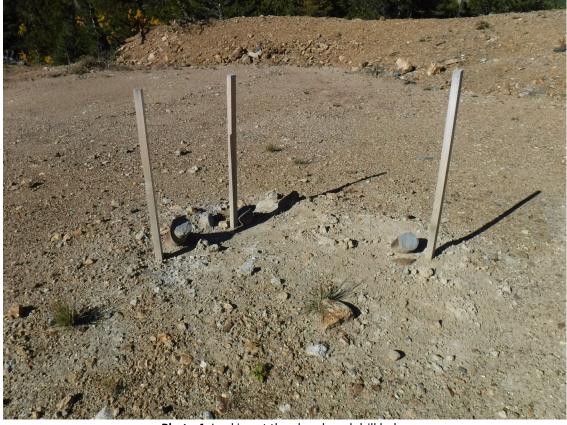
In 2022 the Prospector provided the Division with copies of the Drill Hole Permanent Abandonment Final Reports for 3 boreholes located on the waste rock drill pad. These reports were uploaded to the NOI file online (LaserFiche).

Photo 4: Looking at the abandoned drill holes

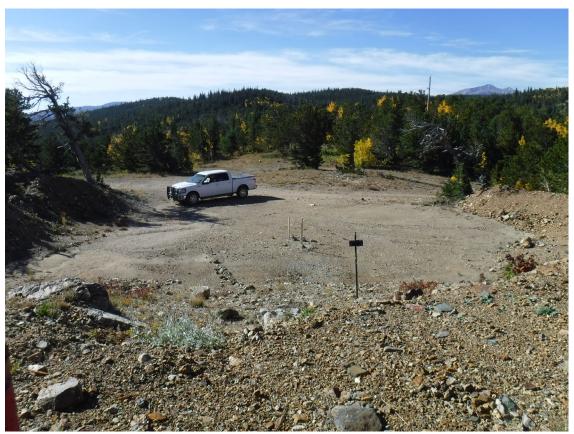
Photo 5: Overview of the drill pad looking south
