## MINERALS PROGRAM INSPECTION REPORT

<b>MINE NAME:</b> Pandora South Exploration Core Drilling	<b>MINE/PROSPECTING ID#:</b> P-2021-015	<b>MINERAL:</b> Silver and gold	<b>COUNTY:</b> Boulder
<b>INSPECTION TYPE:</b> Monitoring	<b>WEATHER:</b> Clear	<b>INSP. DATE:</b> September 28, 2023	<b>INSP. TIME:</b> 09:00
<b>OPERATOR:</b> Grand Island Resources LLC	<b>OPERATOR REPRESENTATIVE:</b> Richard Mittasch	<b>TYPE OF OPERATION:</b> ME - Mineral Exploration	
<b>REASON FOR INSPECTION:</b> Normal I&E Program	<b>BOND CALCULATION TYPE:</b> Partial Bond	<b>BOND AMOUNT:</b> \$27,290.00	
<b>DATE OF COMPLAINT:</b> NA	<b>POST INSP. CONTACTS:</b> None	<b>JOINT INSP. AGENCY:</b> None	
<b>INSPECTOR(S):</b> Patrick Lennberg	<b>INSPECTOR'S SIGNATURE:</b>

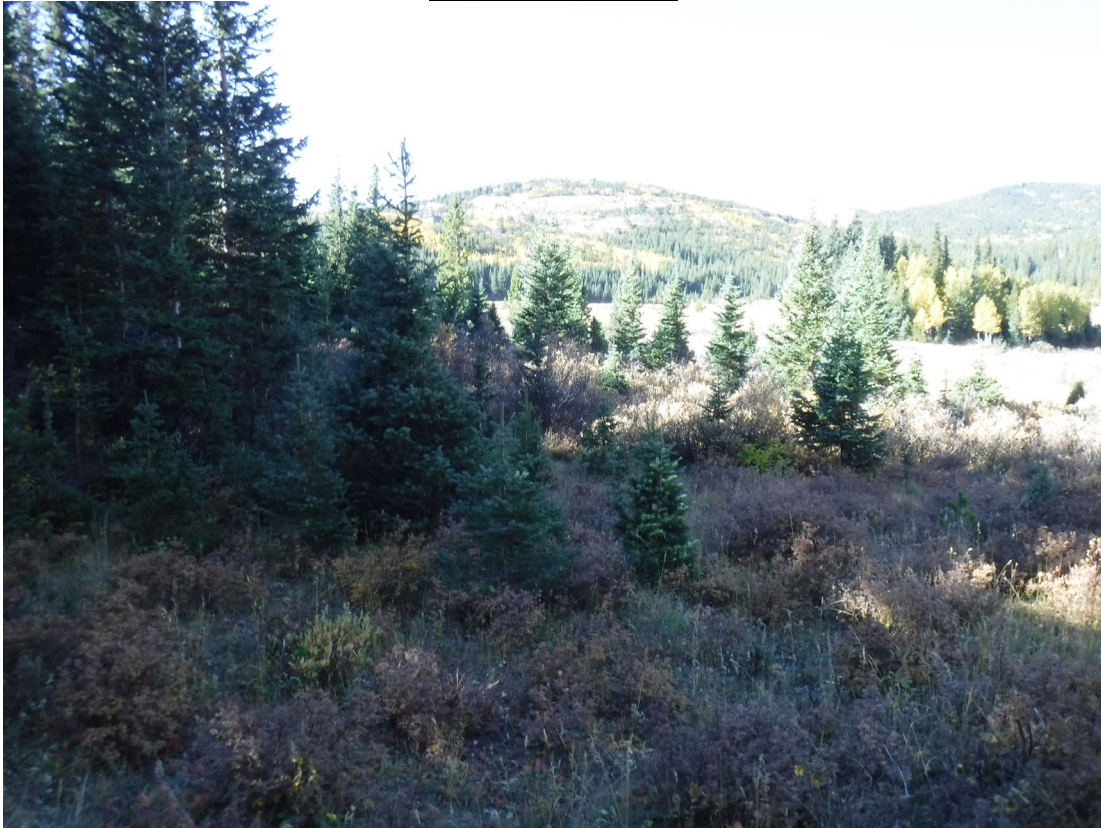
**Photo 1:** Looking south from where the access road is towards drill location

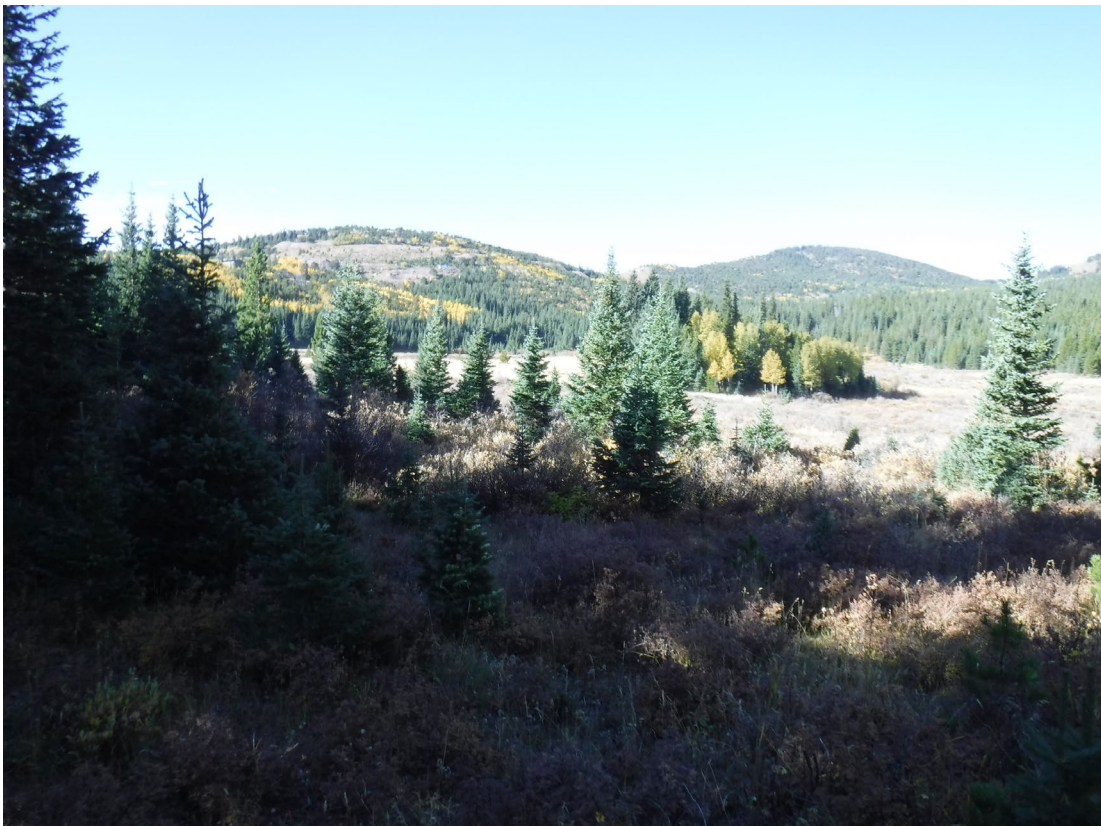
**Photo 2:** Looking south from where the access road is towards drill location

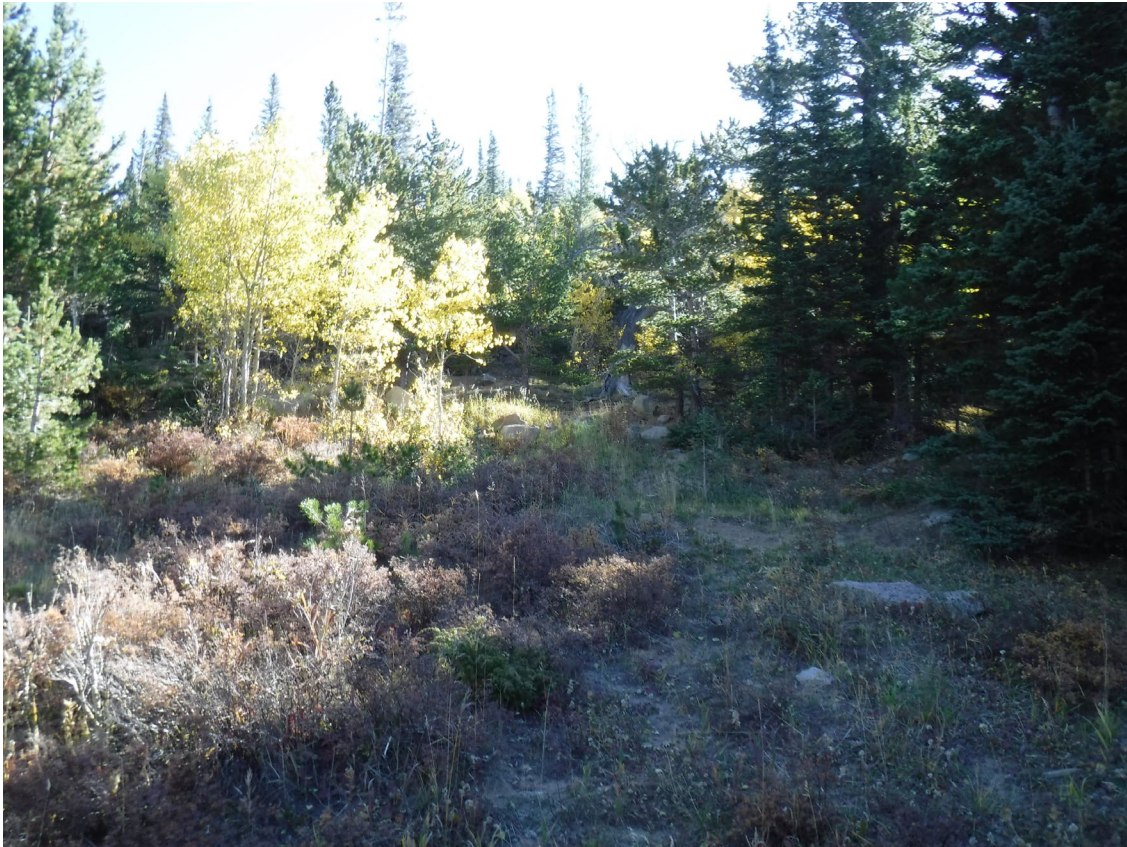
**Photo 3:** Looking east from where the access road is towards FS 505
