MINERALS PROGRAM INSPECTION REPORT
PHONE: (303) 866-3567

MINE NAME: Cross Gold Mine	MINE/PROSPECTING ID#: M-1977-410	MINERAL: Gold, copper, silver,	COUNTY: Boulder
INSPECTION TYPE: Monitoring	WEATHER: Clear	INSP. DATE: September 28, 2023	INSP. TIME: 10:30
OPERATOR: Grand Island Resources LLC	OPERATOR REPRESENTATIVE: Je'an-Paul Brewer	TYPE OF OPERATION: 110(2) - Hard Rock Limited Impact	
REASON FOR INSPECTION: High Priority	BOND CALCULATION TYPE: Partial Bond	BOND AMOUNT: \$546,751.00	
DATE OF COMPLAINT: NA	POST INSP. CONTACTS: None	JOINT INSP. AGENCY: None	
INSPECTOR(S): Patrick Lennberg	INSPECTOR'S SIGNATURE:

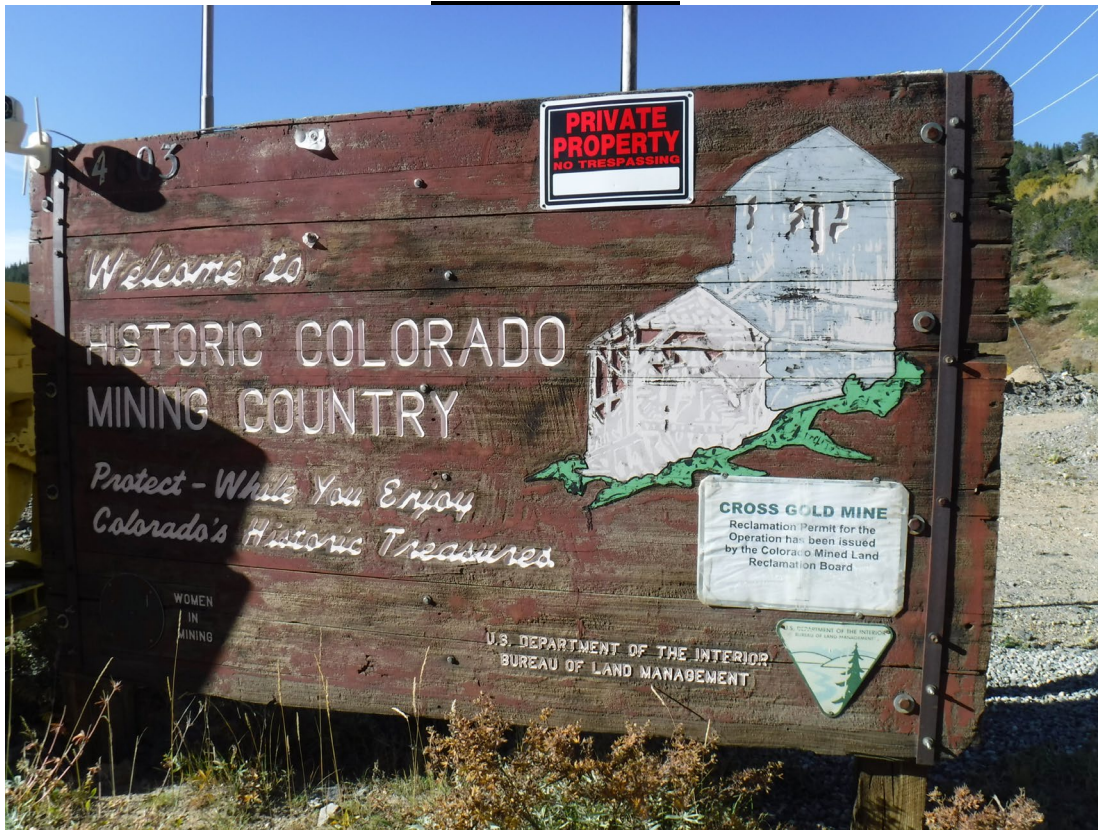
The Cross Gold Mine is a 110(2) underground mine operation permitted for 9.9 acres for the mining of gold, silver, and other minerals. The permit area includes two discharging mine openings: the Cross Mine portal (at the Cross Mine) and the Idaho Tunnel portal (at the Caribou Mine). Discharge from these mines is directed to a series of plastic-lined ponds prior to being treated and discharged into Coon Track Creek at the permitted discharge point (CO0032751). The mine is located on land owned by the permittee. The site is located approximately 4 miles northwest of Nederland, CO in Boulder County, at an elevation of approximately 9,760 feet. Access to the site is off of Caribou Road. A separate entrance exists for each of the two mines at the site, the Cross Mine (to the south) and the Caribou Mine (to the north). The approved post-mining land use is a combination of forestry and residential. A mine sign was observed at the primary mine entrance as required by Rule 3.1.12.

Photo 1: Mine sign at the primary mine entrance location

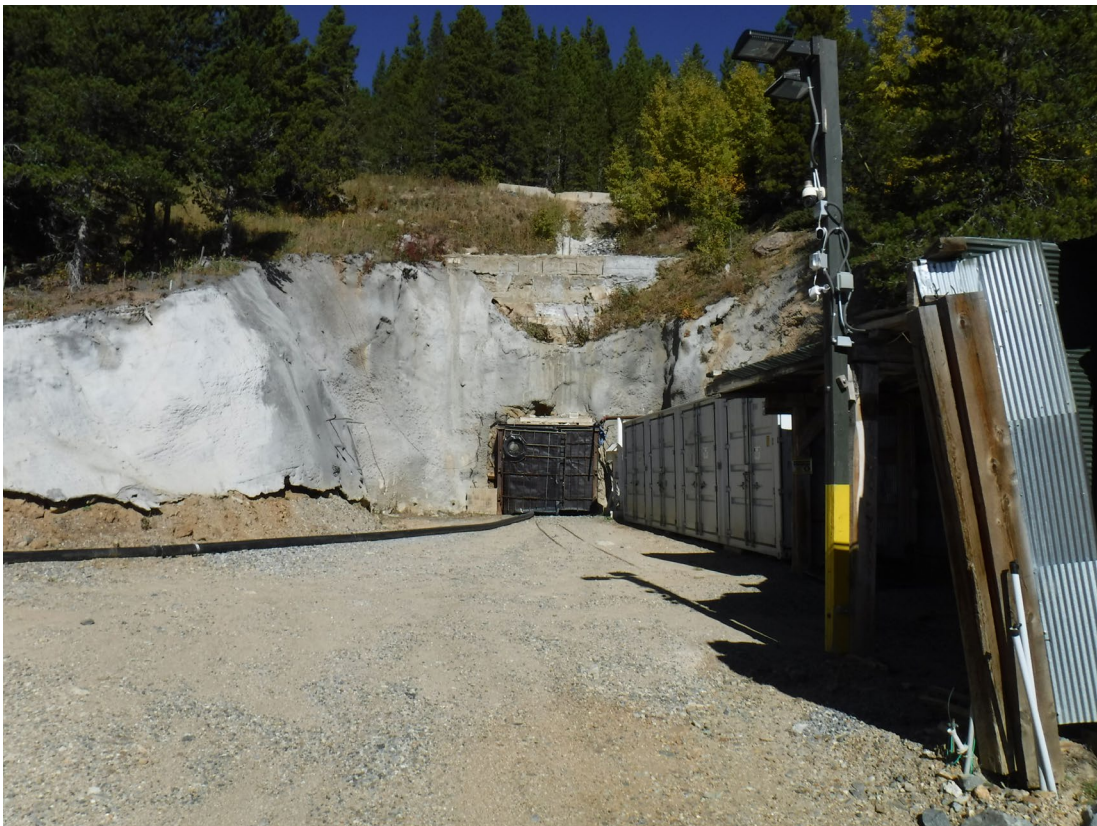
Photo 2: Idaho Tunnel entrance

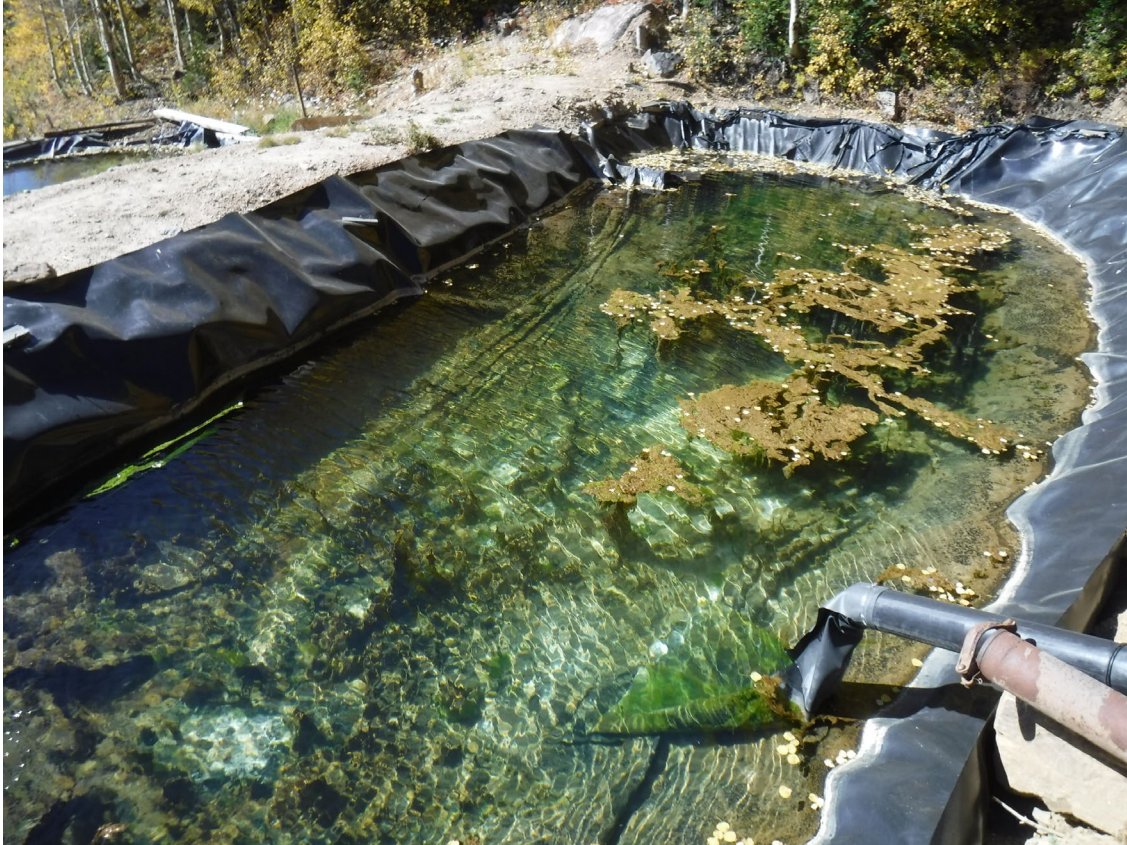
The Division observed water being discharged from the Idaho Tunnel into Ponds 3a, b and c. The water is then conveyed to Pond 1 and then to the Joliet Raise. The Operator stated that the ponds developed dense aquatic vegetation over the summer that required a significant effort to maintain the ponds.

Photo 3: Idaho Tunnel discharge into Pond 3a

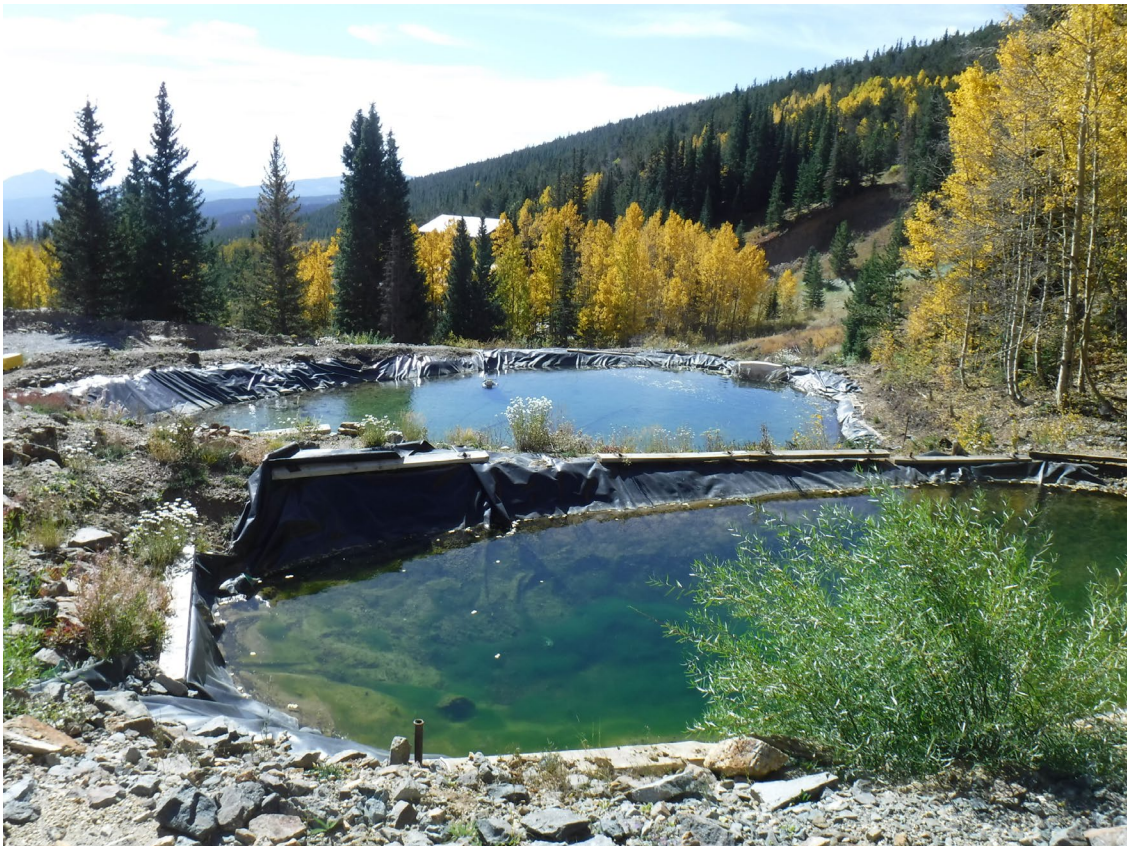
Photo 4: Ponds 3b and 3c

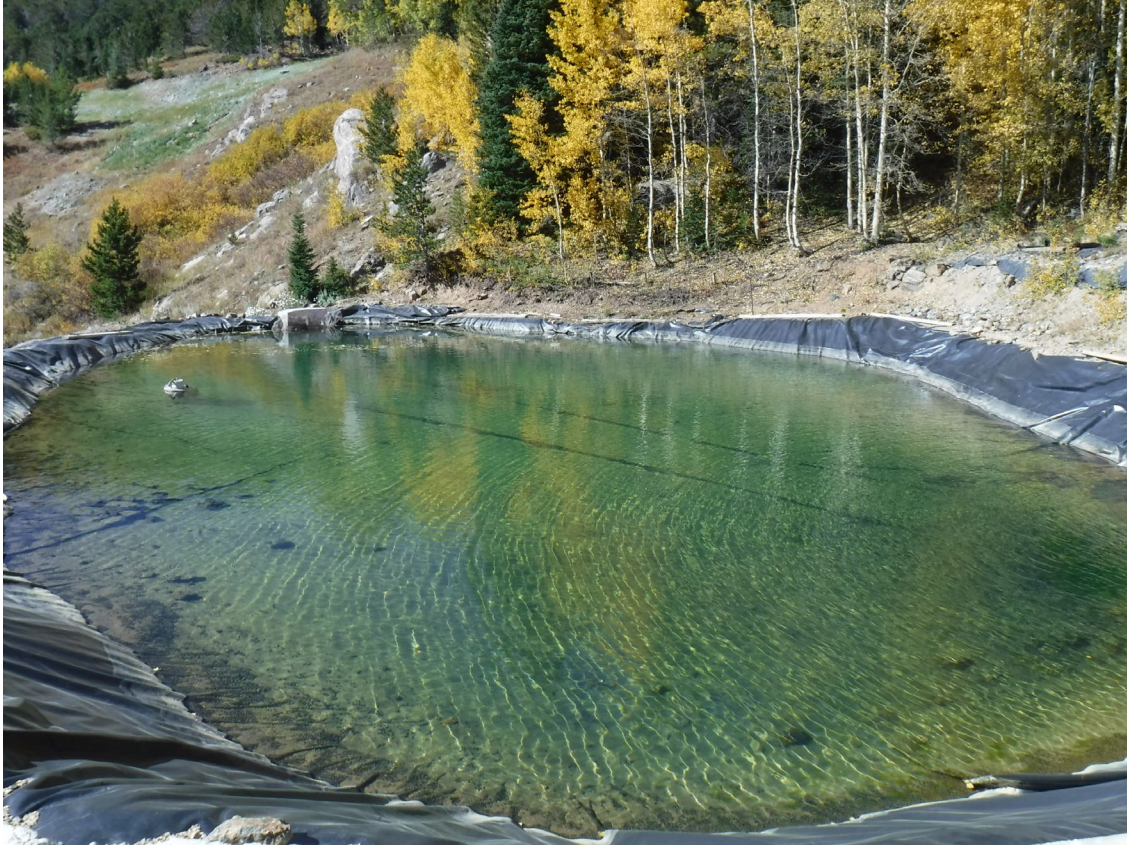
Photo 5: Pond 3c

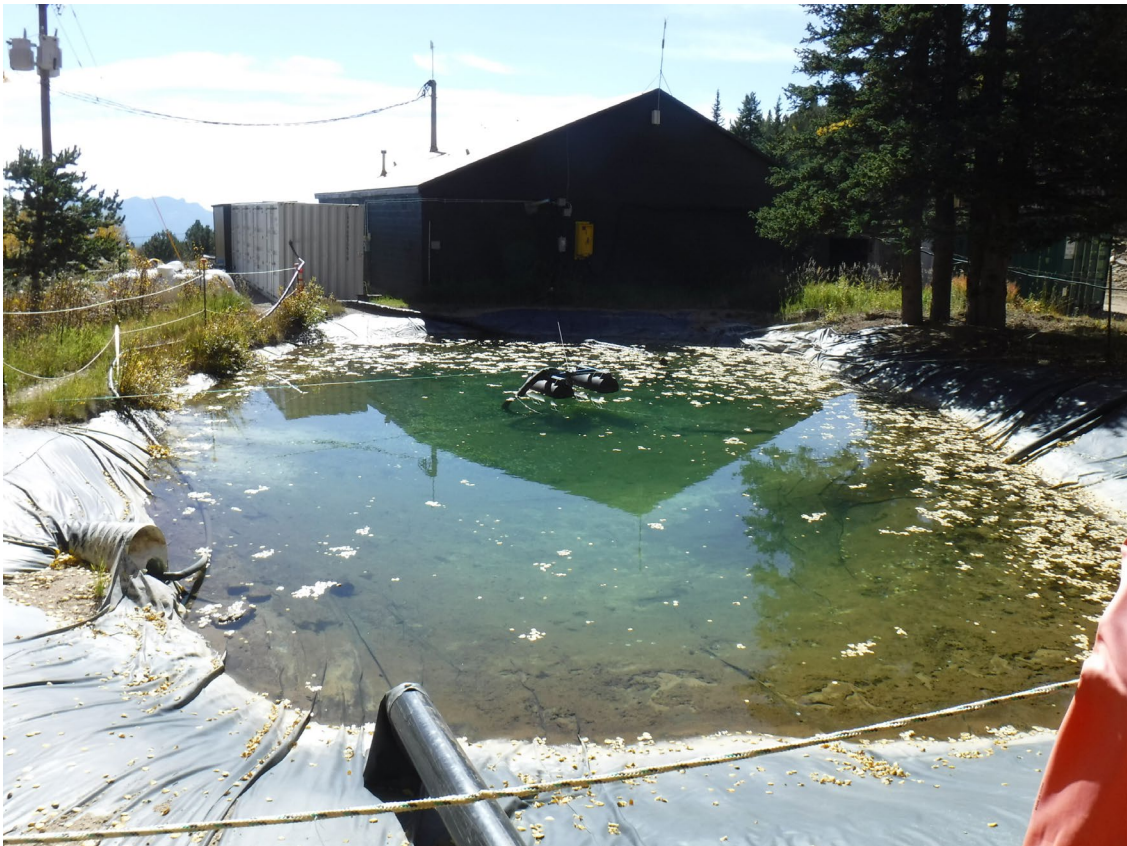
Photo 6: Pond 1, water treatment system in the CONEX boxes (center left)

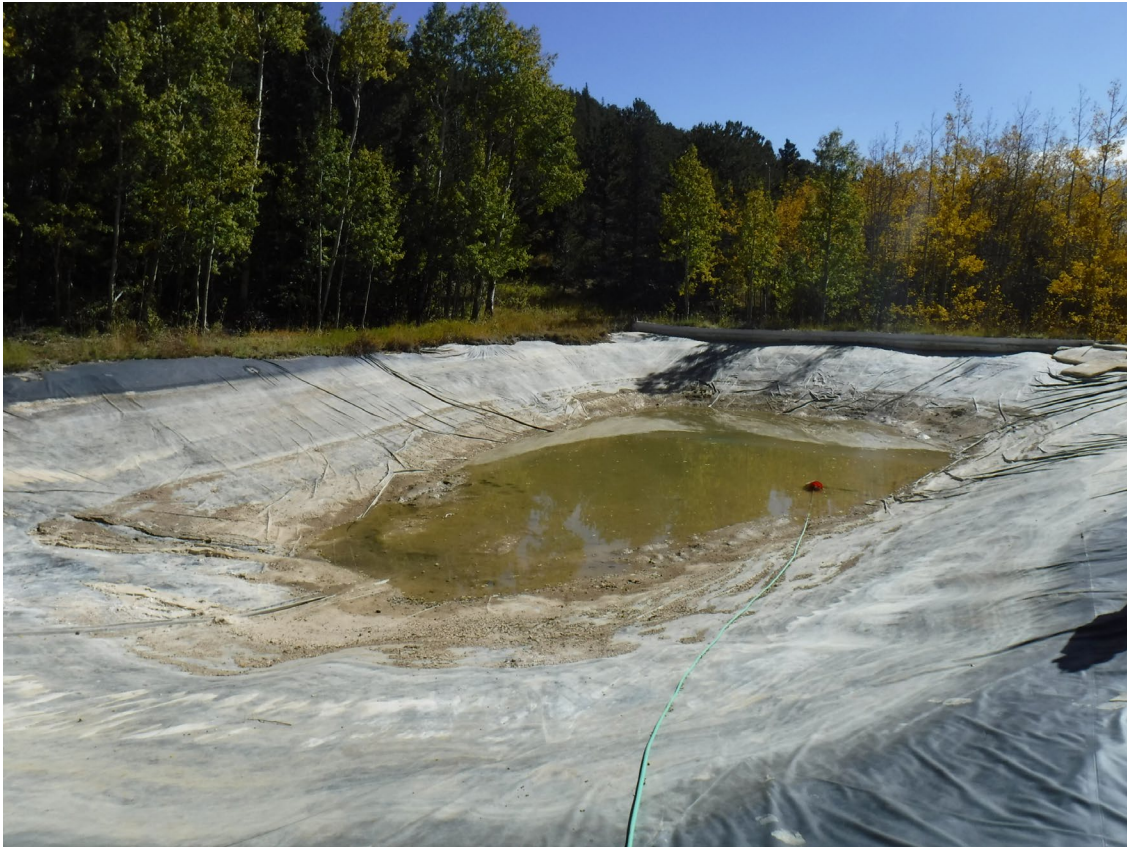
Pond 2 continues to be utilized to contain the back flush water and sediment from the water treatment plant. Pond 2 will be cleaned out again in the future. The Division reiterated, from previous inspections, that when the Operator determines a proper disposable facility for the sediment that they need to provide the Division with the letter of acceptance from the facility along with the analytical results. It was also stated these similar documents were also needed for disposal of the water treatment sludge.

Photo 7: Pond 2

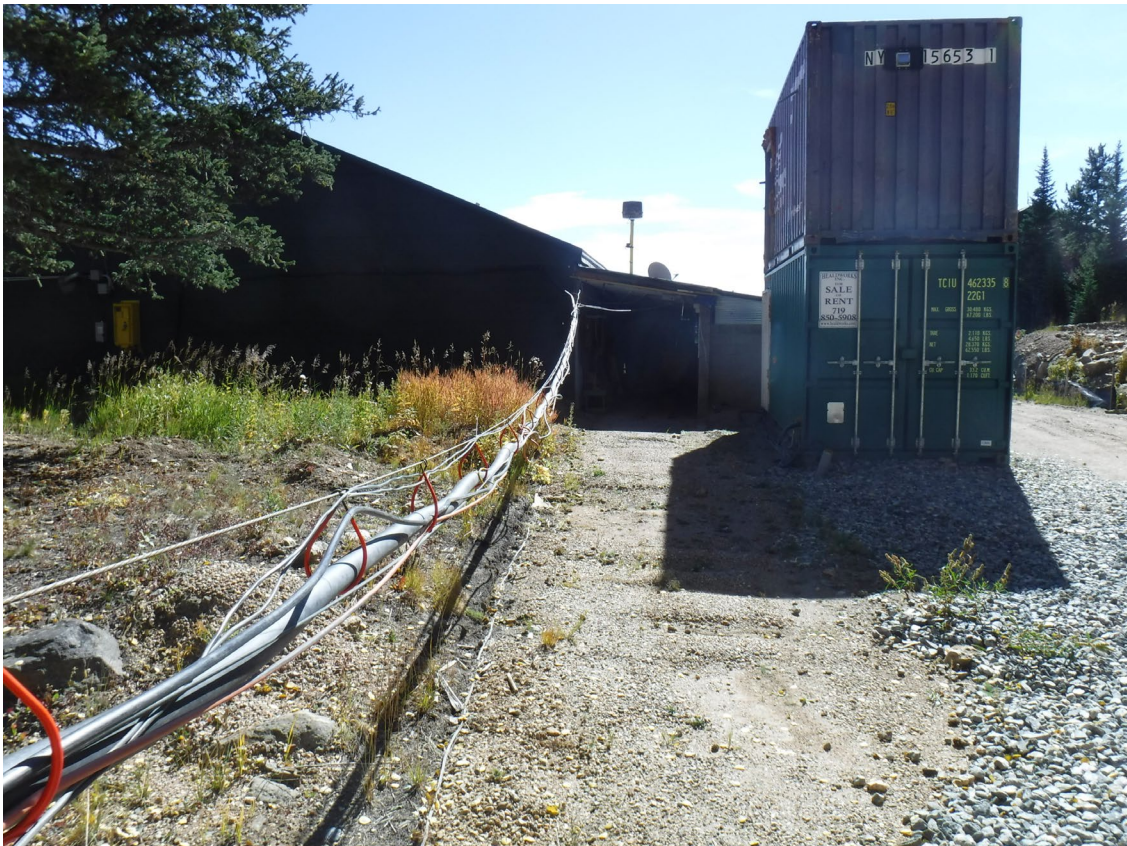
The site was not active at the time of inspection. Since the last inspection two Technical Revisions (TRs) have been submitted and approved. On June 8 TR-12 was submitted for approval of a new snowshed over the Cross Mine tracks, replace the tracks, and relocating the water treatment plant. On June 12 TR-13 was submitted for revising the Groundwater Sampling Plan to allow for collecting a single filed blank sample per sampling event. Both technical revisions were approved by the Division on June 15, 2023.

Photo 8: Approximate location of the snowshed to be built and new water treatment system location
