MINE SITE INSPECTION NARRATIVE

COMPANY: Colowyo Coal Company L.P.

MINE: Colowyo Mine

DATE OF INSPECTION: September 11-12, 2023

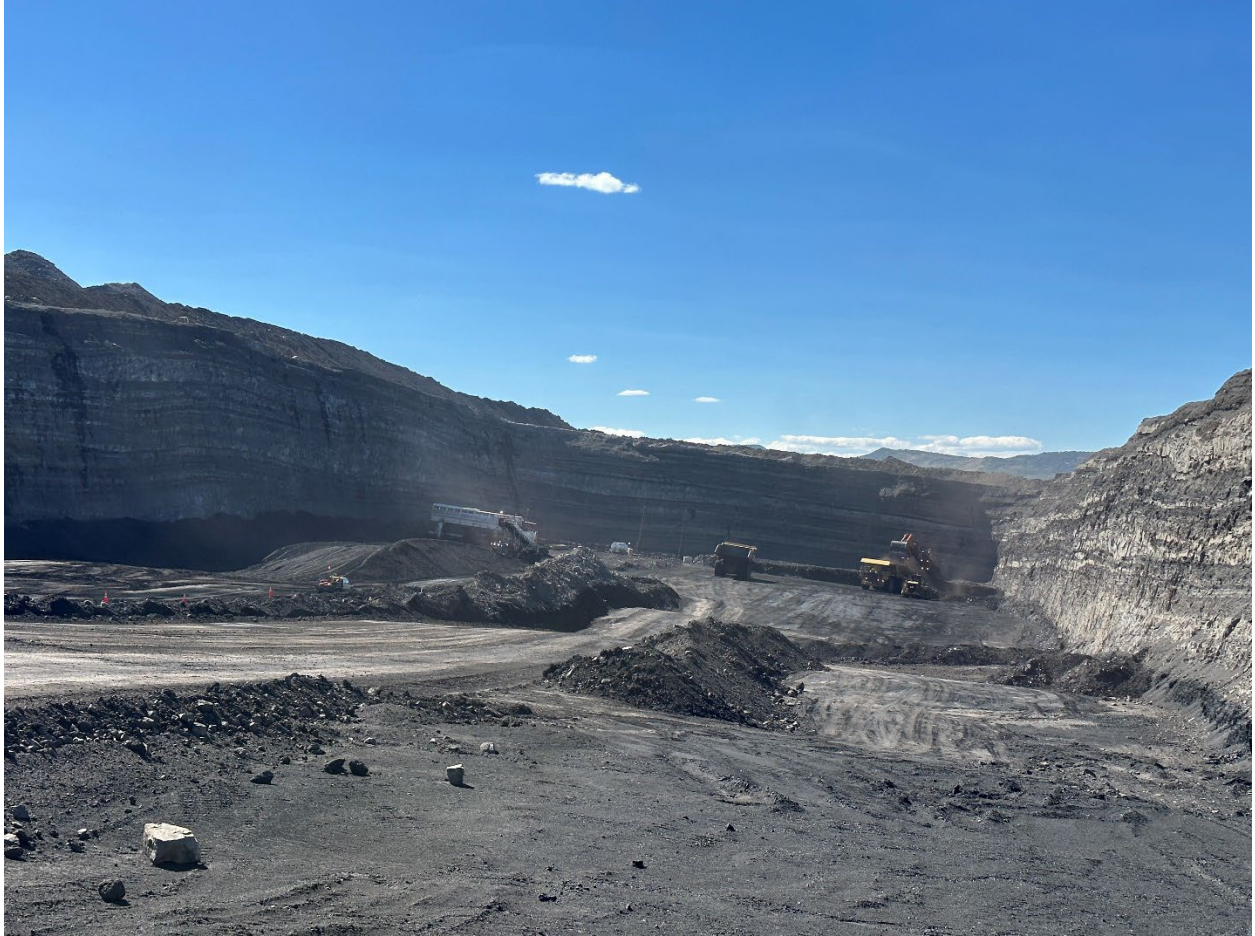
Collom Pit. We inspected the active operations of the Collom Pit, where no issues were noted with the mining (Figure 1), overburden removal (Figure 2), and blasting preparation (Figure 3). The sites were well-organized and operating safely at the time of inspection.

Figure 1 - Active mining in the Collom Pit. This site was stable and well organized at the time of inspection.

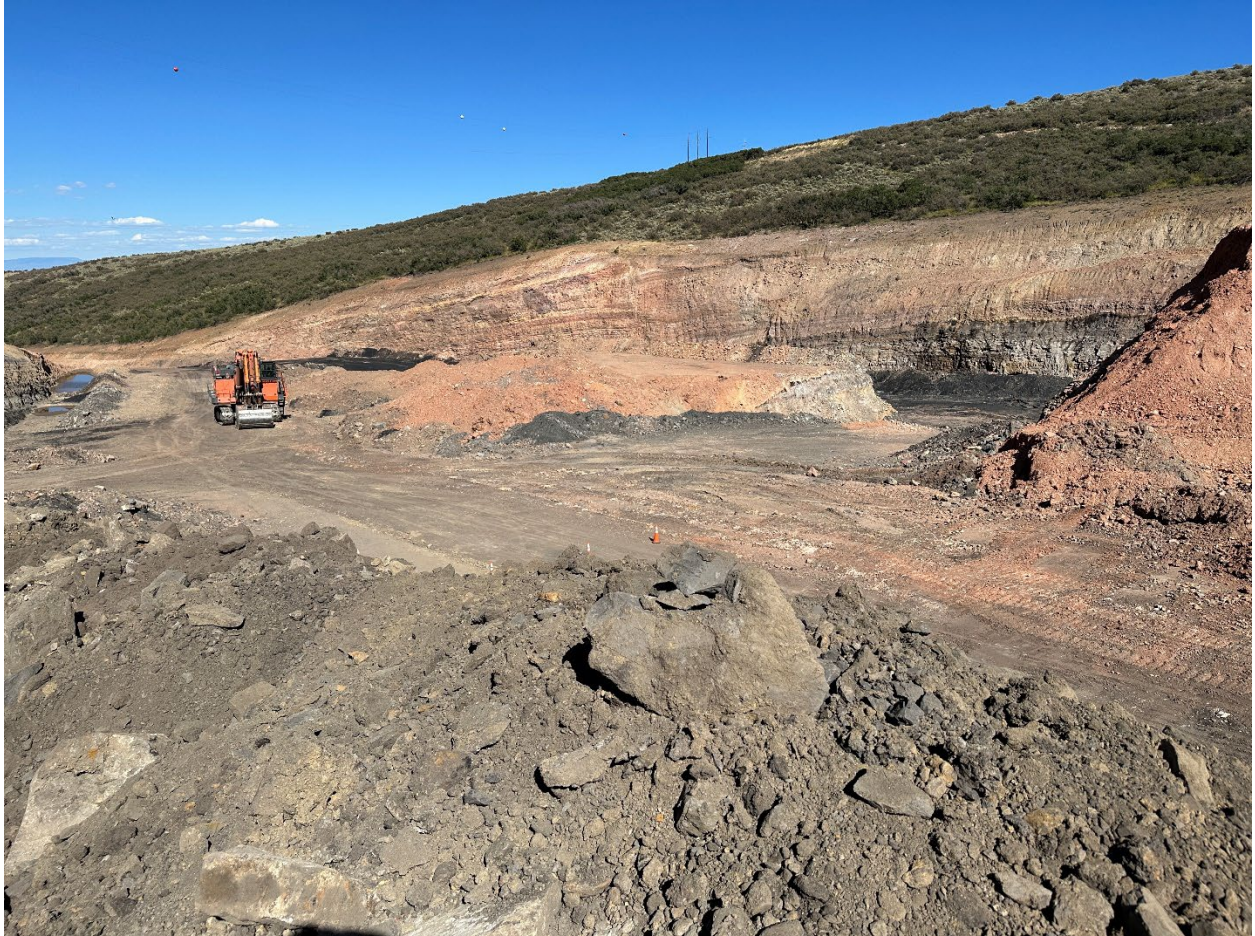
Figure 2 - Manual overburden removal in Little Collom Gulch. No issues were noted at the time of inspection.

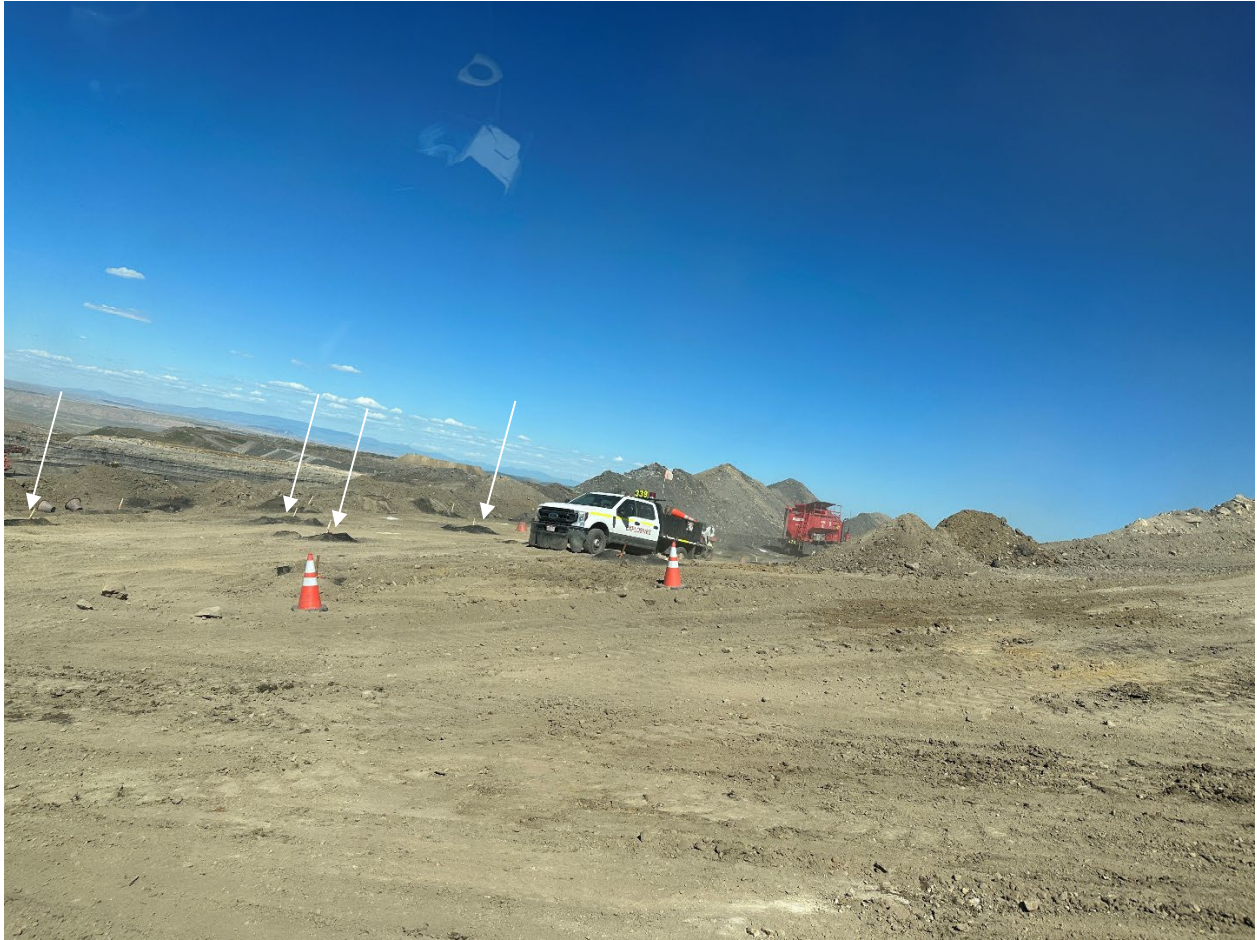
Figure 3 - The operator preparing an overburden blast. Note the blastholes (white arrows).

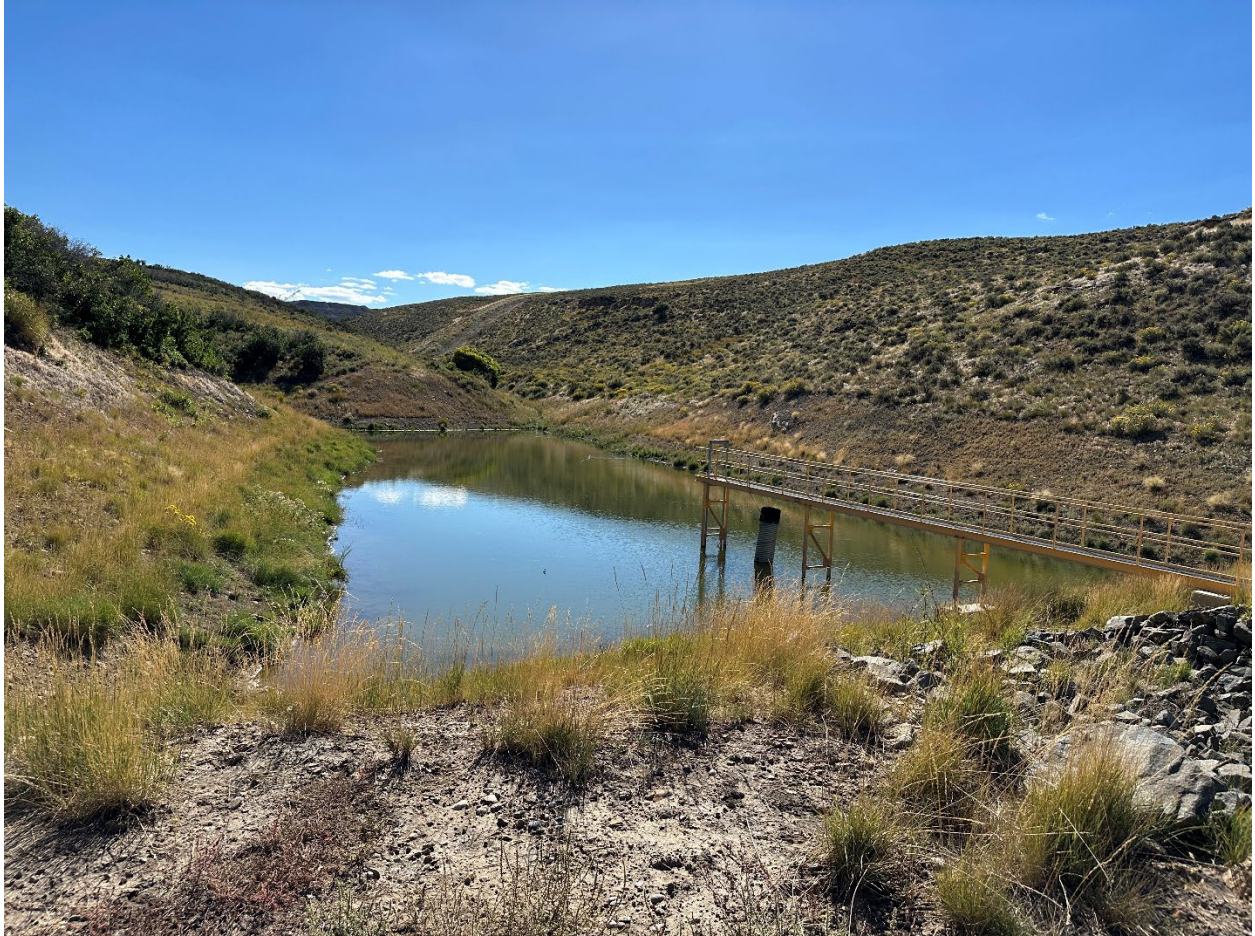
The Sidehill and Section 25 (Figure 4) Ponds were stable, holding water, and fully functional at the time of inspection.

Figure 4 - Section 25 Pond, stable, holding water, and fully functional at the time of inspection.

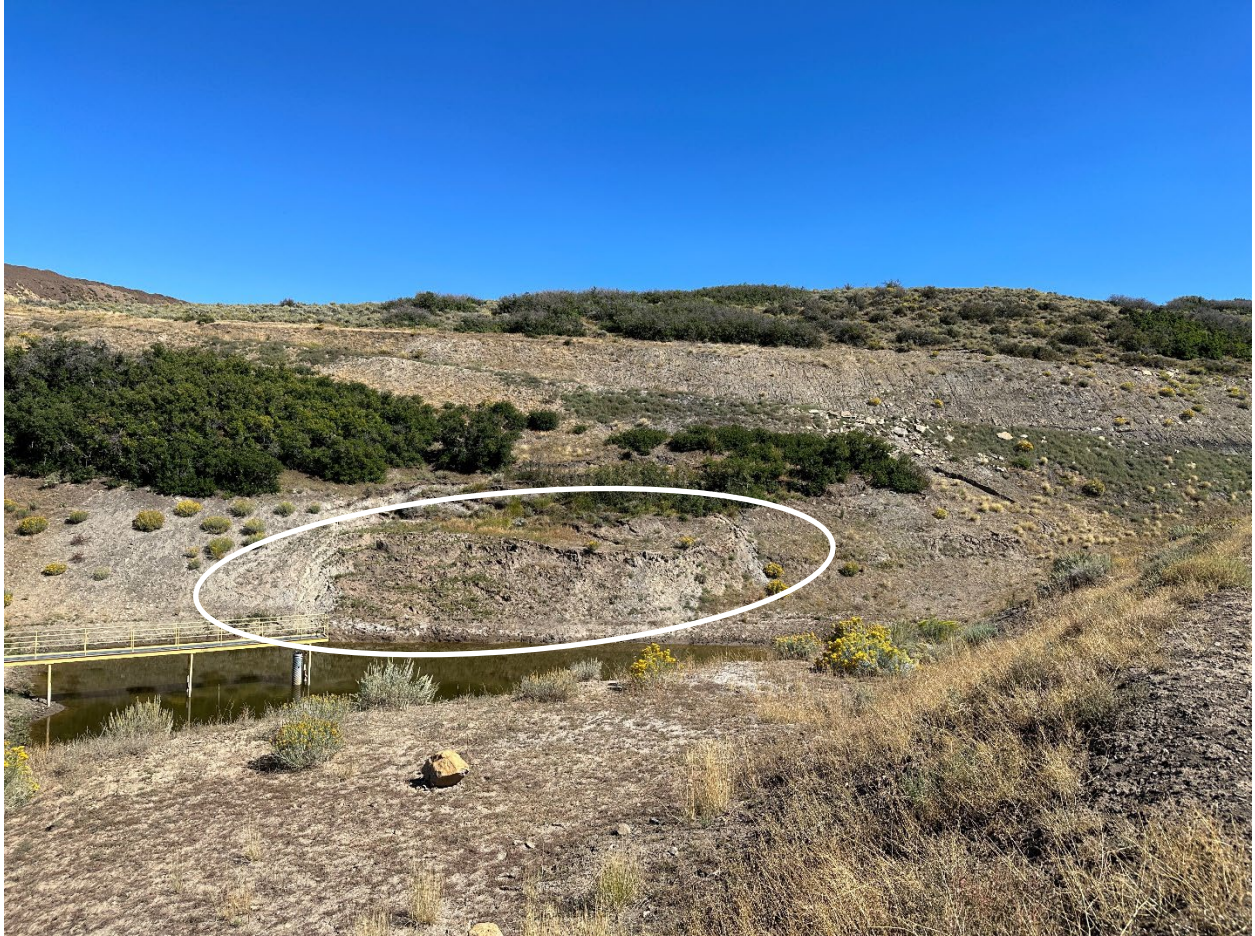
Section 26 Pond was functional at the time of inspection. A portion the upslope embankment is eroding into the pond (Figure 5). The operator discussed repairing this section of the embankment soon in conjunction with removing sediment from the pond.

Figure 5 - Section 26 Pond, holding water and functional at the time of inspection. Part of the upslope embankment is unstable and slumping into the pond (white oval); the operator will repair this when they remove sediment from the pond.

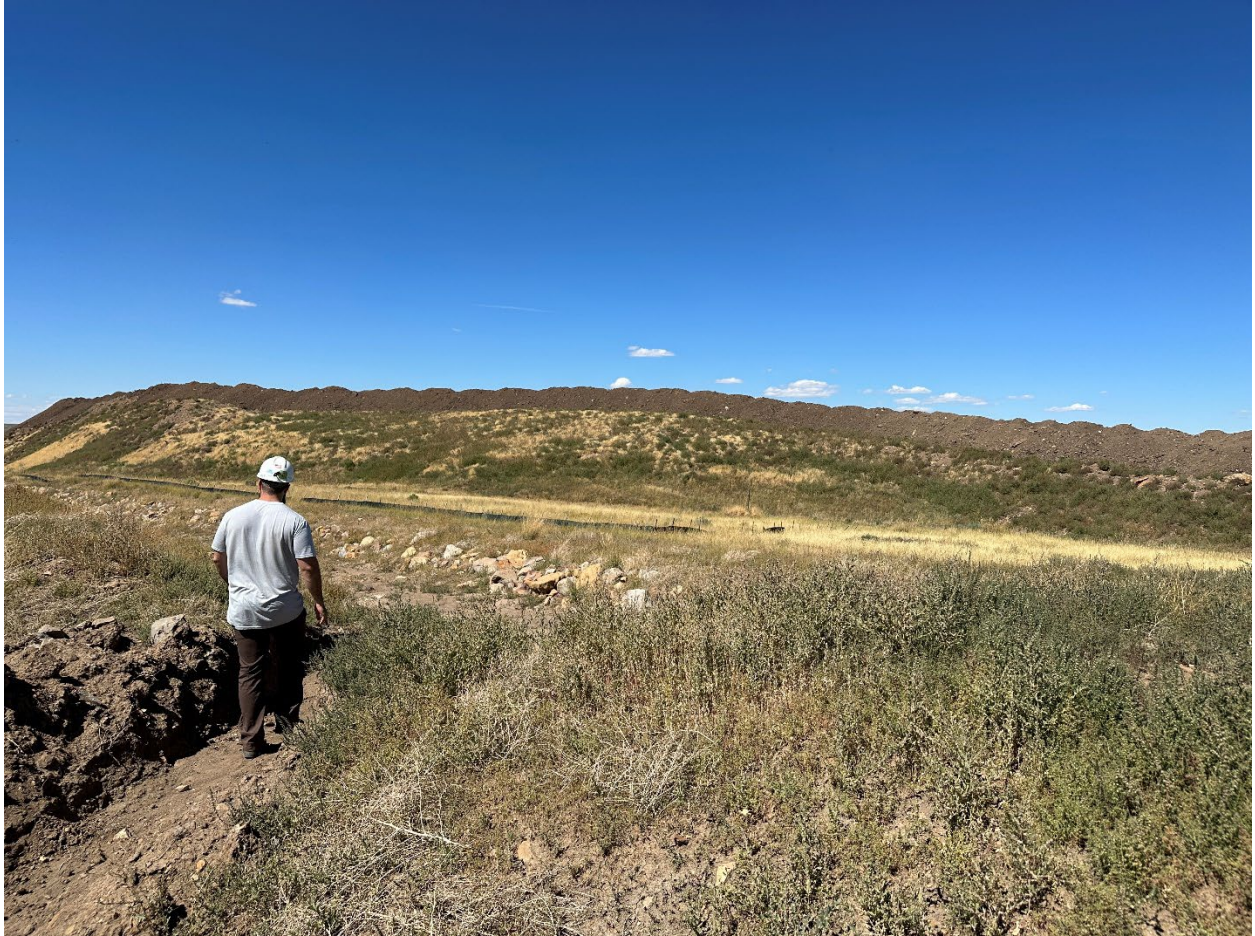
Topsoil Stockpile 26A was inspected from a distance by walking down the D2 Ditch; no issues were noted with either 26A or D2. At the time of inspection, the operator was still adding to 26A from active mining operations (Figure 6).

Figure 6 - Collom Topsoil Storage Pile 26A, stable at the time of inspection. New topsoil can be seen on the ridgeline.

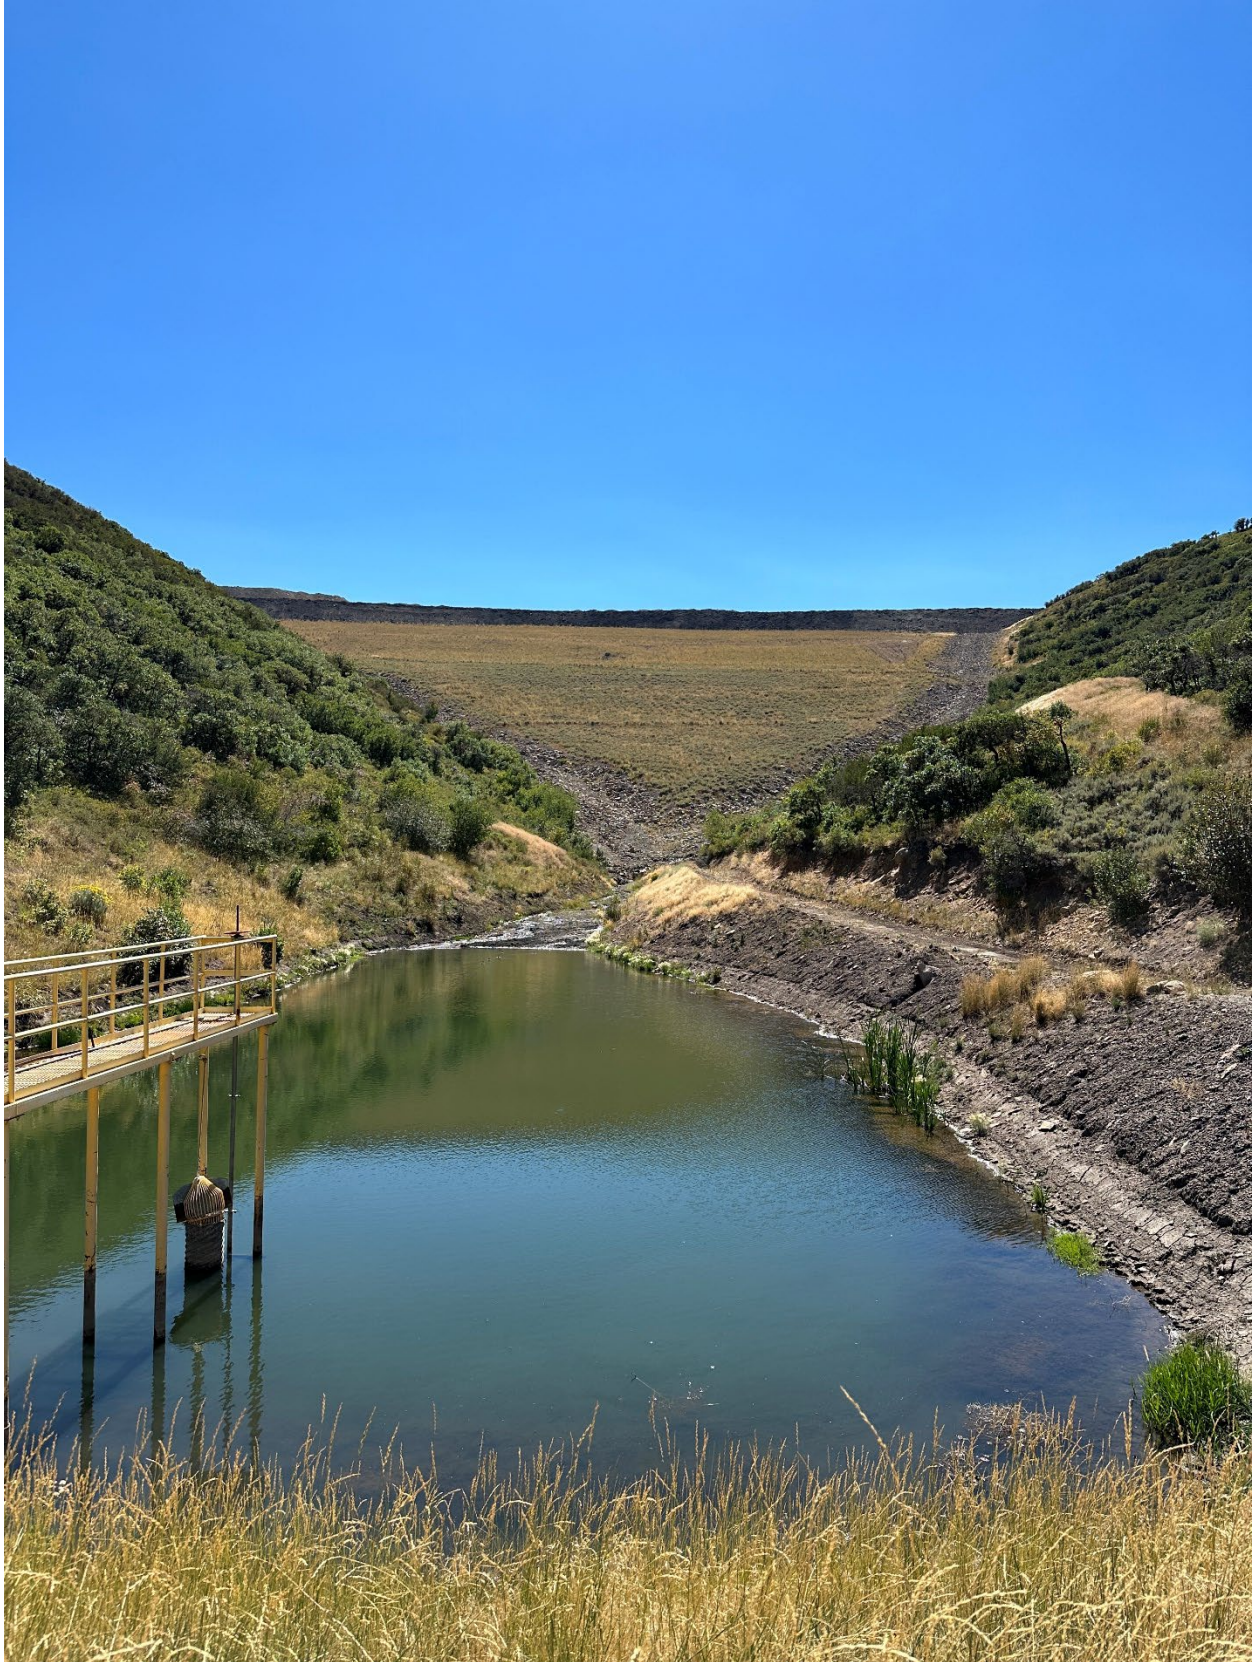
The West Taylor Valley Fill and West Taylor Pond were stable and fully functional at the time of inspection (Figure 7).

Figure 7 - West Taylor Valley Fill and Pond, both stable and fully functional at the time of inspection.

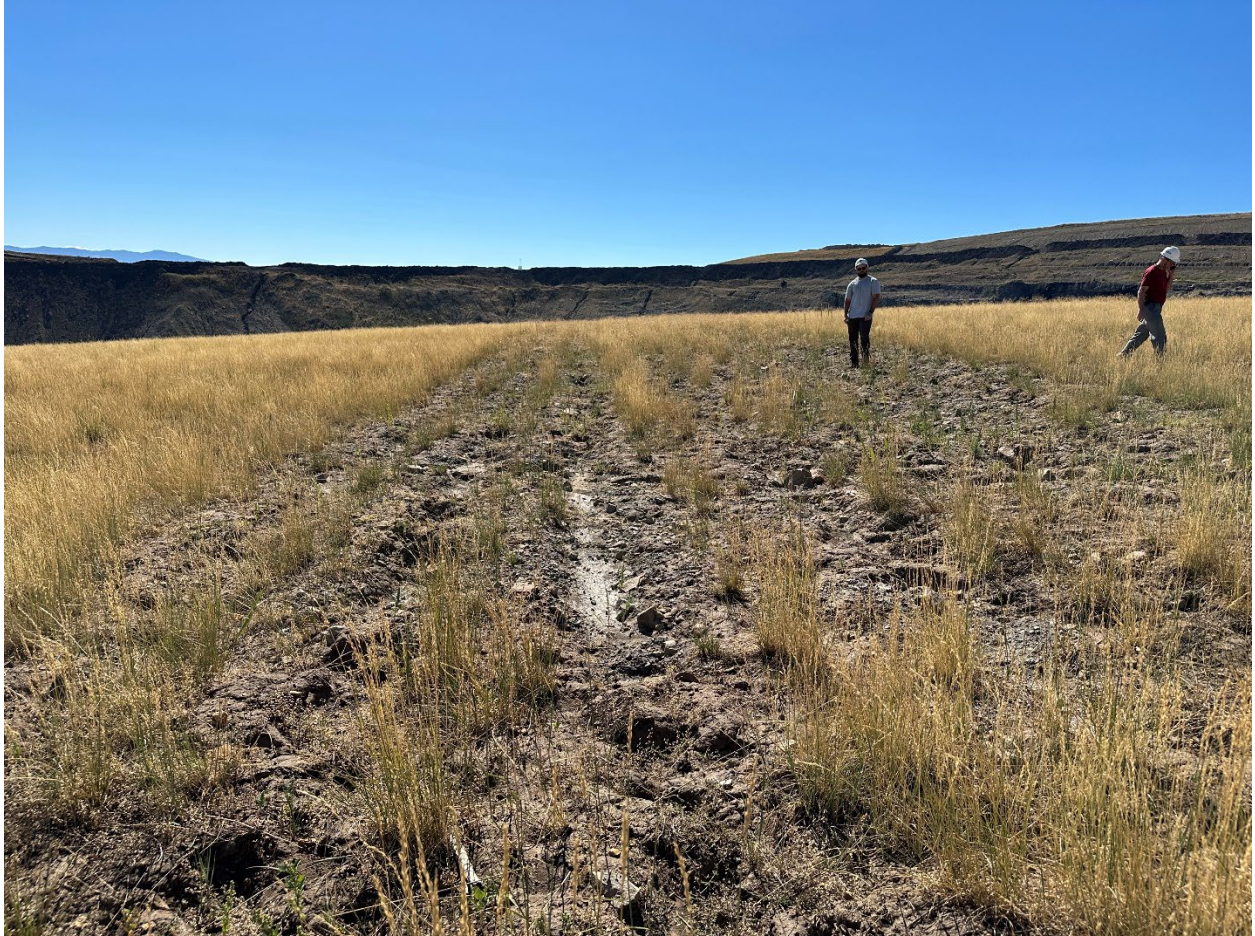
South Taylor Reclamation parcel ST001 was inspected. This site was stable at the time of inspection, but some sections still lack significant vegetation (Figure 8). The operator continues to try different methods for establishing vegetation in these spots, including reseeding and loosening overly compacted soil.

Figure 8 - South Taylor Reclamation parcel ST001, stable at the time of inspection. The operator is aware of the lack of vegetation in some areas and is actively trying to establish self-sustaining vegetation.

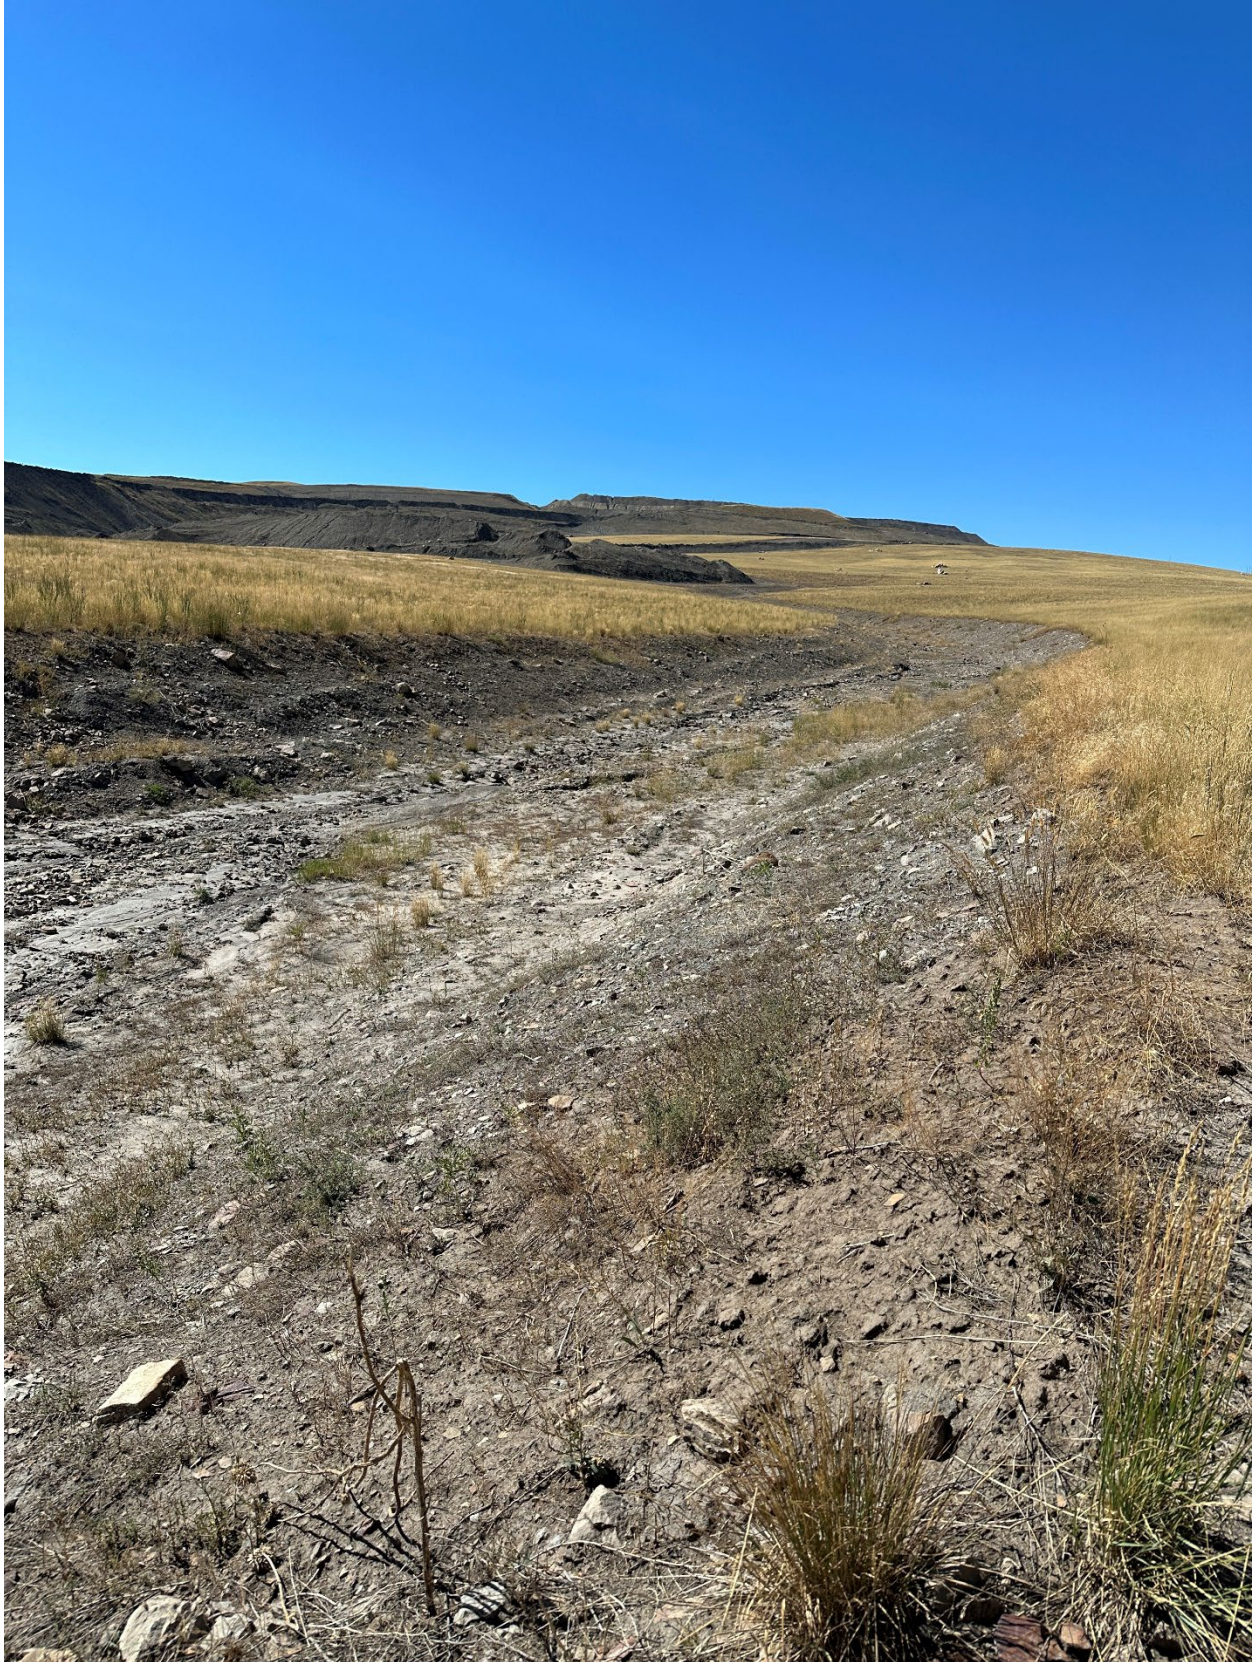
The Buckskin (Figure 9), Taylor, and East Taylor (Figure 10) ditches were stable at the time of inspection. The Taylor and East Taylor ditches were fully functional, whereas the Buckskin ditch construction is still not complete.

Figure 9 - A section of Buckskin Ditch, stable at the time of inspection. The operator still needs to complete its construction.

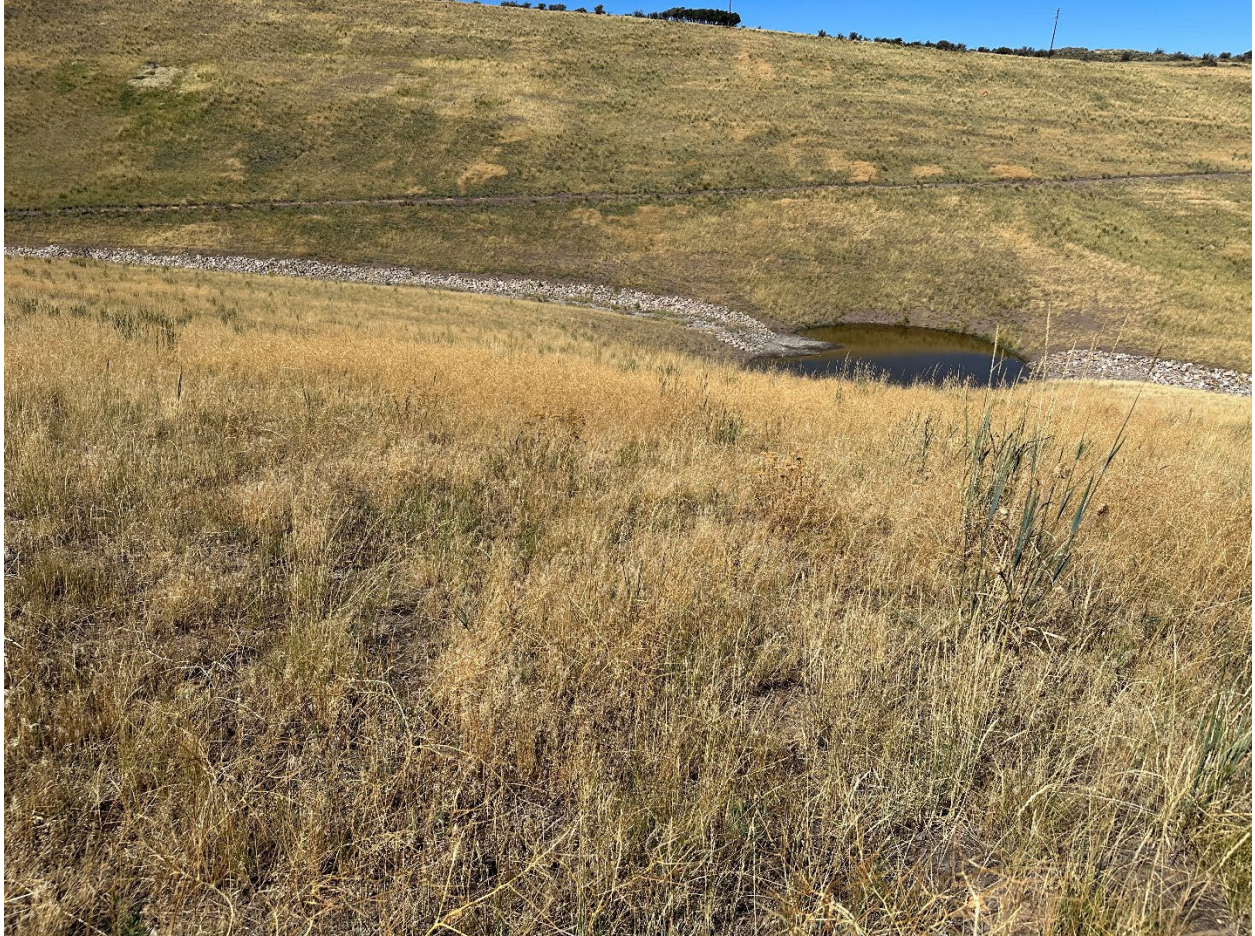
Figure 10 - A section of the East Taylor Ditch including an in-channel pond, stable and fully functional at the time of inspection.

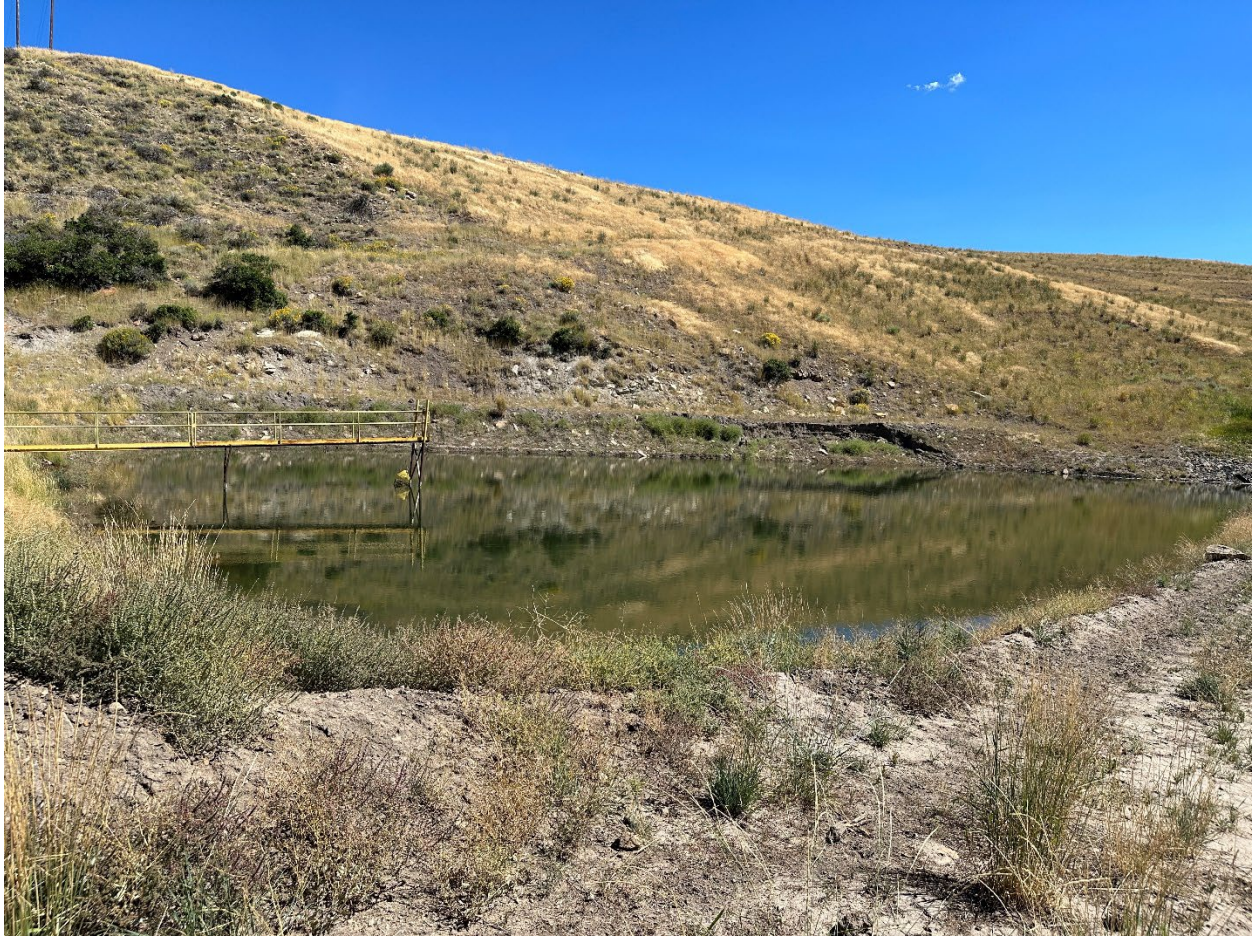
The East Taylor Pond was stable, holding a lot of water, and fully functional at the time of inspection (Figure 11). The operator's representative explained that a musk weed infestation was clogging much of the primary spillway and will be manually cleared (no chemical treatments are allowed) as soon as possible.

Figure 11 - East Taylor Pond, stable and functional at the time of inspection. A musk weed infestation is preventing the primary spillway from adequately discharging the stored water, and the operator will manually remove the infestation as soon as possible.

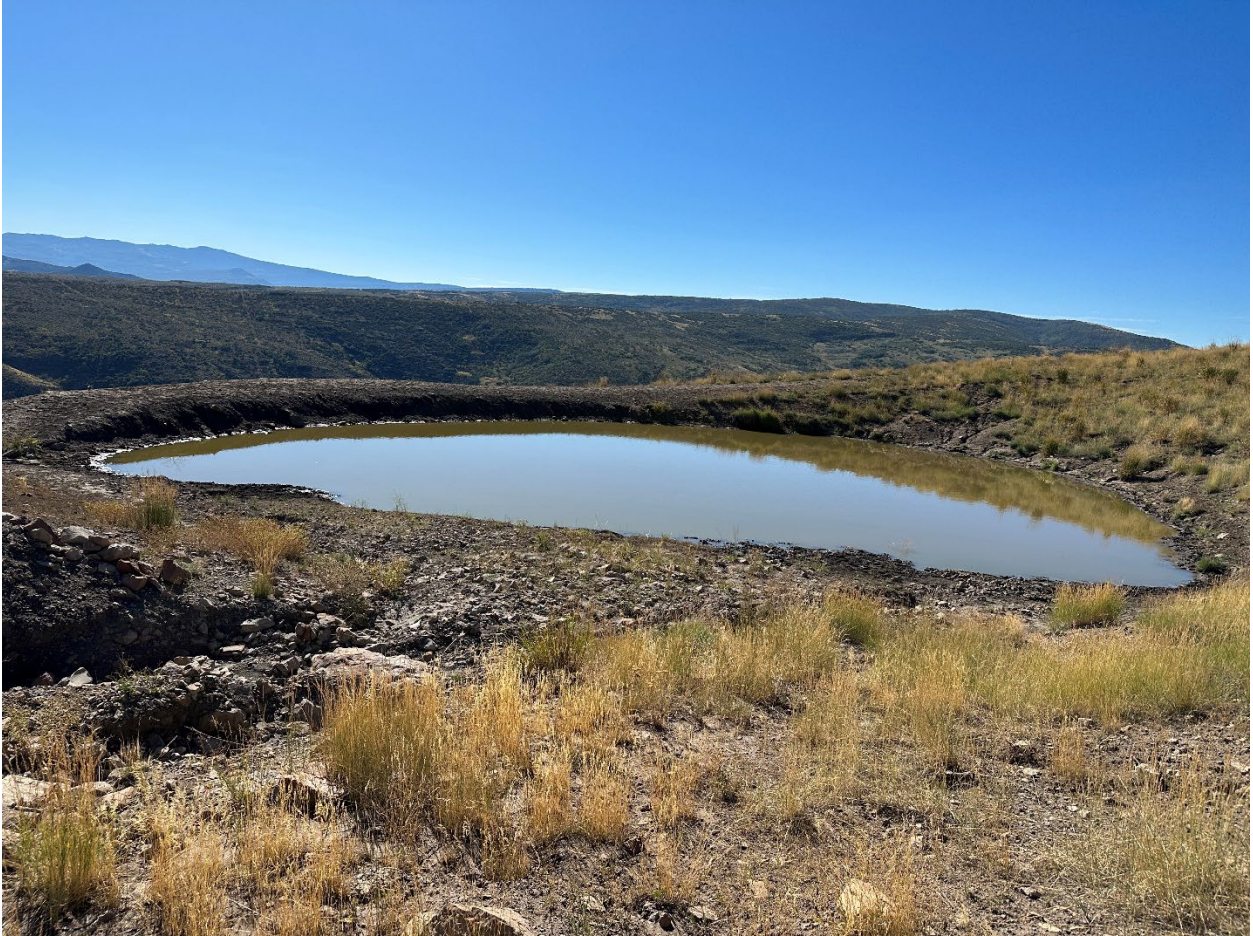
The Prospect Ditch and the associated PD-1 Pond (Figure 12) were stable and fully functional at the time of inspection.

Figure 12 - Pond PD-1, stable, holding water, and fully functional at the time of inspection.

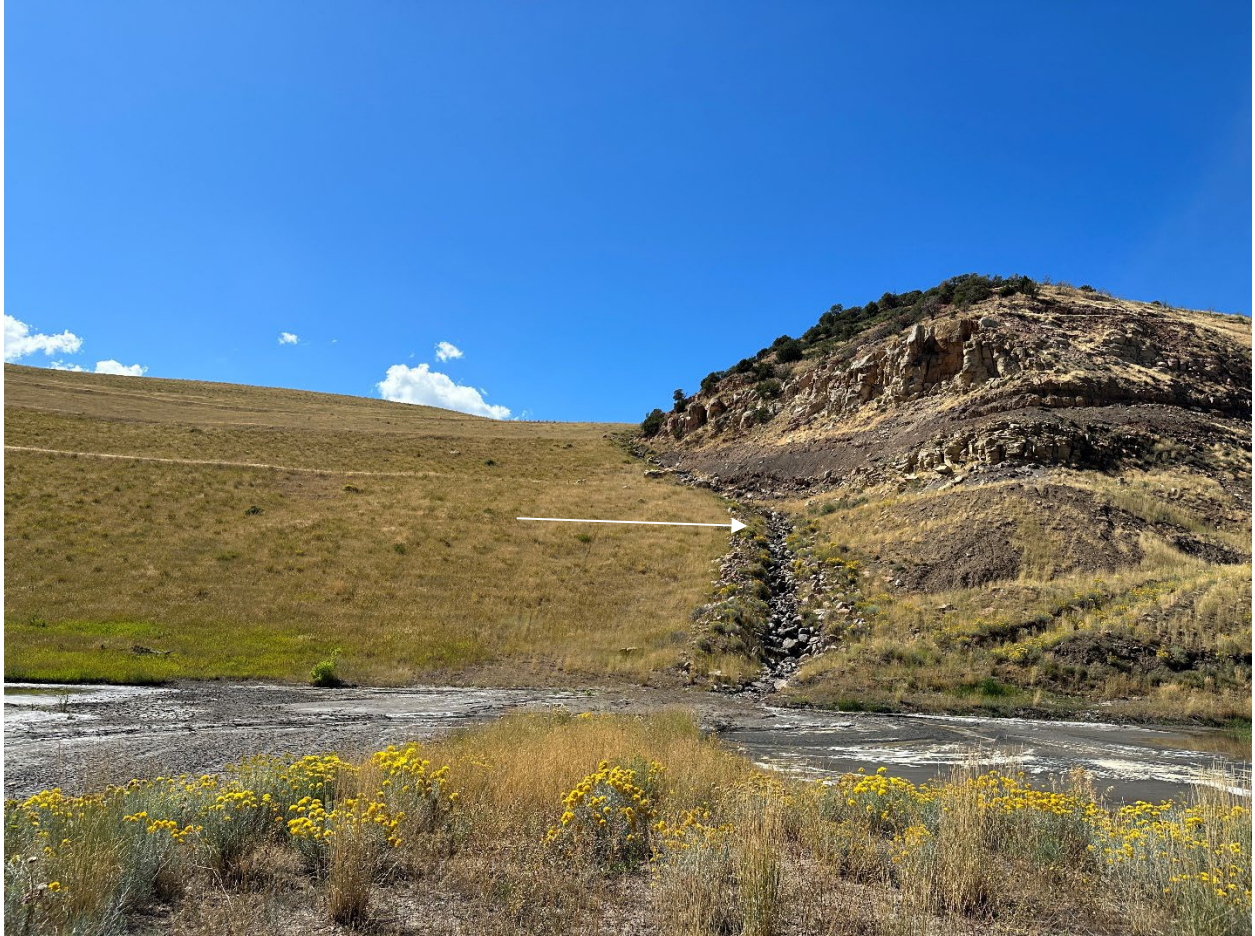
The Streeter ditch and pond were stable and fully functional at the time of inspection. Adjacent to this site is an underground coal seam fire that the Colorado AML program is designing a plan to extinguish (Figure 13).

Figure 13 - The Streeter Ditch (white arrow), stable and fully functional at the time of inspection. An abandoned mine fire is present to the right of the ditch that the Colorado AML program is designing a plan to extinguish.

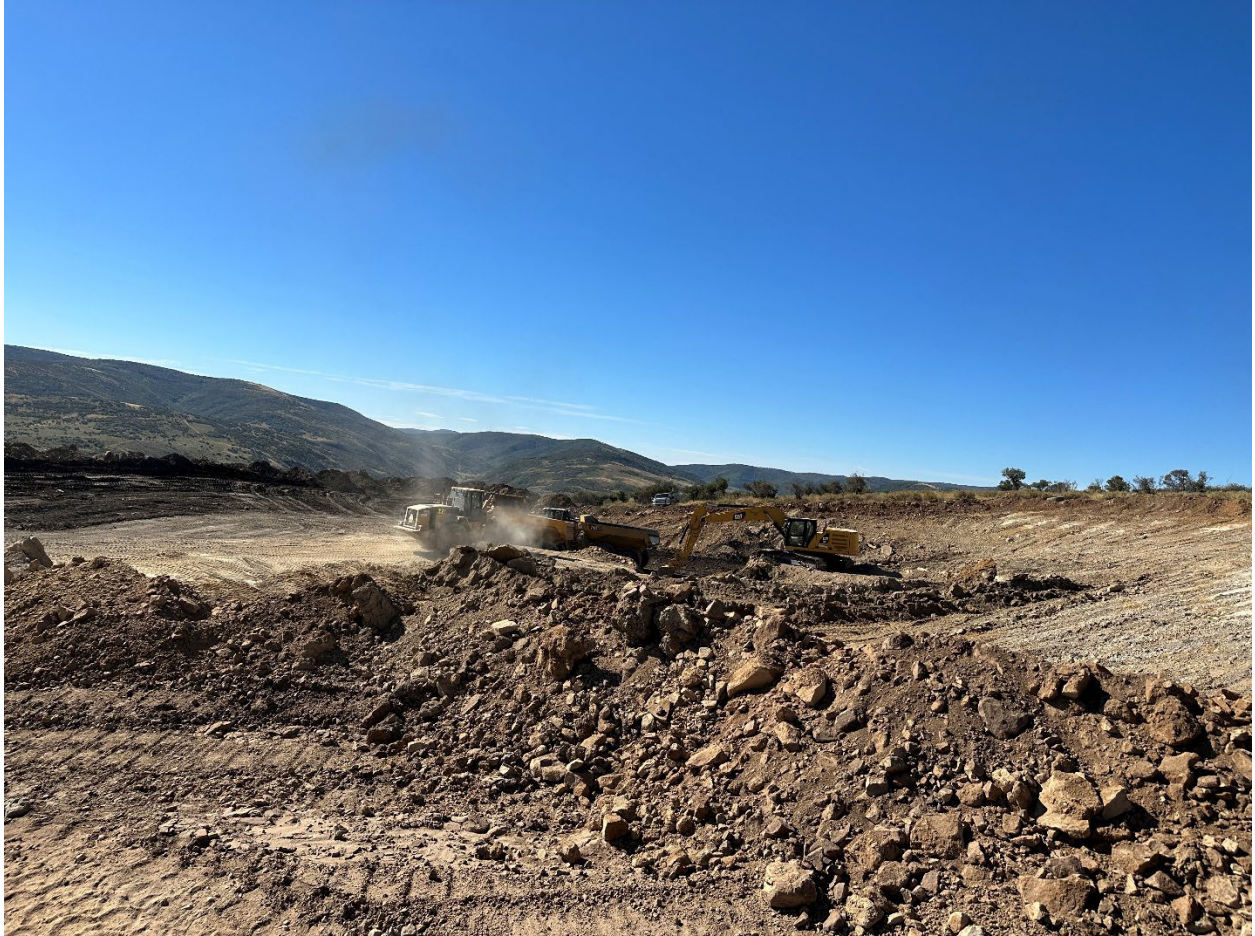
At the time of inspection, the operator was constructing a ditch and pond in Section 15 to alleviate the water surges that resulted in maintenance and repair to the Prospect Drainage ditches; no issues were noted and the operator plans to complete construction by winter (Figure 14). This construction is part of Technical Revision 154, created in response to a violation the operator received on October 12, 2022, as a result of a high intensity precipitation event that caused damage to the Final East Pit Ditch and transported sediment off-site onto private and lands not permitted for disturbance.

Figure 14 - The operator was actively installing a new Pond in Section 15. No issues were noted at the time of inspection.

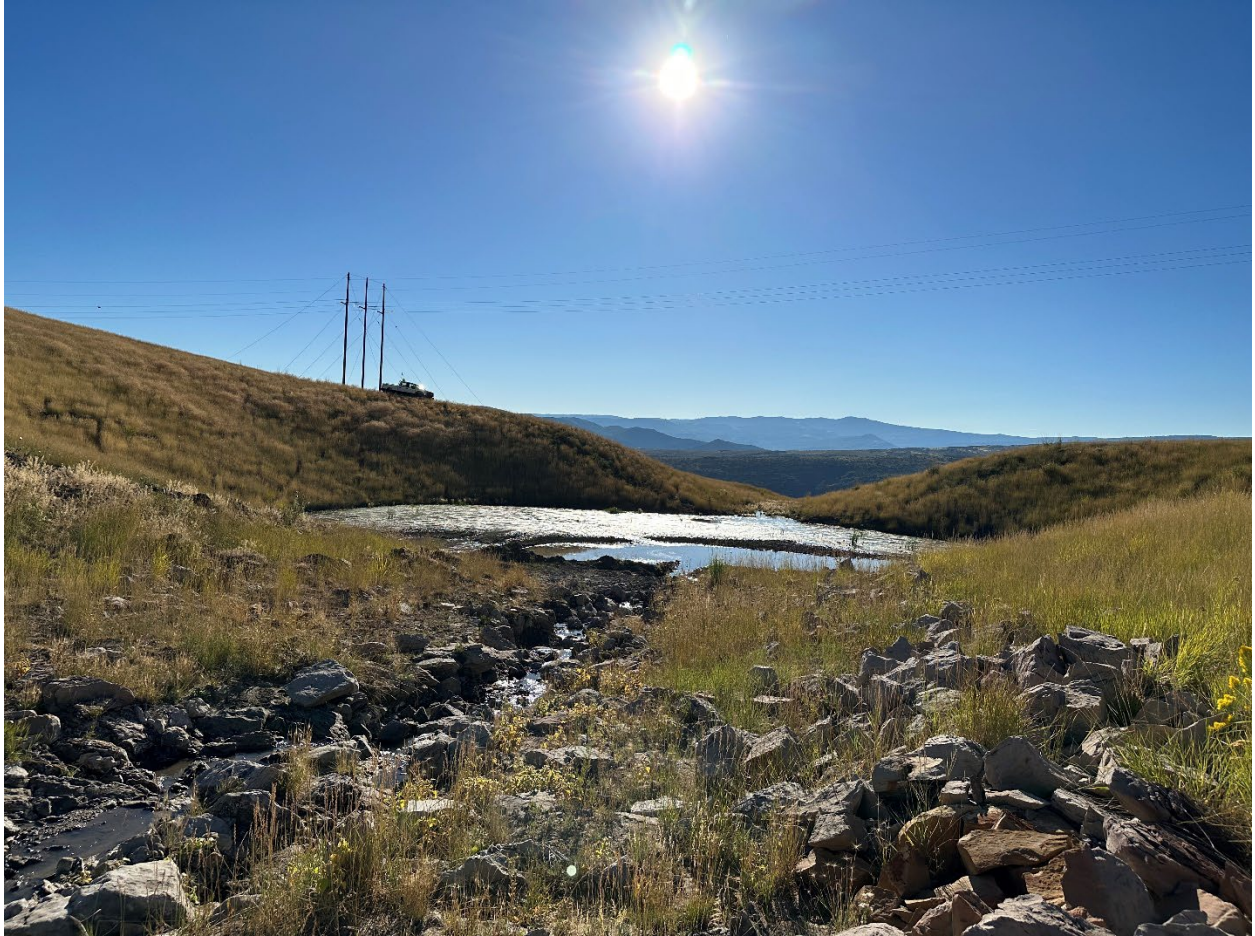
The Final East Pit Ditch (Figure 15) and stock ponds EP1 and EP2 were functional at the time of inspection; EP1 was fully excavated and EP2 was partially excavated and requires further sediment removal. This system was damaged in the October 12, 2022, precipitation event described above. We discussed the additional upgrades to this ditch, including adding gabion baskets to the lowest portion of the ditch to stabilize the channel.

Figure 15 - A section of the Final East Pit Ditch with an associated stock pond. This system was fully functional at the time of inspection.

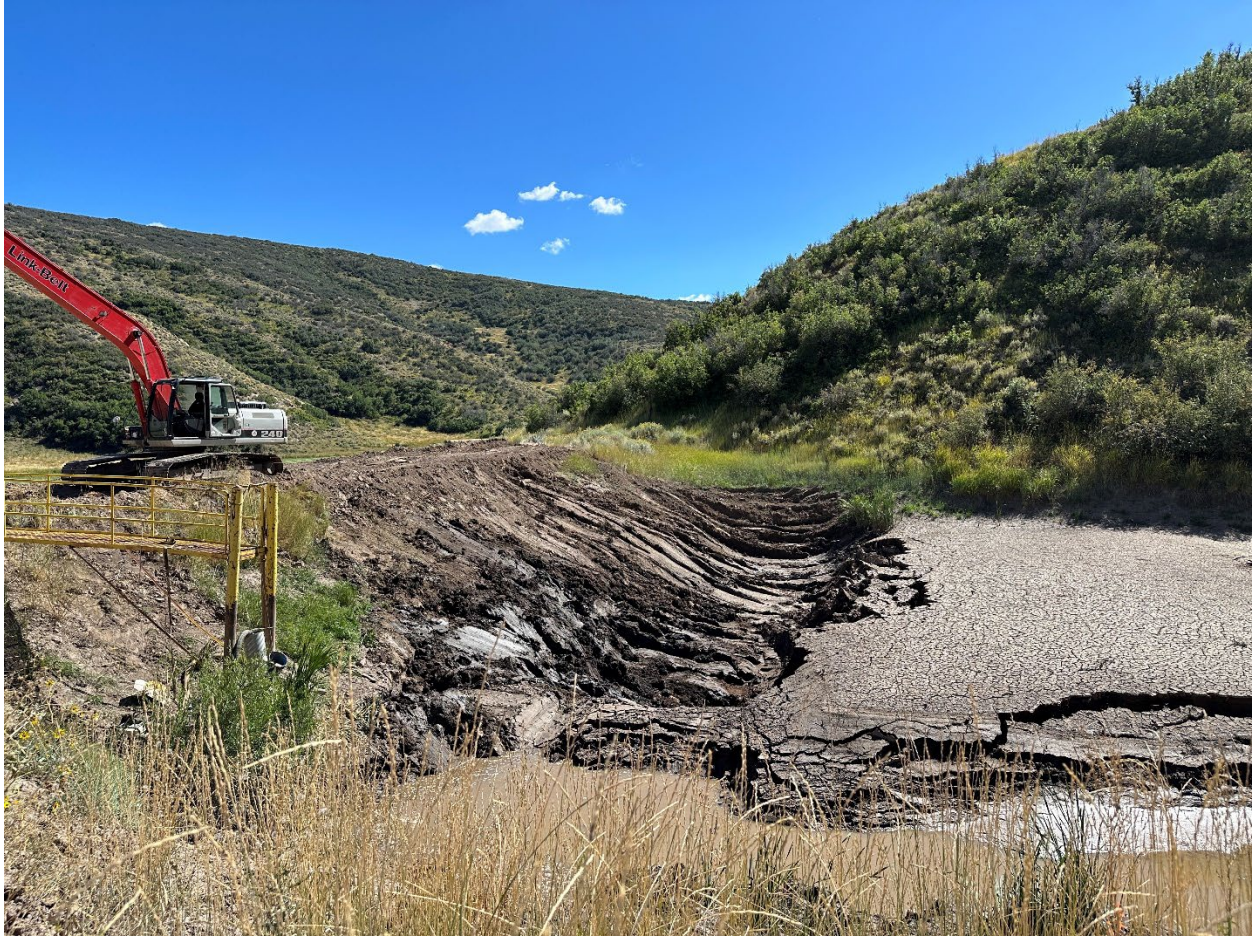
Prospect Pond was stable, holding water, and functional at the time of inspection. Sediment removal was ongoing, and no issues were noted (Figure 16).

Figure 16 - Prospect Pond, stable at the time of inspection. The operator was actively excavating sediment to return the pond to full capacity.
