Job Number: 99-3983

Subject: Quarterly Observation Report, Refuse Pile, Foidel Creek Mine, Routt County, Colorado.

Project: Refuse Pile

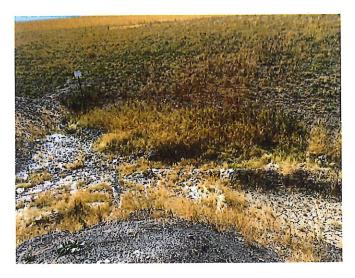
September 28, 2018- Southwest End of Underdrain

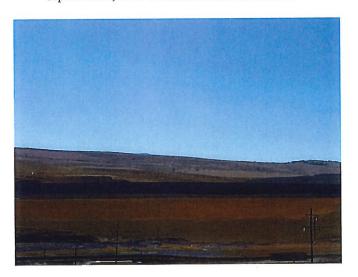
Septermber 28, 2018-Bench 1 and 2 Revegetation

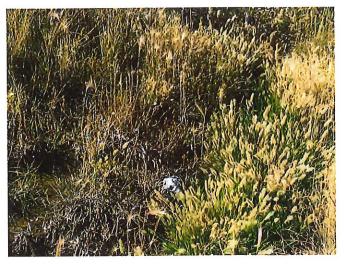
A seepage area at the toe of the northeast end of the refuse pile expansion area, approximately 30 feet northwest of the outlet of the underdrain, developed in fall 2014. At the time of our observations, the seepage was surfacing at the toe of the slope and flowing into the drainage from the undrain outlet then into the existing pond east of the Refuse Pile Expansion Area. The discharge was clear, with no evidence of sediment. No signs of washout, slumps or slope instability were observed at this time. The seepage area

will be monitored during future inspections and noted in our inspection reports. Photographs of the seepage area taken at the time of our inspection on September 28, 2018 are attached.

September 28, 2018-Seepage Area

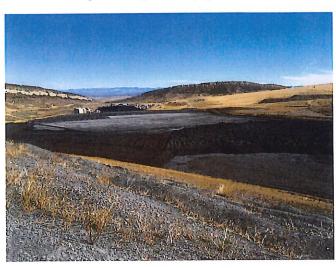
September 28, 2018-Expansion Area from Areas 2, 3, 4
