January 7, 2018

Job Number: 99-3983

Subject: Quarterly Observation Report, Refuse Pile, Foidel Creek Mine, Routt County, Colorado.

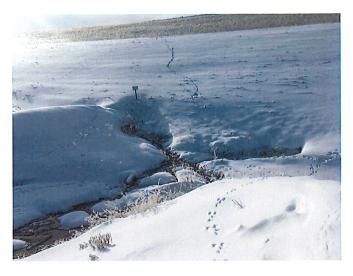
A seepage area at the toe of the northeast end of the refuse pile expansion area, approximately 30 feet northwest of the outlet of the underdrain, developed in fall 2014. At the time of our observations, the seepage was surfacing at the toe of the slope and flowing into the drainage from the undrain outlet then into the existing pond east of the Refuse Pile Expansion Area. The discharge was clear, with no evidence of sediment. No signs of washout, slumps or slope instability were observed at this time. The seepage area

will be monitored during future inspections and noted in our inspection reports. Photographs of the seepage area taken at the time of our inspection on December 28, 2018 are attached.

December 28, 2018-Underdain Outlet/Seepage Area

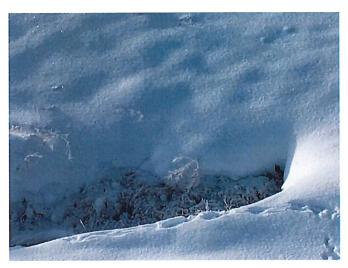
December 28, 2018-Seepage Area

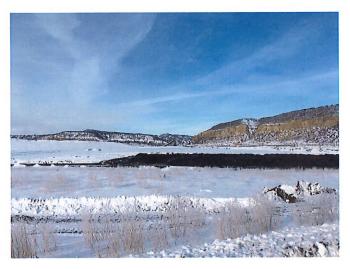
At the time of our site visit on December 28, 2018, NWCC completed a site inspection of the existing refuse pile. Based on our observations made during this visit, it appeared that the contractor was presently stockpiling and compacting refuse coal in the new Expansion Area. At the time of our site visit the refuse coal had been placed and compacted to an elevation above the second bench situated along the east side of the stockpile.

December 28, 2018- Expansion Area-Stockpiles

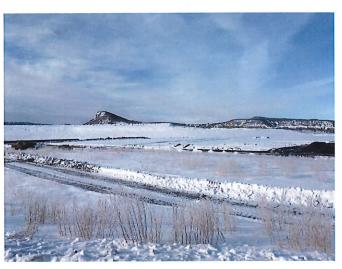
December 28, 2018- Areas 2, 3, 4 from Expansion Area

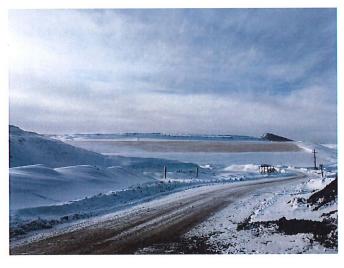
December 28, 2018-Bench 1 and 2

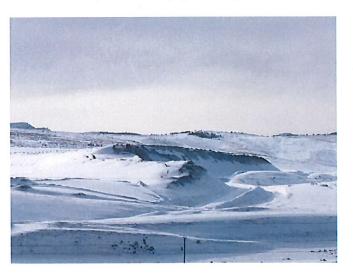
The internal roadways in the new expansion area of the pile are in good condition. The upper haul road to Areas 2, 3 and 4 of the refuse pile was not accessible at the time of our site visit due to snow.

December 28, 2018-Road to Areas 2, 3 and 4
