Roadside Mine, C-1981-041, October Inspection Report

PERMIT INFORMATION

Permit Number: C-1981-041 Mine Name: Roadside Portals Operator: Snowcap Coal Company, Inc. Operator Address: MS Tonya Hammond P.O. Box 1430 Palisade, CO 81526	County: Mesa Operation Type: Underground Permit Status: Active Ownership: Private
	Operator Representative Present: Tonya Hammond
Operator Representative Signature: (Field Issuance Only)

INSPECTION INFORMATION

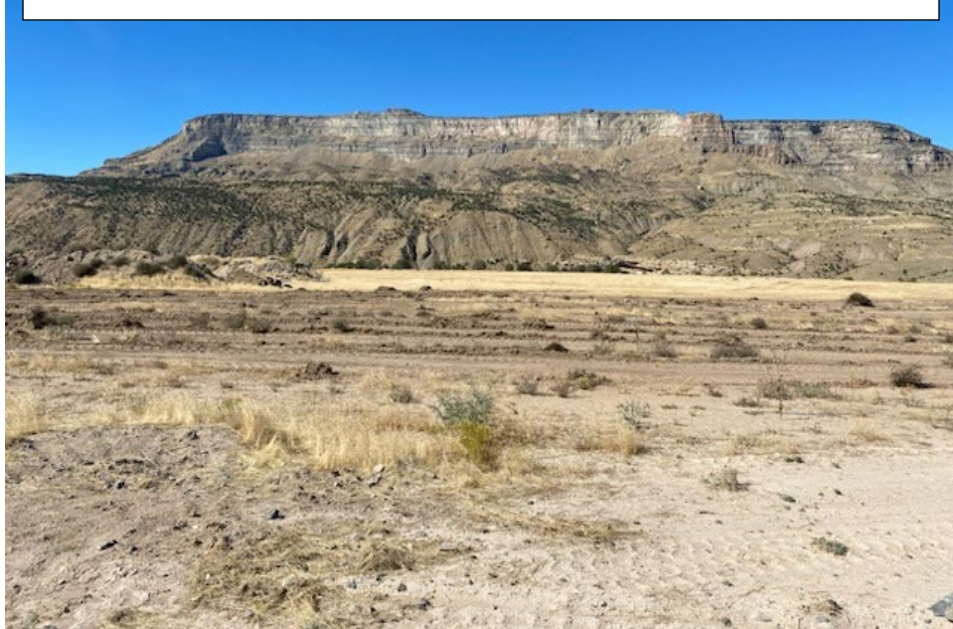
The TR-69 Repair Area is the only remaining disturbance permitted at the Roadside Mine. The area is located in the northern portion of what is referred to as Tract 71. The TR-69 Repair Area consists of approximately 0.4 acres of land that was reclaimed in the fall of 2019. Prior to this inspection SCC had established vegetative cover and implemented sediment control features at the TR-69 Repair Area as required by the Rules. Please refer to the Division's previous Inspection Reports for the Roadside Mine for more details. During the inspection, the Division observed five to six rows of bladed vegetation transecting north/south across the western portion of Tract 71 (Photos 1 and 2). Three to four of these bladed transects crossed through the TR-69 Repair Area (Photos 3 and 4). Without the TR-69 Repair Area's boundary markers in place at the time of the inspection, it was unclear if all four of the transects were within the disturbed area. The bladed transects ended at the northern portion of the TR-69 Repair Area and on the south side of Mr. Fontanari's northern trench. The end of the transects had small piles of bladed Rock, dirt and vegetation (Photo 5). SCC's disturbed area boundary markers, previously installed straw waddles, and mine identification sign were removed from the TR-69 Repair Area. All materials removed from the TR-69 Repair Area were found piled up on the northern embankment of the Carey Pit (Photos 6 and 7). The Carey Pit is located to the southwest of the TR-69 Repair Area and in the southwestern corner of Tract 71. Based on information by Tonya Hammond, all activities observed in the TR-69 Repair Area were not conducted by or

Photo 1: The western portion of Tract 71 with the bladed transects. The Photo was taken looking to the west.

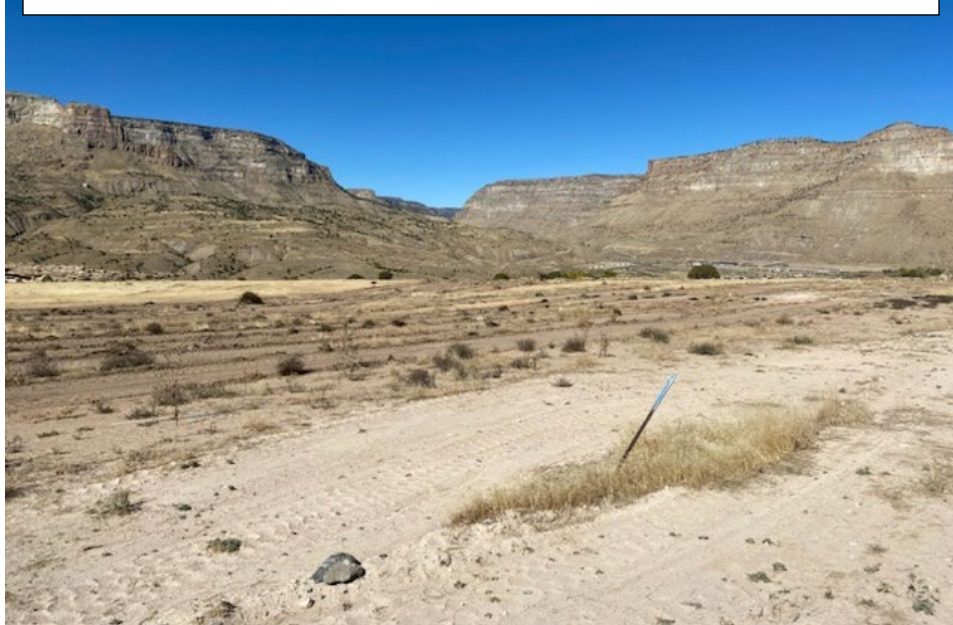
Photo 2: The northwestern portion of Tract 71 with the bladed transects. The photo was taken looking to the northeast.

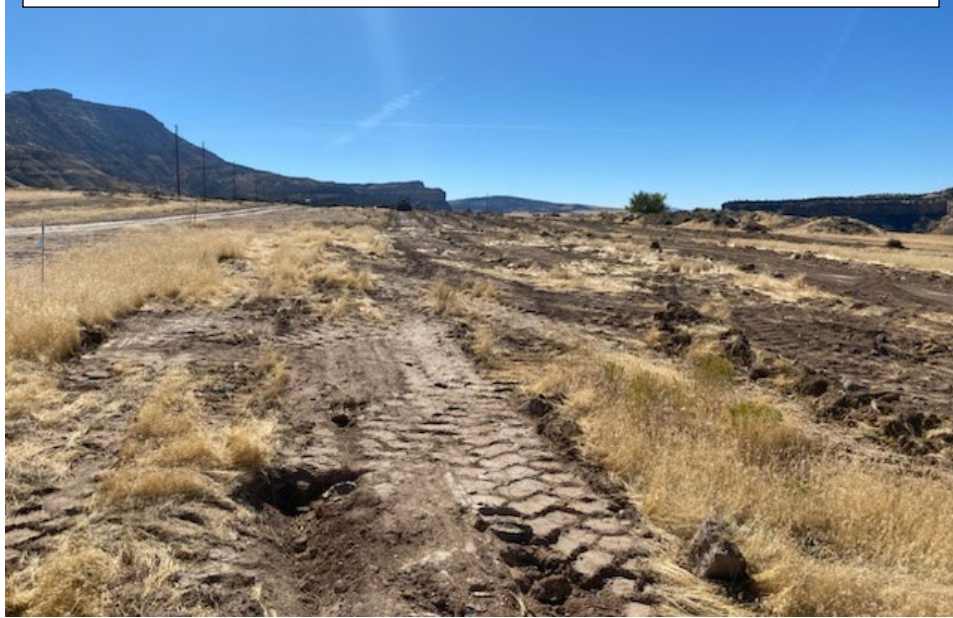
Photo 3: The eastern portion of the TR-69 Repair Area. The photo was taken looking to the south.

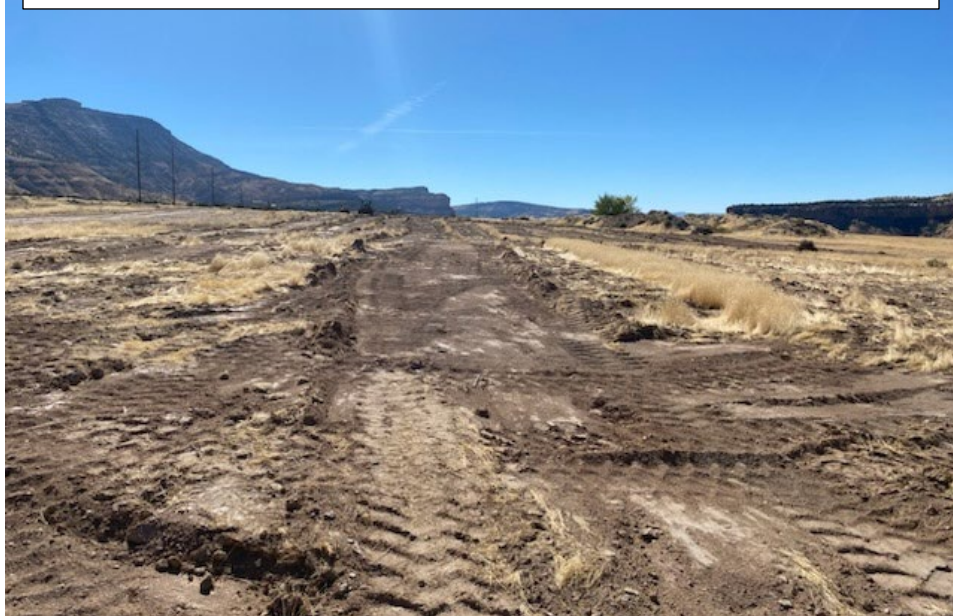
Photo 4: The central and western portions of the TR-69 Repair Area. The photo was taken looking to the south.

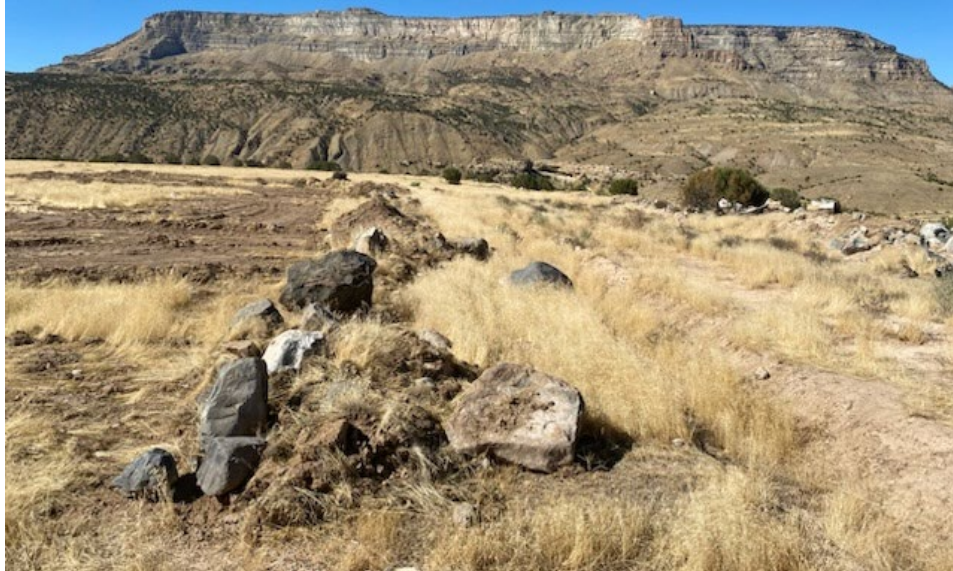
Photo 5: The northern portion of the TR-69 Repair Area. The end of the bladed transects with piles of rock, dirt and vegetation. The photo was taken looking to the west.

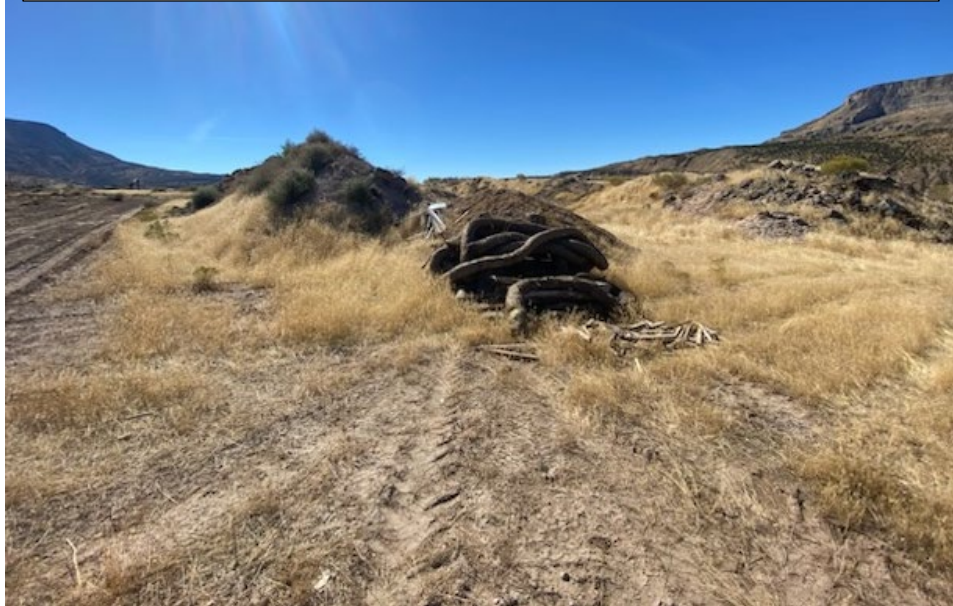
Photo 6: The straw waddles and wooden stakes found stockpiled on the north embankment of the Carey Pit.

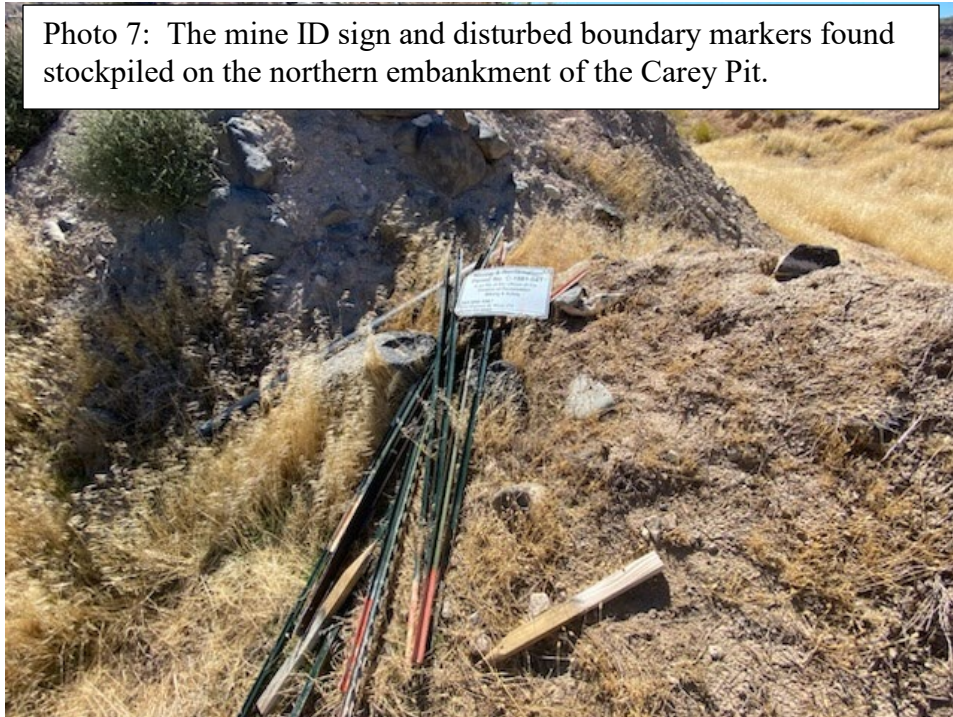
Photo 7: The mine ID sign and disturbed boundary markers found stockpiled on the northern embankment of the Carey Pit.
