M1984041, Eagle-Gypsum Mine, August 2023 Inspection Report

MINERALS PROGRAM INSPECTION REPORT

MINE NAME: Eagle-Gypsum Mine	MINE/PROSPECTING ID#: M-1984-041	MINERAL: Anhydrite, gypsum	COUNTY: Eagle
INSPECTION TYPE: Monitoring	WEATHER: Clear	INSP. DATE: August 17, 2023	INSP. TIME: 10:30
OPERATOR: American Gypsum Company LLC	OPERATOR REPRESENTATIVE: Jon Edeen	TYPE OF OPERATION: 112c - Construction Regular Operation

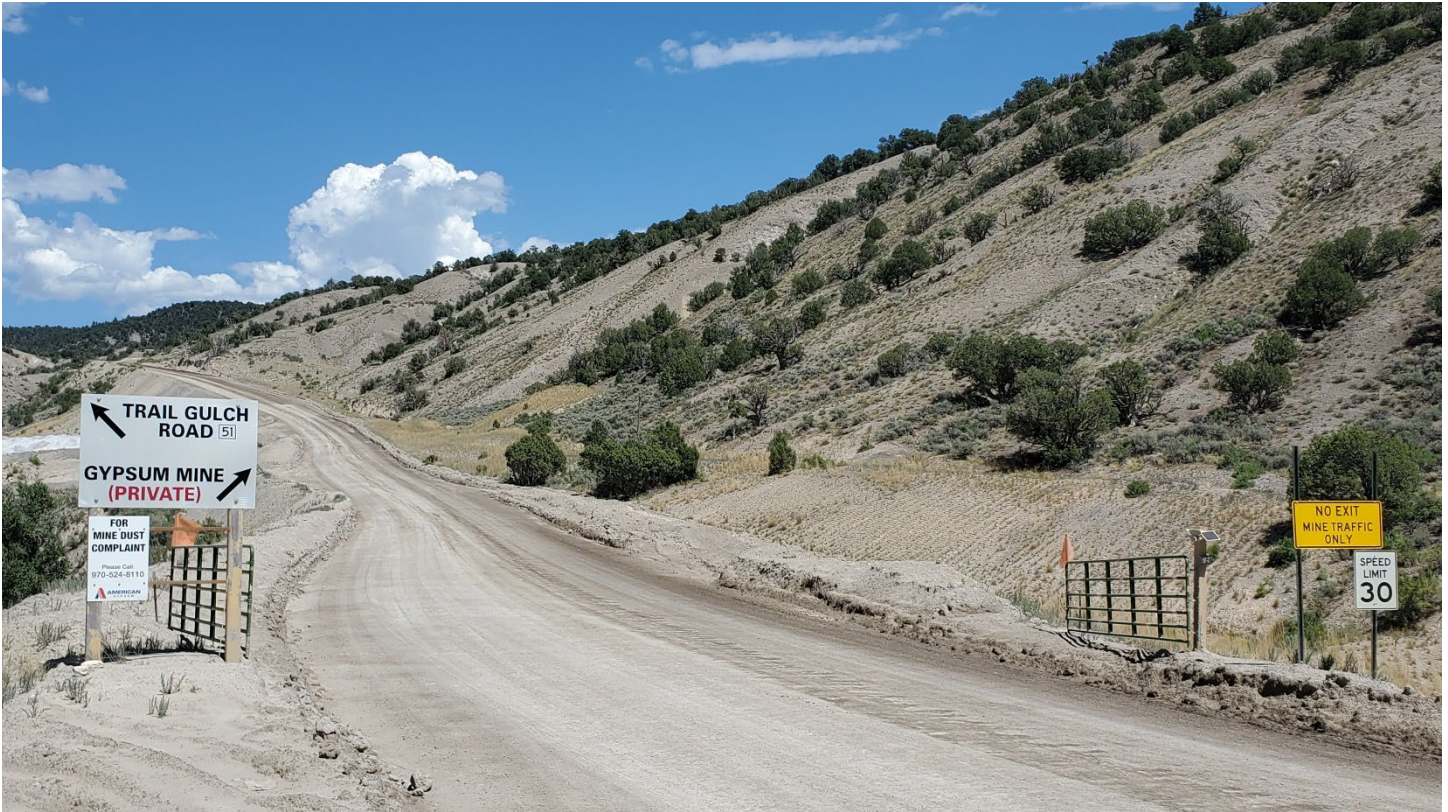
PROBLEM/POSSIBLE VIOLATION: Problem: The mine identification sign was not posted at the entrance of the mine site. This is a problem for failure to post a mine identification sign as required by Section 3.1.12(1) of the rule. The Operator shall, at the entrance of the mine site post a sign, which shall be clearly visible from the access road, with a minimum size equaling one hundred and eighty-seven (187) square inches, such as eleven (11) inches in height and seventeen (17) inches in width, with appropriate font size, with the following: the name of the Operator, a statement that a reclamation permit for the operation has been issued by the Colorado Mined Land Reclamation Board; and the permit number.

The sign posted at the mine entrance did not satisfy the requirements of the Rules, details are given in the problem citation on the first page of this report, (see Figure 3).

Figure 3: Mine entrance, showing inadequate Mine ID sign, (a)

CORRECTIVE ACTIONS: The operator shall, at the entrance of the mine site, post a sign which shall be clearly visible from the access road with the following: the name of the operator, a statement that a reclamation permit for the operation has been issued by the Colorado Mined Land Reclamation Board; and the permit number. The operator shall submit photo documentation that a proper sign has been posted by the corrective action date.

CORRECTIVE ACTION DUE DATE: 11/17/23

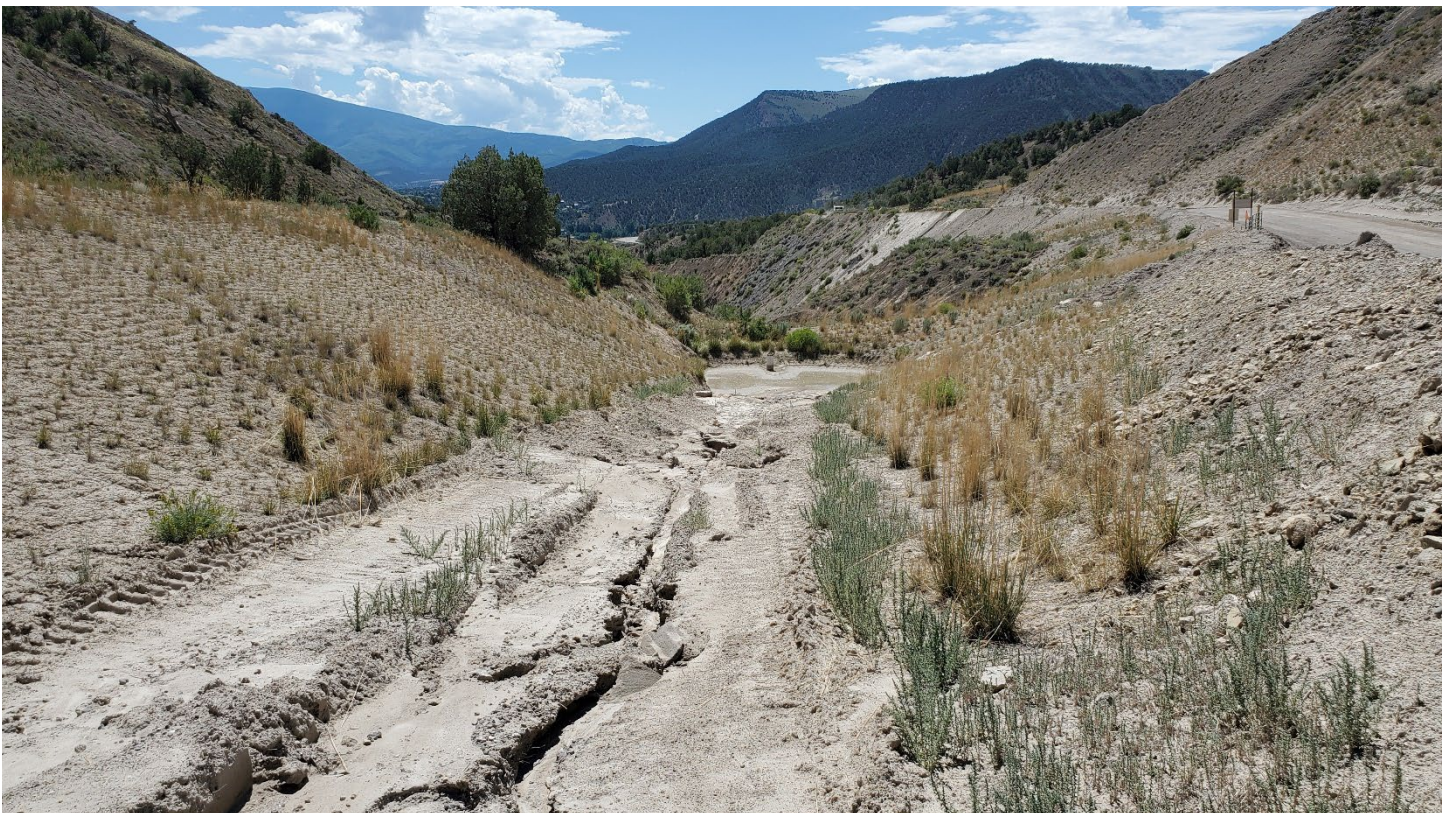
Figure 4: Sediment pond 1 south, cleaned earlier this year. Previous erosion problems mitigated with check dams. Most runoff diverted to the Sediment pond 1 north, (b)

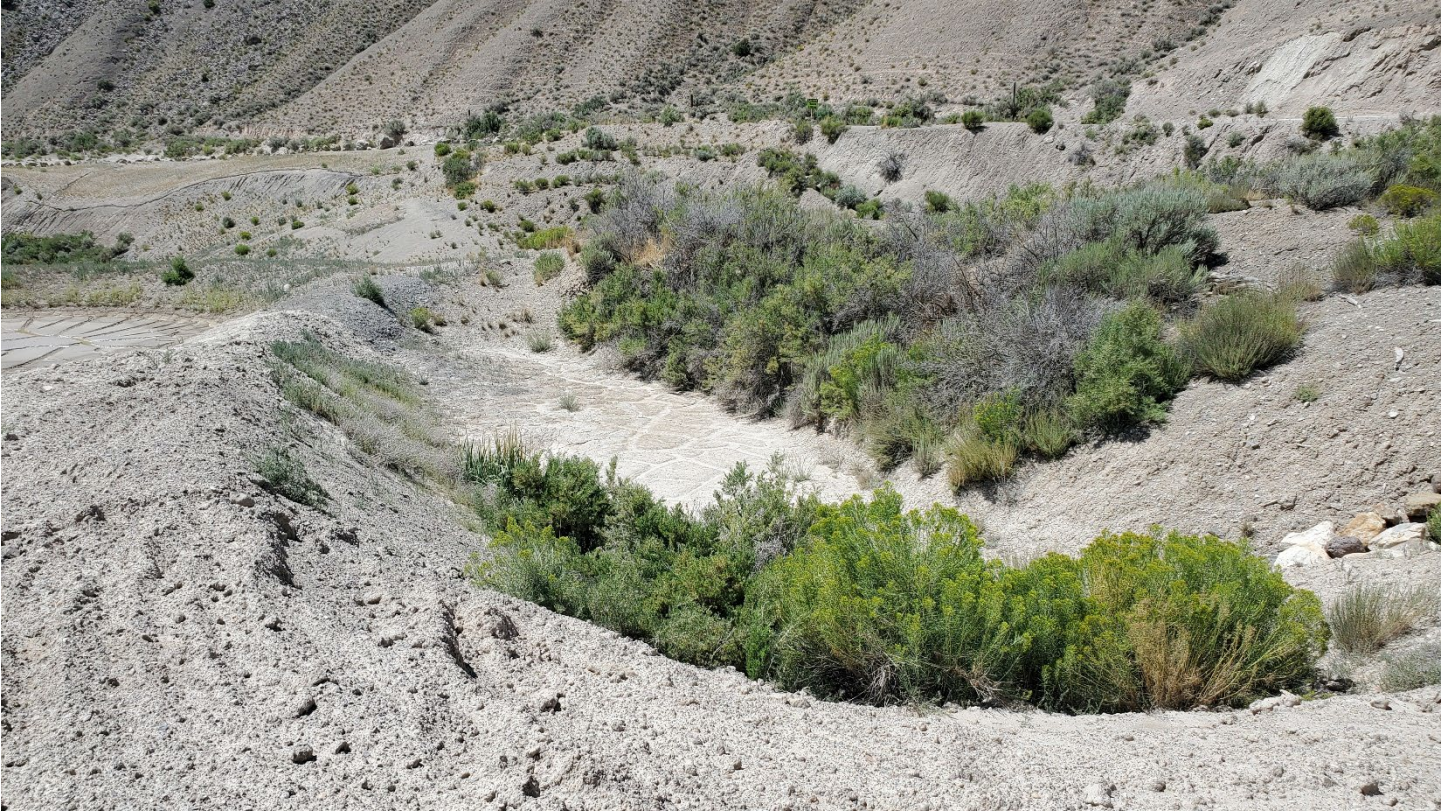
Figure 5: Lower of two sumps for Ore Storage Area, no discharge, (c)

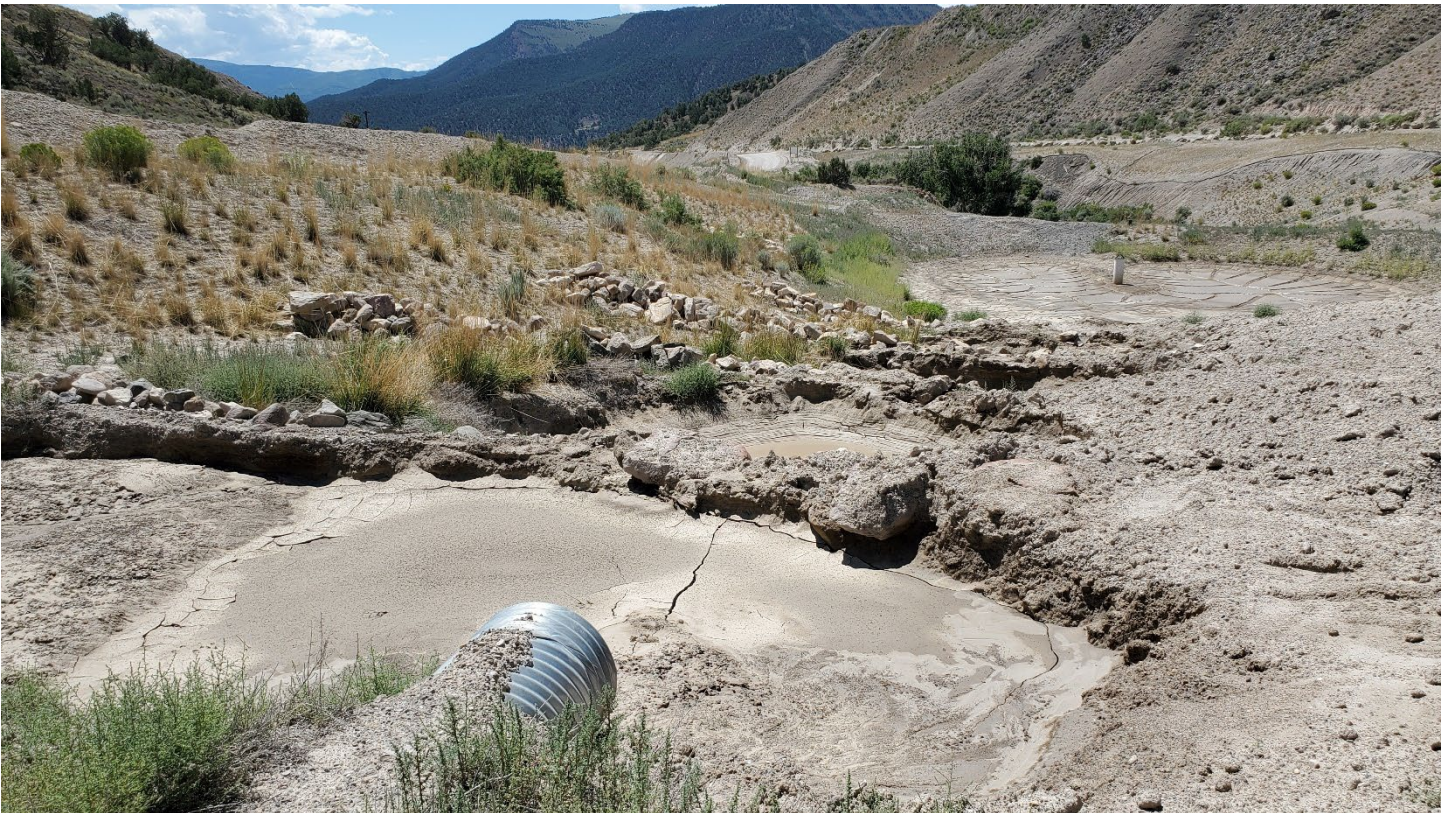
Figure 6: Sediment pond 1 north, (d)

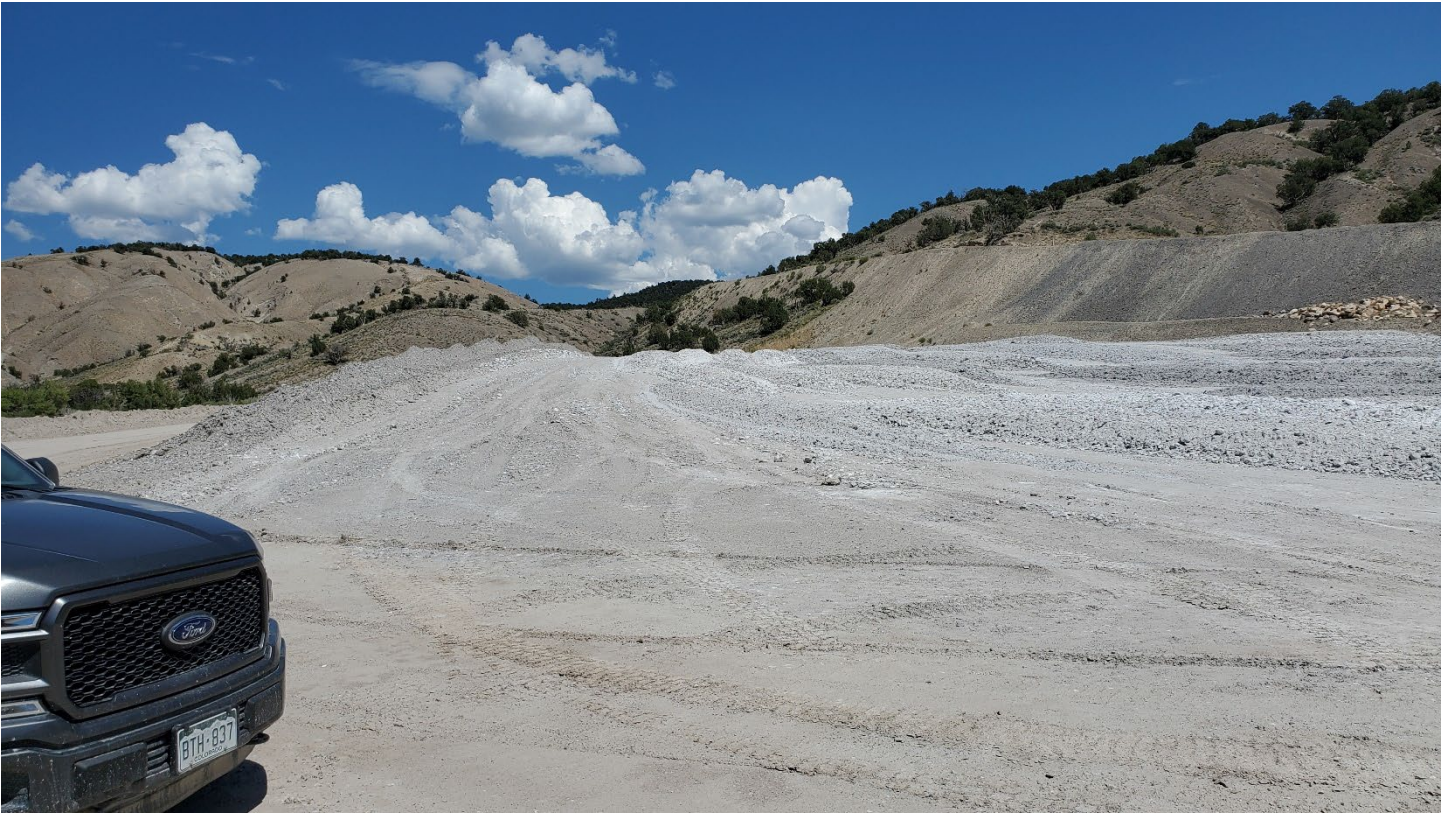
Figure 7: Ore Storage Area. Contains enough material for ~2 weeks, around 24,000 tons. No discharge, (e)

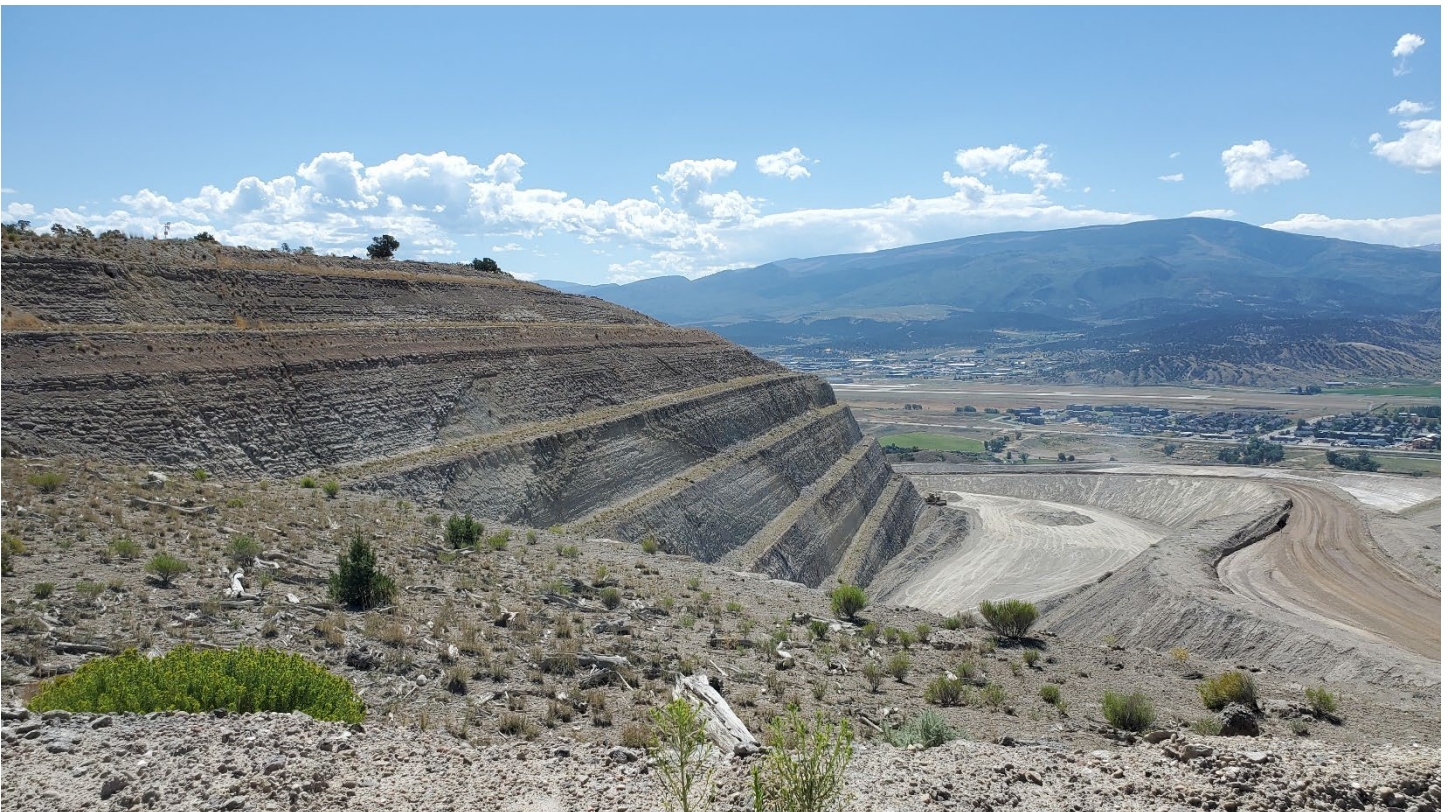
The existing haul road to the Lower Pit was in use for the transportation of material, but, to the east, a new haul road which will replace it was under construction. The mine plan calls for the lower (southern) section of the existing haul road to be mined through and for the upper (northern) section to be backfilled, (see Figures 2 and 8).

Figure 8: Lower Pit North - mined out, (f). Upper section of new haul road on right side of picture.

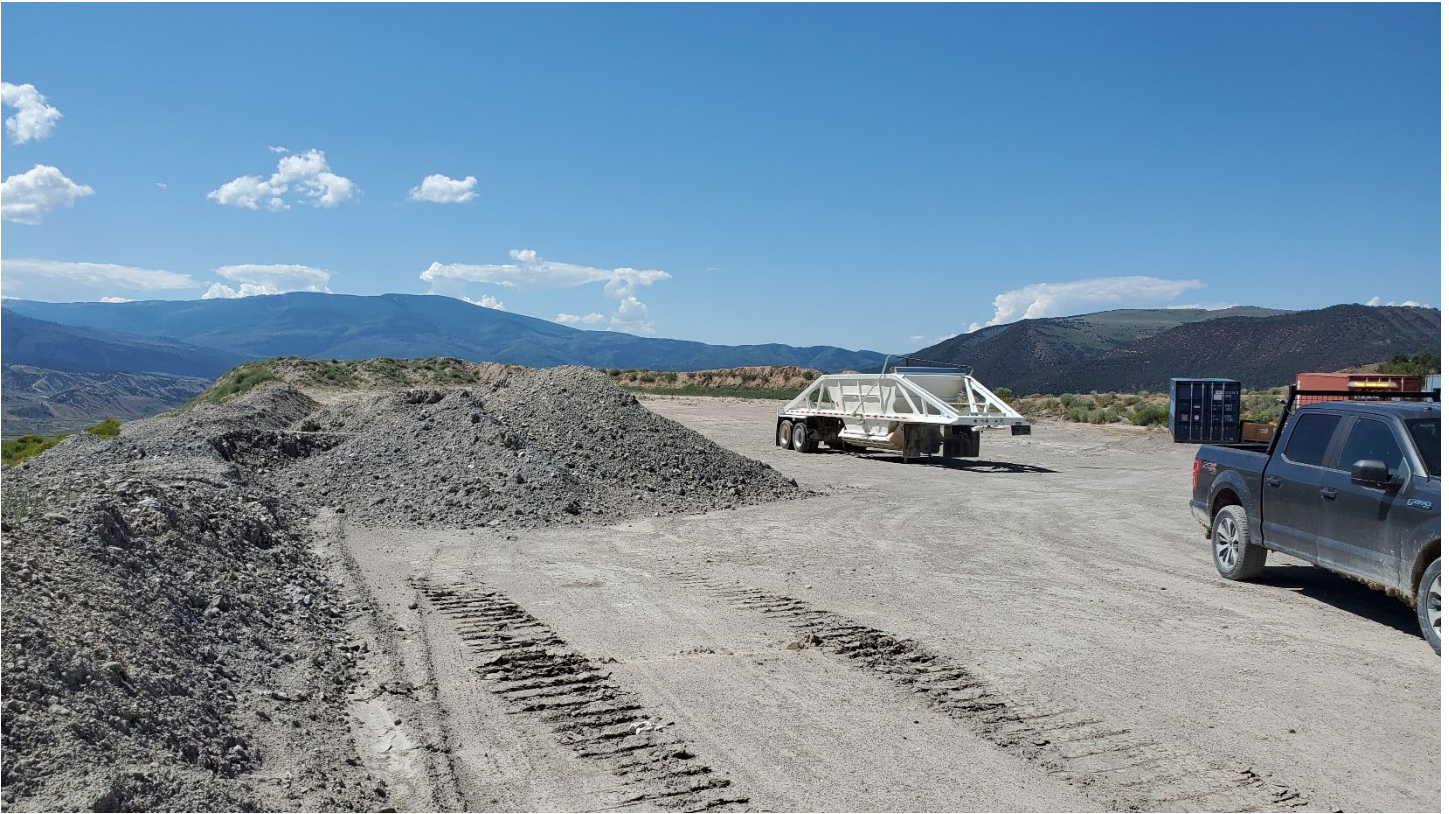
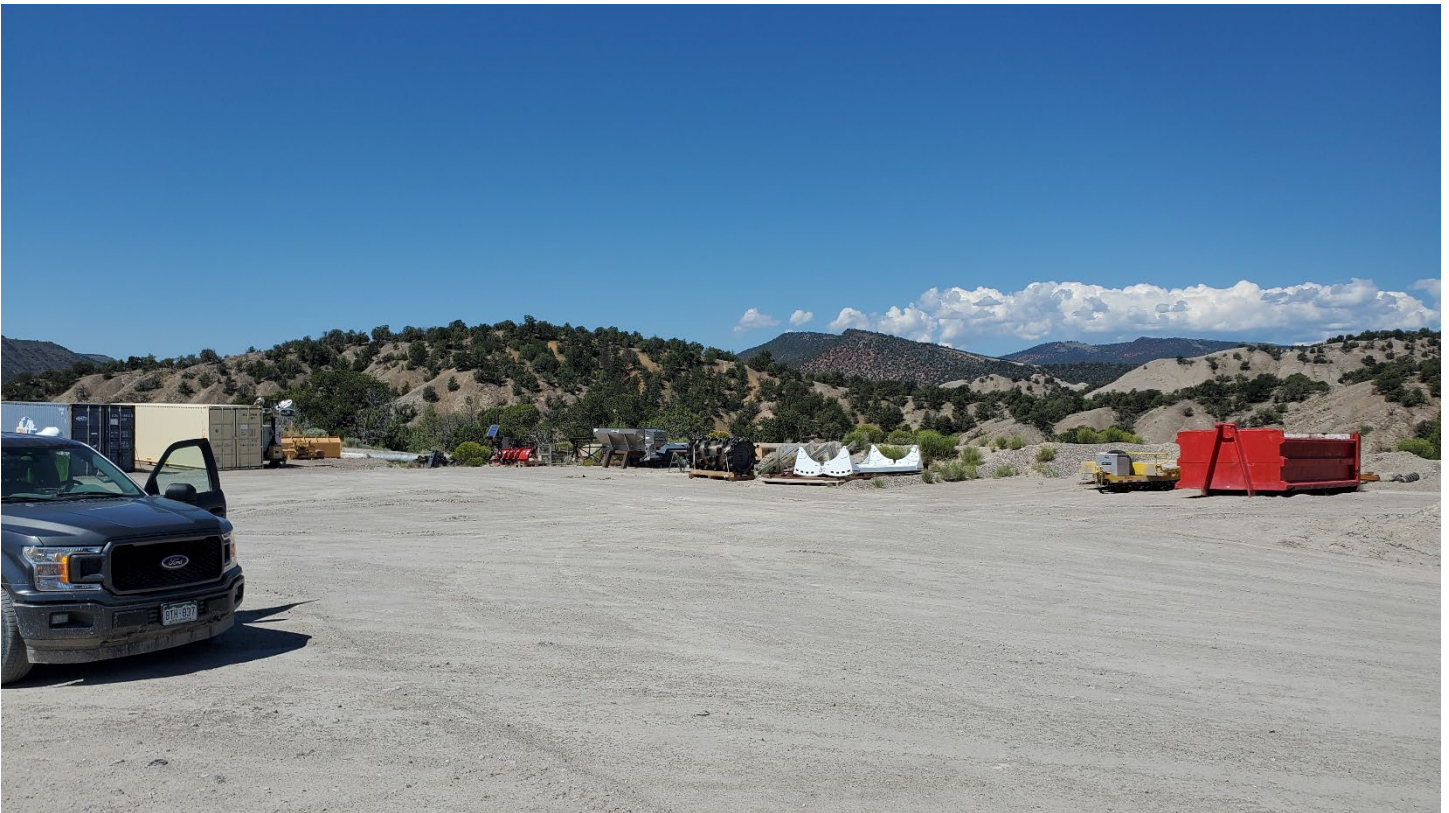
Figure 9: Upper waste rock dump, parts and equipment storage, (g) (1 of 2)

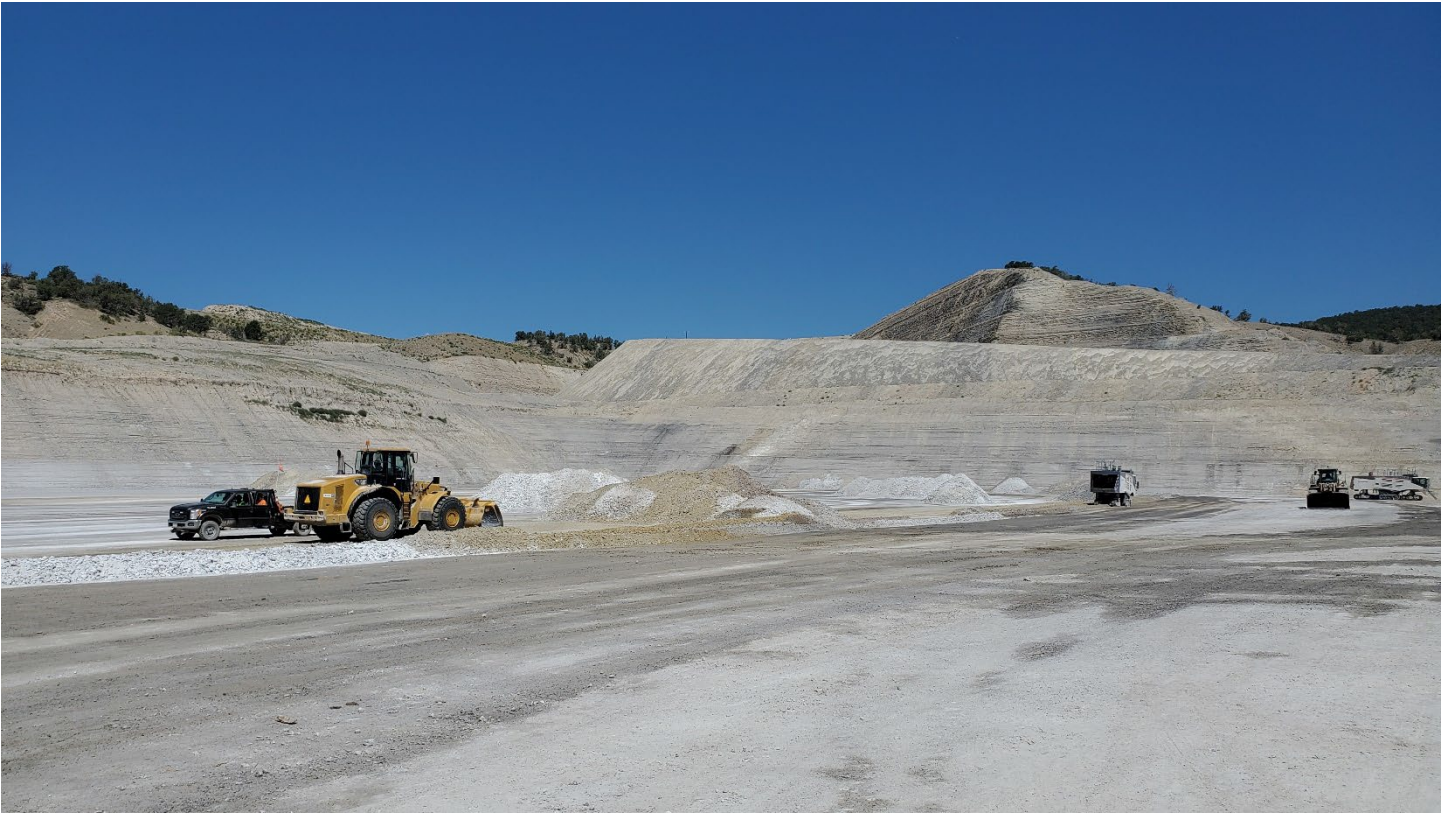
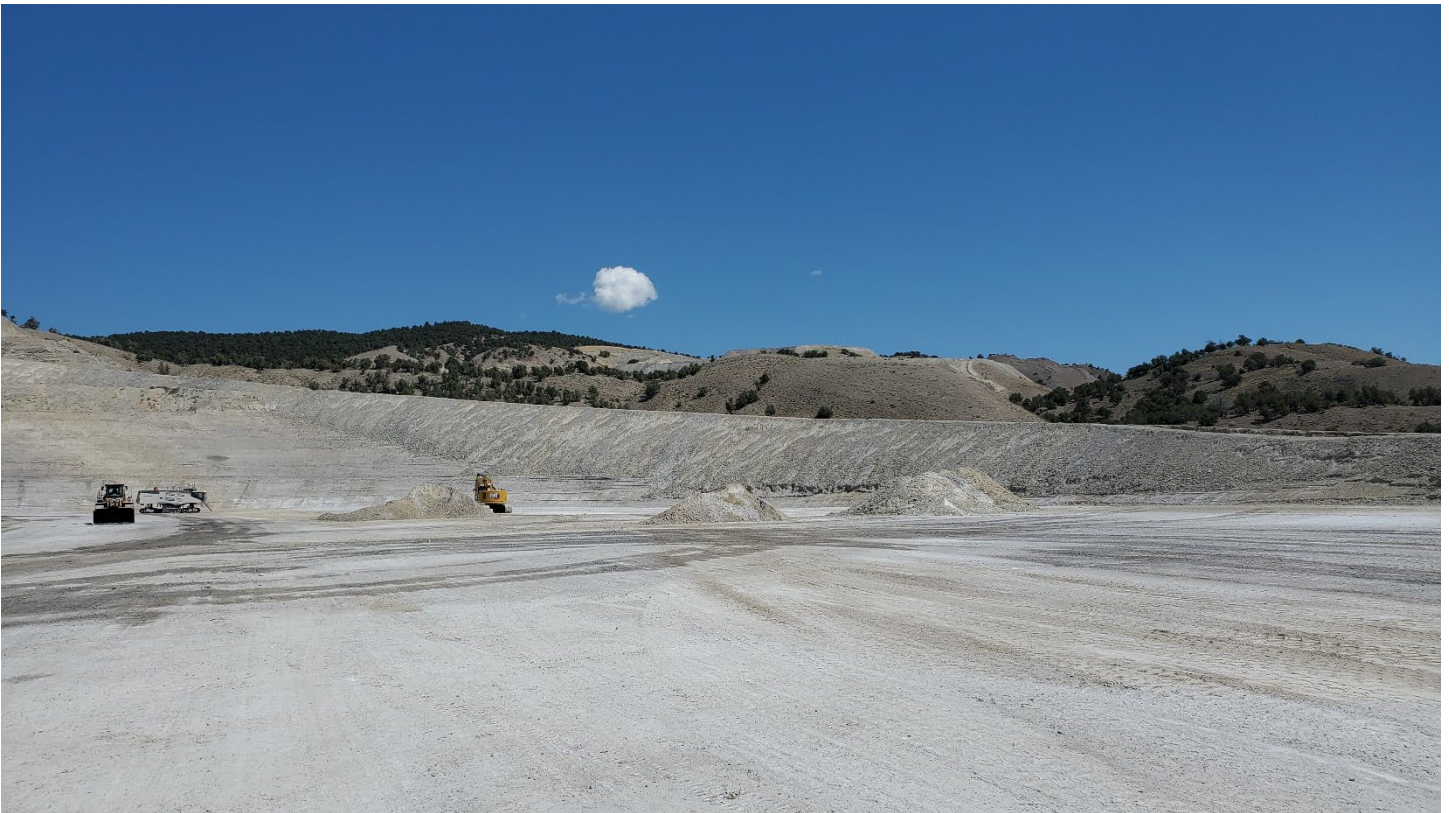
Figure 11: Mining in progress, Lower pit, (h)

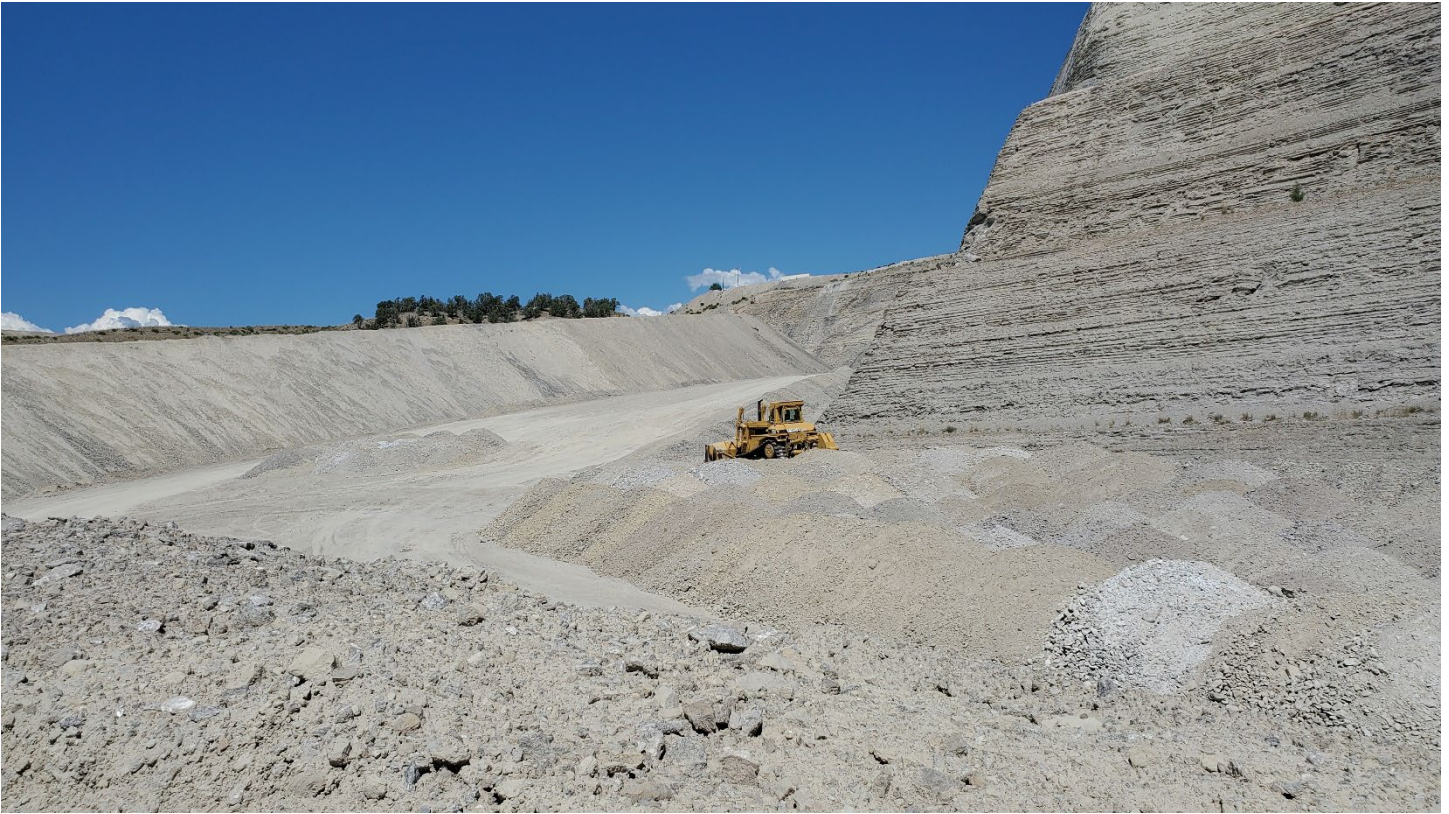
Mr Edeen estimated that the Lower Pit will be mined for three more years, and the pit floor will be lowered by 30-50 ft. The approved reclamation plan is to backfill the pit wall to the ridge, with a maximum 3H:1V slope. Backfilling on the north east edge of the pit had begun and was currently in progress, (see Figure 13). It's possible that there will be a future project to explore the ridge to the east, although no exploration plan had yet been proposed.

Figure 13: Backfilling in progress, Lower pit, (i)

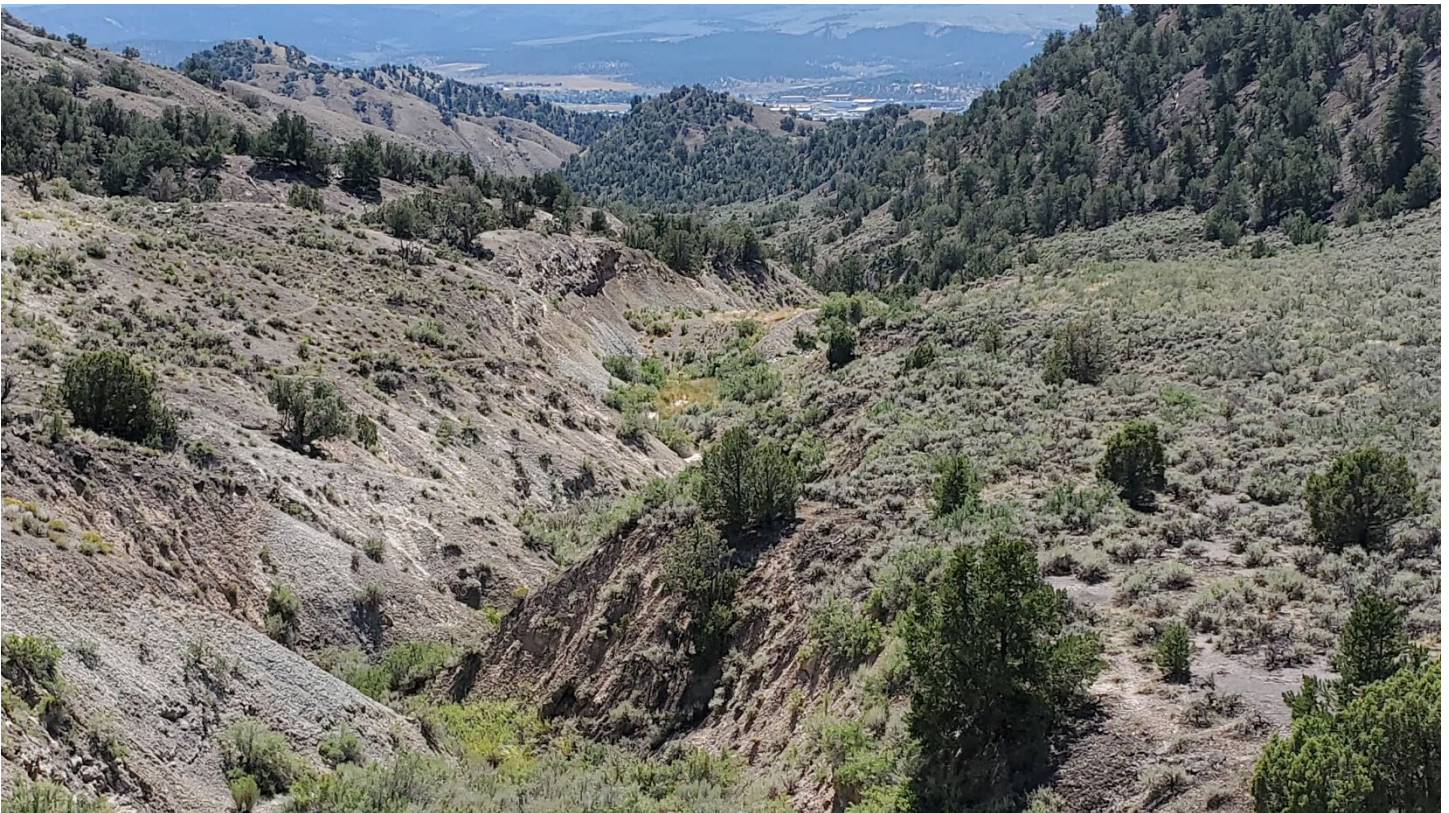
Figure 14: Sediment pond M201, (j)

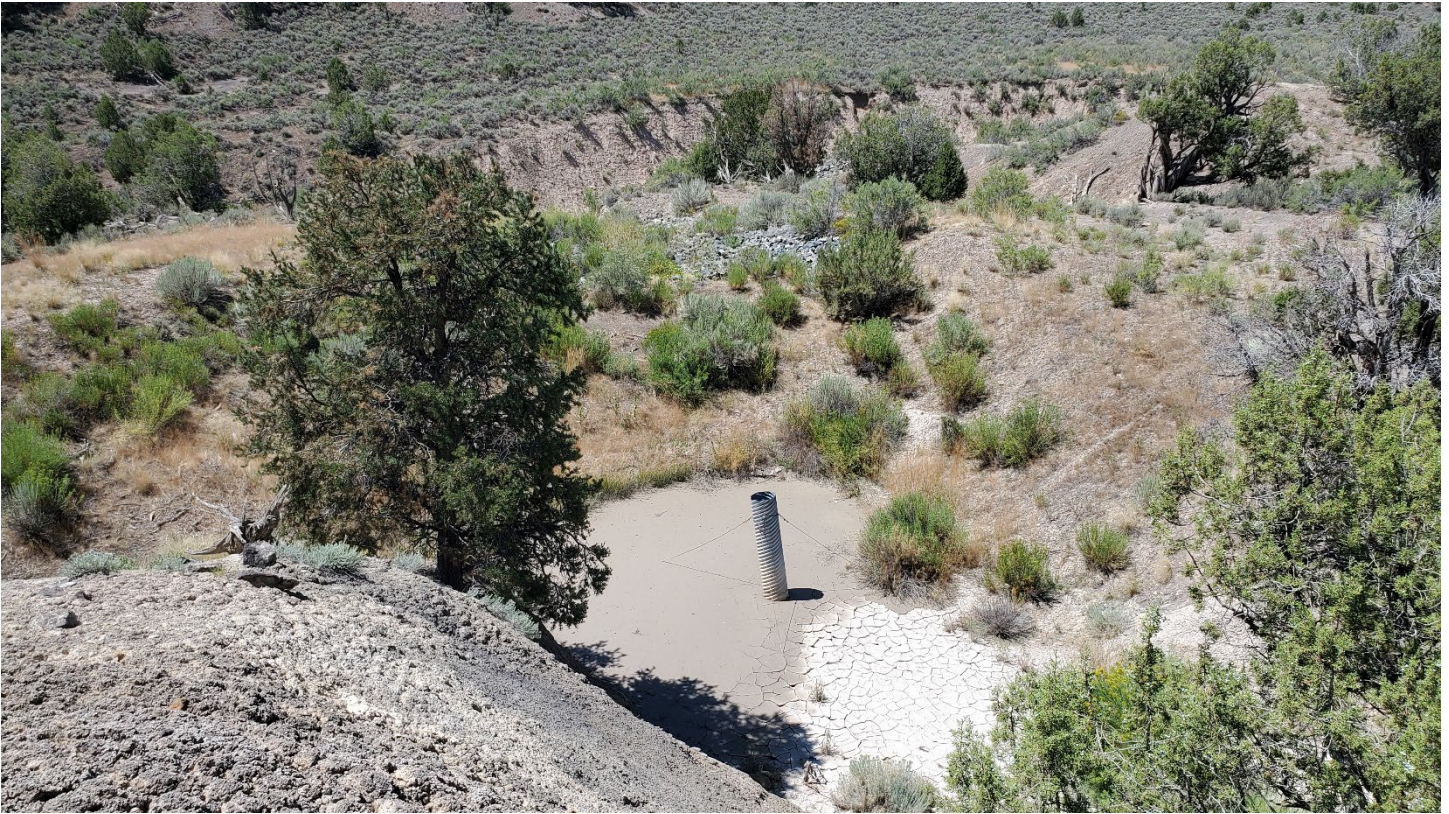
Figure 15: Sediment pond M301, (k)

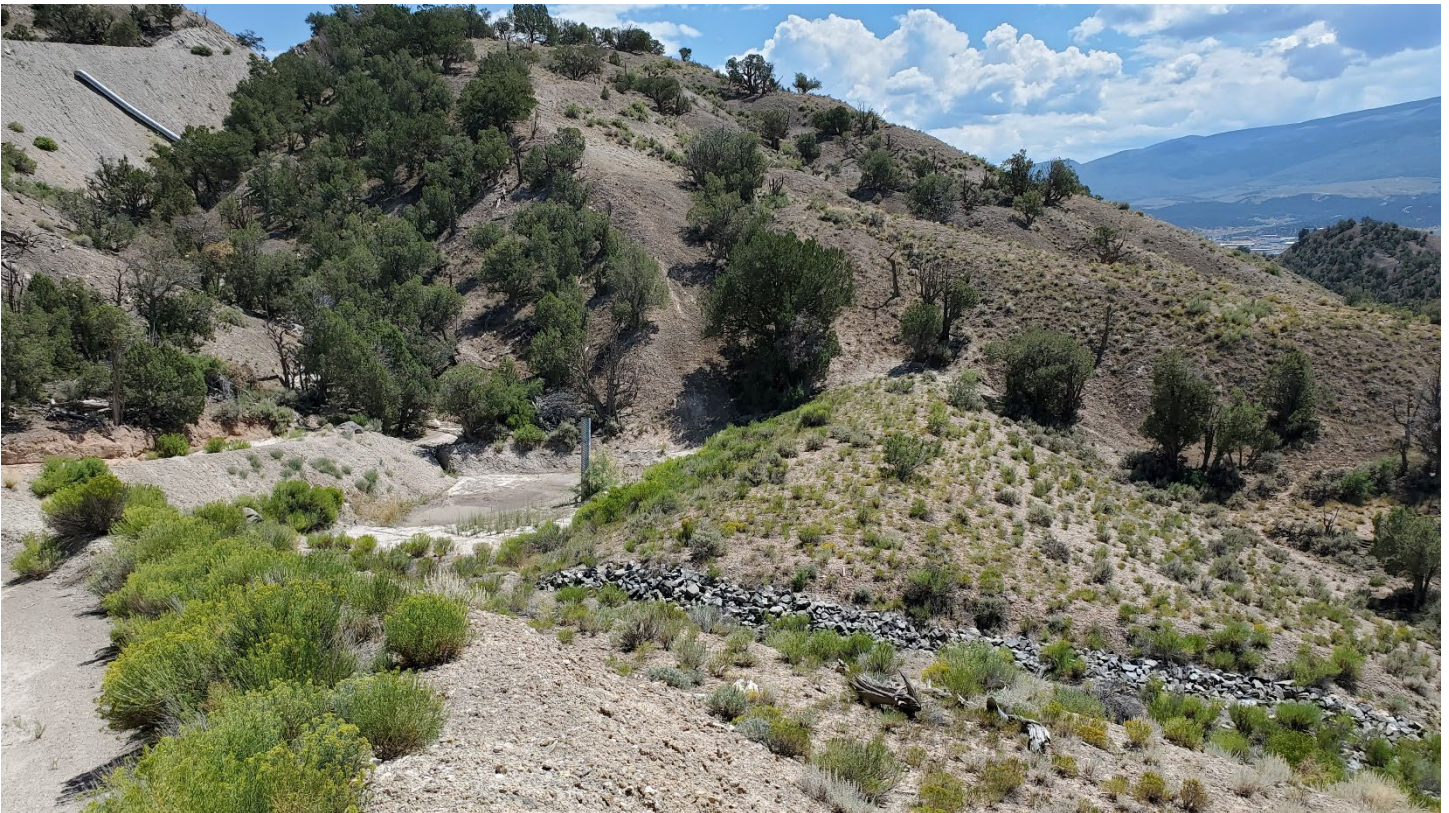
Figure 16: sediment pond M401, (l)

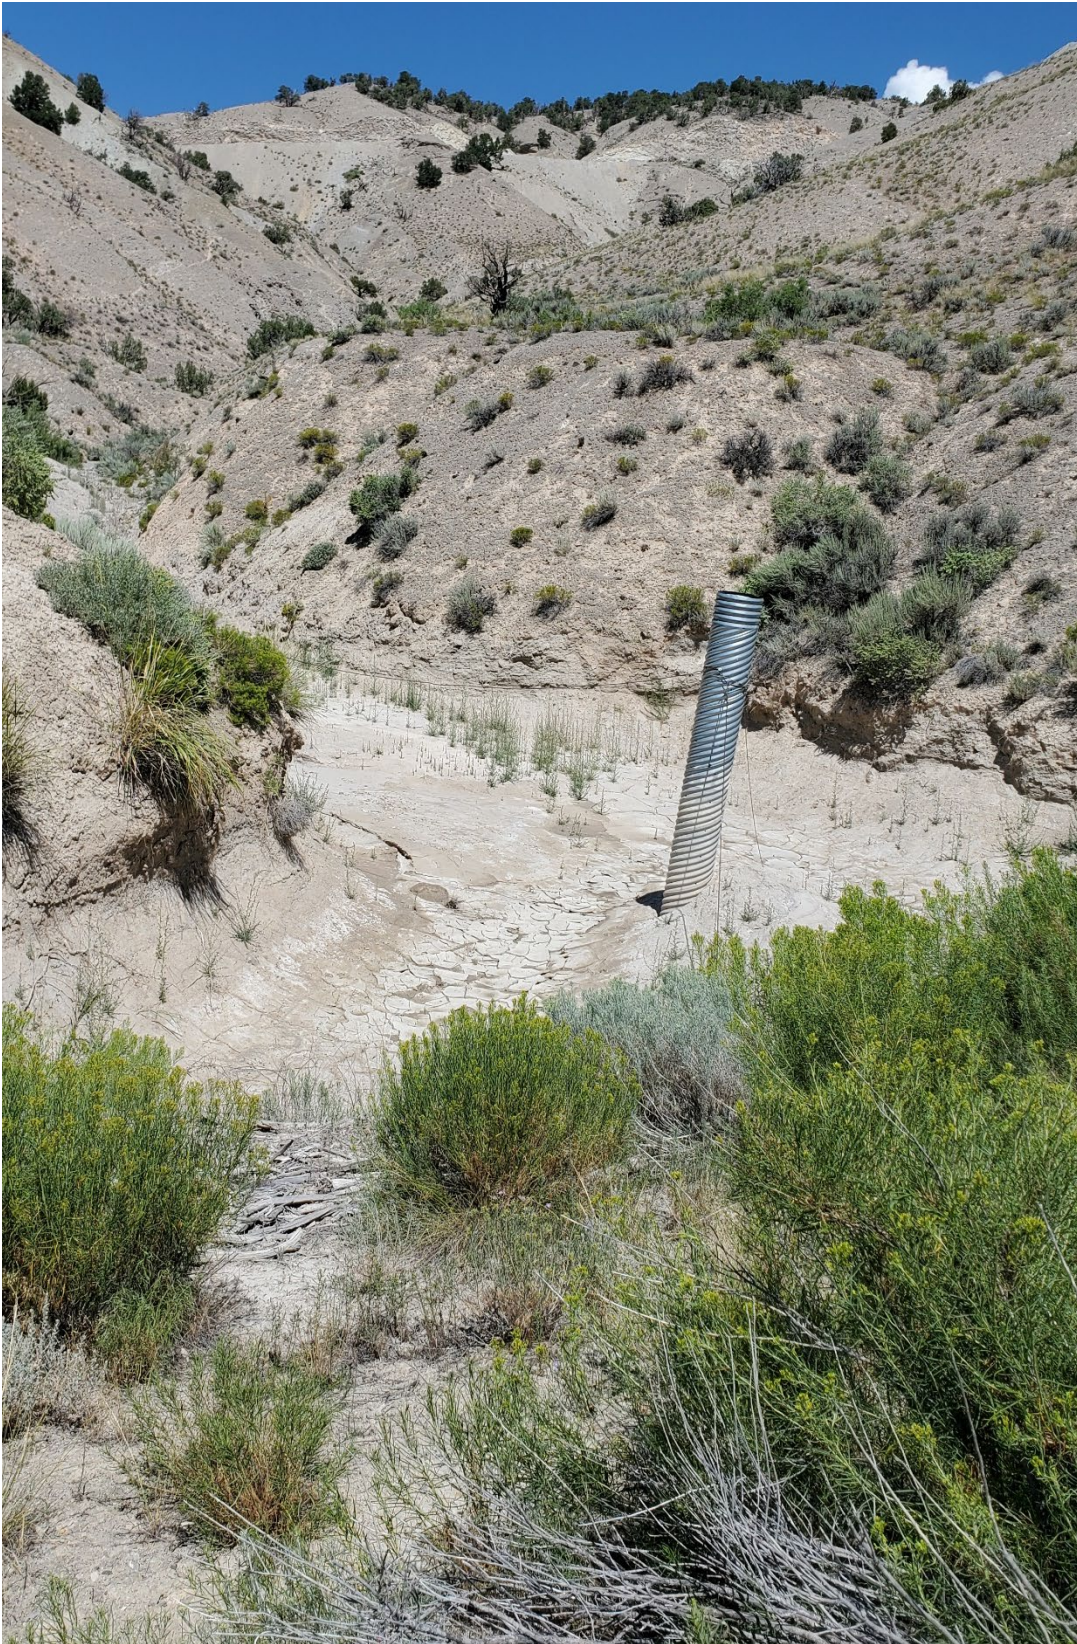
Figure 17: Sediment pond M501, cleaned out in 2020, (m)

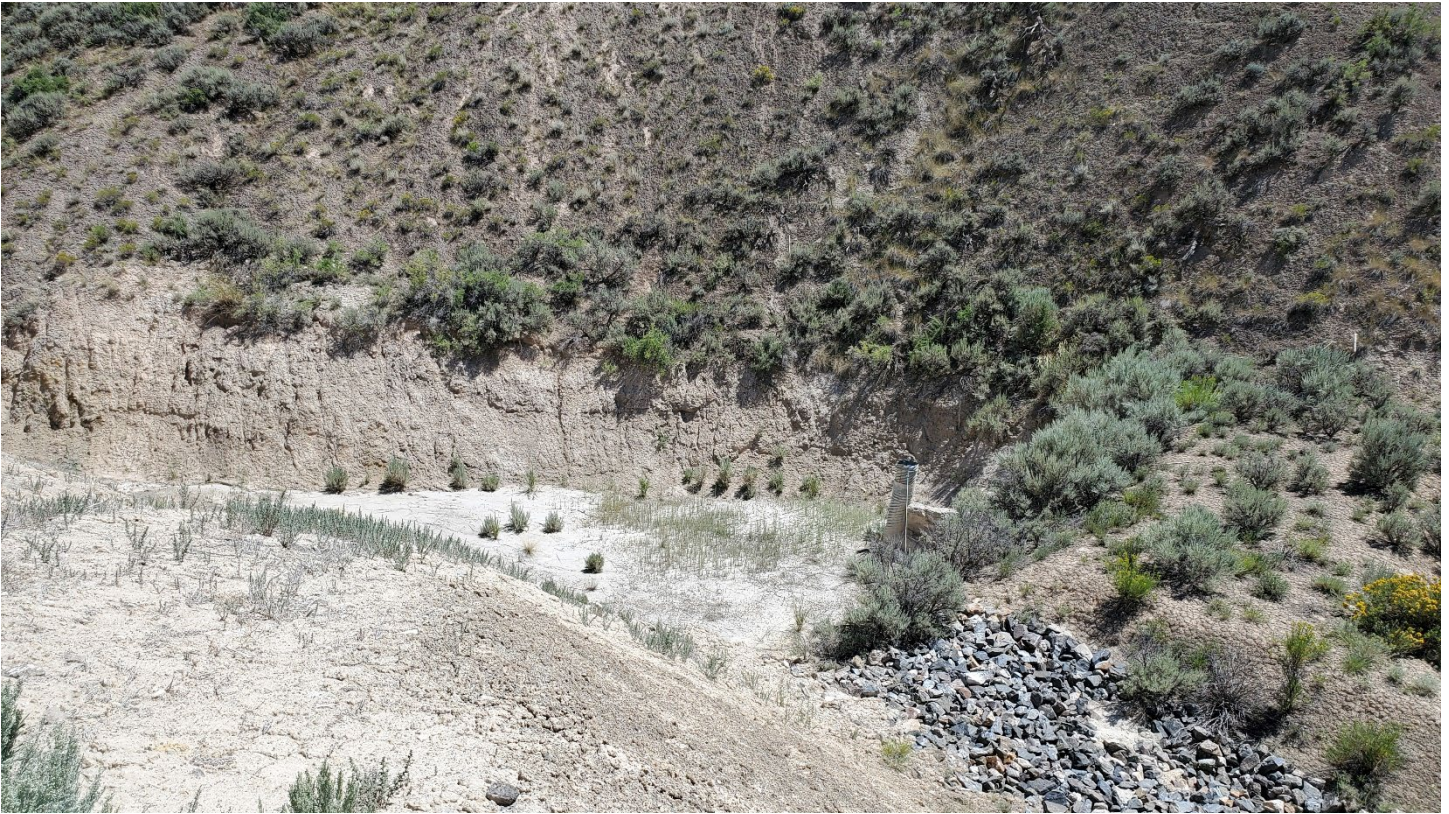
Figure 18: Sediment pond M601, made bigger with permitting of East Pit, (n)
