M1984041, Eagle-Gypsum Mine, August 2023 Inspection Report

MINERALS PROGRAM INSPECTION REPORT

MINE NAME: Eagle-Gypsum Mine	MINE/PROSPECTING ID#: M-1984-041	MINERAL: Anhydrite, gypsum	COUNTY: Eagle
INSPECTION TYPE: Monitoring	WEATHER: Clear	INSP. DATE: August 17, 2023	INSP. TIME: 10:30
OPERATOR: American Gypsum Company LLC	OPERATOR REPRESENTATIVE: Jon Edeen	TYPE OF OPERATION: 112c - Construction Regular Operation

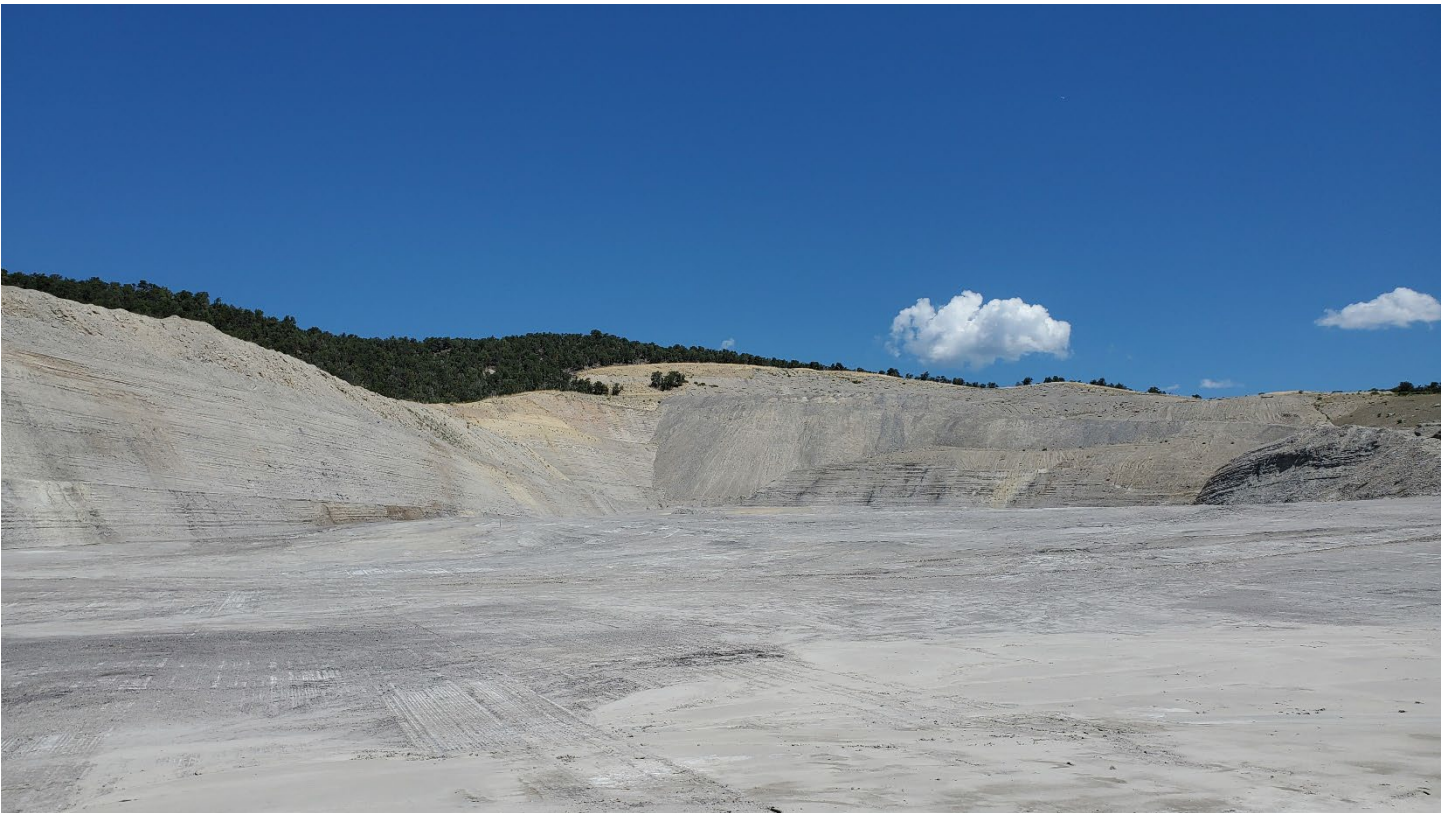
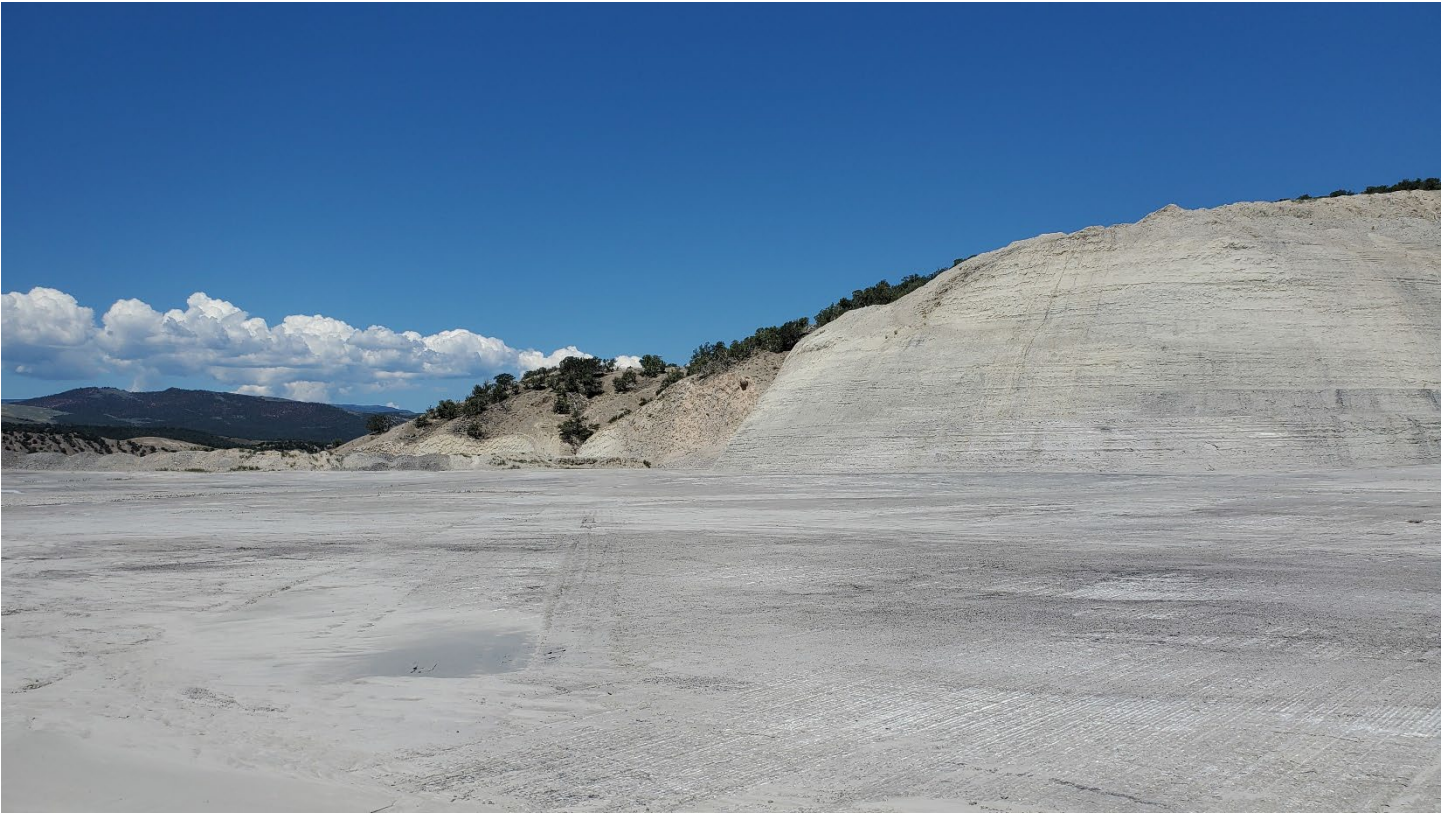
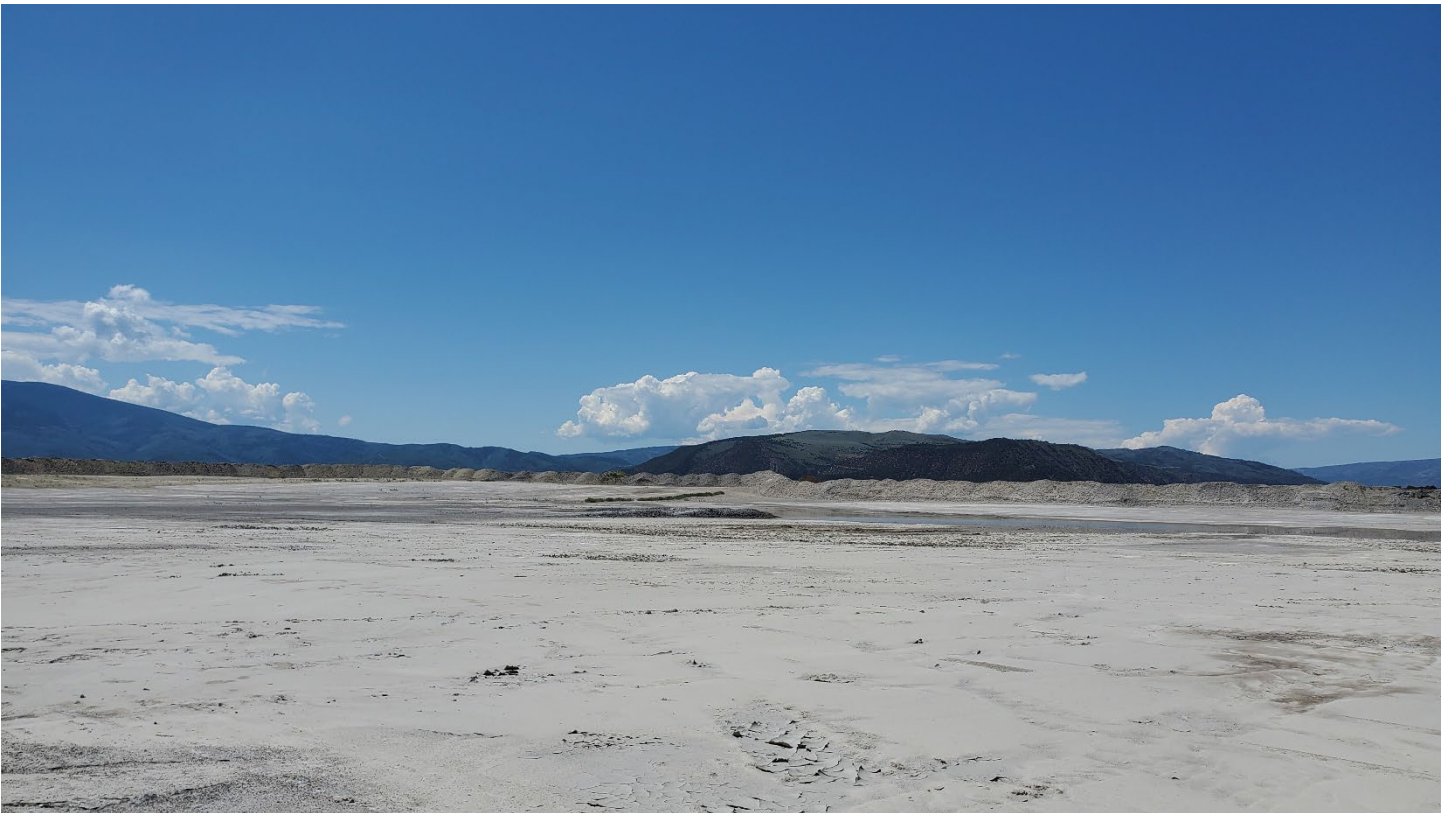
At the time of the inspection there was no activity in the Upper Pit, (see Figures 19-22). The currently approved plan calls for the pit floor to be lowered by 50-200 ft by future mining.

Figure 19: Upper Pit, (o) (1 of 3)

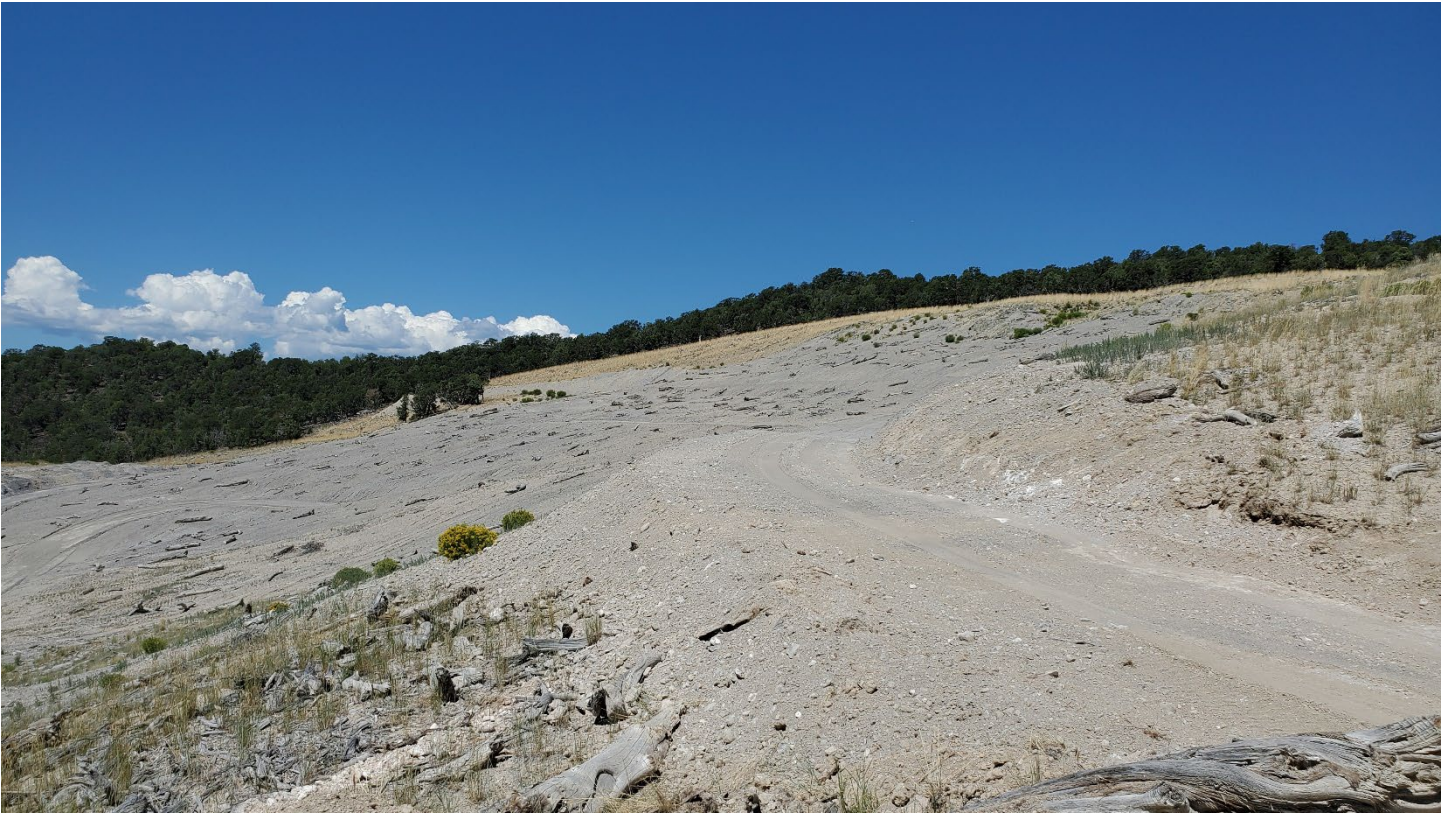
Figure 22: Reclaimed area north of Upper Pit. Bare area was regraded to reduce steepness at BLM request. Will be hydro-seeded again in autumn, (p)

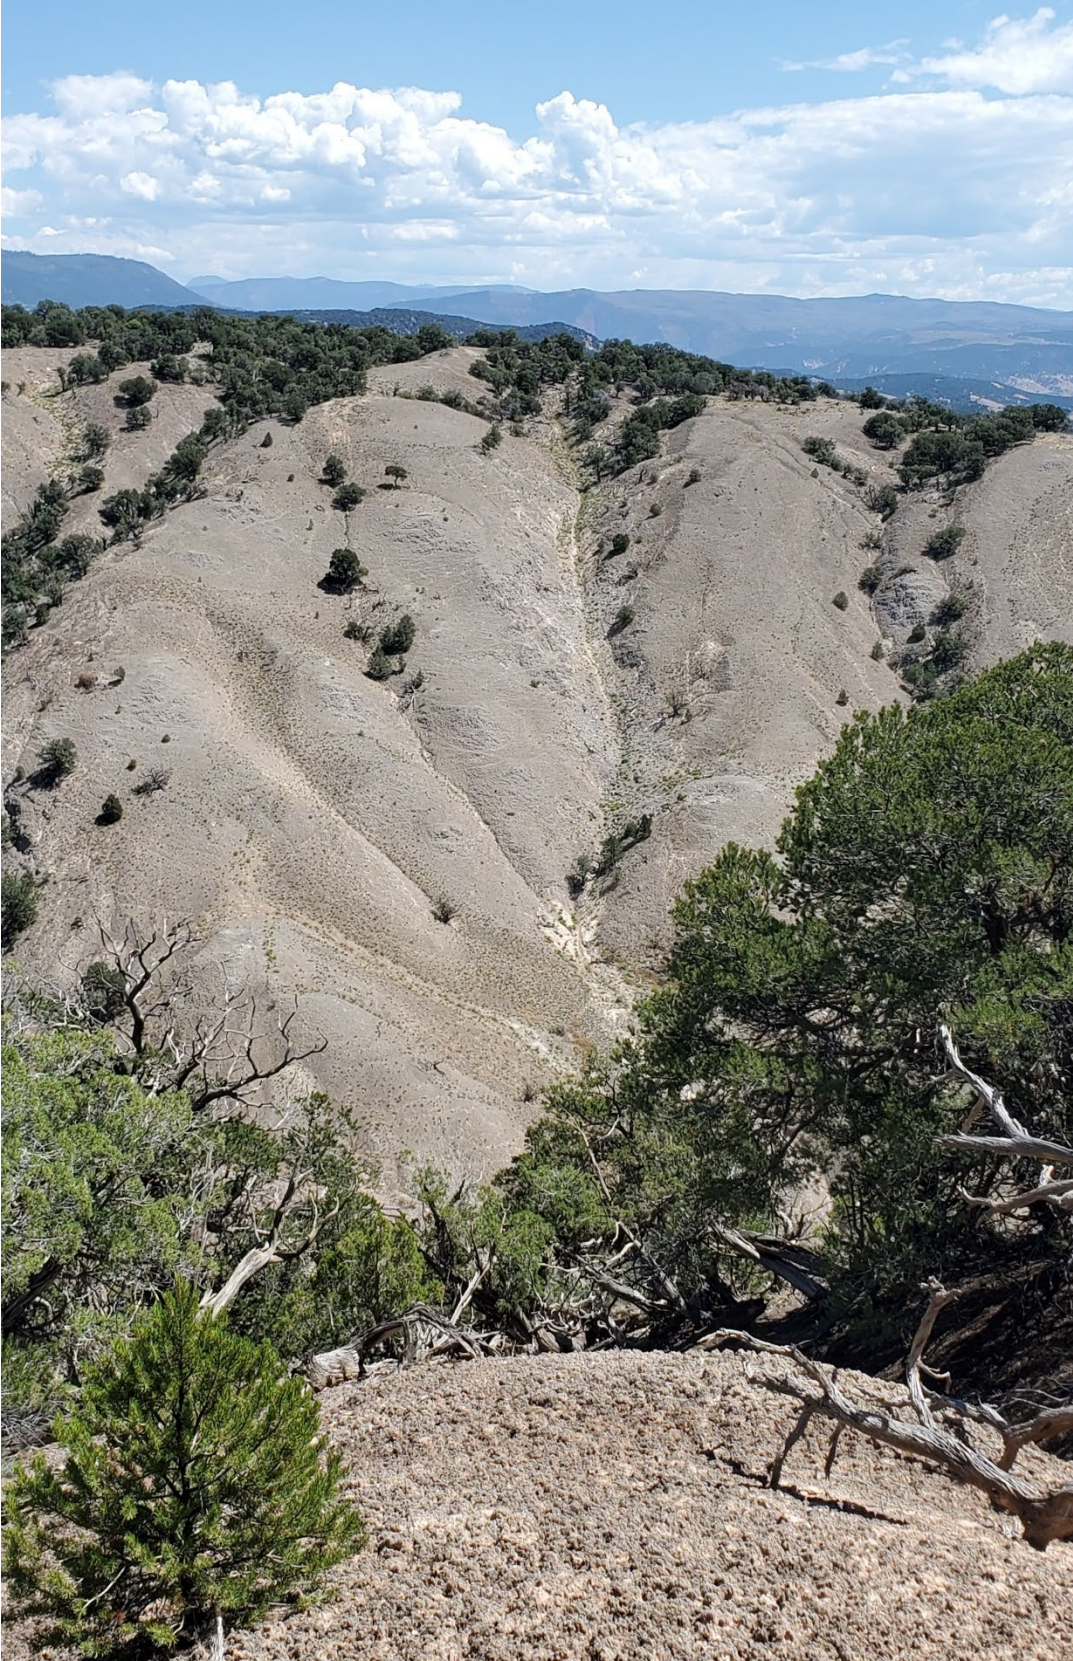
Reclamation of the Beaver Slide was viewed from across the drainage. The area had been disturbed for exploration drilling in 2016. Although most of the bond for the exploration had been released some was still held for this drainage, at the request of the BLM. Mr Edeen had made check dams and broadcast seed in 2019/20. At the time of the inspection the reclaimed area appeared to blend in well with the surroundings, (see Figure 23).

Figure 23: Beaver Slide from across drainage (q)

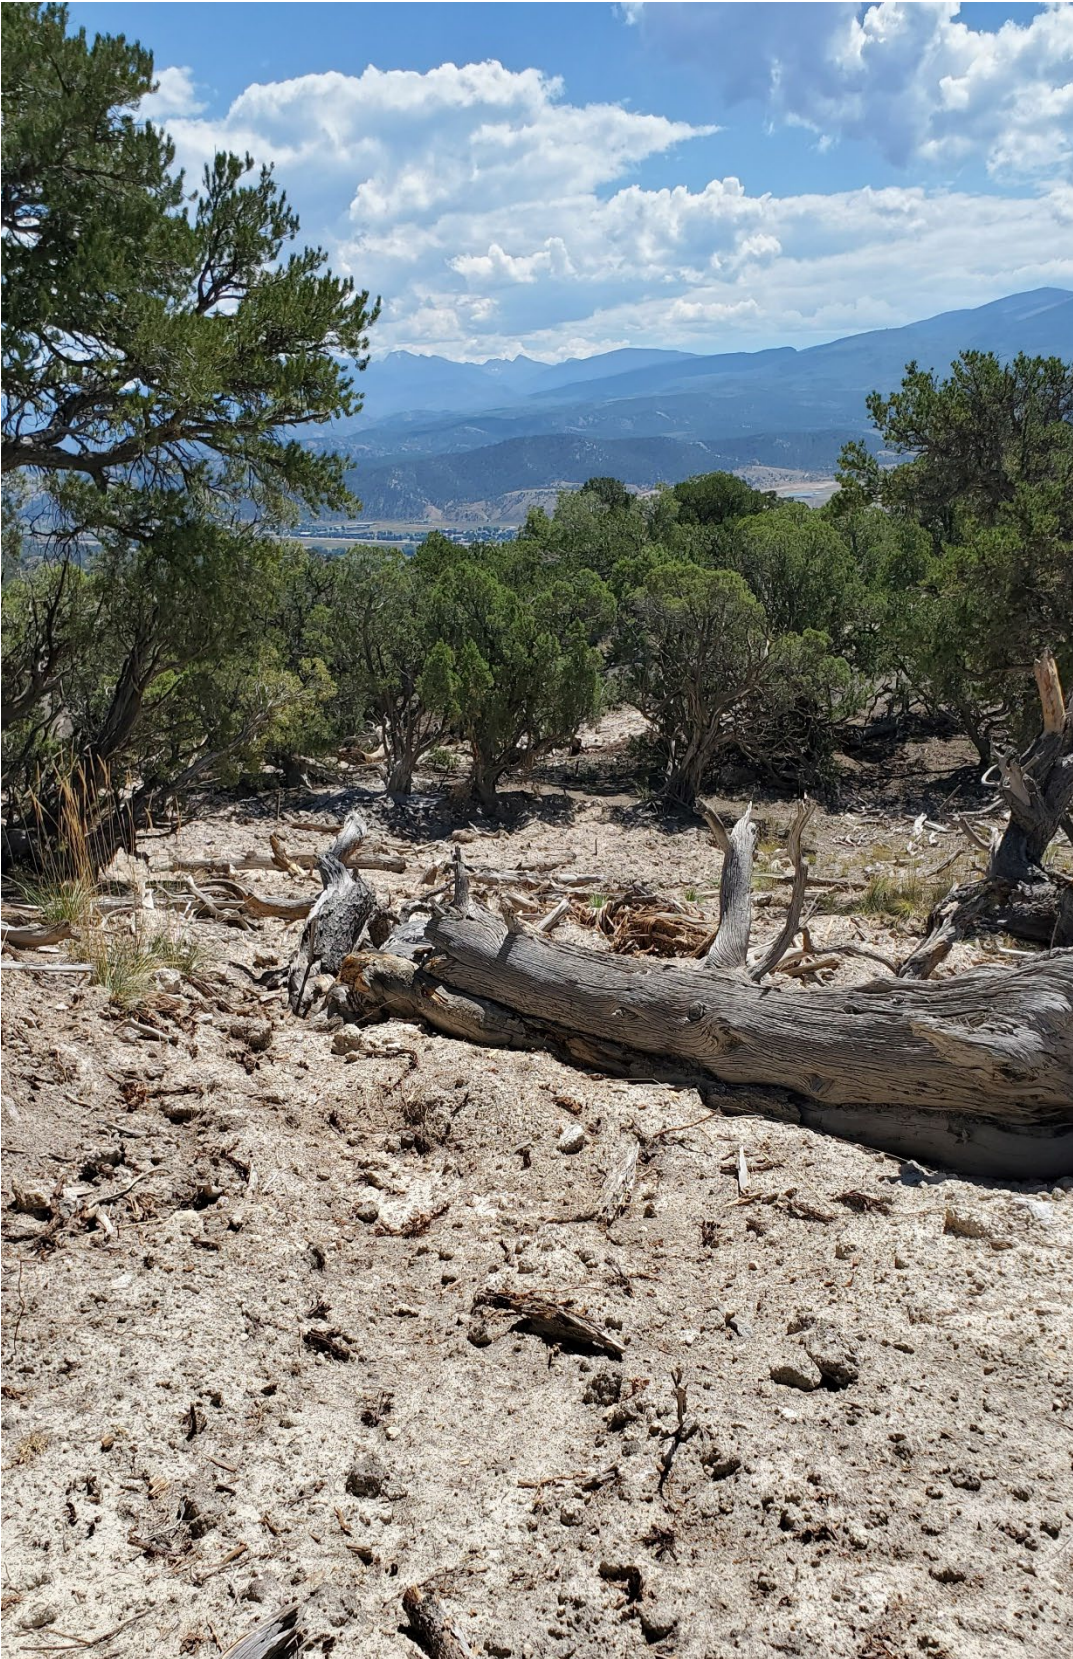
No vegetation had yet germinated on a reclaimed section of exploration road, (see Figure 24).

Figure 24: Reclaimed exploration road, (r)
