MINERALS PROGRAM INSPECTION REPORT

MINE NAME: Weathers Mine #1	MINE/PROSPECTING ID#: M-1999-089	MINERAL: Borrow material for construction, Sand, Clay	COUNTY: Yuma
INSPECTION TYPE: Monitoring	WEATHER: Clear	INSP. DATE: August 31, 2023	INSP. TIME: 14:00
OPERATOR: Byron J. & LaLani R. Weathers	OPERATOR REPRESENTATIVE: Bryon Weathers	TYPE OF OPERATION: 110c - Construction Limited Impact	
REASON FOR INSPECTION: Normal I&E Program	BOND CALCULATION TYPE: Complete Bond	BOND AMOUNT: \$22,000.00	
DATE OF COMPLAINT: NA	POST INSP. CONTACTS: None	JOINT INSP. AGENCY: None	
INSPECTOR(S): Nikie Gagnon	INSPECTOR'S SIGNATURE:

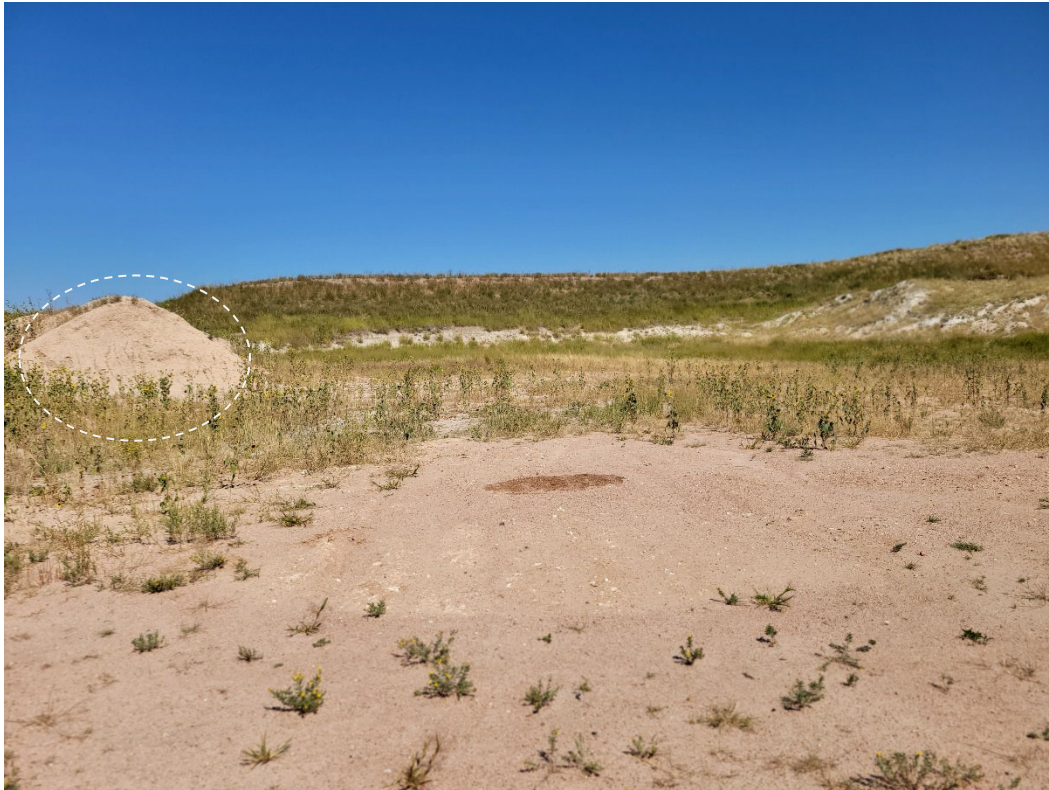
Photo 1: Looking northeast into the east side pit. Topsoil is stored above the pit on the northern and eastern sides. Stockpile of material in the pit (circled).

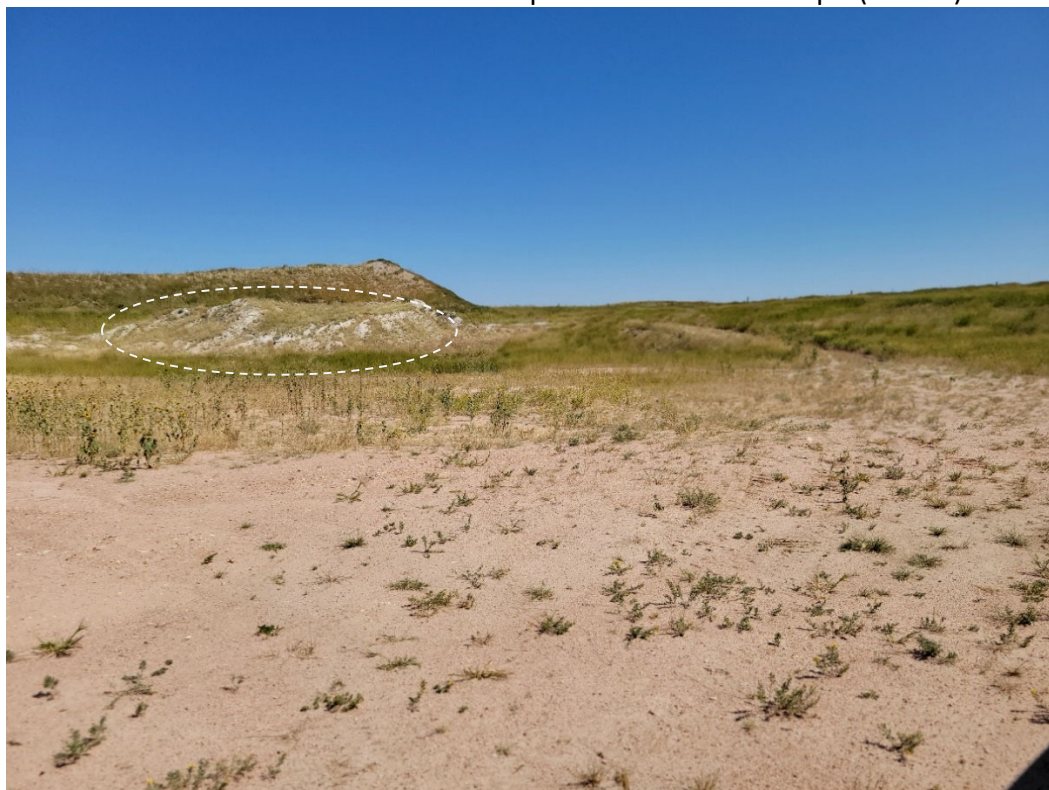
Photo 2: Looking east at the east pit. Stockpiled overburden at the base of the eastern wall (circled)

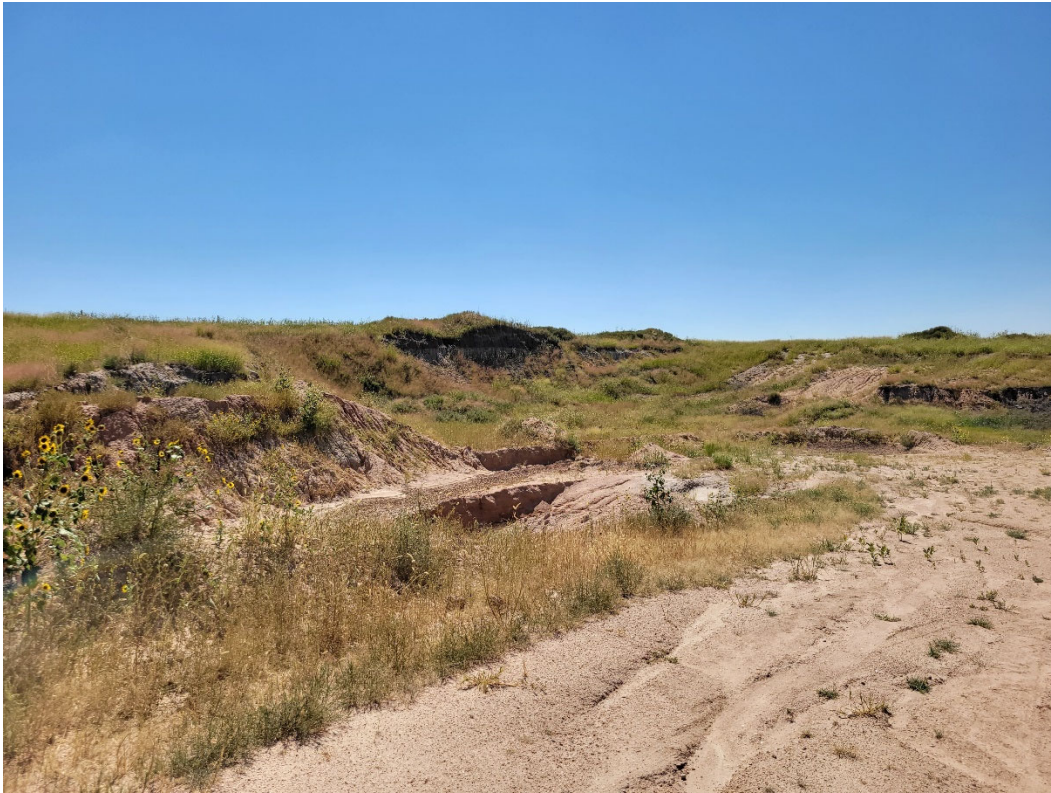
Photo 3: Looking west into the west side pit

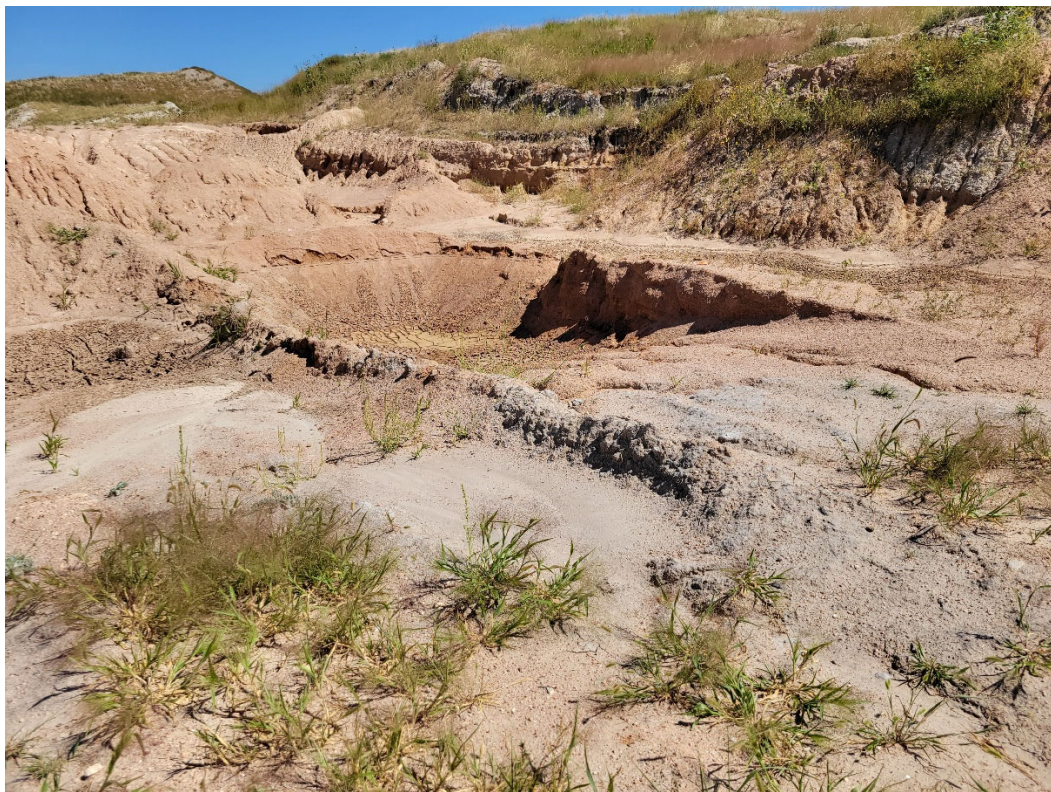
On the west side, the pit floor and the deeper excavated pits appear to be collecting storm water. Soil cracks were evident in two areas and several inches of water was observed below the northern highwall in the northeast corner in an excavated pit. Based on the color of the water, and staining of the pit walls above the water indicating the water was higher at one point in time, stormwater is not draining quickly. Additionally, Google imagery from 08/2022 and 09/2023 shows standing water in both the east and west mining areas.

Photo 4: Looking southeast at a pit excavated in the west side. Soil evidence of previous standing water in the pit.

CORRECTIVE ACTIONS: By the corrective action due date, the operator shall submit photo evidence demonstrating that appropriate grading and/or removal of impediments to proper surface drainage have been achieved to prevent the continued impoundment of surface water. Alternatively, the operator shall provide evidence that measures are being taken (e.g., application for a substitute water supply plan) to gain compliance with DWR for the impounded water at the site.

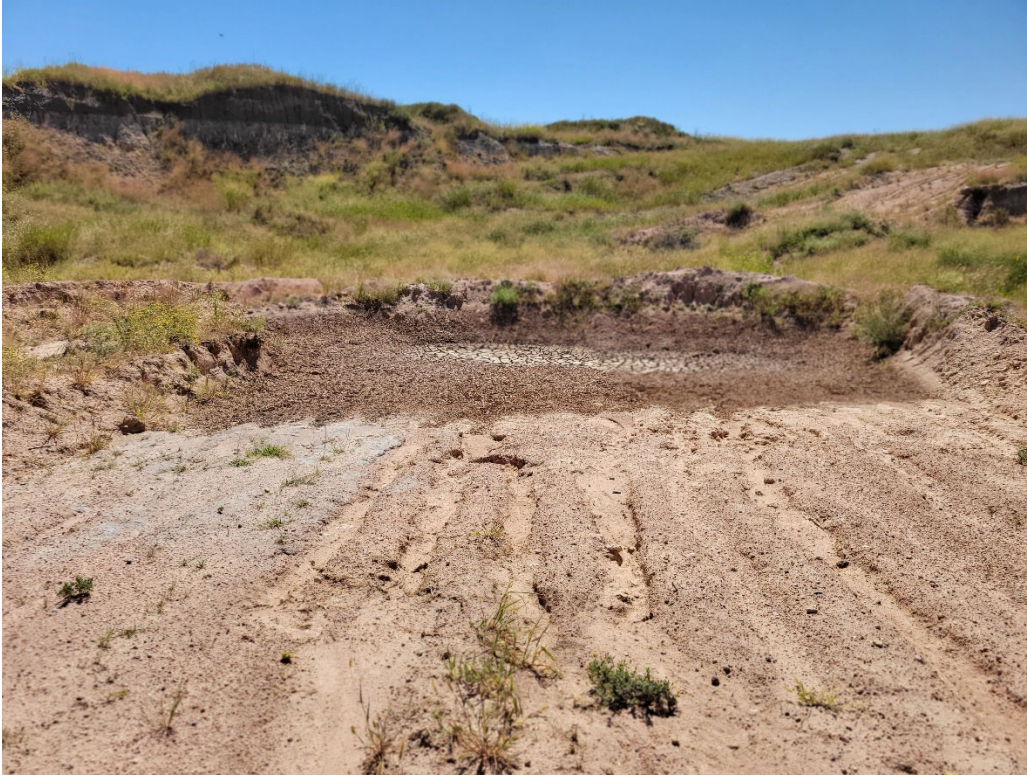
Photo 5: Looking west below the u-shaped highwall in the west mining area. Soil evidence of previous standing water.

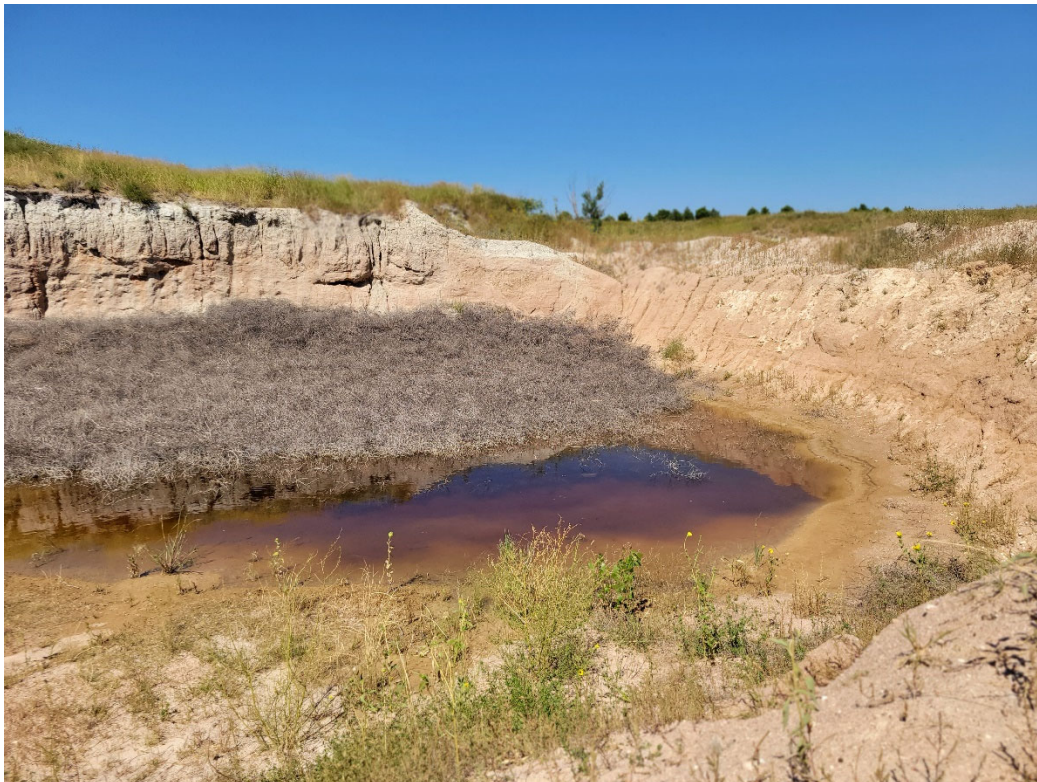
PROBLEM/POSSIBLE VIOLATION: Problem #1: The site is improperly impounding surface drainage/runoff. This is a problem related to C.R.S. 34-32.5-116(4)(h) and Rule 3.1.6(1)(a) governing injury to existing water rights. The Division of Water Resources (DWR) requires that any stormwater runoff intercepted by this operation that is not diverted or captured in priority must infiltrate into the ground or be released to the stream system within 72 hours; otherwise the operator will need to make replacements for evaporation through a substitute water supply plan approved by DWR or a plan for augmentation decreed by the water court.

Photo 6: Looking north, excavation in the northeast corner of the west area. Standing water and tumbleweeds accumulating here.

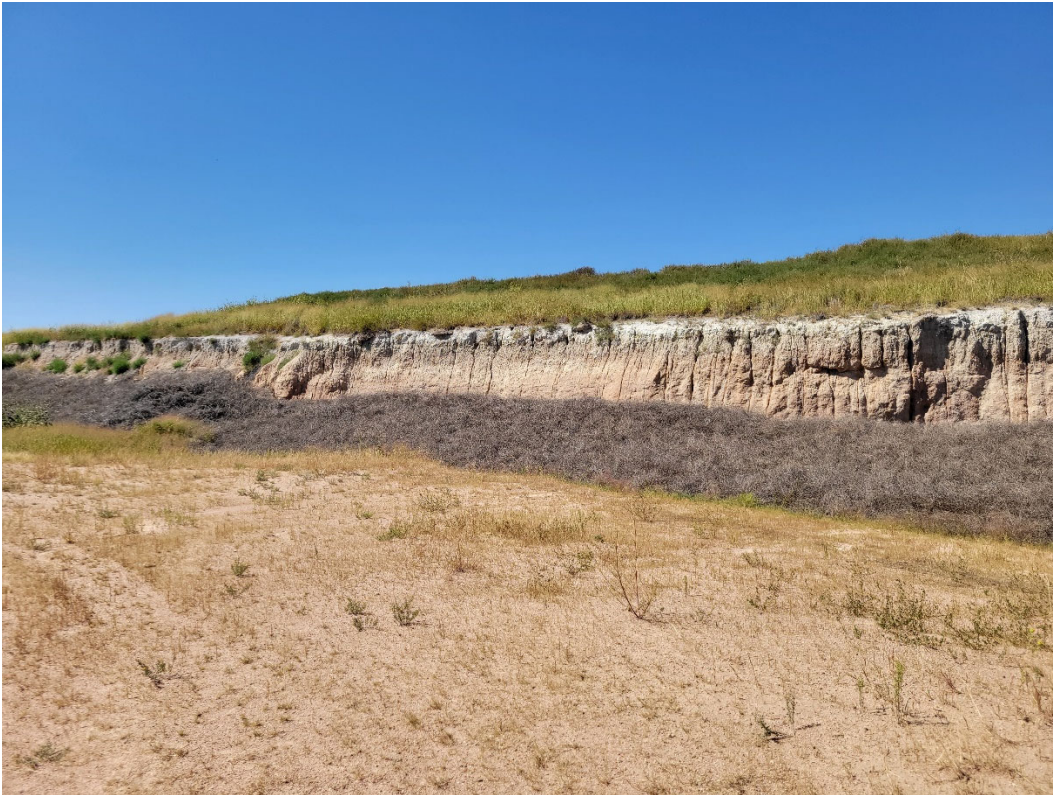
Photo 7: Looking north at highwall in the west area. Topsoil stored in berm above the pit. Tumble weeds accumulating at the base of the pit. Drainage flows to the east and is trapped in the pit area.

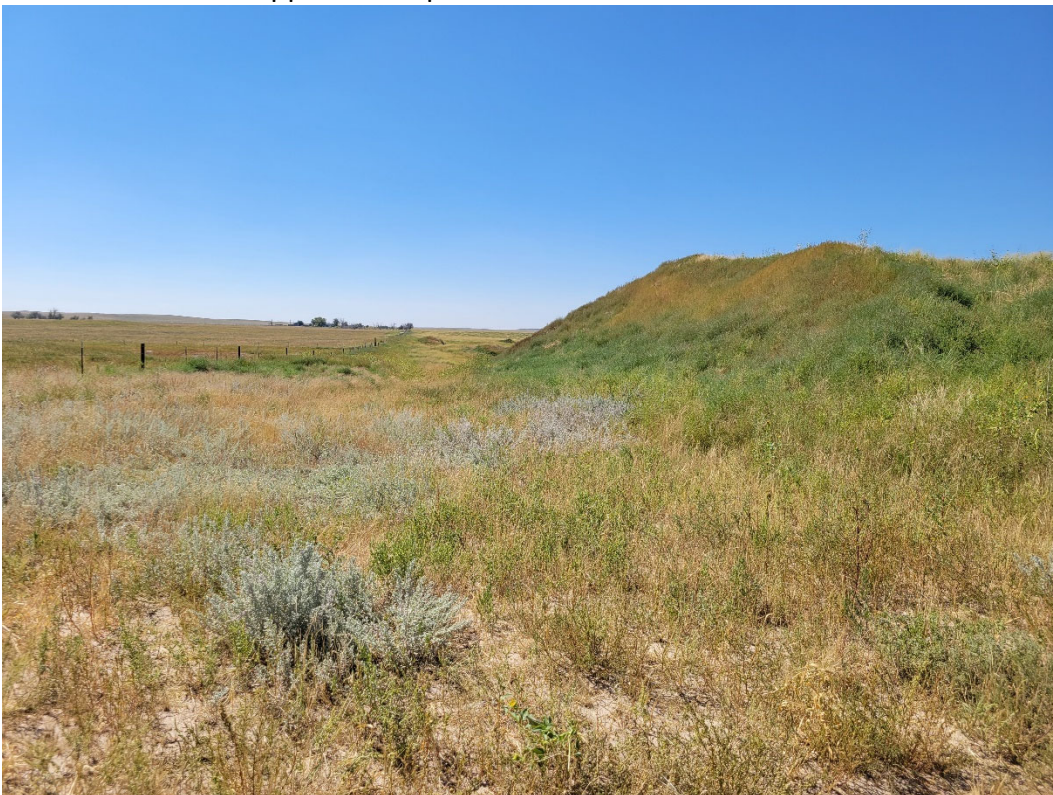
Photo 8: Backside of berm above the east pit. A buffer is currently maintained between the pit and the permit boundary.

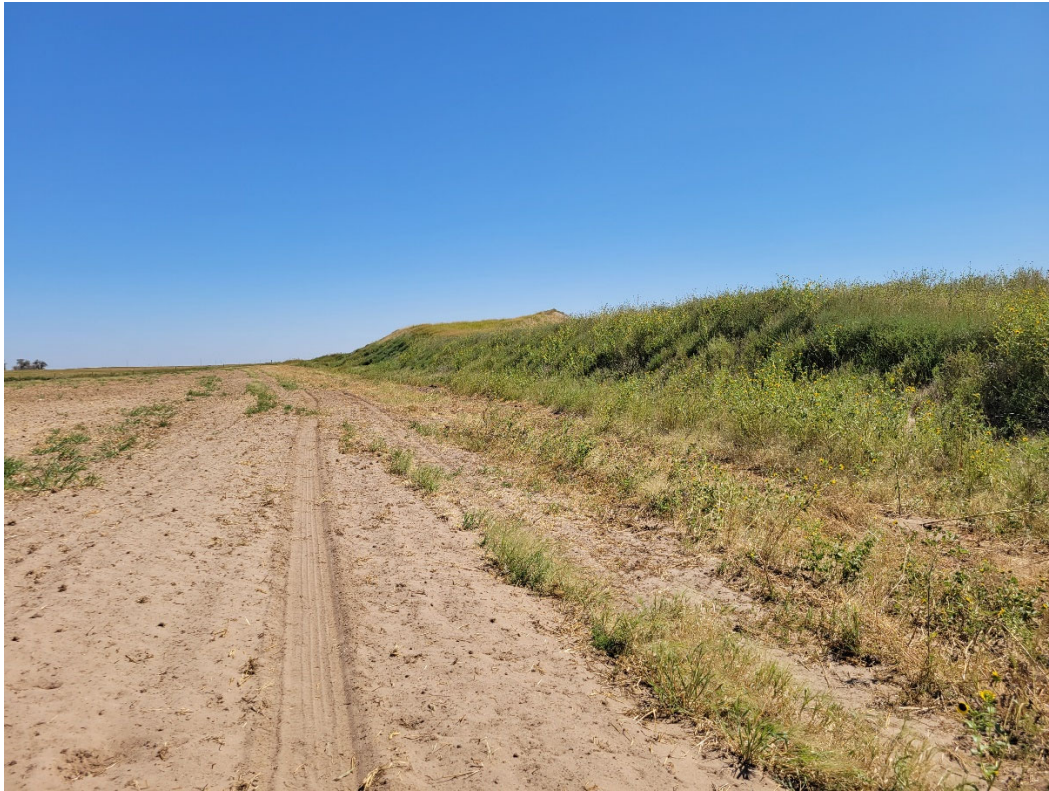
Photo 9: Backside of topsoil berm located above the eastern pit.

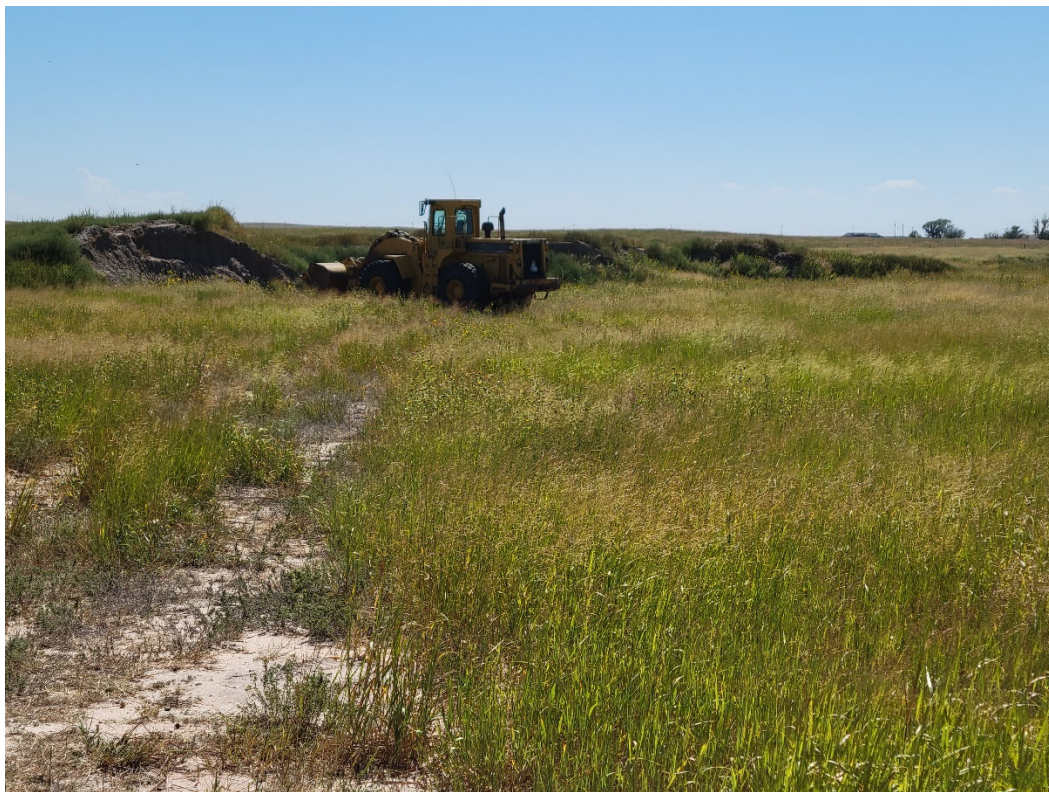
Topsoil is stored in three berms on the east, south and north sides of the pits. The only equipment on site was a front-end loader parked in front of the topsoil berm than runs along the northern boundary of the west side of the access road. The Division observed a small excavation in this topsoil pile. The Division reminded the Operator that the topsoil stored on site must be stored to minimize erosion and disturbance and should only be used to reclaim the affected mining area.

Photo 10: Backside of topsoil pile located about the western pit.
