TRAPPER MINING INC.
CRAIG, COLORADO

HORSE GULCH FILL
QUARTERLY FILL CERTIFICATION

Horse Gulch Fill Quarterly Inspection Report

Fourth Quarter 2023

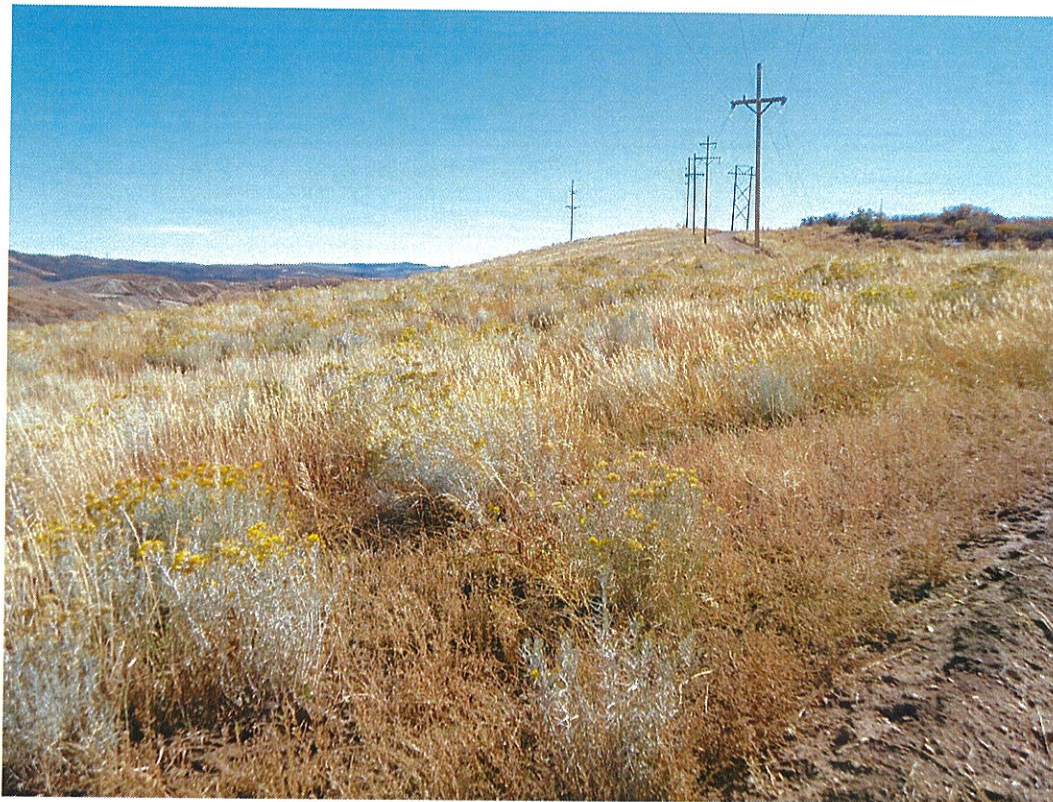
No appearances of instability, structural weakness, or other hazardous conditions were observed. Both the southeast side of the fill and the northeast side of the fill were inspected this quarter (Photographs 1 and 2). The area where cracks were detected on the top south portion of the dump during the first quarter of 2013 inspection was checked. There was no additional cracking found.

Photograph 1: East Side Looking South (10/17/2023)

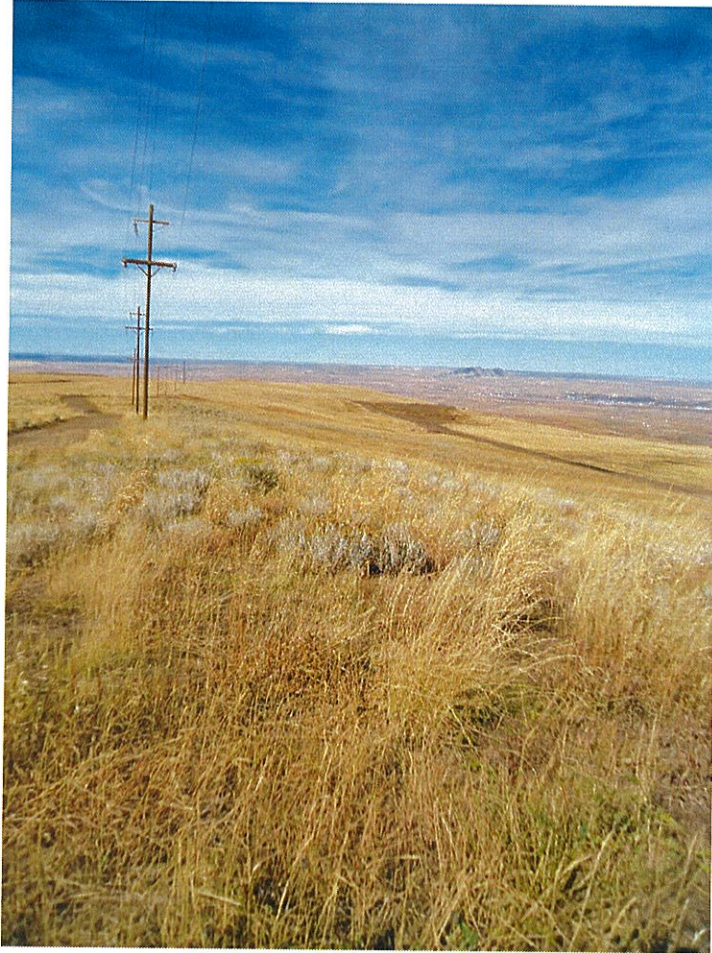
Photograph 2: South Side Looking North (10/17/2023)

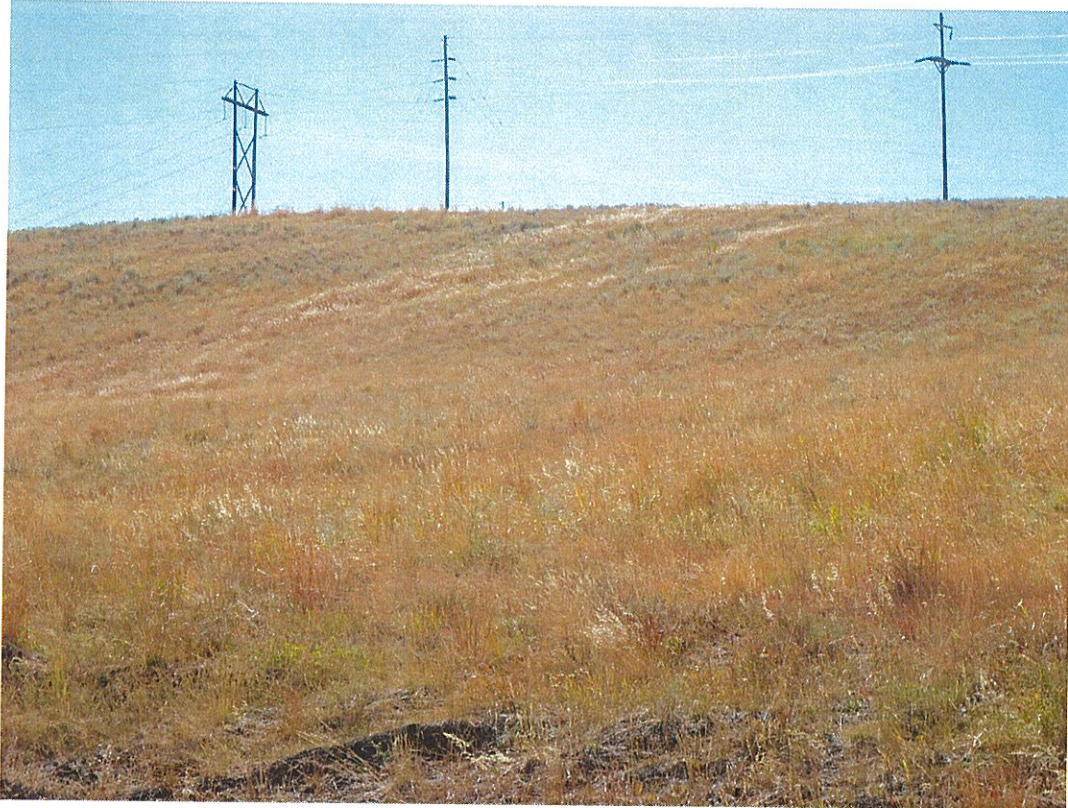
There was no placement of material or contour work done on the fill this quarter. All the required material for the fill has been placed and compacted. It is anticipated there will be no more additional fill material placed on the fill.

Photograph 3: East Side of the Fill Looking South-west (10/17/2023)
